DESIGN / HERITAGE IMPACT  
ASSESSMENT

HENNERY / PIGGERY AT  
BARWICKSTEAD, BECKERMET – 22  
March 2022 – Rev A – 19 July 2022

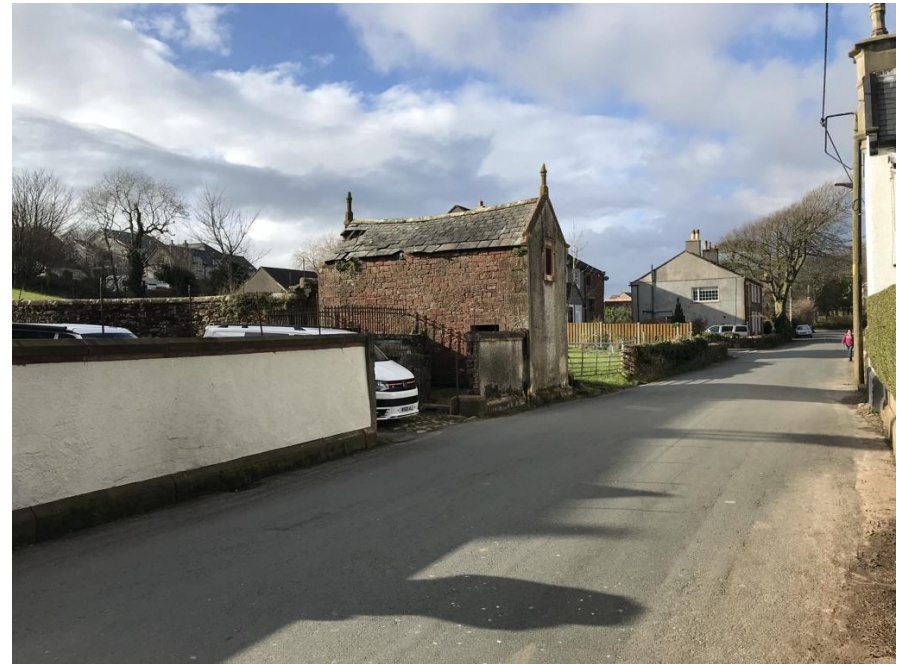
View of Piggery from Main Street, deflection in existing roof evident and loose slates.

4. Roof coverings - the roof will be stripped off and the existing slates removed and re-dressed / re-holed before re-laying with new 25 x 50mm softwood treated graded roof battens. Additional roof slates will be required to make up defective / re-holed slates and this will be sourced as diminishing coursed second hand green slates. A modern breathable roofing felt will be installed to allow flexibility for future use of the building.

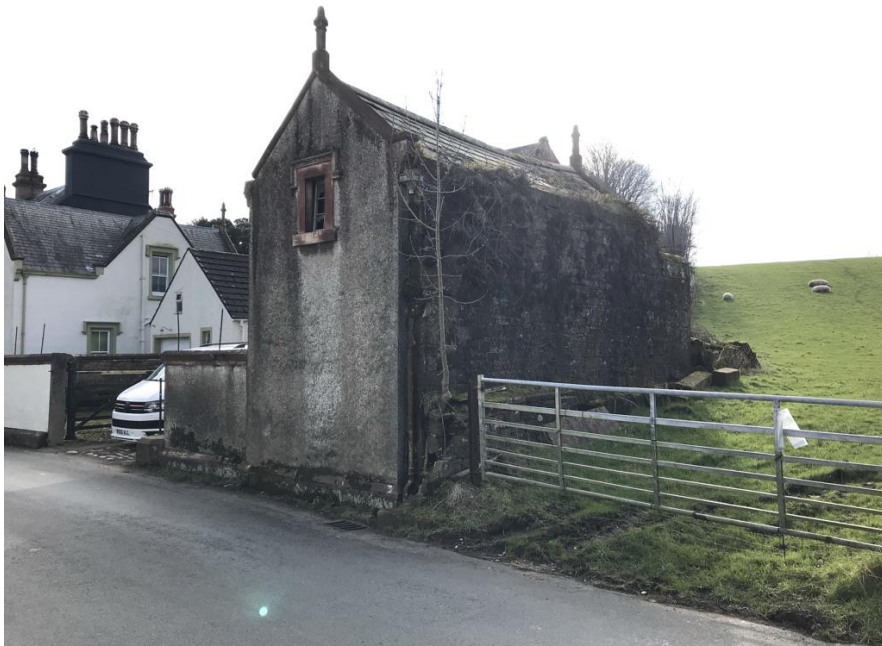
View away from Barwickstead showing barn built into hillside. Vegetation growths to stonework require removal

1. External walls - retained and repaired where required to include re-bedding loose stonework, mouldings etc and bedding with lime mortar. Removal of all vegetation growth from the jointing of the stonework. Elevations to be cleaned off with power washing with option for light sandblast cleaning in areas of lime wash / render. Loose mortar joints to be raked out and re-pointed in lime mortar.
2. Internal walls - these are to be cleaned down and re-pointed with all vegetation growth removed.

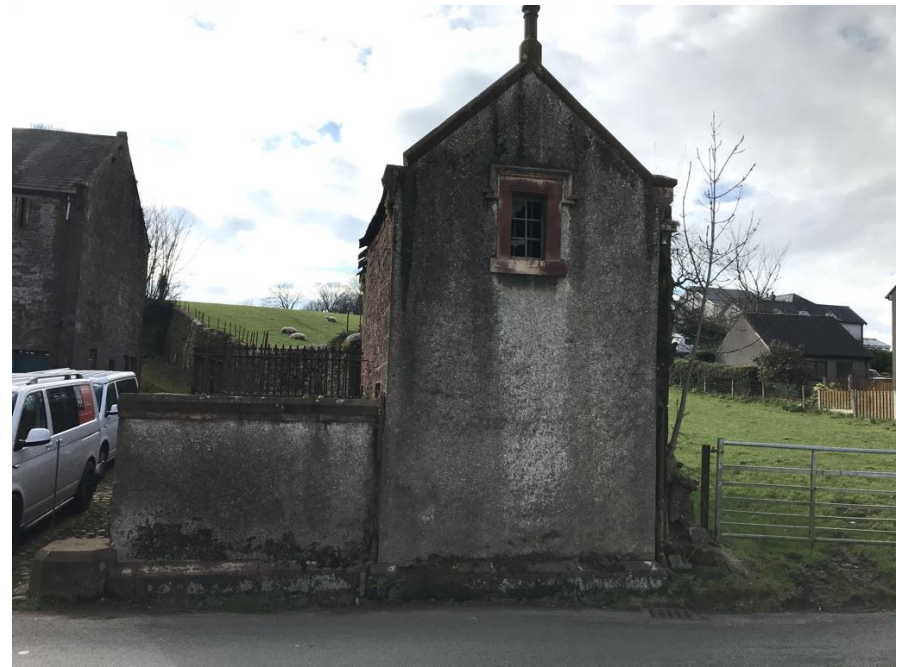
Front elevation with spar dash to roadside and hooded mouldings to gable window

With reference to the rendered gable on the roadside we believe this is a modern addition to aid waterproofing, this will be removed and the condition of the walling behind will be checked, if in poor condition we will consider re-rendering this wall in a new lime render

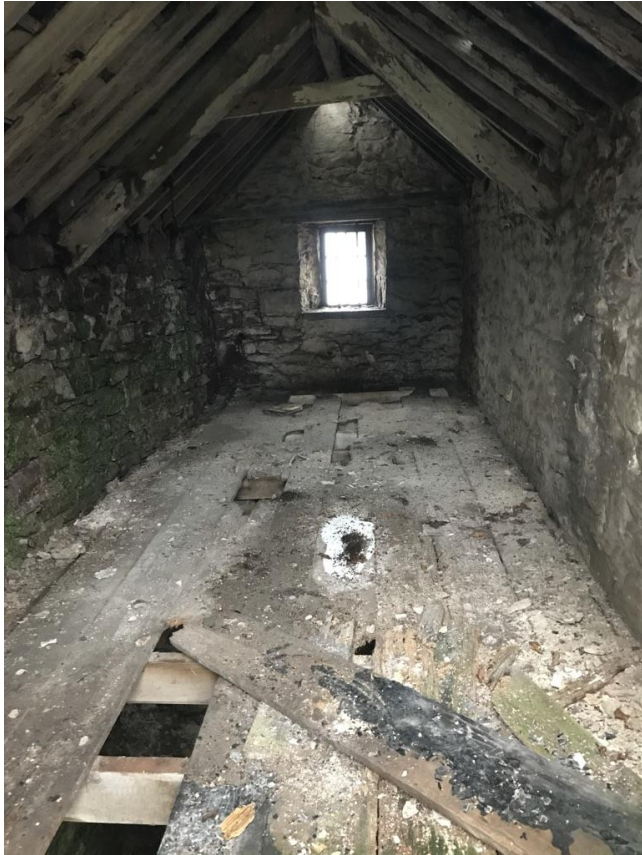
Internal view of upper floor level with decayed floor boards and joists

5. Lower Ground Floor - stone floor - this will be lifted and repaired and re-laid onto new compacted stone base layer.
6. Upper Ground Floor - existing floor joists are rotten and this need removing. These will be replaced with new softwood treated timbers to match the existing cross sections, and then re-pocketed into the solid external sandstone walls. The ends of the floor joists will be protected in dpc to

prevent driven moisture effecting the ends of the timbers.

The existing timber plank flooring is to be removed and replaced due to decay - with new 22mm timber floor rough sawn treated timber to replicate existing coverings.

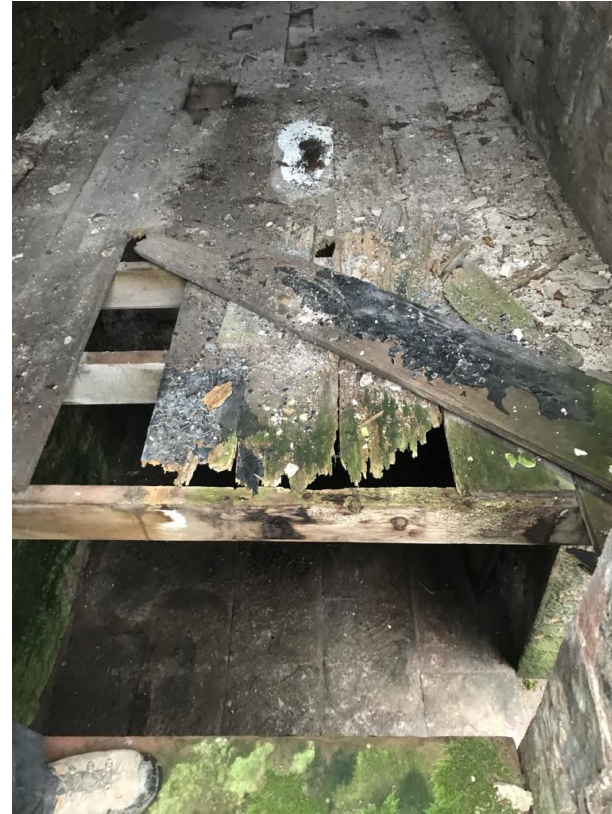
Joists and flooring missing at entrance due to water penetration below the original door

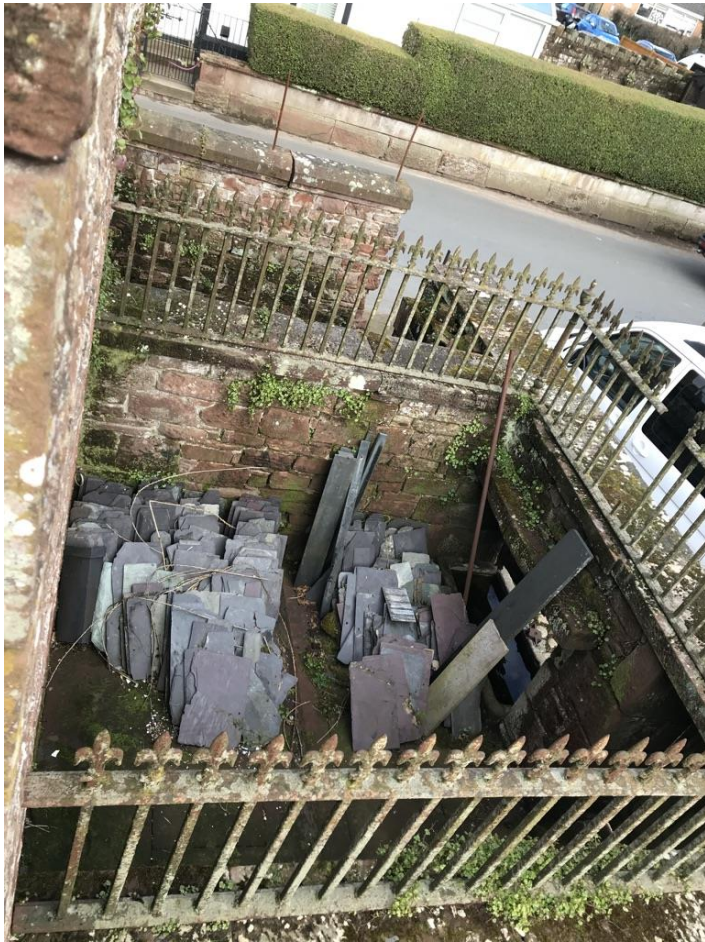
View down into rear of external pigsty from rear access stair

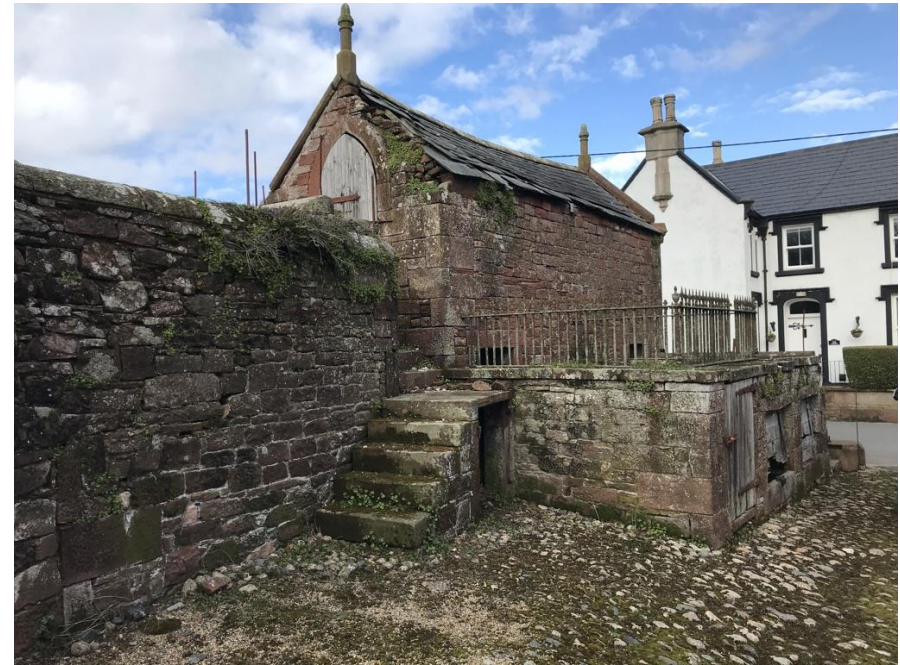
Rear view of Piggery showing decay in stonework (retained on site) and loose / slipped slates as a result of timber failure.
