## Proposed Residential Development

Cleator Mills, Cumbria

# Flood Risk Assessment

# Cleator Flood Asset Condition Assessment

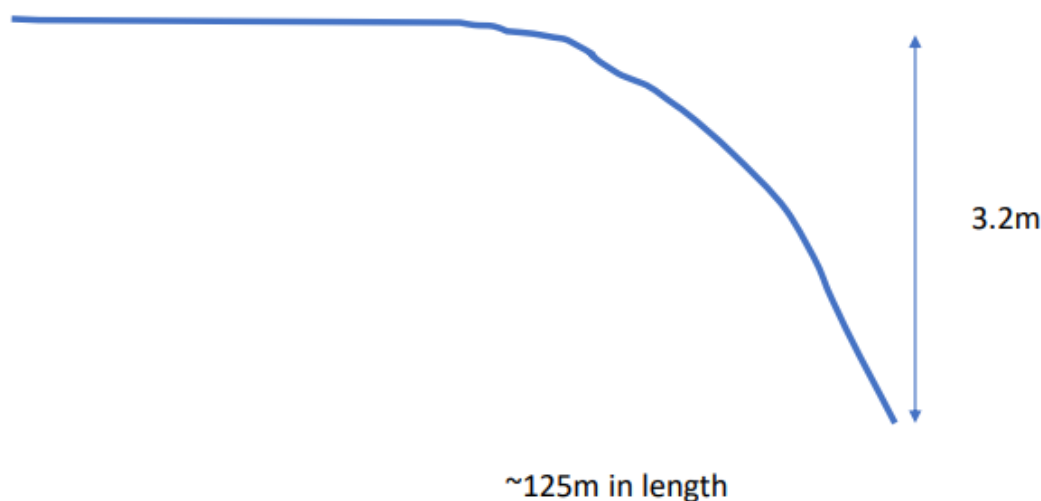
## CL13 – Natural High Ground

Stretch of natural high ground with vegetation and trees.

Significant undermining, erosion, and presence of light foreign objects on channel side. High ground in good condition.

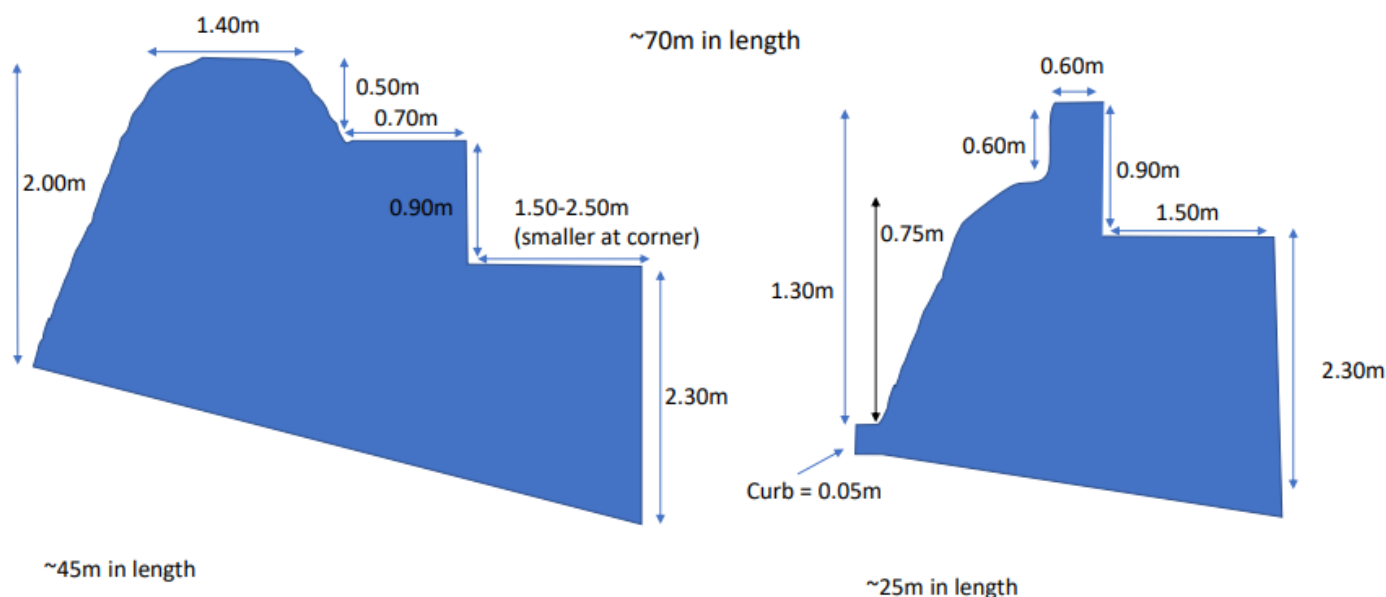
## CL22 – Embankment

Earth embankment with stone wall and sheet piling exposed faces and concrete berm. Crest height and embankment width reduce as earth landward face diminishes and crest changes to stone crest.

Minor vegetation growth within berm 1 and exposed face 2 with minor mortar loss. Uneven crest with some low spots but well vegetated. Berm 2 and channel side in good condition with minor cosmetic defects to sheet piling. Landward face and exposed face 1 are well vegetated but uneven. Landward face 2 around corner and has minor vegetation growing through stone and minor mortar loss.

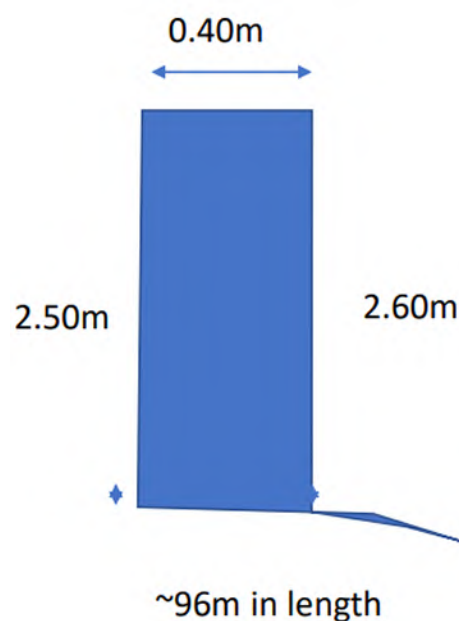
## CL24 – Wall

High stone wall with capping stones located off right bank and going away from main channel towards village.

Minor vegetation growth through crest. Minor mortar loss on exposed face and a couple of holes on both faces, not whole way though. Few bricks missing for drainage

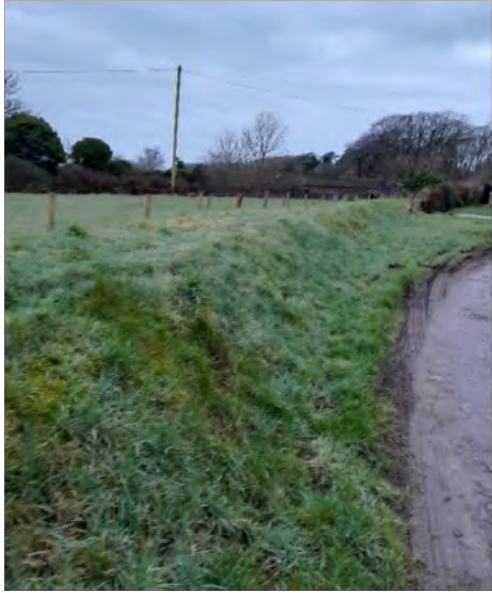
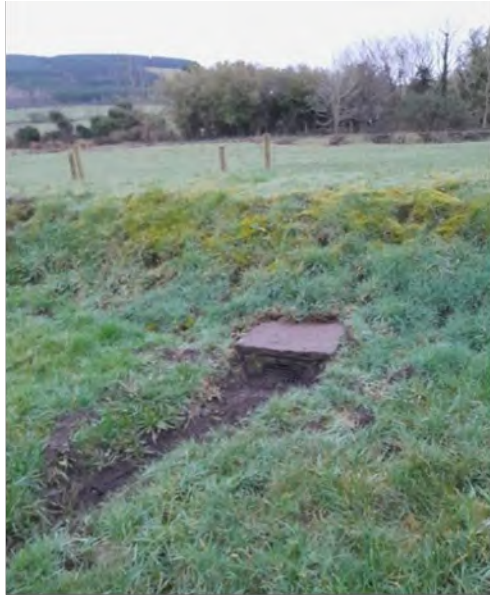
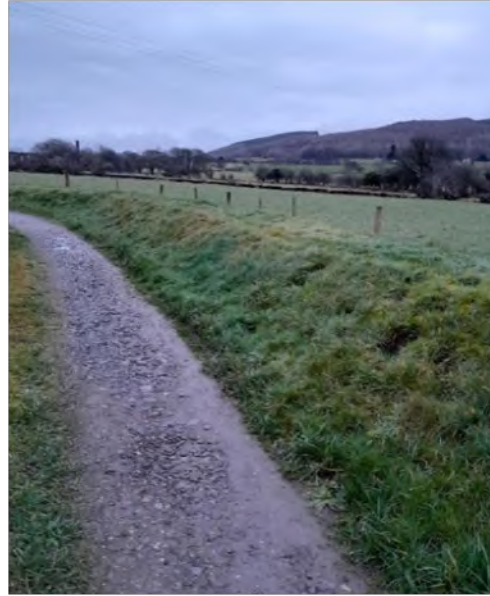
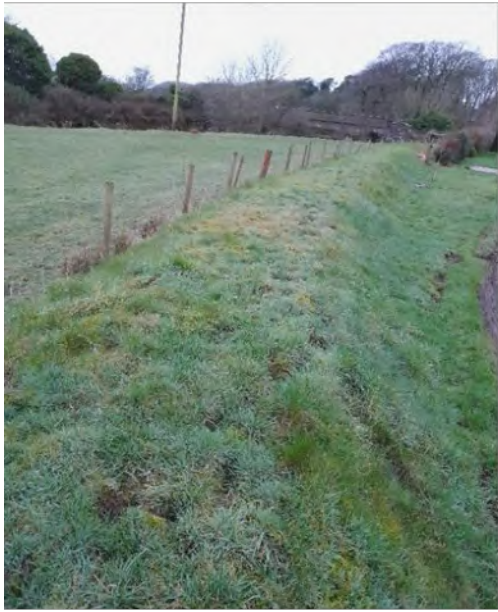
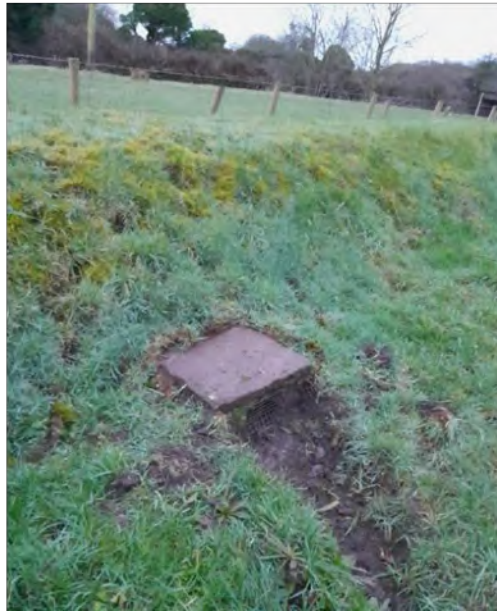
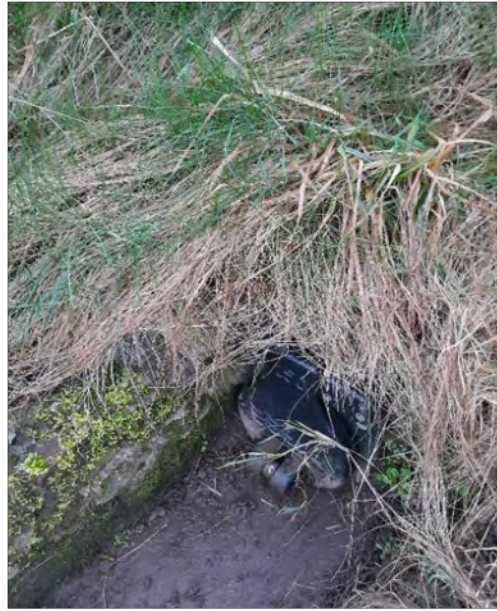
| <b>Comments</b> | Variant weighting used for crest as <4m wide. Drainage pipe running through entire width of embankment, low spots, some animal holes and rutting on crest, Landward face and exposed face have some holes and uneven slopes but are well vegetated. Undermining, minor erosion and light foreign objects present on channel side but currently stable. | | | | | | |

| <b>Recommendations</b> | Infill low spots on crest, remove drainage pipe from embankment and consider pest control. | | | | | | |

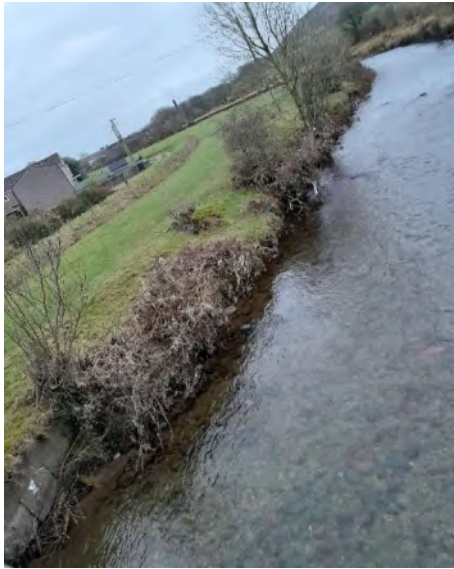
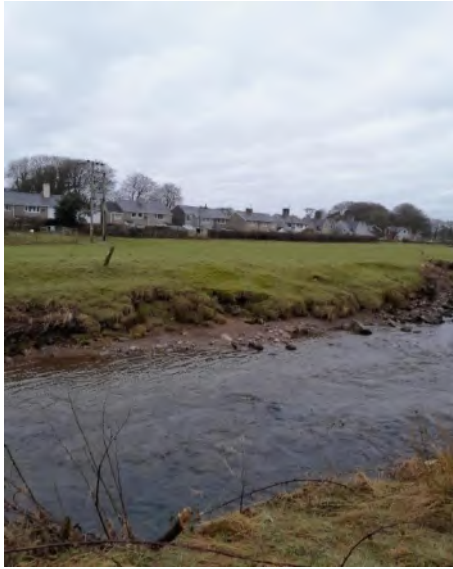
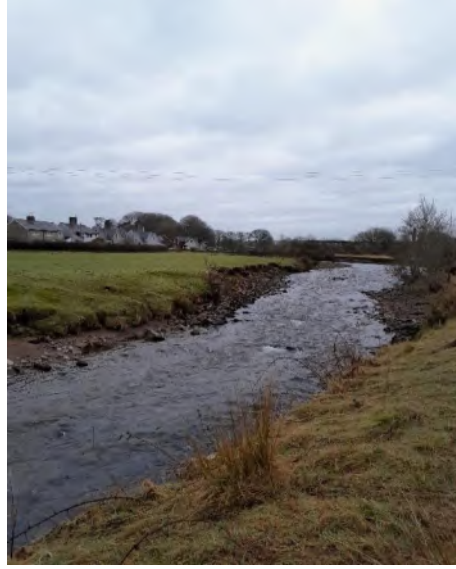
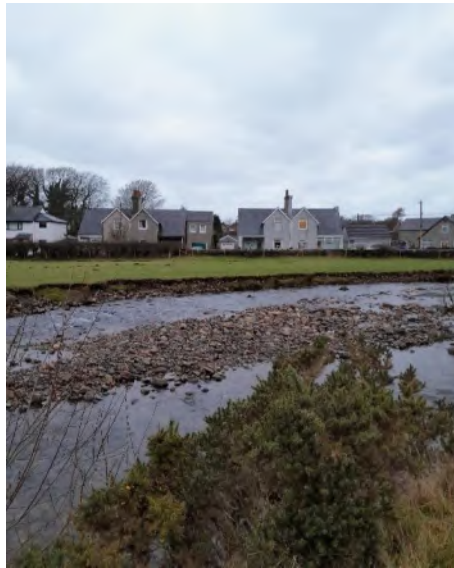
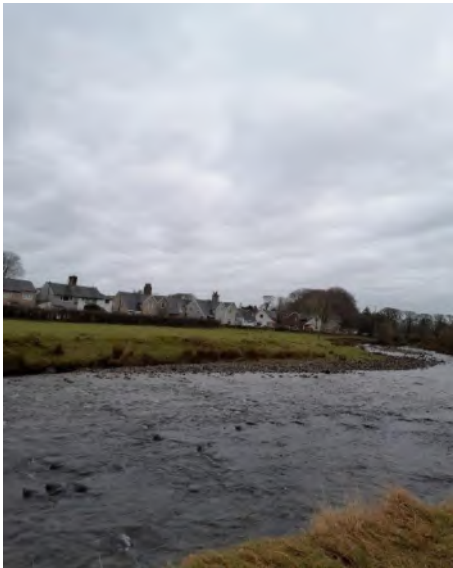
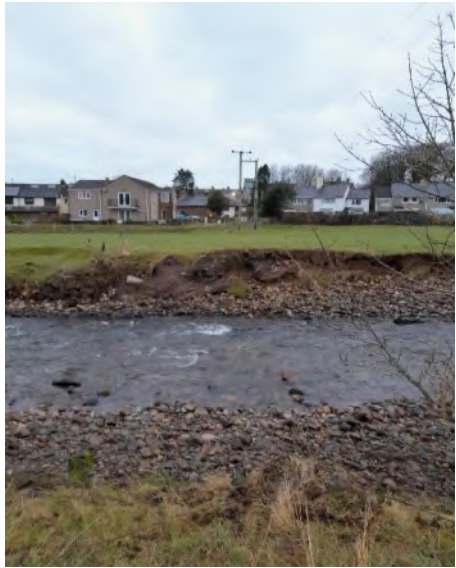
| Asset ID | | Frequency | | | | | |
|---|---|---|---|---|---|---|---|
| Comments | Significant undermining, erosion and presence of light foreign objects on channel side. High ground in good condition. | | | | | | |

| Asset ID | | Frequency | | | | | |
|---|---|---|---|---|---|---|---|
| Recommendations | Monitor erosion, consider installing erosion protection layer to channel side. | | | | | | |

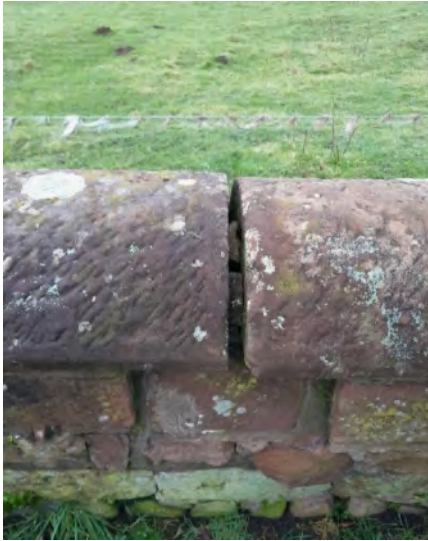
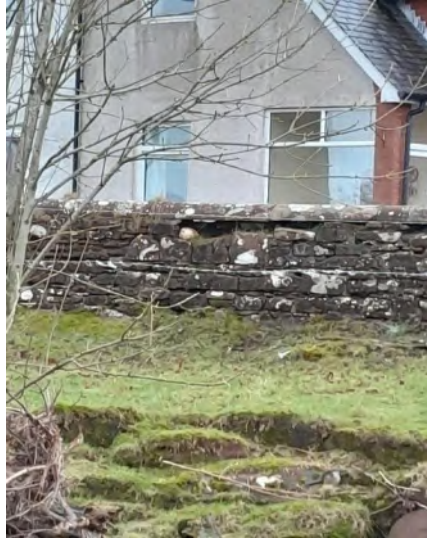
| Asset ID | CL3 | Frequency | | | | | |
|---|---|---|---|---|---|---|---|
| Comments | Variant weightings used for both faces as no revetments. Significant mortar loss to crest, holes through wall, bulging of wall where light foreign objects are growing in front on wall, distorting its shape and minor erosion to channel side. | | | | | | |

| Asset ID | CL3 | Frequency | | | | | |
|---|---|---|---|---|---|---|---|
| Recommendations | Rebuild wall and remove trees in front of wall. | | | | | | |

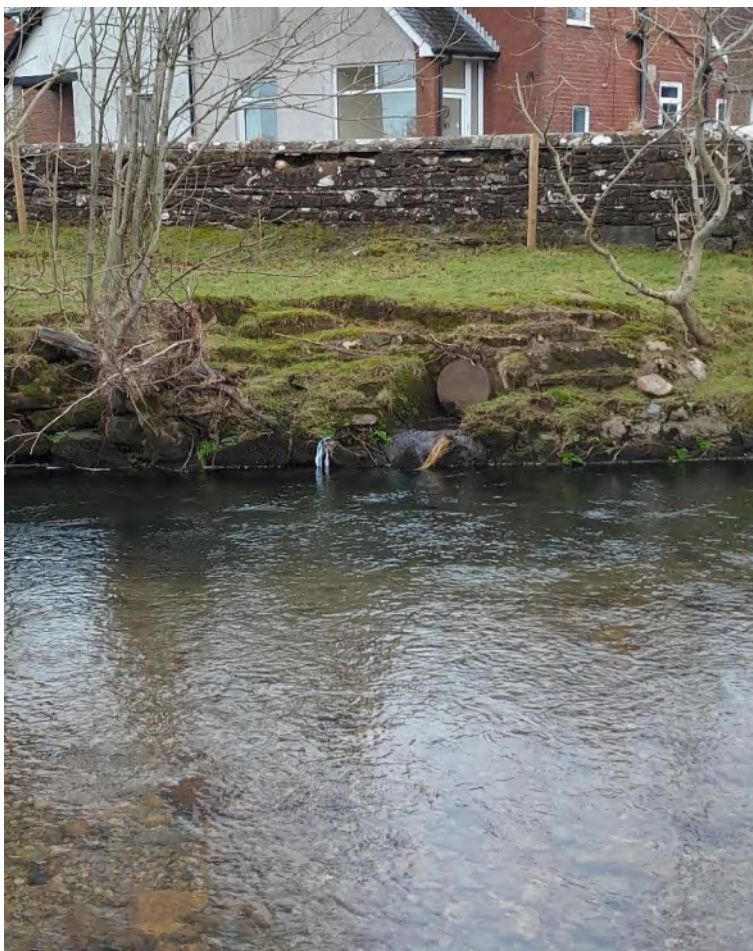
| <b>Asset ID</b> | CL4 | <b>Frequency</b> | | | | | |

| <b>Comments</b> | Vegetation around headwall. Unable to see through pipe and no CCTV footage available. | | | | | | |

| <b>Recommendations</b> | Conduct a CCTV survey to inspect pipe and remove vegetation around headwall. | | | | | | |

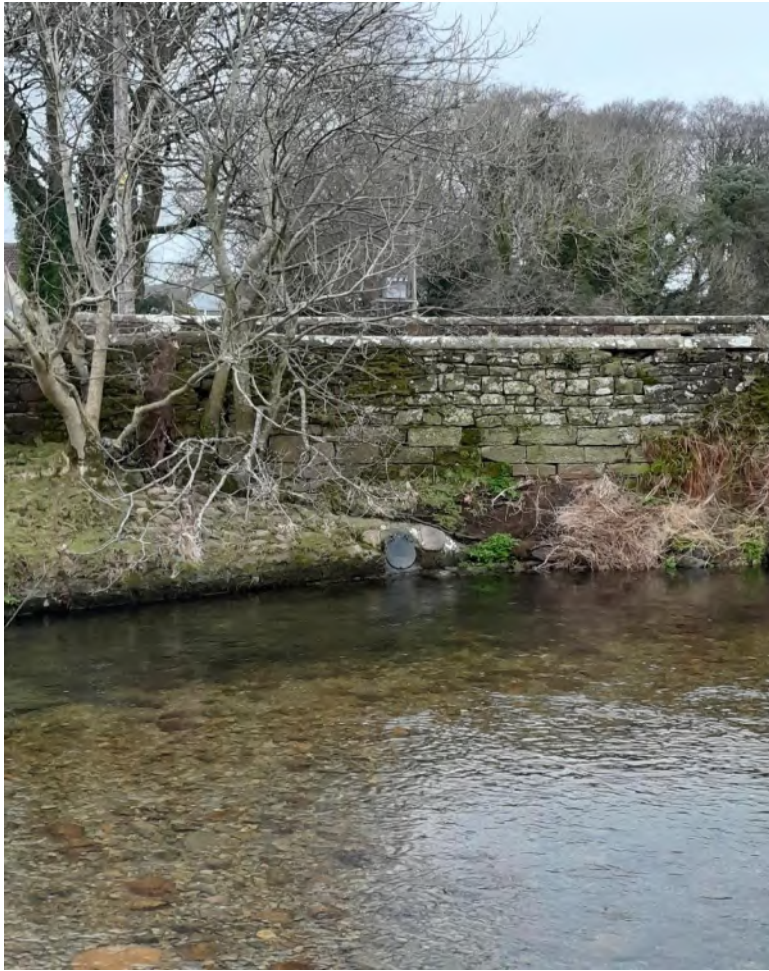
| <b>Asset ID</b> | CL5 | <b>Frequency</b> | | | | | |

| <b>Comments</b> | Outfall in good condition, very minor corrosion present on frame and flap valve. Unable to see through pipe and no CCTV footage available. | | | | | | |

| <b>Recommendations</b> | Conduct a CCTV survey to inspect pipe. | | | | | | |

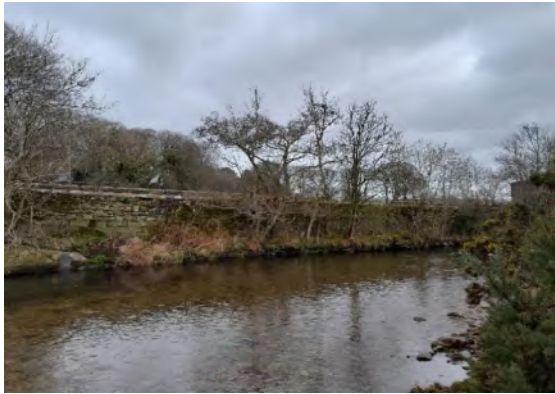
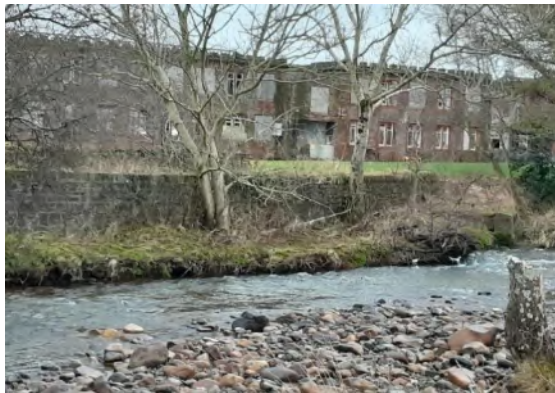
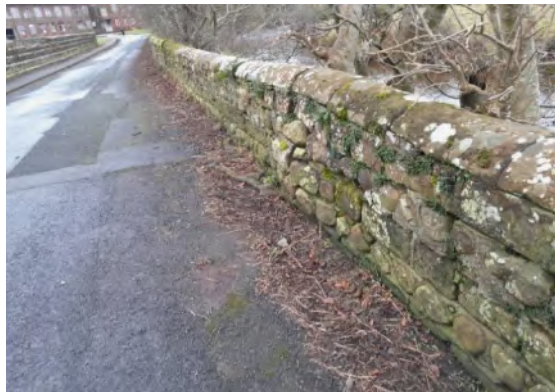
| Asset ID | CL6 | Frequency | | | | | |
|---|---|---|---|---|---|---|---|
| Comments | Heavy foreign objects growing towards channel on berm and channel side and undermining on channel side causing channel side to be unstable. Ivy growth on wall, heavy foreign objects growing close to wall causing bulging to wall and capping stones lost from crest halfway across wall. | | | | | | |

| Asset ID | CL6 | Frequency | | | | | |
|---|---|---|---|---|---|---|---|
| Recommendations | Rebuild wall, remove unstable trees and remove trees next to wall. | | | | | | |

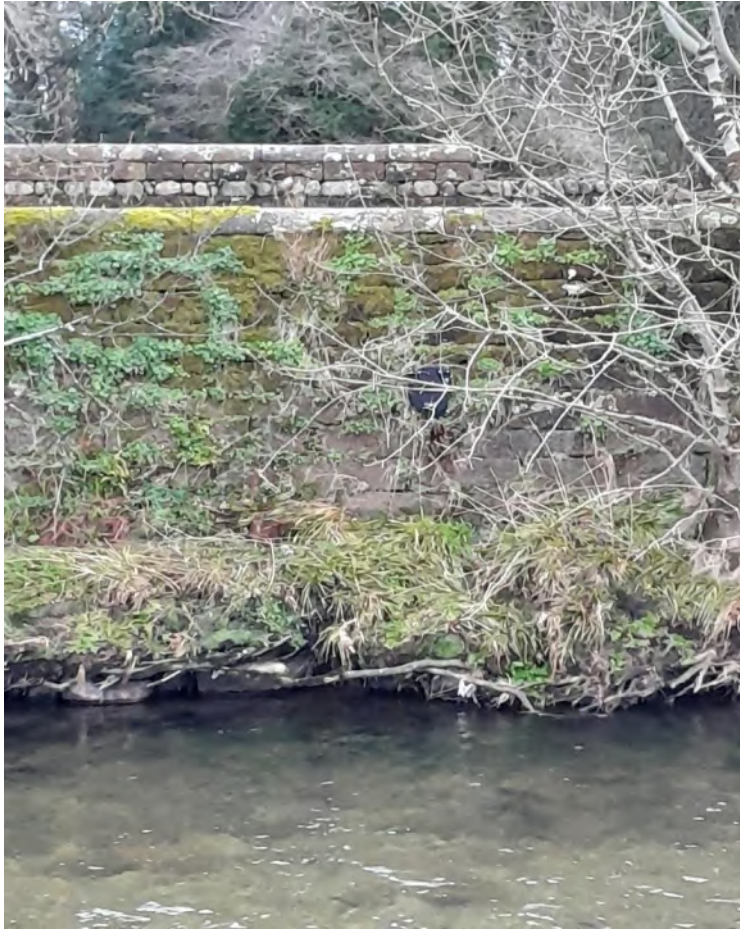
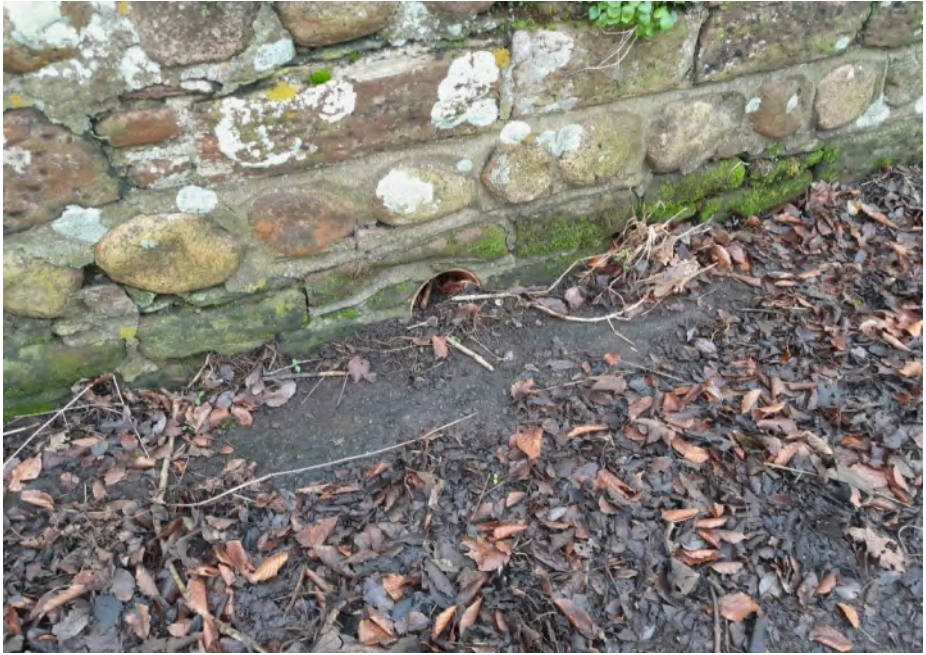
| <b>Comments</b> | No signs of corrosion to flap valve or frame, pipe has minor leaf debris but no blockages or damage. Downstream headwall has some cracks, vegetation growth and mortar loss. | | | | | | |

| <b>Recommendations</b> | Continue with ongoing vegetation maintenance. | | | | | | |

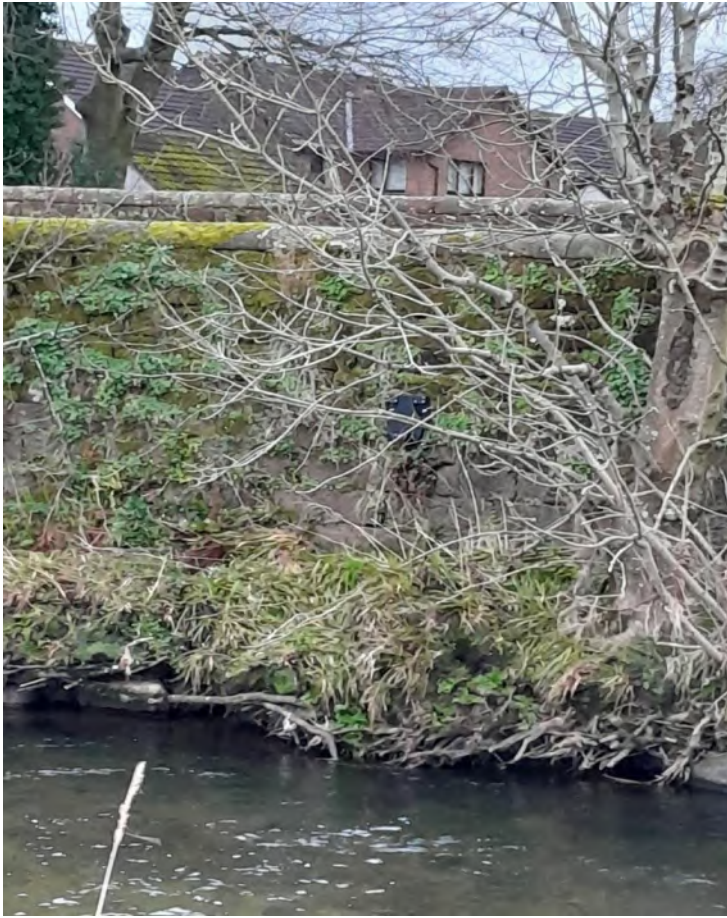
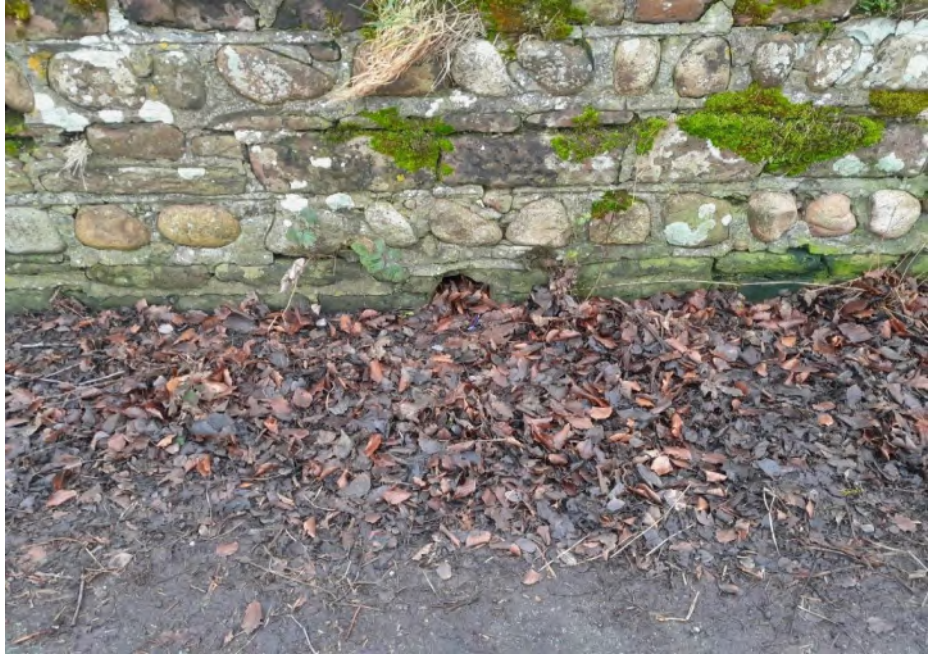
| <b>Comments</b> | No signs of corrosion to flap valve or frame, pipe has minor leaf debris but no blockages or damage. Minor crack to downstream headwall, vegetation growth and mortar loss. | | | | | | |

| <b>Recommendations</b> | Continue with ongoing vegetation maintenance. | | | | | | |

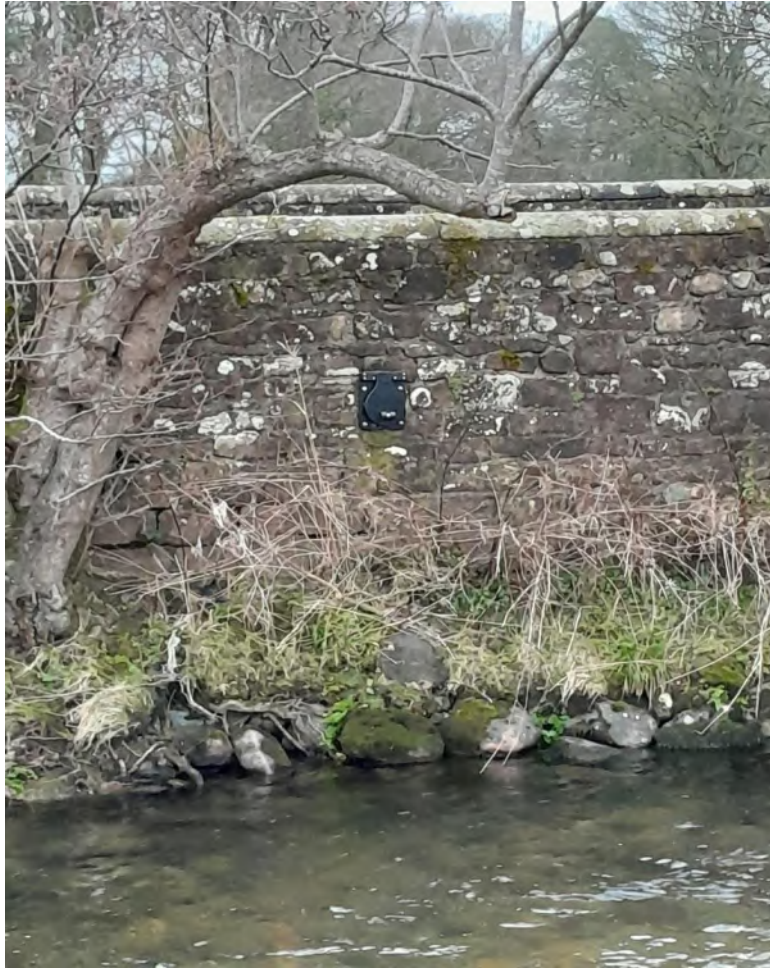
| <b>Comments</b> | No corrosion to flap valve or frame. Cracks and mortar loss on headwall. Pipe has minor leaf debris but no blockages or damage. | | | | | | |

| <b>Recommendations</b> | Remove vegetation and continue with vegetation maintenance. | | | | | | |

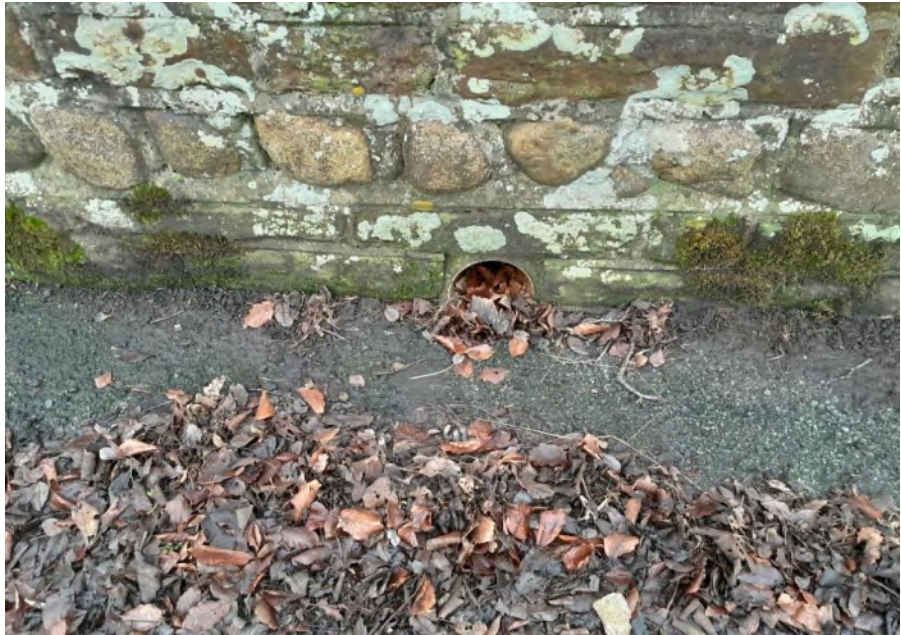
| <b>Comments</b> | Ivy growth around frame and headwall. No corrosion to flap valve. Cracks and vegetation growth on headwall. Pipe has minor leaf debris but no blockages or damage. | | | | | | |

| <b>Recommendations</b> | Remove vegetation and continue with vegetation maintenance. | | | | | | |

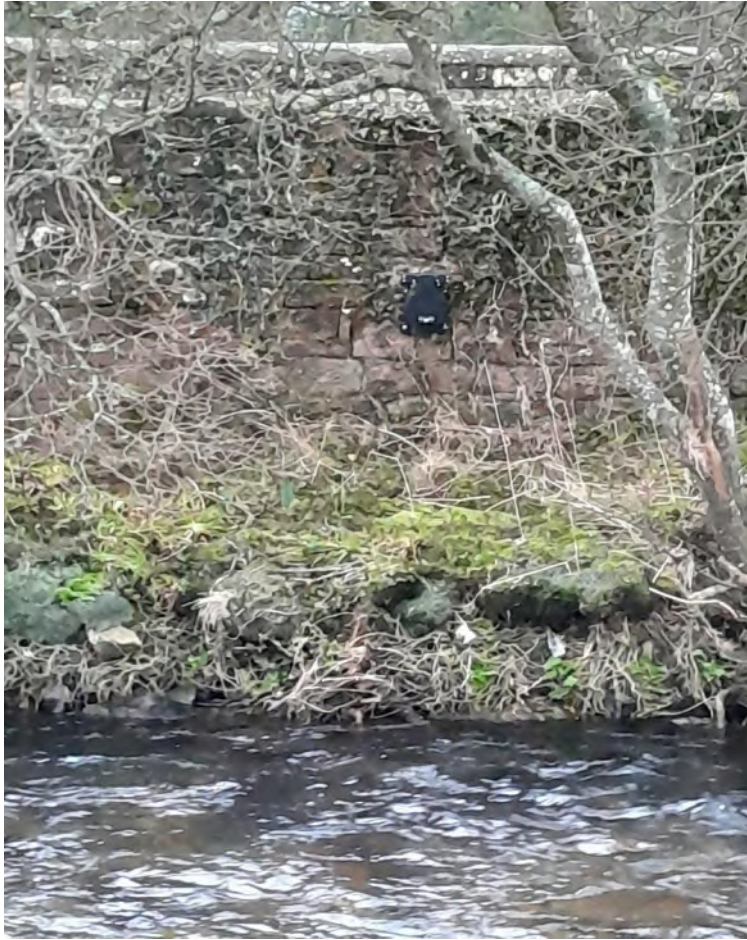
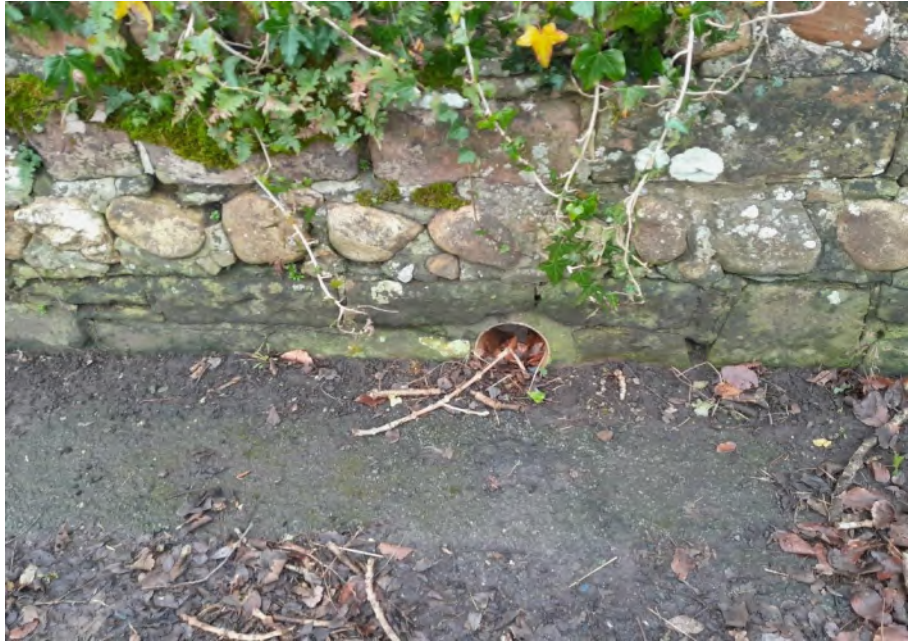
| <b>Comments</b> | Ivy growth around frame and headwall. No corrosion to flap valve. Minor cracks and vegetation growth on headwall. Pipe has vegetation debris but no blockages or damage. | | | | | | | |

| <b>Recommendations</b> | Remove vegetation and continue with vegetation maintenance. | | | | | | | |

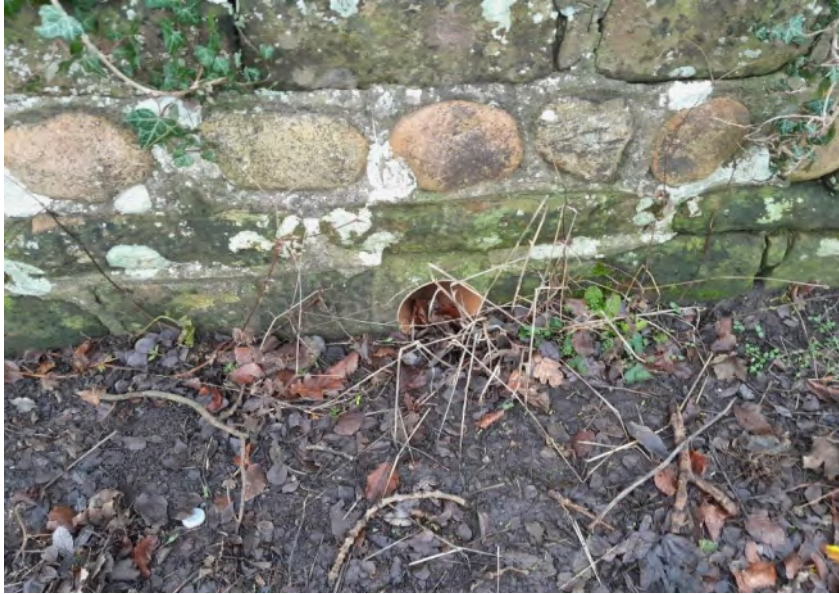
| <b>Asset ID</b> | CL12 | <b>Frequency</b> | | | | | |

| <b>Comments</b> | No corrosion to flap valve or frame. Minor cracks, mortar loss and minor vegetation growth on headwall. Pipe has minor leaf debris but no blockages or damage. | | | | | | |

| <b>Recommendations</b> | Remove vegetation and continue with vegetation maintenance. | | | | | | |

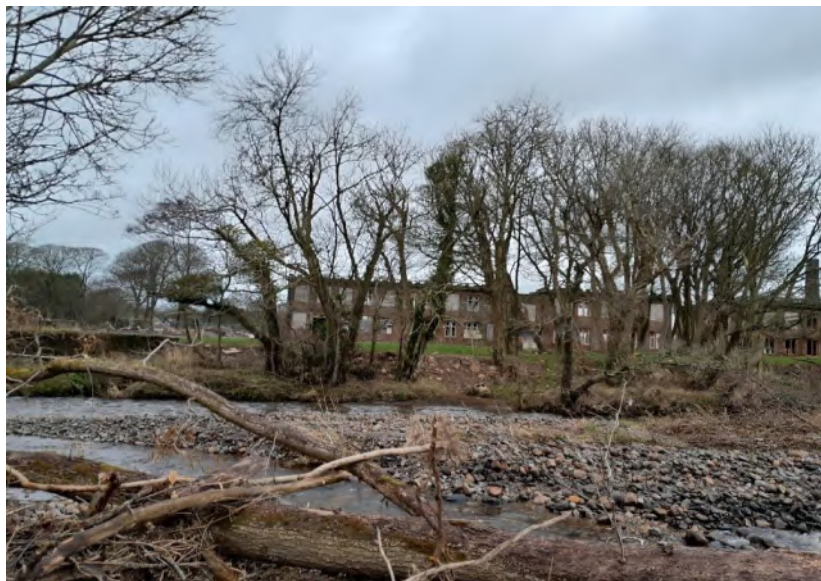
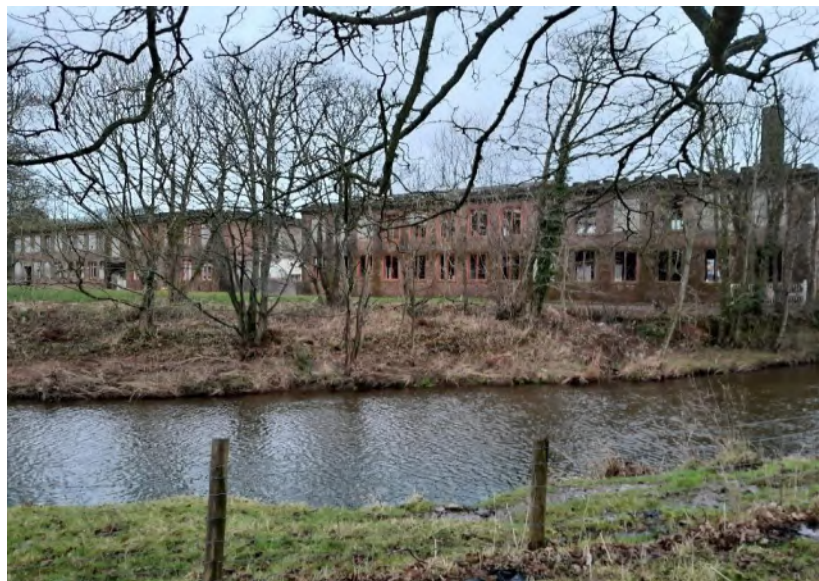
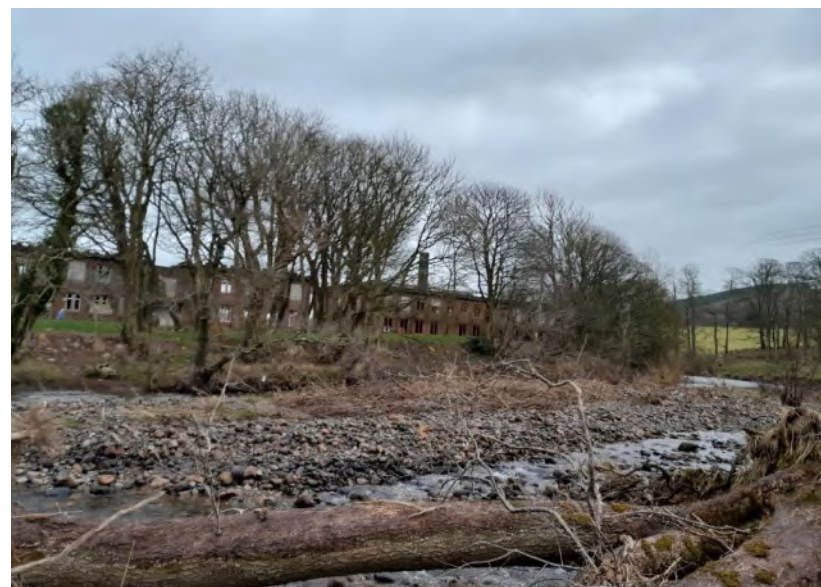
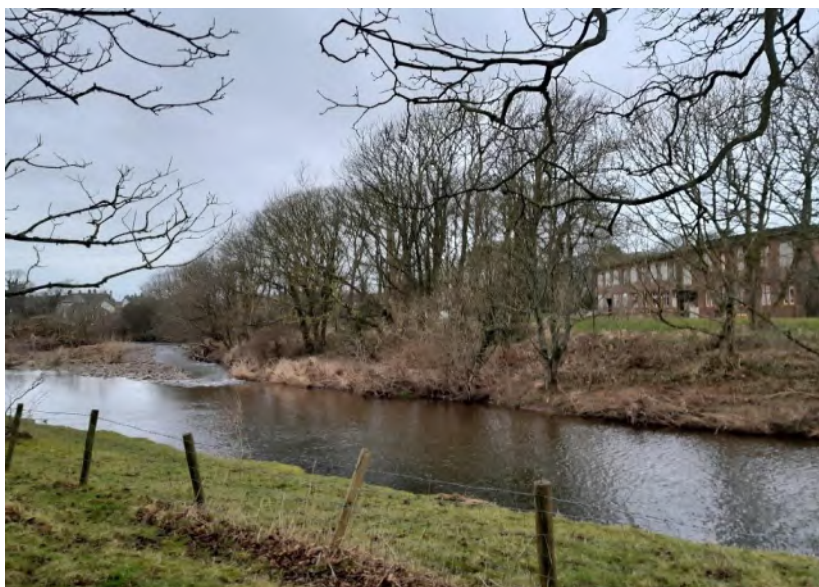
| <b>Asset ID</b> | CL13 | <b>Frequency</b> | | | | | | |

| <b>Comments</b> | Significant undermining, erosion and presence of light foreign objects on channel side. High ground in good condition. | | | | | | | |

| <b>Recommendations</b> | Monitor erosion, consider installing erosion protection layer to channel side. | | | | | | | |

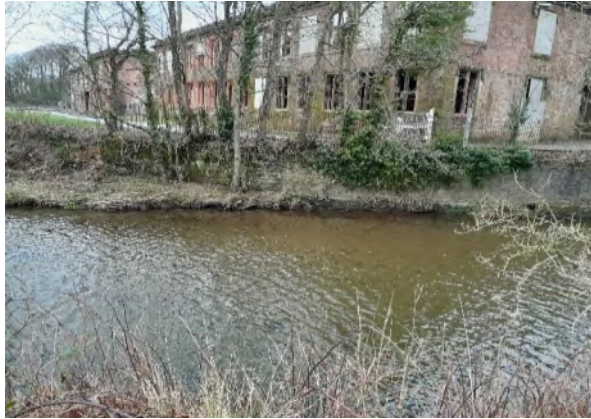
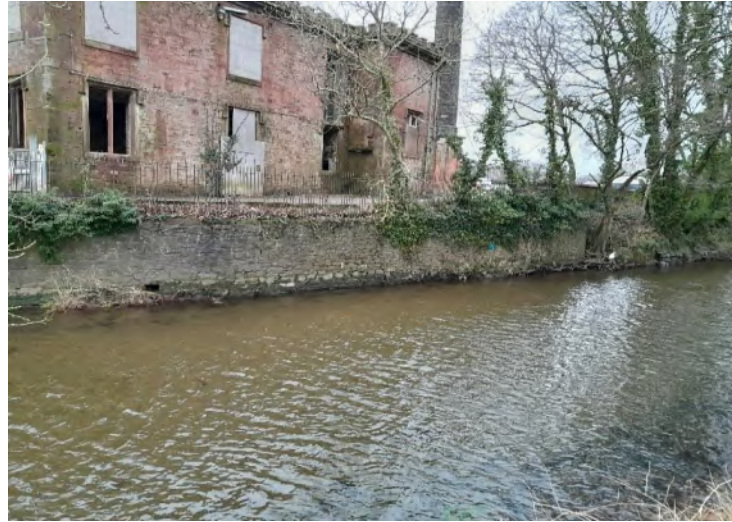
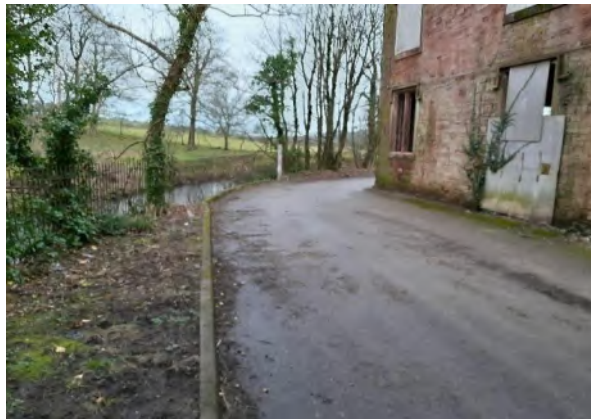
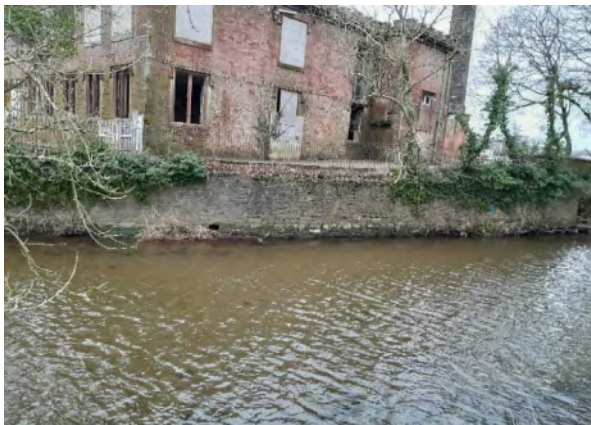
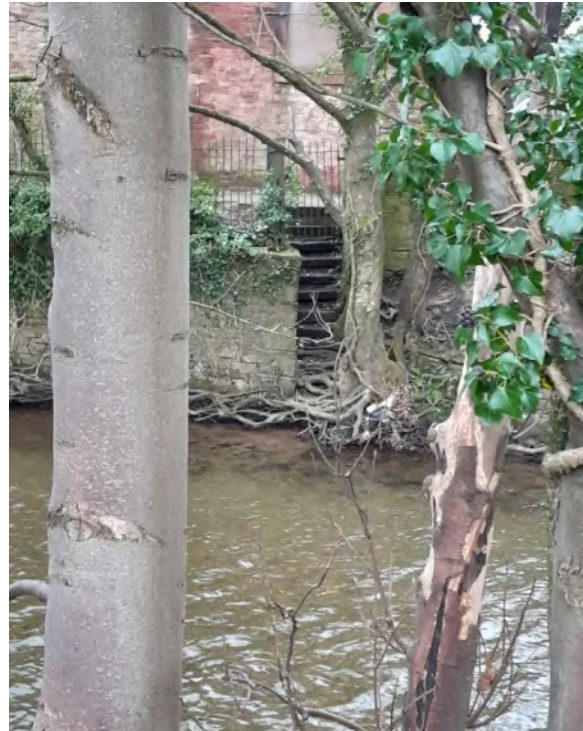
| <b>Comments</b> | Light foreign objects and ivy growing in front of and on top of channel side wall. High ground is road in good condition. Heavy foreign object upstream with roots growing into channel side brickwork. | | | | | | | |

| <b>Recommendations</b> | Remove trees on top of and in front of channel side brickwork. Remove ivy. | | | | | | | |

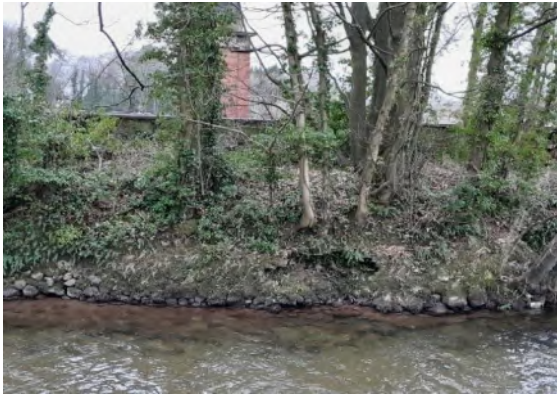
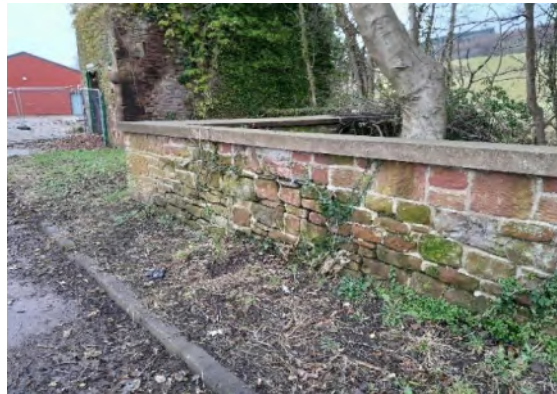
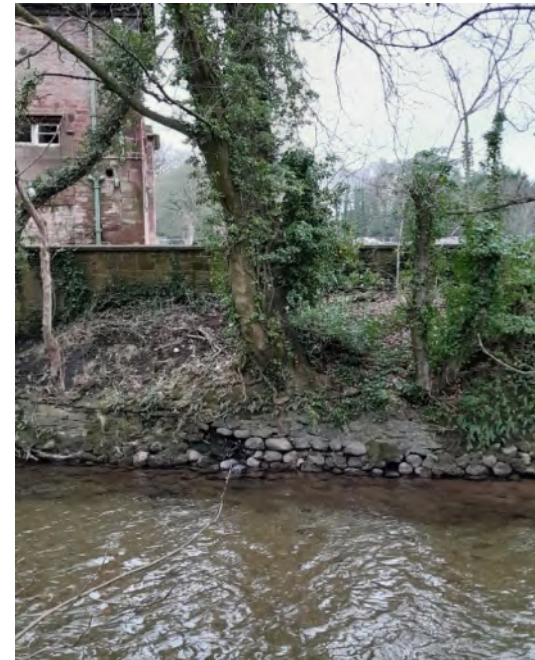
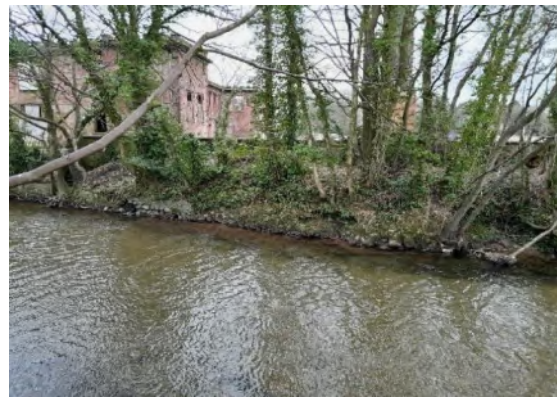
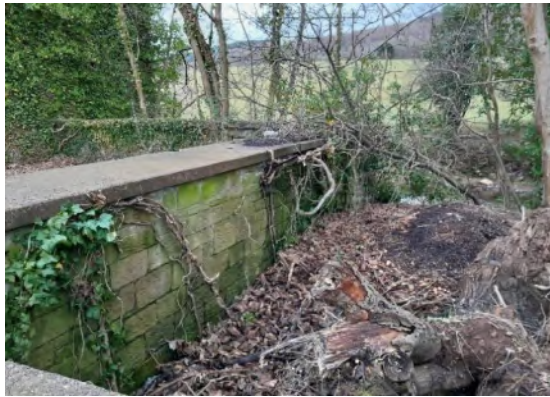
| Asset ID | CL15 | Frequency | | | | | |
|---|---|---|---|---|---|---|---|
| Comments | Several heavy foreign objects on berm and channel side. Severe mortar loss in landward face, exposed face difficult to inspect but wall covered in ivy and some tree roots and growing through it. Crest is uneven where ivy has grown around it. | | | | | | |

| Asset ID | CL15 | Frequency | | | | | |
|---|---|---|---|---|---|---|---|
| Recommendations | Rebuild wall, remove ivy and remove trees growing into wall. | | | | | | |

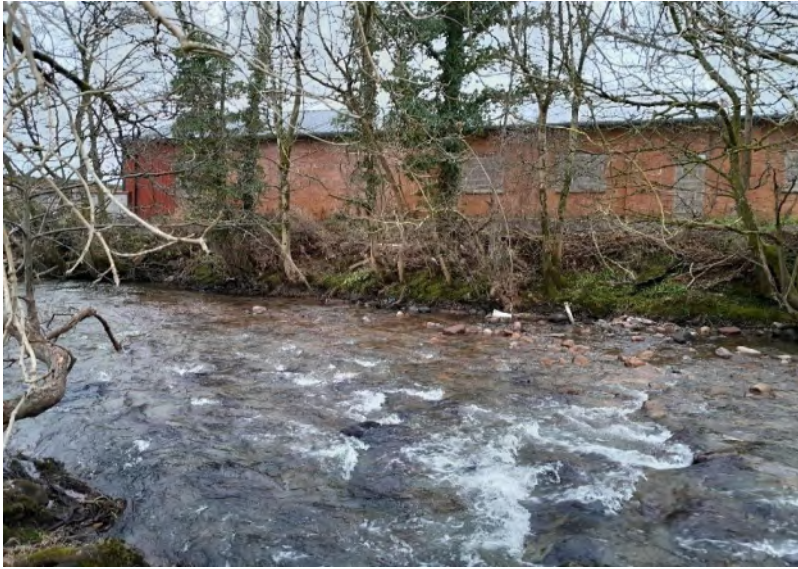
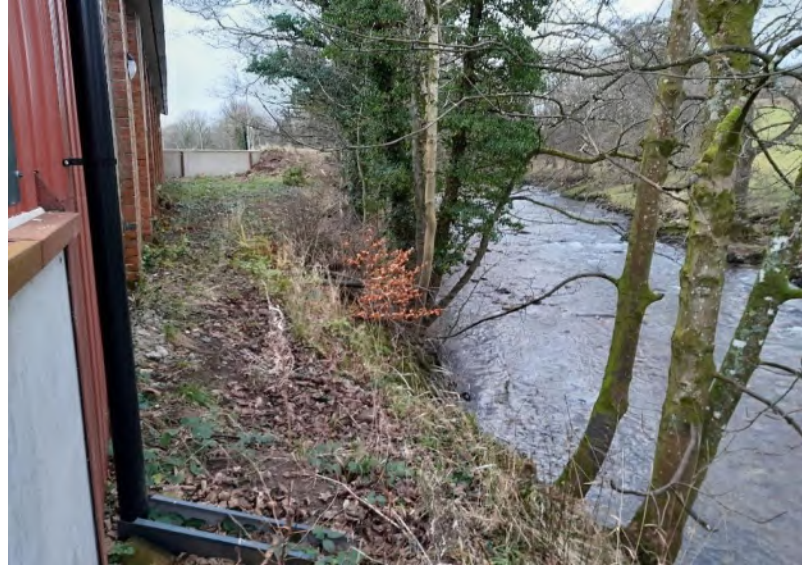
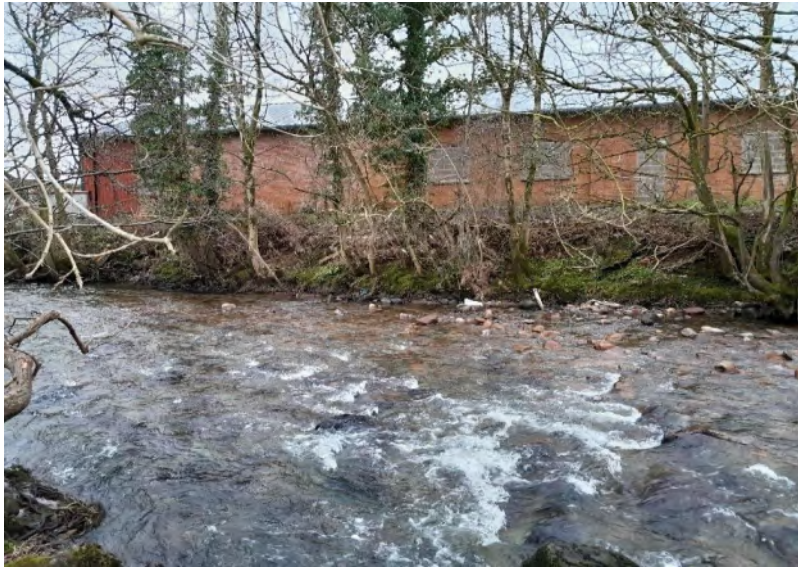
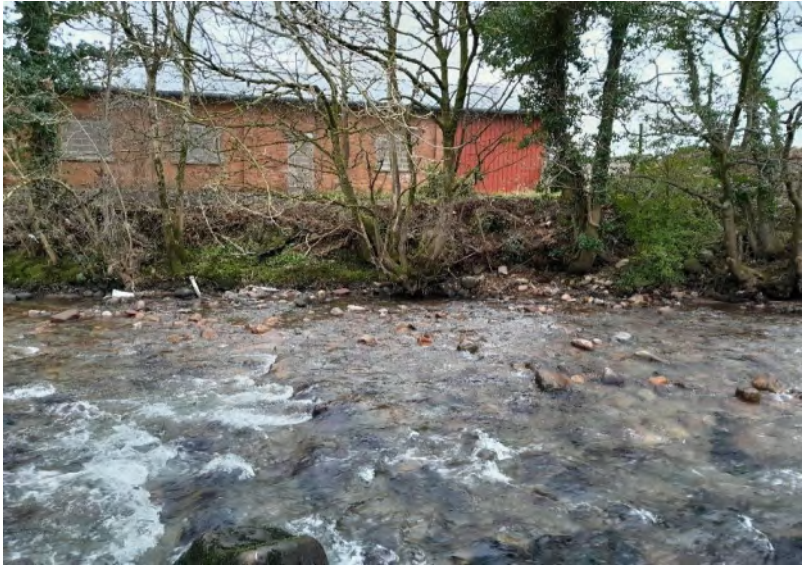
| Asset ID | CL17 | Frequency | | | | | |
|---|---|---|---|---|---|---|---|
| Comments | Heavy foreign objects on channel side leaning towards channel. Building <3m from channel on high ground. | | | | | | |

| Asset ID | CL17 | Frequency | | | | | |
|---|---|---|---|---|---|---|---|
| Recommendations | Continue with vegetation maintenance and monitor tree growth. | | | | | | |
