## Proposed Residential Development

Cleator Mills, Cumbria

# Flood Risk Assessment

# Cleator Flood Asset Condition Assessment

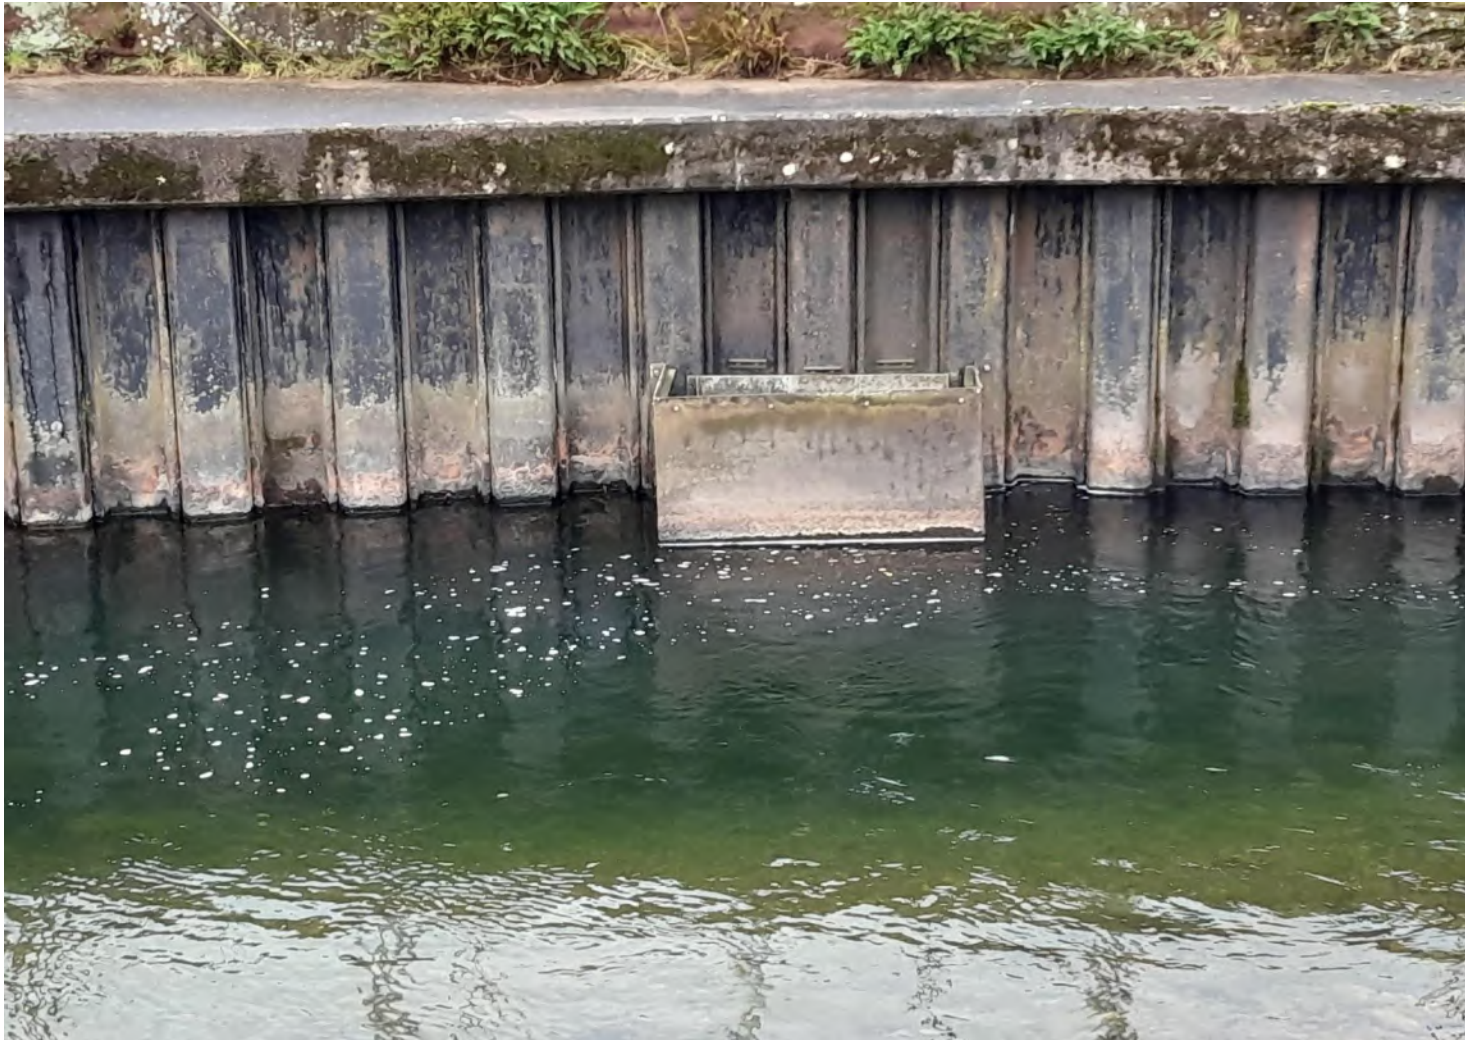
| Asset ID | CL23 | Frequency | | | | | | | |
|---|---|---|---|---|---|---|---|---|--|
| Comments | Minor corrosion to barrier. Unable to see headwall and pipe due to high water level and barrier around. | | | | | | | | |

| Asset ID | CL23 | Frequency | | | | | | | |
|---|---|---|---|---|---|---|---|---|--|
| Recommendations | Conduct CCTV inspection for pipe and headwall. | | | | | | | | |

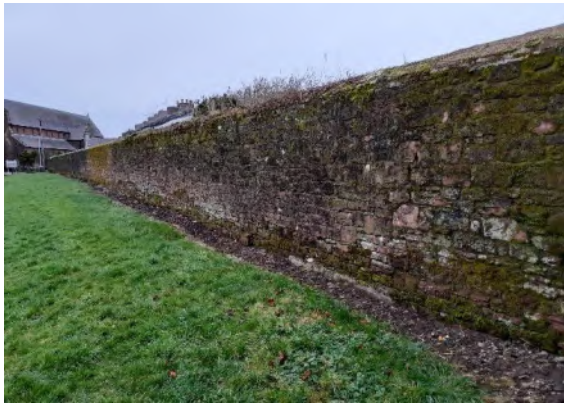
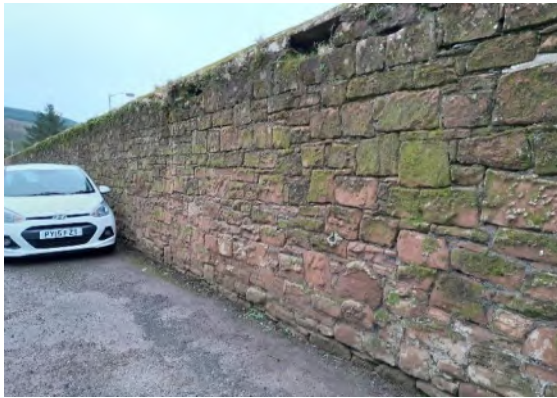
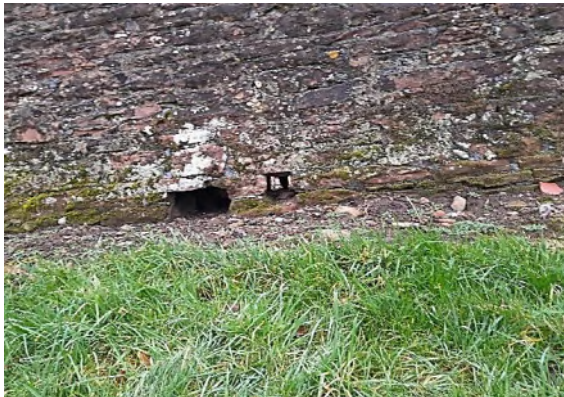
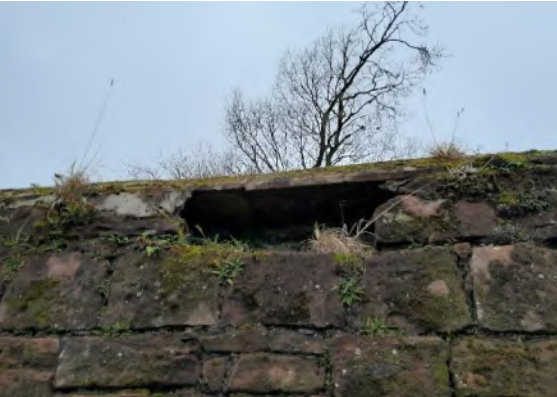
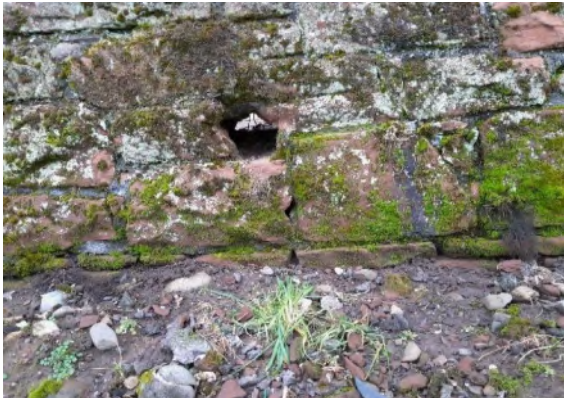
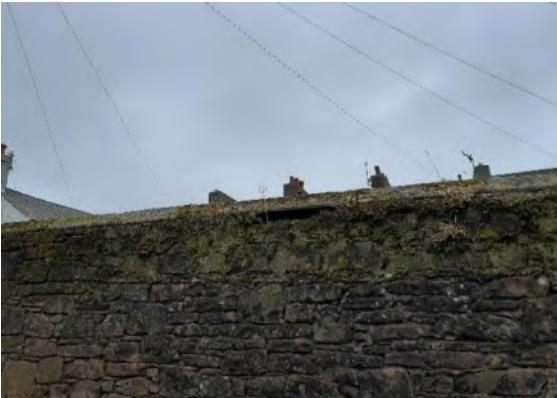
| <b>Comments</b> | Minor vegetation growth through crest. Minor mortar loss on exposed face and a couple of holes on both faces, not whole way though. Few bricks missing for drainage. | | | | | | |

| <b>Recommendations</b> | Repair holes in wall and remove vegetation. | | | | | | |
