**Project Name:** 2025-11-33287 Thomas Armstrong CO Ltd Barfs Road  
Distington

**Project Date:** 12/01/2026

**Inspection Standard:** MSCC5 Sewers & Drainage GB (SRM5 Scoring)

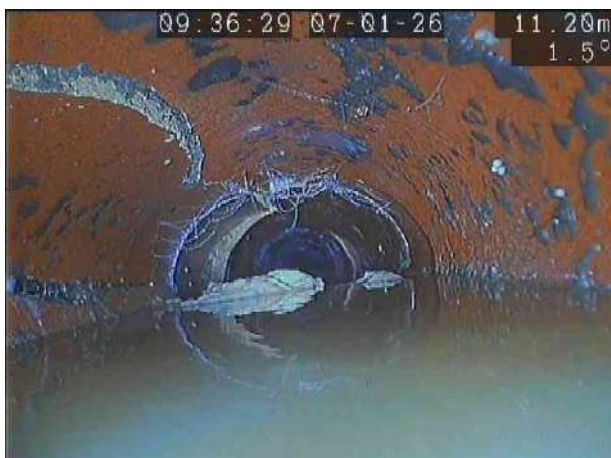
| Section | PLR | Grade | Description |
|---|---|---|---|
| 1 | F1X | 4 | Broken pipe from 8 o'clock to 5 o'clock |

| Scale: | 1:99 | Position [m] | Code | Observation | MPEG | Photo | Grade |
|---|---|---|---|---|---|---|---|
| | | 11.20 | B | Broken pipe from 8 o'clock to 5 o'clock | 00:01:11 | F1X_67b17bf0-8fd4-4490-a28f- | 4 |

F1X\_67b17bf0-8fd4-4490-a28f-ffde36719d92\_20260112\_151609\_193.jpg, 00:01:11, 11.20 m  
 Broken pipe from 8 o'clock to 5 o'clock

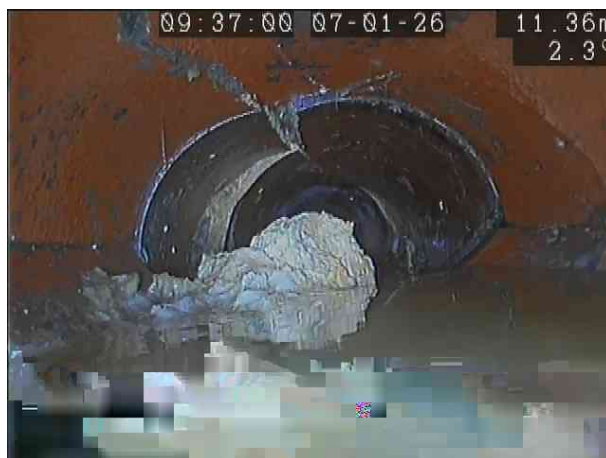
F1X\_5838b374-6a7a-4296-a643-91c1efd343d9\_20260112\_151645\_770.jpg, 00:01:11, 11.20 m  
 Broken pipe from 8 o'clock to 5 o'clock

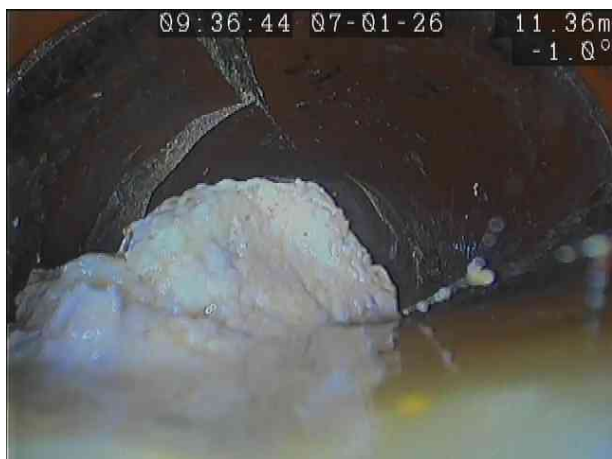
F1X\_410dbf36-2f06-44dd-a2a4-ce88e90eca63\_20260112\_151726\_322.jpg, 00:01:27, 11.35 m  
 Settled deposits, other, 25% cross-sectional area loss, Build up of deposits/ tissue

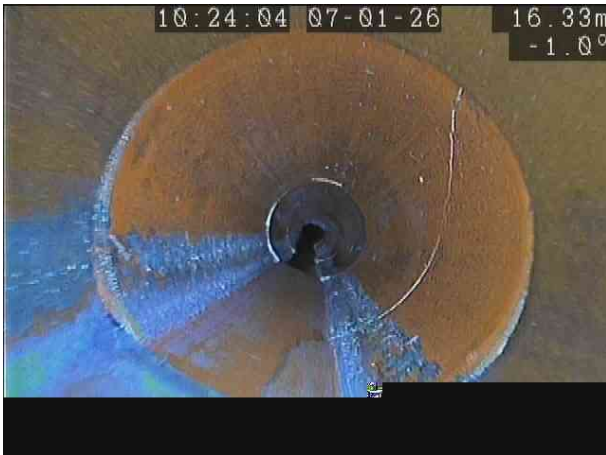
F3X\_d4a1069f-cfc8-4e9f-a40a-843b956b0bde\_20260112\_155  
 647\_153.jpg, 00:01:19, 16.42 m  
 Crack, circumferential from 2 o'clock to 5 o'clock

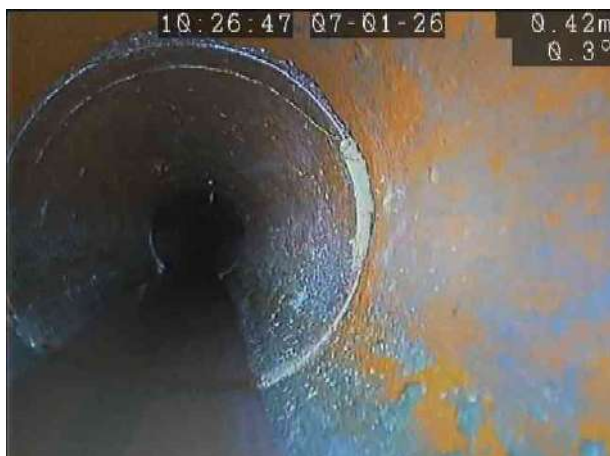
<table><tr><td>0.00</td><td>MH</td><td>Start node, manhole, reference: F4</td><td>00:00:00</td><td></td><td></td></tr><tr><td>0.46</td><td>CCJ</td><td>Crack, circumferential at joint from 9 o'clock to 2 o'clock</td><td>00:00:10</td><td>F4X_a9e5a6e2-4a96-432f-8085</td><td>2 / 2</td></tr></table>

F4X\_a9e5a6e2-4a96-432f-8085-0c3a392ff9b0\_20260112\_16  
 0750\_892.jpg, 00:00:10, 0.46 m  
 Crack, circumferential at joint from 9 o'clock to 2 o'clock

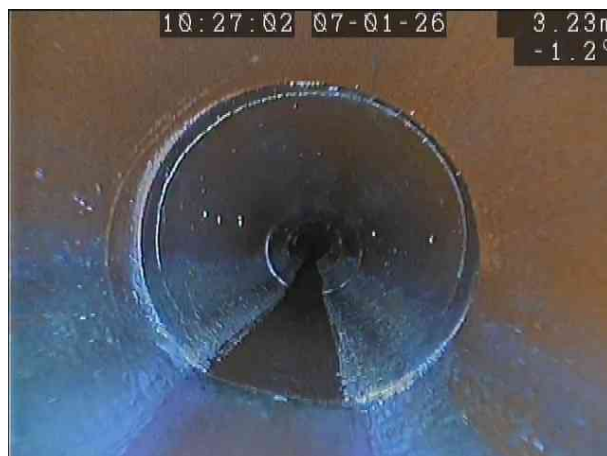
<table><tr><td>0.00</td><td>MH</td><td>Start node, manhole, reference: F4</td><td>00:00:00</td><td></td><td></td></tr><tr><td>3.23</td><td>CCJ</td><td>Crack, circumferential at joint from 9 o'clock to 4 o'clock</td><td>00:00:24</td><td>F4X_bc02be3d-55bd-4e5e-8d9f</td><td>2 / 2</td></tr></table>

F4X\_bc02be3d-55bd-4e5e-8d9f-91656924ff69\_20260112\_16  
 0815\_757.jpg, 00:00:24, 3.23 m  
 Crack, circumferential at joint from 9 o'clock to 4 o'clock

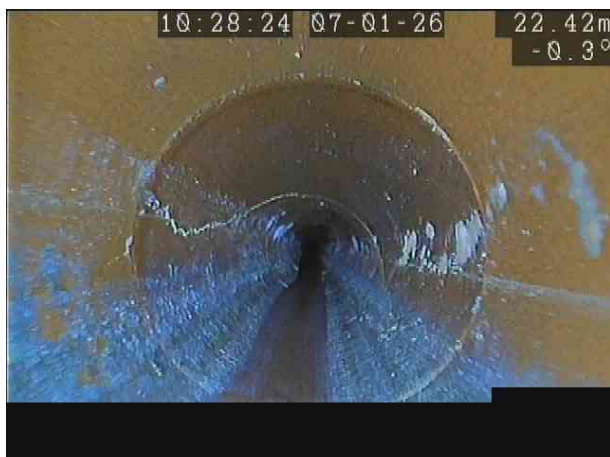
| Section | PLR | Grade | Description |
|---|---|---|---|
| 5 | F4X | 3 | Cracks, spiral from 9 o'clock to 3 o'clock |

<table><tr><td>0.00</td><td>MH</td><td>Start node, manhole, reference: F4</td><td>00:00:00</td><td></td><td></td></tr><tr><td>22.60</td><td>CS</td><td>Cracks, spiral from 9 o'clock to 3 o'clock</td><td>00:01:48</td><td>F4X_03cf1129-bd24-41dc-97ae</td><td>3 / 2</td></tr></table>

F4X\_03cf1129-bd24-41dc-97ae-39b5bc84fe72\_20260112\_16  
 0921\_010.jpg, 00:01:48, 22.60 m  
 Cracks, spiral from 9 o'clock to 3 o'clock

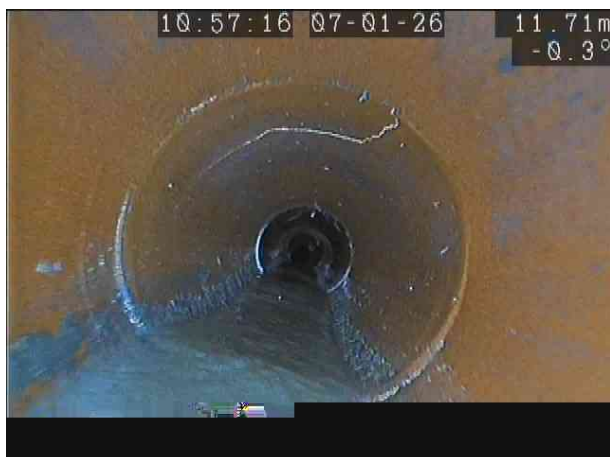
<table><tr> <td>0.00</td><td>MH</td><td>Start node, manhole, reference: F5</td><td>00:00:00</td><td></td><td></td><td></td></tr><tr> <td>11.79</td><td>CCJ</td><td>Crack, circumferential at joint from 10 o'clock to 1 o'clock</td><td>00:00:56</td><td>F5X_1705<br/>9ce4-4398<br/>-4c52-ba4</td><td></td><td>2 / 2</td></tr></table>

F5X\_17059ce4-4398-4c52-ba4e-9d7219542f39\_20260112\_162807\_562.jpg, 00:00:56, 11.79 m  
 Crack, circumferential at joint from 10 o'clock to 1 o'clock

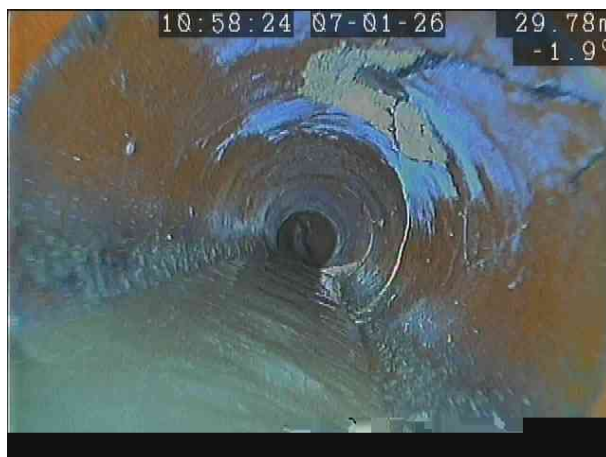
F5X\_3cfdc30e-0c9d-4ad8-b902-7c392805fc84\_20260112\_163217\_809.jpg, 00:02:05, 29.78 m  
 Hole in drain or sewer from 12 o'clock to 1 o'clock

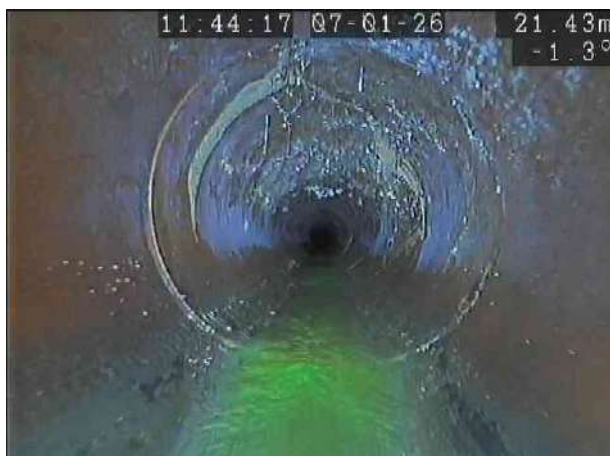
| Section | PLR | Grade | Description |
|---|---|---|---|
| 8 | F6X | 3 | Fracture, circumferential from 9 o'clock to 2 o'clock |

<table><tr><td>MH</td><td>Start node, manhole, reference: F6</td><td>00:00:00</td><td></td><td></td></tr><tr><td>FC</td><td>Fracture, circumferential from 9 o'clock to 2 o'clock</td><td>00:01:36</td><td>F6X_ac07<br/>6561-1e8e<br/>-471a-937</td><td>3 / 2</td></tr></table>

F6X\_ac076561-1e8e-471a-937a-8ed1a30195ee\_20260112\_1  
 64600\_330.jpg, 00:01:36, 21.52 m  
 Fracture, circumferential from 9 o'clock to 2 o'clock

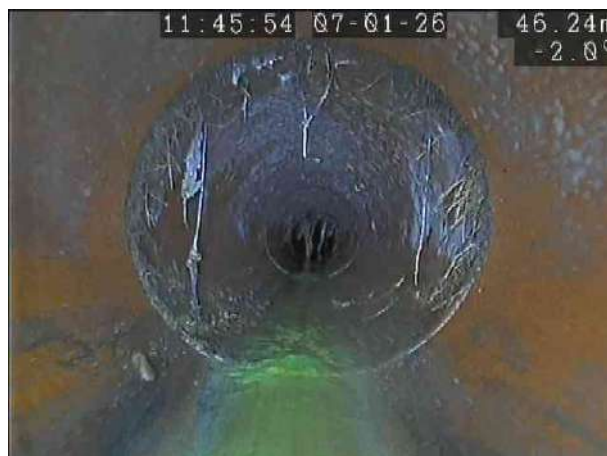
F6X\_e61b8769-9f19-422e-b610-2d909e8e712a\_20260112\_1  
 64823\_396.jpg, 00:03:13, 46.32 m  
 Roots, fine at joint

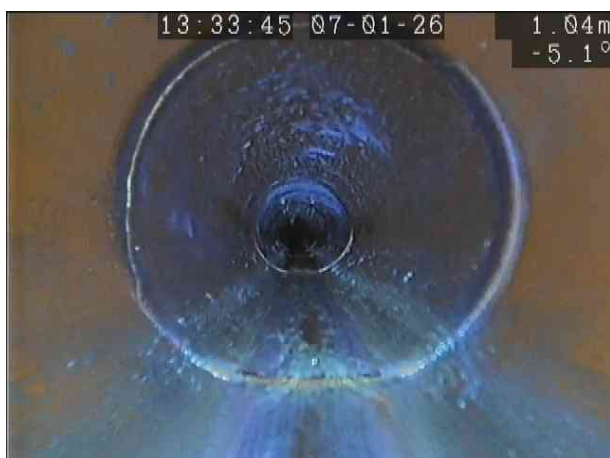
<table><tr> <td>0.00</td><td>MH</td><td>Start node, manhole, reference: F9</td><td>00:00:00</td><td></td><td></td><td></td></tr><tr> <td>1.11</td><td>CCJ</td><td>Crack, circumferential at joint from 8 o'clock to 1 o'clock</td><td>00:00:16</td><td>F9X_7a34<br/>7b84-d681<br/>-4ce0-9d2</td><td>2 / 2</td><td></td></tr></table>

F9X\_7a347b84-d681-4ce0-9d2c-b3cefc7ed3d8\_20260113\_101746\_845.jpg, 00:00:16, 1.11 m  
 Crack, circumferential at joint from 8 o'clock to 1 o'clock

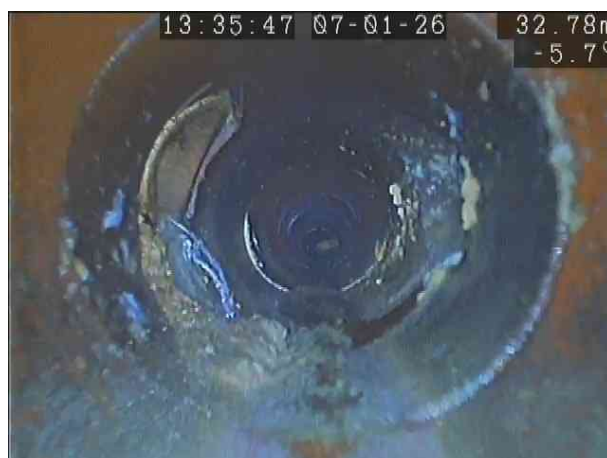
F9X\_ca75f934-bbf3-4c72-8b8f-dea9d25fdc89\_20260113\_101937\_686.jpg, 00:02:19, 32.86 m  
 Connection other than junction at 10 o'clock, 150mm dia

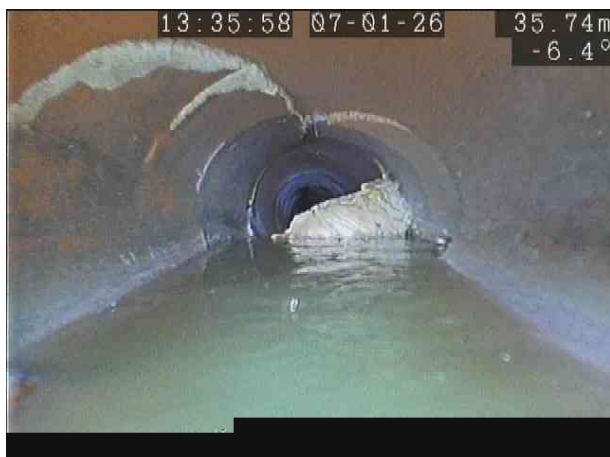
| Section | PLR | Grade | Description |
|---|---|---|---|
| 13 | F9X | 4 | Broken pipe from 7 o'clock to 4 o'clock |

<table><tr> <td>0.00</td><td>MH</td><td>Start node, manhole, reference: F9</td><td>00:00:00</td><td></td><td></td><td></td></tr><tr> <td>35.85</td><td>B</td><td>Broken pipe from 7 o'clock to 4 o'clock</td><td>00:02:30</td><td>F9X_ac26<br/>a8d9-d522<br/>-4fa7-8565</td><td>4</td><td></td></tr></table>

F9X\_ac26a8d9-d522-4fa7-8565-7c5dfe7c730\_20260113\_102022\_051.jpg, 00:02:30, 35.85 m  
 Broken pipe from 7 o'clock to 4 o'clock

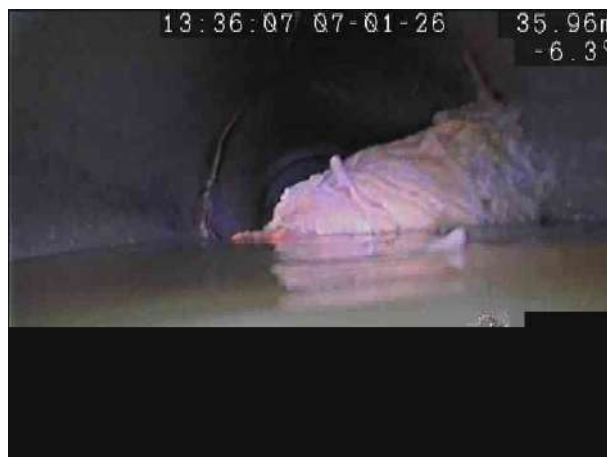
F9X\_af65bf37-e4e7-4cdc-a093-bc78bb8aae3f\_20260113\_103211\_161.jpg, 00:02:39, 35.96 m  
 Settled deposits, other, 35% cross-sectional area loss, Debris and tissue build up

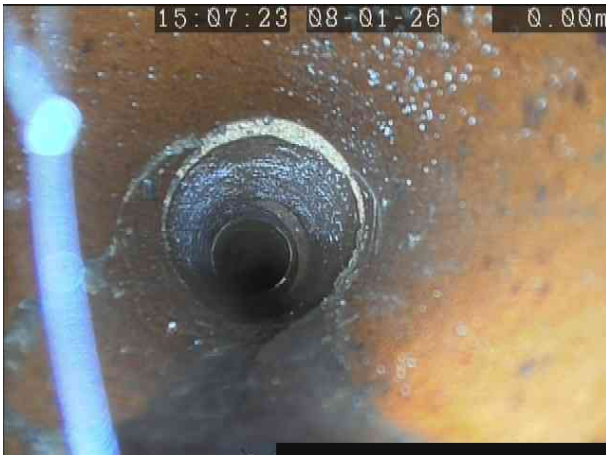
<table><tr><td>0.00</td><td>MH</td><td>Start node, manhole, reference: F16 Branch B</td><td>00:00:00</td><td></td><td></td></tr><tr><td>0.01</td><td>FC</td><td>Fracture, circumferential from 8 o'clock to 5 o'clock</td><td>00:00:07</td><td>UTPX_00b<br/>a62ba-722<br/>8-4e3a-ab</td><td>3 / 2</td></tr></table>

UTPX\_00ba62ba-7228-4e3a-ab50-67f647fc064b\_20260114\_111550\_842.jpg, 00:00:07, 0.01 m  
 Fracture, circumferential from 8 o'clock to 5 o'clock

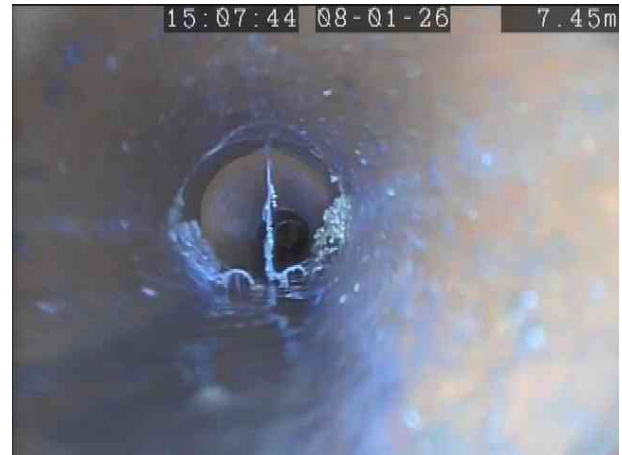
UTPX\_d8244e51-3385-48a3-b232-4742af6de5db\_20260114\_111646\_958.jpg, 00:00:27, 7.57 m  
 Roots, fine at joint

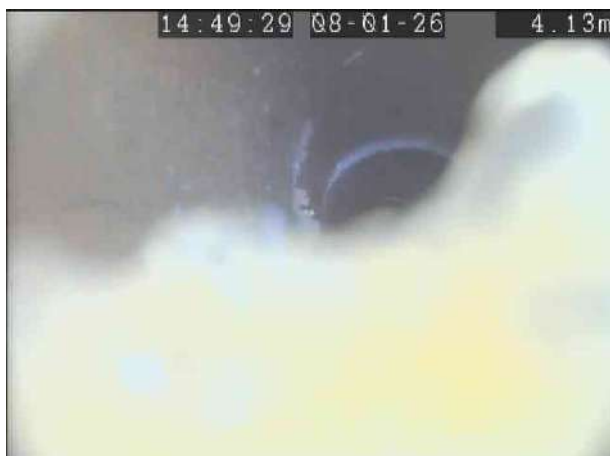
| Scale: 1:214 | Position [m] | Code | Observation | MPEG | Photo | Grade |
|---|---|---|---|---|---|---|
| | 4.25 | CC | Crack, circumferential from 8 o'clock to 1 o'clock | 00:00:25 | UTPX_c30<br>d5d1f-99a<br>7-486b-83 | 2 / 2 |

UTPX\_c30d5d1f-99a7-486b-8360-744e4e757505\_20260114\_102854\_811.jpg, 00:00:25, 4.25 m  
 Crack, circumferential from 8 o'clock to 1 o'clock

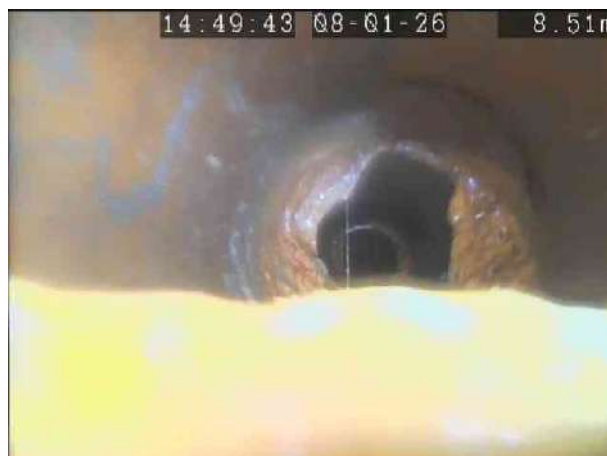
UTPX\_8bb7cd00-efc-41fb-a15a-5ea06e7c3178\_20260114\_103230\_866.jpg, 00:00:40, 8.75 m  
 Settled deposits, hard or compacted at joint, 20% cross-sectional area loss

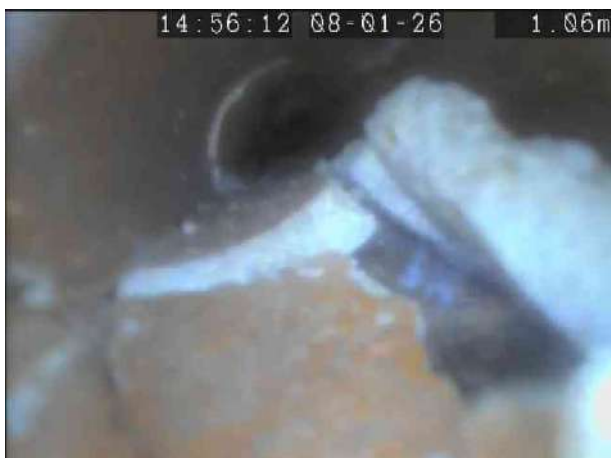
<table><tr><td>0.00</td><td>MH</td><td>Start node, manhole, reference: F15 Branch C</td><td>00:00:00</td><td></td><td></td></tr><tr><td>1.06</td><td>B</td><td>Broken pipe from 12 o'clock to 12 o'clock</td><td>00:00:14</td><td>UTPX_606<br/>85376-5ae<br/>1-4ae4-83</td><td>4</td></tr></table>

UTPX\_60685376-5ae1-4ae4-83d2-2ea7bcbe5f80\_20260114\_111204\_098.jpg, 00:00:14, 1.06 m  
 Broken pipe from 12 o'clock to 12 o'clock

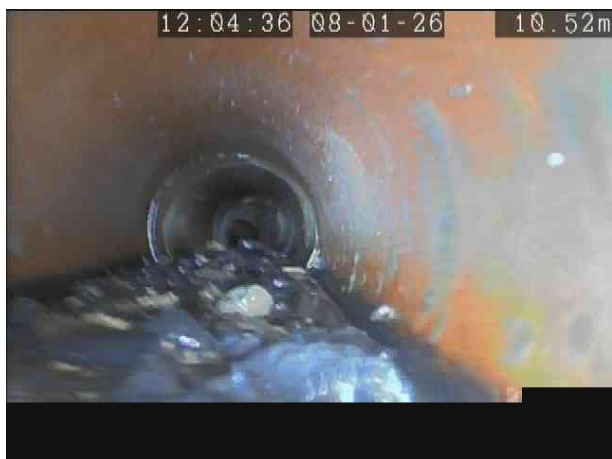
S5X\_17eee903-8ff5-46f8-a699-af2aa11c2443\_20260113\_155422\_302.jpg, 00:00:35, 10.88 m  
 Crack, circumferential at joint from 8 o'clock to 2 o'clock

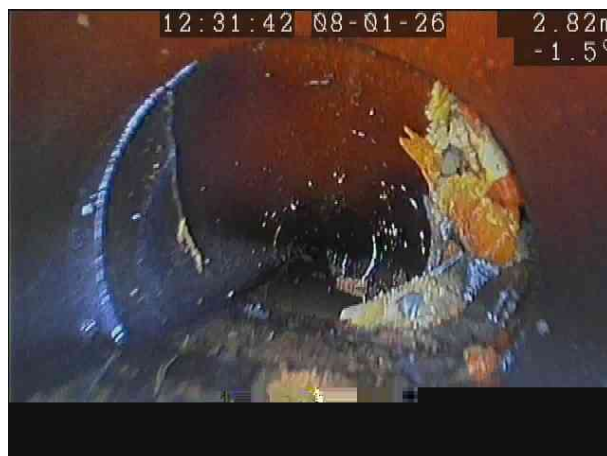
| Section | PLR | Grade | Description |
|---|---|---|---|
| 36 | S1X | 4 | Broken pipe from 2 o'clock to 5 o'clock |

<table><tr><td>0.00</td><td>MH</td><td>Start node, manhole, reference: S1</td><td>00:00:00</td><td></td><td></td></tr><tr><td>2.82</td><td>B</td><td>Broken pipe from 2 o'clock to 5 o'clock</td><td>00:00:17</td><td>S1X_e6de<br/>85a4-e77f-<br/>4b3c-874c</td><td>4</td></tr></table>

S1X\_e6de85a4-e77f-4b3c-874c-8ecab18b4f68\_20260113\_160719\_668.jpg, 00:00:17, 2.82 m  
 Broken pipe from 2 o'clock to 5 o'clock

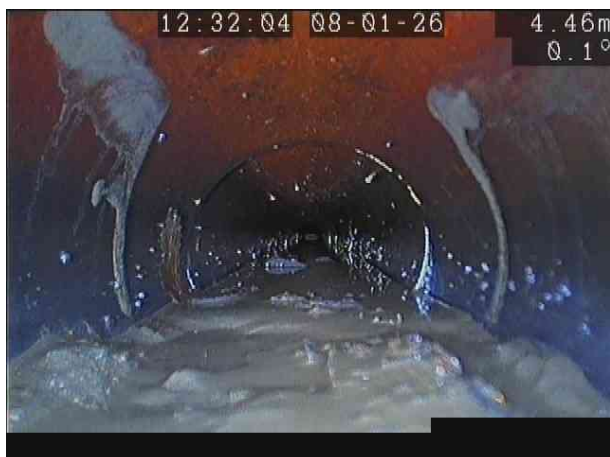
S1X\_ff8da6ed-839d-4570-b4ff-7c0343390d01\_20260113\_160946\_324.jpg, 00:00:40, 4.46 m  
 Settled deposits, coarse, 10% cross-sectional area loss

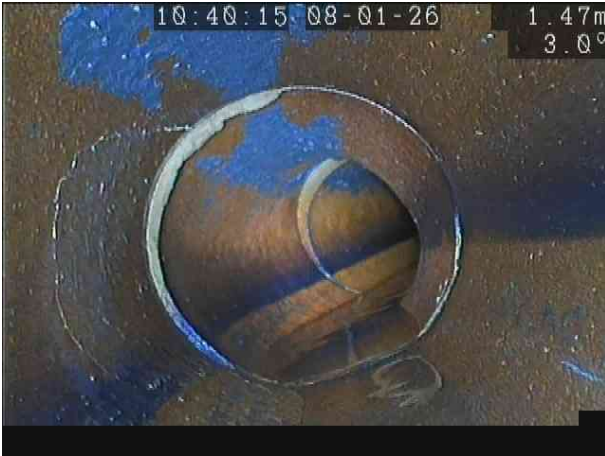
S9X\_61cc44ea-df28-4f1b-b7a7-17a3a2038ca0\_20260113\_13  
 2829\_202.jpg, 00:00:28, 0.90 m  
 Crack, circumferential at joint from 8 o'clock to 10 o'clock

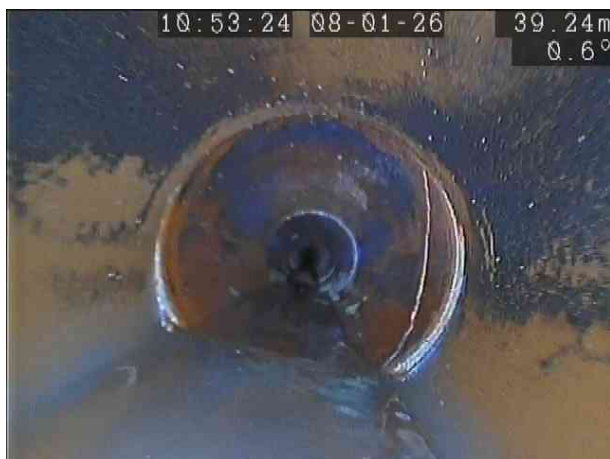
S11X\_653b3242-1829-473c-8dc0-a8582c7b2bad\_20260113\_133827\_063.jpg, 00:02:36, 39.24 m  
 Crack, circumferential at joint from 2 o'clock to 5 o'clock

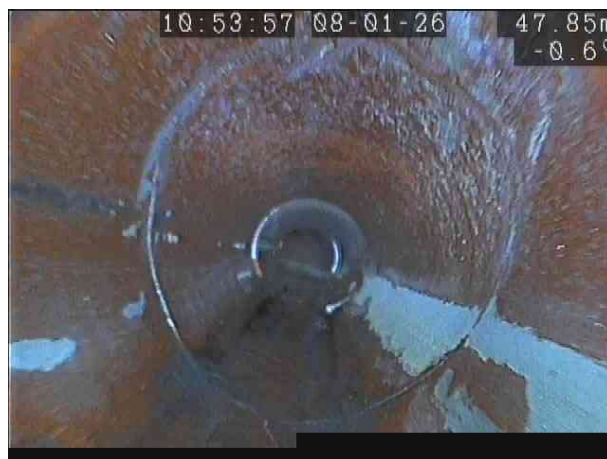
S11X\_aabb6734-aea7-4a7f-9b52-c7fee8de099a\_20260113\_133857\_576.jpg, 00:03:09, 47.85 m  
 Crack, circumferential from 4 o'clock to 10 o'clock

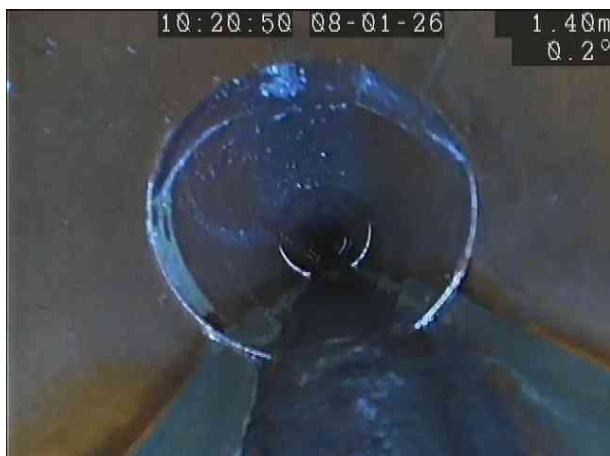
S12X\_629ef316-9d30-47f9-8d5b-13e2ddea95e0\_20260113\_131904\_905.jpg, 00:00:33, 1.40 m  
 Crack, circumferential at joint from 9 o'clock to 3 o'clock

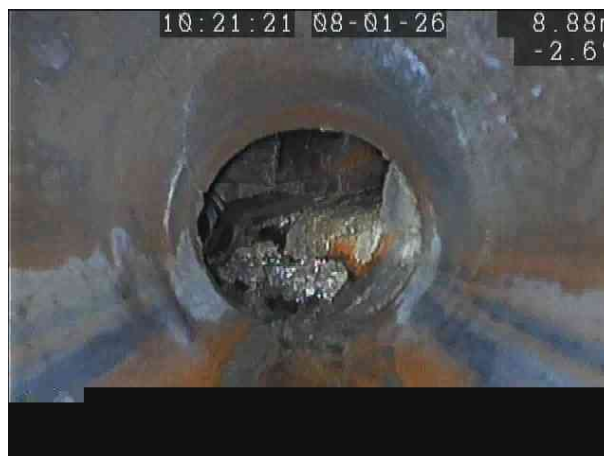
S12X\_49f3b57a-a9ff-4c89-90a3-f8d0d7894cd5\_20260113\_131950\_414.jpg, 00:01:04, 9.03 m  
 Crack, circumferential from 9 o'clock to 10 o'clock

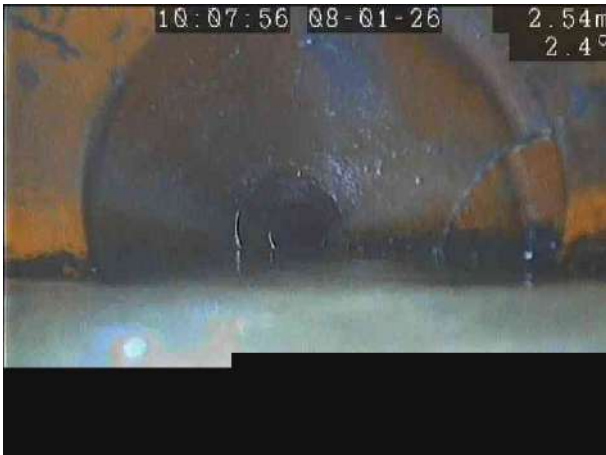
| Section | PLR | Grade | Description |
|---|---|---|---|
| 46 | S14X | 3 | Fracture, circumferential at joint from 3 o'clock to 5 o'clock |

S14X\_1265df48-cd84-4abf-a135-6a8a5ebc4b1e\_20260113\_130230\_779.jpg, 00:00:19, 2.54 m  
 Fracture, circumferential at joint from 3 o'clock to 5 o'clock

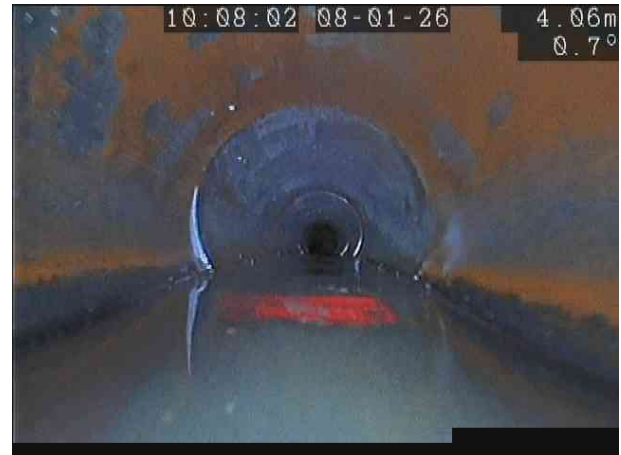
S14X\_aeea9044-2881-4b75-9df7-7db3bc777343\_20260113\_130218\_960.jpg, 00:00:26, 4.24 m  
 Settled deposits, other, 10% cross-sectional area loss, Debris

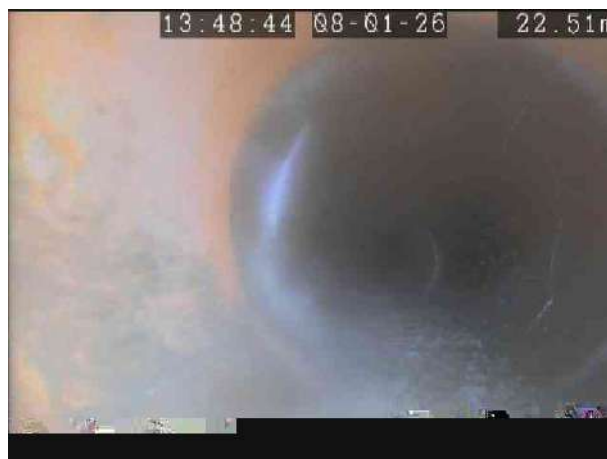
MH  
 DX\_cb897b6e-0abc-422c-896a-ad59f3276434\_20260113\_16  
 2328\_795.jpg, 00:01:19, 22.51 m  
 Crack, circumferential from 8 o'clock to 4 o'clock

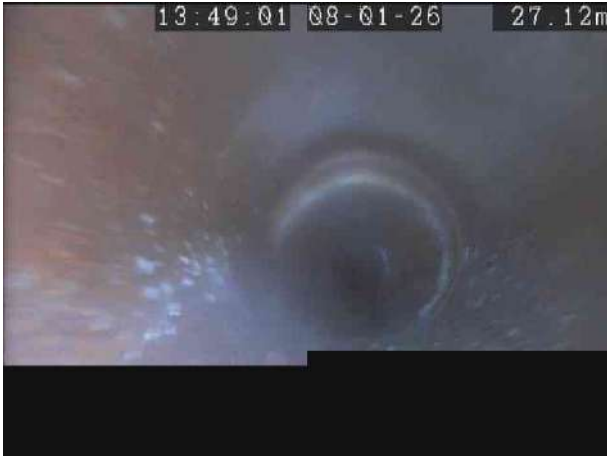
MH  
 DX\_423219d4-26d9-43dc-9b9d-a2cc66988e55\_20260113\_16  
 2404\_296.jpg, 00:01:36, 27.36 m  
 Crack, circumferential from 10 o'clock to 4 o'clock

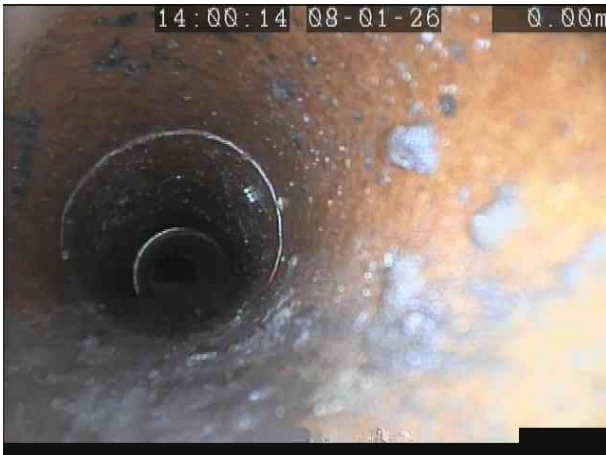
UTPX\_c742aa9b-e4e0-4005-b7d6-50032fb3d565\_20260113\_162922\_911.jpg, 00:00:10, 0.05 m  
 Crack, circumferential from 8 o'clock to 4 o'clock

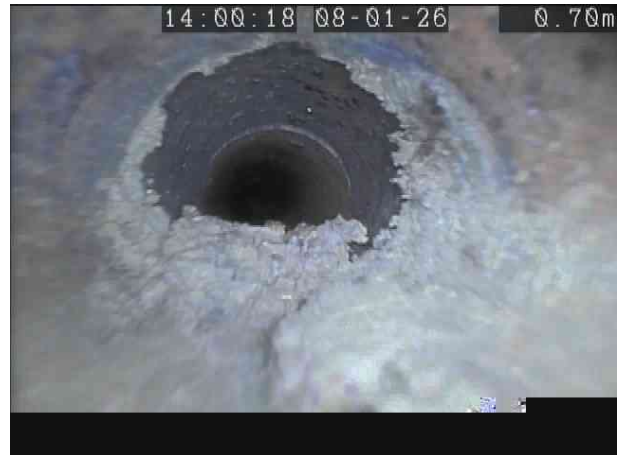
UTPX\_60e97b13-af89-4c0c-b4e1-6fdc76e06bcd\_20260113\_163021\_984.jpg, 00:00:15, 0.70 m  
 Settled deposits, coarse, 30% cross-sectional area loss
