**Visual Structural Inspection  
of  
Steele House Extension, Sandwith  
For  
Mr & Mrs Regan**

Reference - 2025.356 rep001 Rev -  
Date - 08/04/2025  
Author - Paul Crooks BEng CEng MICE  
ICE membership No: 48526190

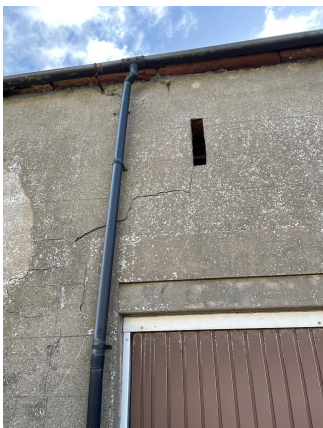
photo 3.1a

Cracking is visible to the front wall above the garage opening where the building adjoins its neighbour. Cracking in this area is visible internally on the party wall (see photos 3.1a and 3.2a)

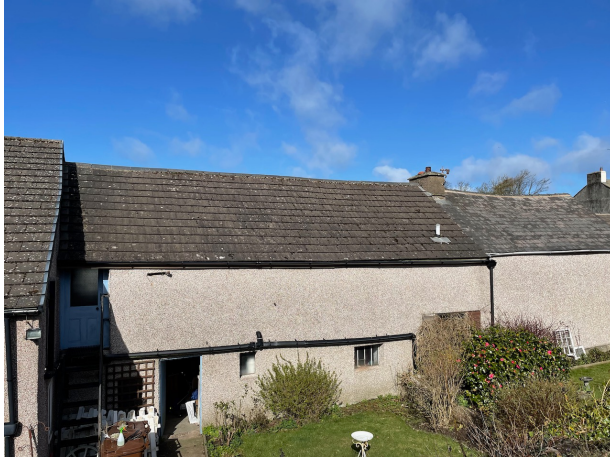
photo 3.2a

The rear wall is fully rendered externally. No movement or defects were visible. (see photo 3.2a).

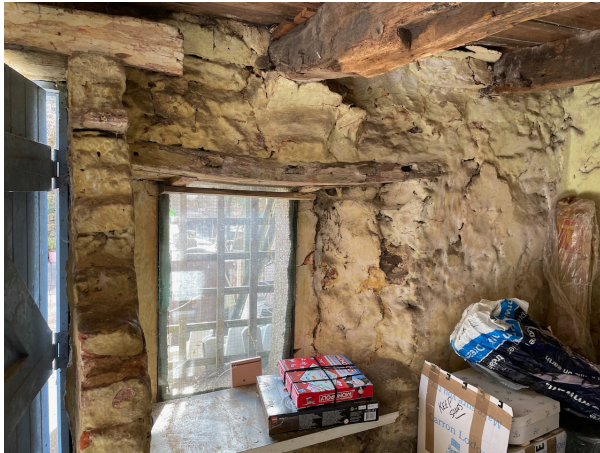
photo 3.2b

Deflection of the timber lintels to the windows and door is visible, although this is to be expected of a building of this age (see photo 3.2b)

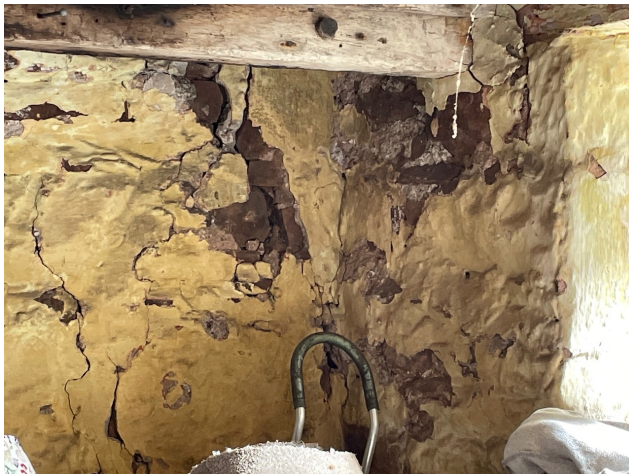
photo 3.3a

Cracking is visible where the cross wall meets the rear external wall (see photo 3.3a).

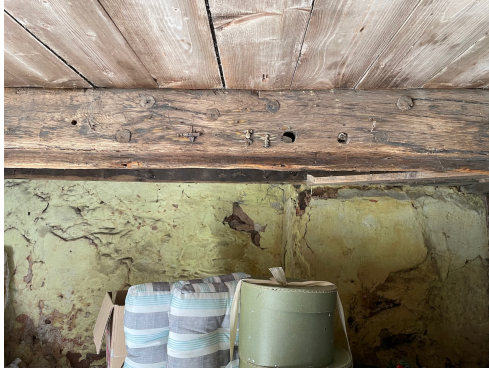
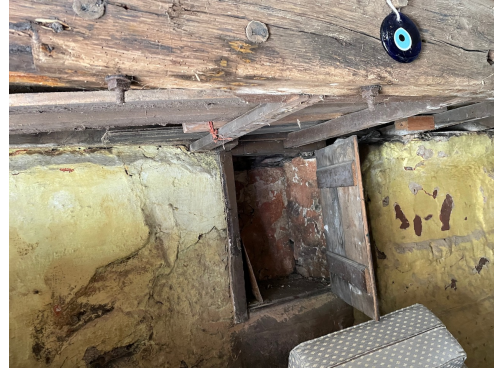
The first floor timber floorboards are in poor/unsafe condition. The timber floor beams are suffering from woodworm (see photos 3.4a & 3.4b)

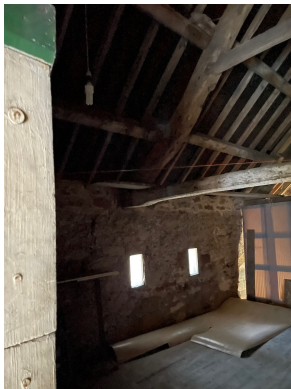
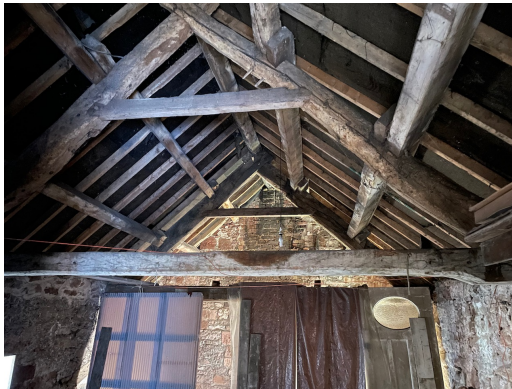
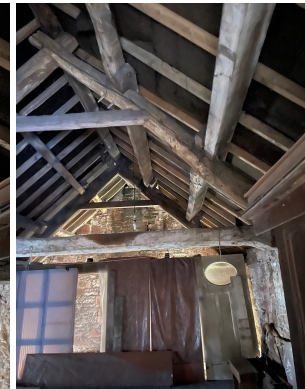
Due to the poor condition of the first floor examination of the roof was from a distance. Considering the building age the roof timbers are generally in reasonable condition although a number do appear to be beginning to deteriorate (see photos 3.5a to 3.5c)
