**GADSDEN CONSULTING**

# STRUCTURAL INSPECTION REPORT

**LOCATION:** QUARRY HOUSE, CASTLE VIEW, MILLOM,  
CUMBRIA. LA18 5AQ

**JOB No:** 24263

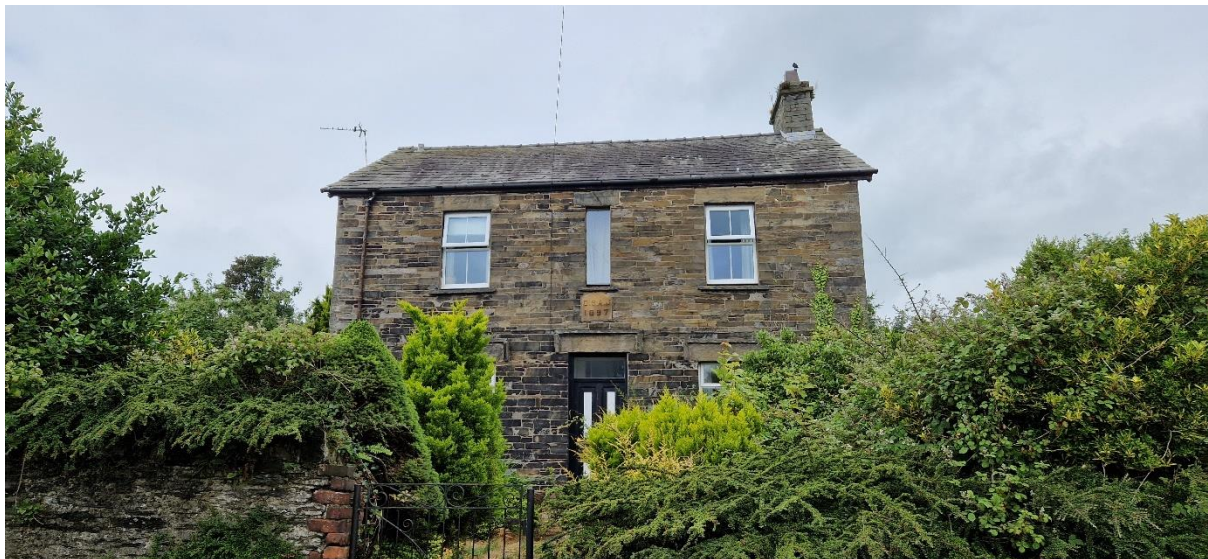
*Photo 1 - Front Elevation*

- There has been some lateral movement around first floor centrally both horizontally and vertically.

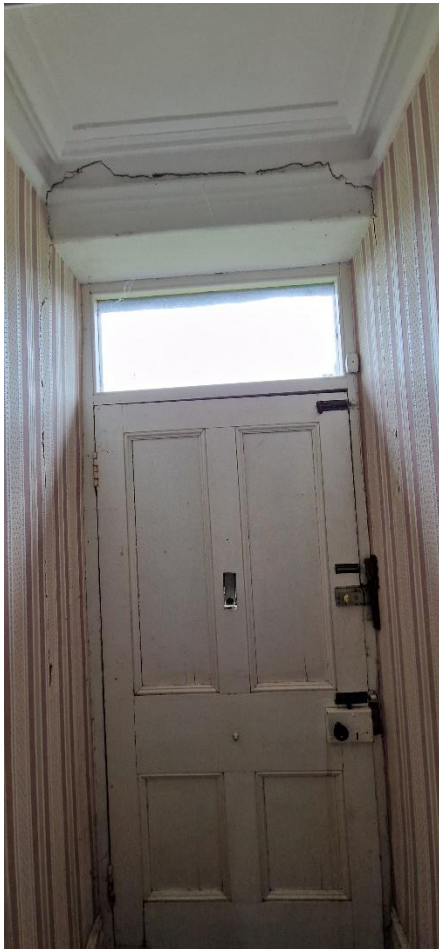
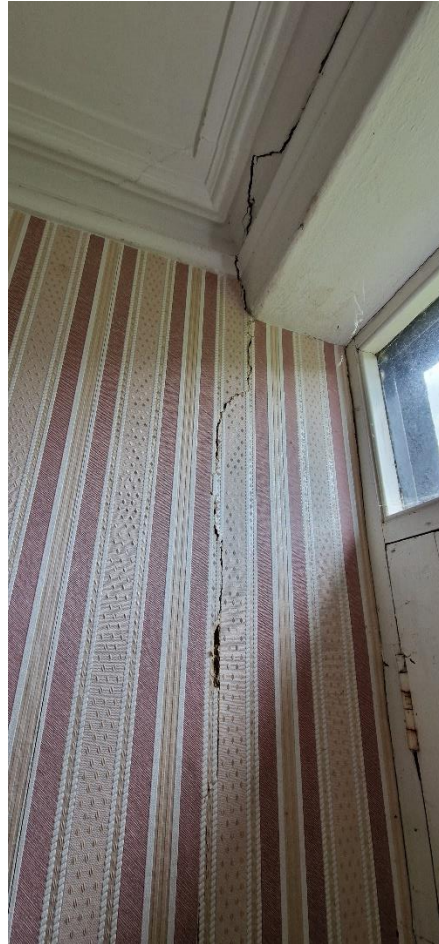
- A vertical crack extends from approximately 1200mm above the floor, running up to the coving, across the door head, and then descending to roughly the same height on the opposite side. This crack measures approximately 4-5mm in thickness. (Category 2)
- Additionally, there are hairline cracks in the coving and ceiling generally. (Category 0)
- The solid floor in the main hall exhibits some undulation, sloping downward from the door entrance toward the staircase.

*Photo 2 - Cracking Around Front Door*

*Photo 3 – Cracking Around Front Door*

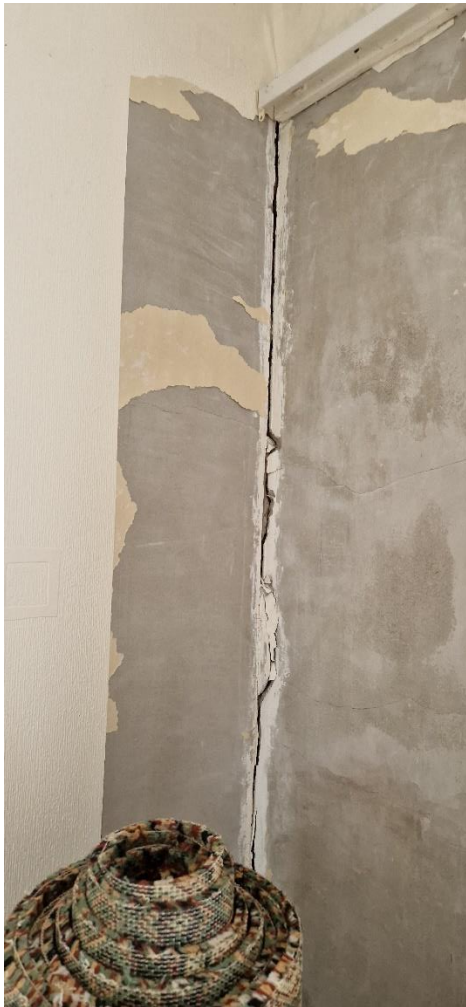
- The front half features a suspended timber floor with joists spanning from left to right.
- The floor exhibits undulation, sloping downward toward the front, rising in the middle, and then descending where it meets the concrete floor at the rear.
- The solid floor at the rear feels relatively level.
- Internally, the front corners appear to be in good condition.
- However, at the rear left junction with the hall wall, there is a severe crack extending from floor to ceiling. At its worst, the gap opens to approximately 10mm. (Category 3)
- On the right-hand side, diagonal cracking emanates from the rear wall and intersects with vertical cracking at the junction with the rear wall. (Category 1/2)
- Sporadic hairline cracking is visible on the right-hand side elevation. (Category 0)
- Finally, there is minor movement around the coving at ceiling level. (Category 0)

*Photo 4 - Right Reception - Vertical Cracking to Rear Left*

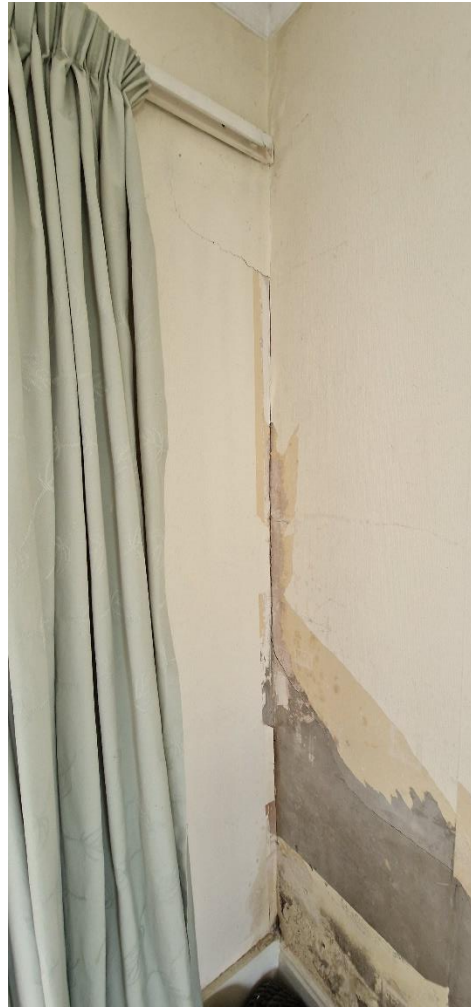
*Photo 5 - Right Reception - Cracking to Rear Right*

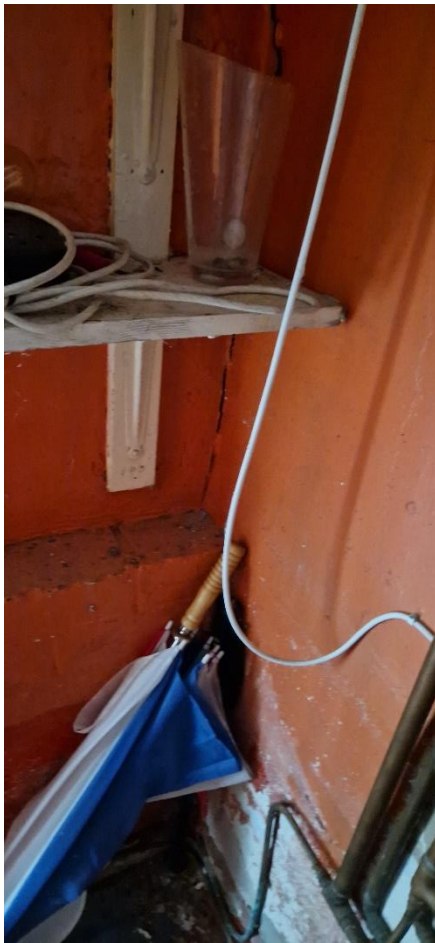
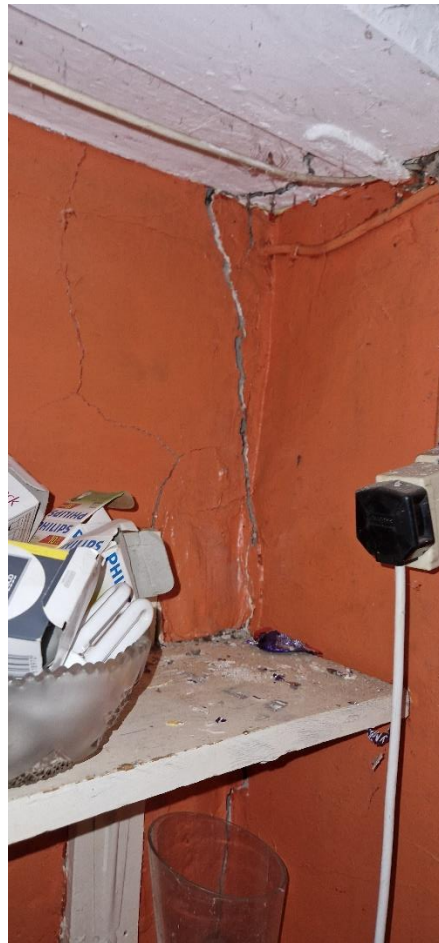
- The floor exhibits undulation.
- To the right-hand side of the backdoor, there is a vertical crack running from the ceiling down to floor level. This crack extends into the plaster, measuring 7-8mm in thickness. There is very little tie between the internal and external walls. (Category 3)
- In the understairs cupboard, there is a severe vertical crack, measuring up to 10mm wide mirroring the crack noted above. There is a similar crack in the wall separating the cupboard with the right reception. There is also a gap to the landing above. (Category 3)

*Photo 6 - Cracking in Cupboard*

*Photo 7 - Cracking in Cupboard*

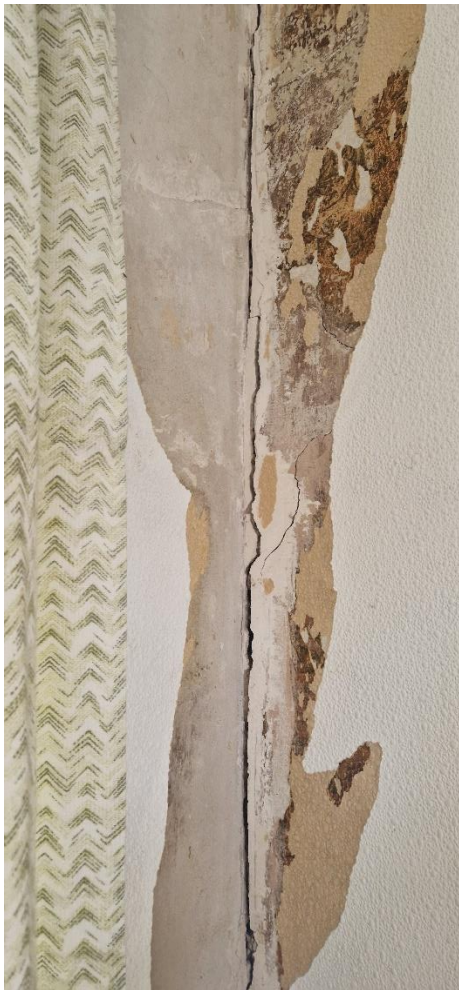
- The vertical cracking noted in the cupboard below continues up both sides of the hall. At their worst they are upto 25mm wide. (Category 4)
- At the first-floor level, solid walls flank either side of the staircase running front to back. All other walls at first floor level are stud.
- Floor joists run front to back at first floor level.

*Photo 8 - Hall - Vertical Crack to Right Side at Rear*

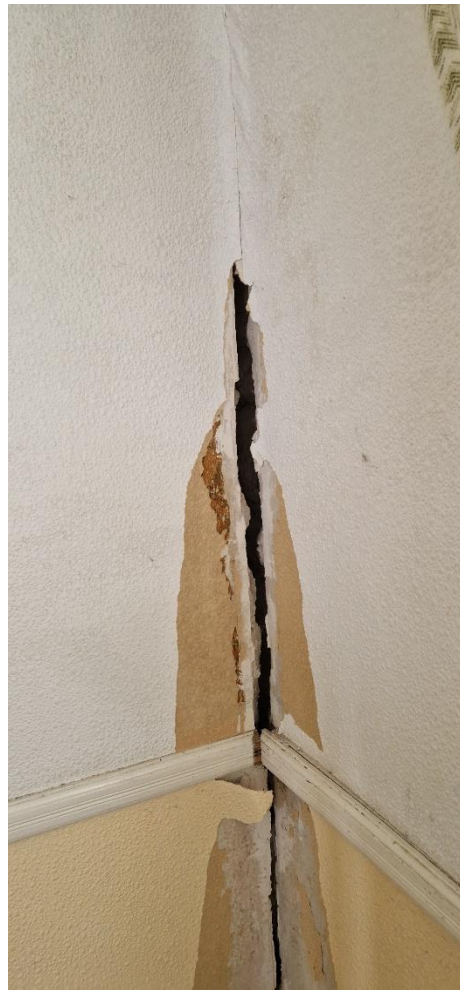
*Photo 9 - Hall - Vertical Crack to Left Side at Rear*

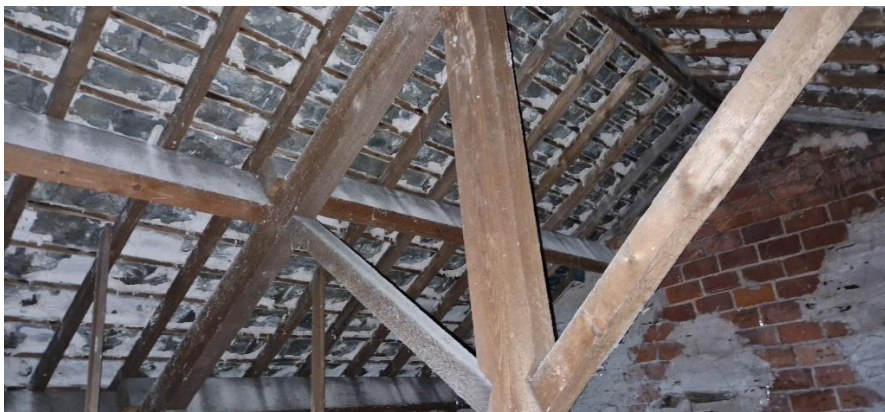
*Photo 10 - Roof*

- Two intermediate queen post trusses roughly positioned at thirds supporting two rows of side purlins and a ridge. In turn these support the rafters. All section sizes appear to be of good proportions and where observed the timber appears to be in good condition. We would however point out that several slates were missing, and water ingress is likely to have occurred which could have damaged some timber.

There has obviously been perishment to the building fabric and this would all require renewal as part of the renovation works including ensuring the roof is watertight. We would recommend that the roof have a breathable membrane installed to ensure a long-term watertight roof structure. All timbers being retained should be inspected by a timber specialist and treated as required.

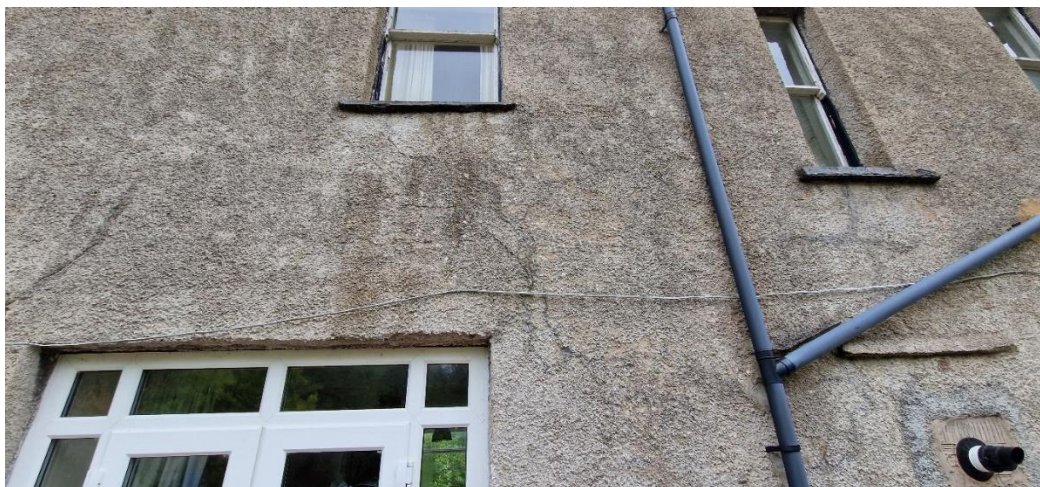
- There are cracks around wall penetrations. These appear due to corrosion and rust. (Category 1)
- On the right-hand side of the kitchen window, there are hairline cracks present. (Category 0/1)
- Moving centrally on the elevation, behind the downspout and bathroom outlet, there is sporadic cracking. These previously filled cracks have not reopened. (Category 0/1)
- Above the right-hand side of the French doors, there are sporadic cracks in the render. These have been filled with mastic and haven't reopened. (Category 0/1)

*Photo 11 - Rear Elevation - Sporadic Cracking*

- Severe lateral movement is evident, particularly in the central area.
- Whilst the roof is generally straight and true with no real undulation, the chimney seems to be leaning inwards.

Despite the thick stone walls and internal masonry walls (all at ground floor and spine walls at first floor) the property has suffered from lateral movement on all elevations. The movement to the front elevation is at this stage relatively minor and the render coat applied to the gable elevations appears to have slowed this process down. However, the rear elevation has suffered to a much greater degree. The cracking observed internally at the junction of internal and external walls is significant with as much as 25mm cracking observed. We recommend that a large section of the rear elevation be demolished and rebuilt.
