# 1. INTRODUCTION

Civic Engineers have been appointed by Maple Grove Development to undertake a Phase 1 Desk Based Site Investigation to determine the geo-environmental conditions at the proposed development site, to identify any potential constraints, to inform the design of the proposals and to advise as to further investigation which may be required.

The Report is to be submitted in support a full Planning Application for a proposed new residential extra care facility on a site at Coach Road, Whitehaven.

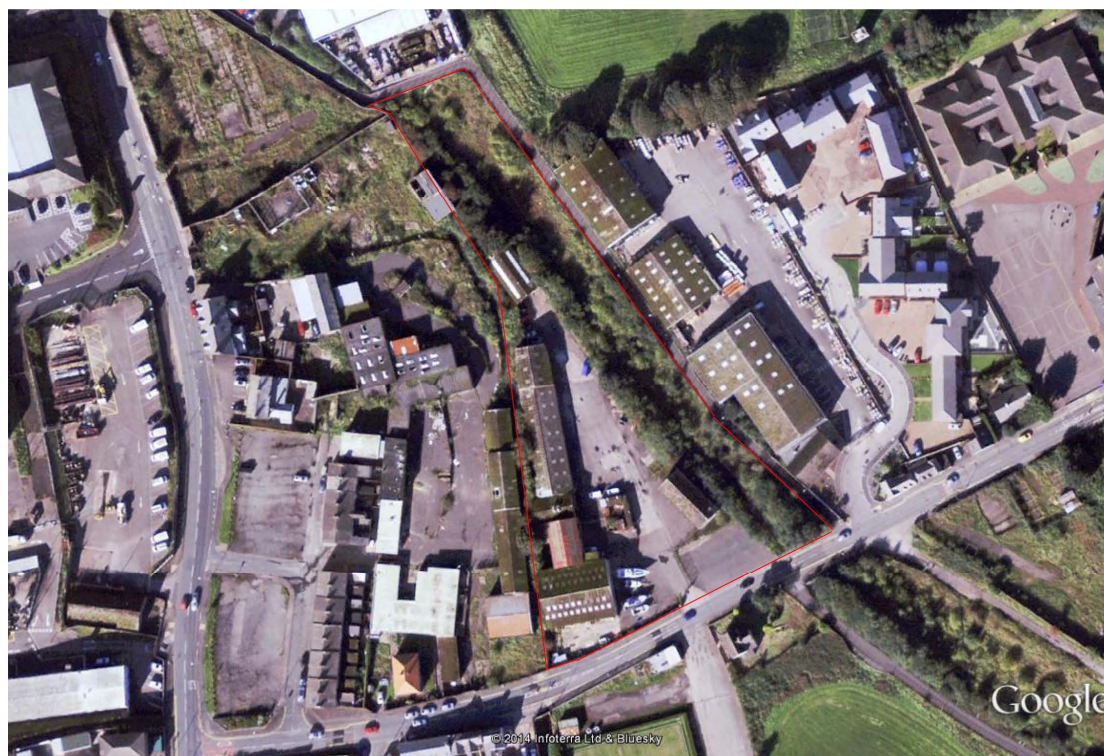
Figure 1; Aerial Image of the site taken from Google Earth (2008)

The total site area is approximately 1.039Ha with approximately 0.5Ha covered in hardstanding and buildings and the remaining section, to the east of the site, covered in grassland. None of the buildings at the site are currently occupied. An aerial image of the site can be seen below and further site photographs can be found in Appendix B of this document.
