Project Ref: 6046

## The Library – External & Internal Condition Examples

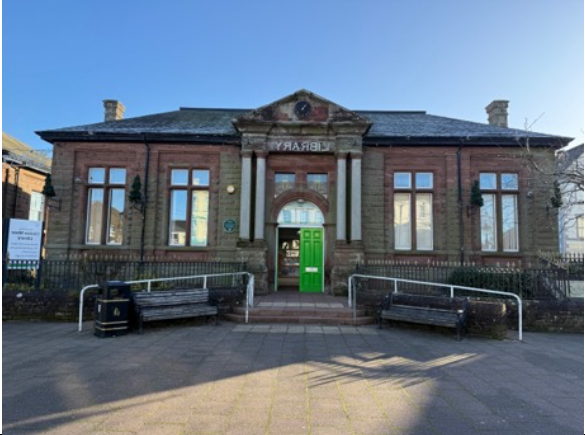
| <b>Northeast Elevation - General</b> | Roof Slate - Moss & vegetation growth to pitched roof slopes. | Above Ground Rainwater Goods – Defective downpipe. |

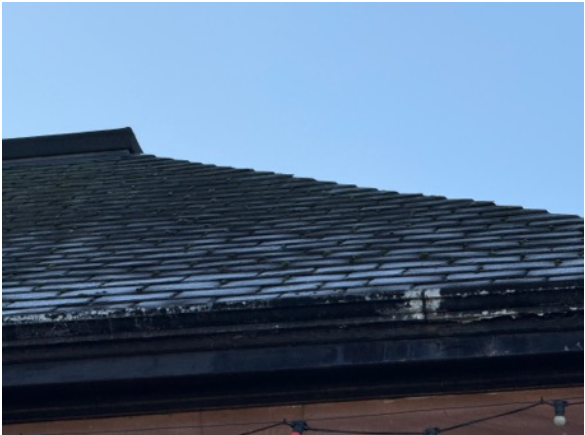
| Above Ground Rainwater Goods – Defective guttering. | Above Ground Rainwater Goods – Defective guttering & downpipe. | Timber Fascia's & Soffits – Defective fascia and soffit. |

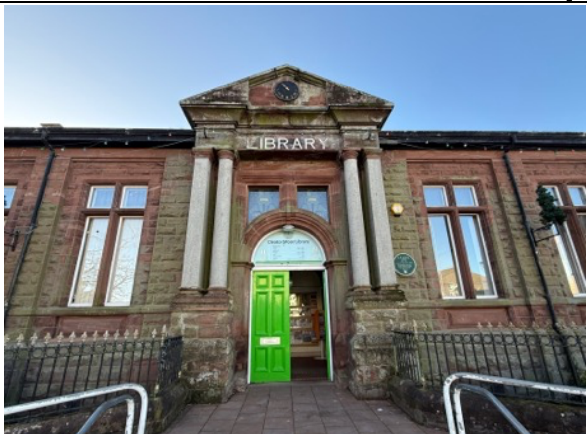
| <p>Stonework Cleaning – Sandstone façade greening with moss and algae.</p> | <p>Stonework Cleaning – Sandstone façade greening with moss and algae.</p> | <p>Stonework Cleaning – Vegetation growth behind portico gable.</p> |

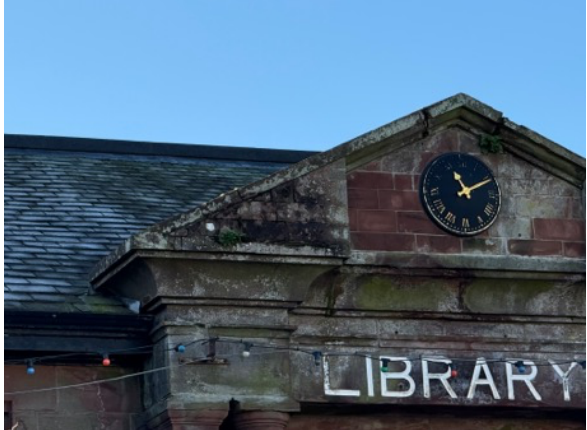
| <p>Stonework Repairs – Central apex stone to portico requiring lifting &amp; re-bedding.</p> | <p>External Joinery – Typical condition of unmaintained timber framed windows.</p> | |

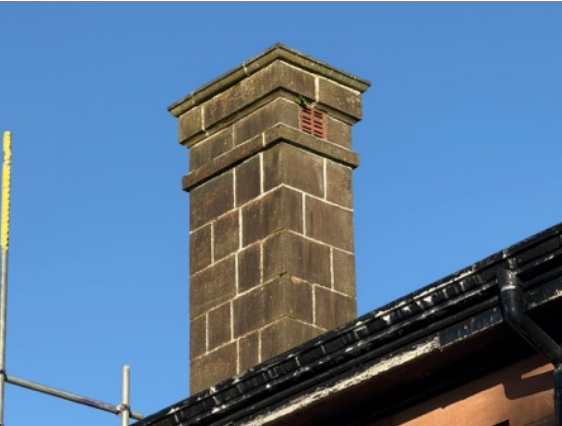
| <p><b>Southeast Elevation - General</b></p> | <p>Chimney Structure - Deleterious mortar pointing.</p> | <p>Above Ground Rainwater Goods – Defective cast iron downpipe.</p> |

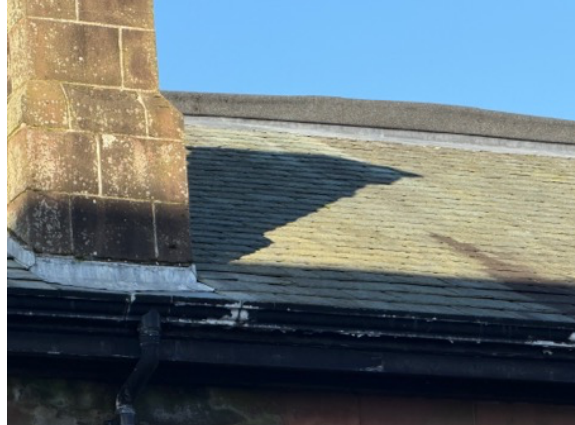
| <p>Above Ground Rainwater Goods – Defective guttering and downpipe.</p> | <p>Timber Fascia's &amp; Soffits – Unmaintained soffits and fascias.</p> | <p>Stonework Cleaning - Sandstone façade greening with moss and algae.</p> |

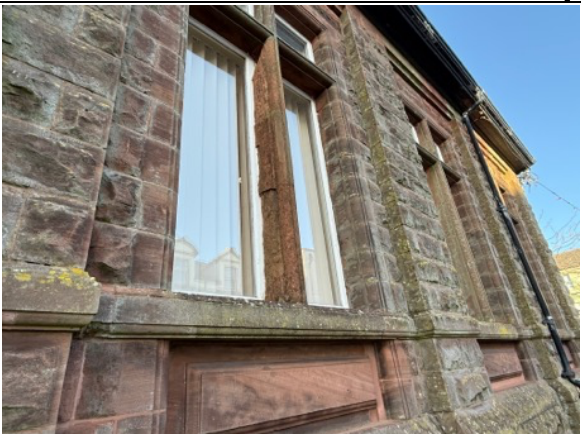
| <p>Stonework Repairs – Deteriorated sandstone mullion.</p> | <p>Stonework Repairs – Deteriorated sandstone mullion.</p> | <p>General Masonry Pointing – Deleterious mortar pointing.</p> |

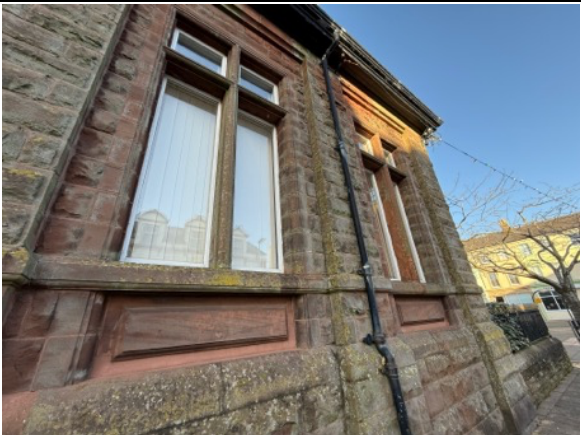
| <p>External Joinery – Typical condition of unmaintained timber framed windows.</p> | | |

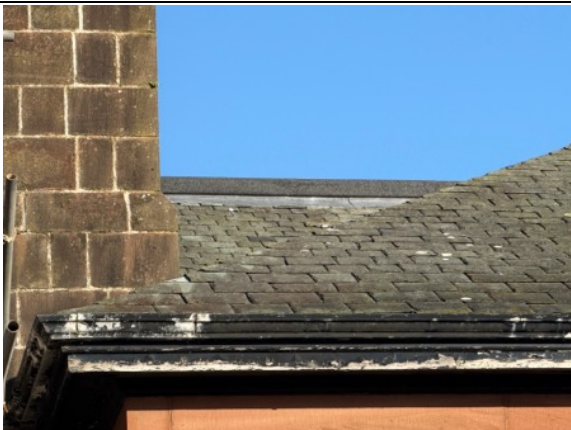
| <p><b>Southwest Elevation - General</b></p> | <p><b>Slate Repairs – Tagged and damaged roof slates.</b></p> | <p><b>Above Ground Rainwater Goods – Defective guttering.</b></p> |

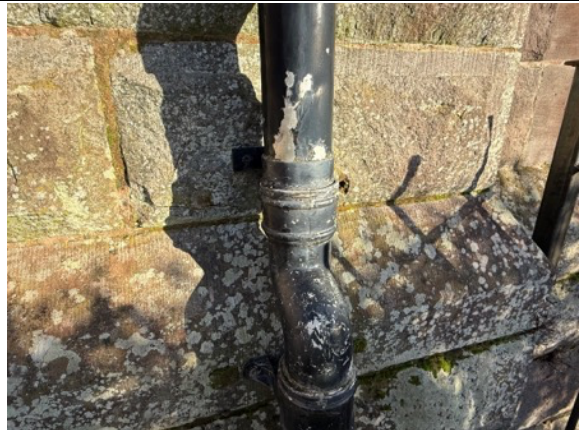
| <p><b>Above Ground Rainwater Goods – Defective and poorly maintained downpipe.</b></p> | <p><b>Timber Fascia's &amp; Soffits – Unmaintained soffits &amp; fascias.</b></p> | <p><b>Stonework Cleaning - Sandstone façade greening with moss and algae.</b></p> |

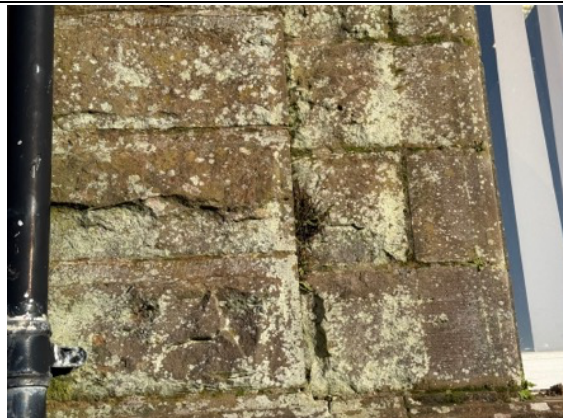
| <p>General Masonry Pointing - Deleterious mortar pointing.</p> | <p>General Masonry Pointing - Deleterious mortar pointing.</p> | <p>External Joinery - Typical condition of unmaintained timber framed windows.</p> |

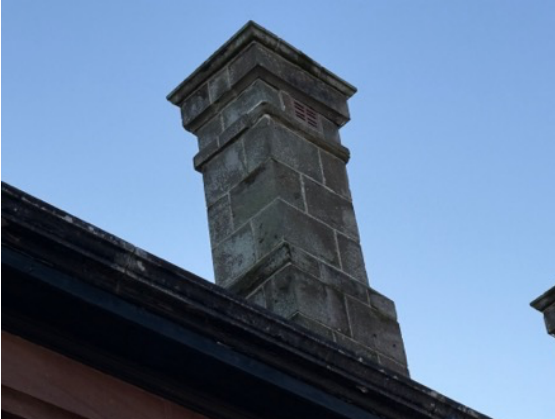
| <p><b>Northwest Elevation</b> - General</p> | <p>Chimney Structure - Deleterious mortar pointing.</p> | <p>Slate Repairs – Tagged and damaged roof slates.</p> |

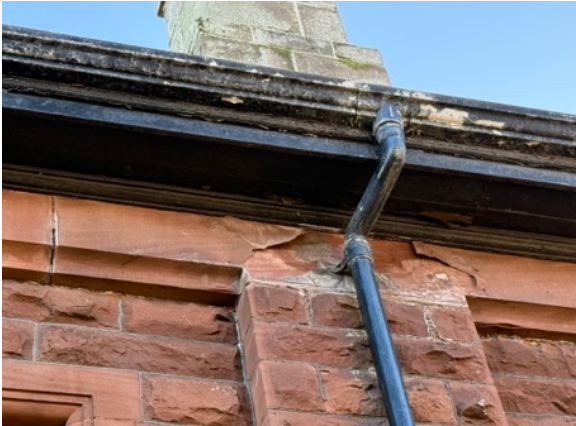
| <p>Above Ground Rainwater Goods – Defective guttering.</p> | <p>Above Ground Rainwater Goods – Defective and poorly maintained downpipe.</p> | <p>Above Ground Rainwater Goods – Defective and poorly maintained downpipe.</p> |

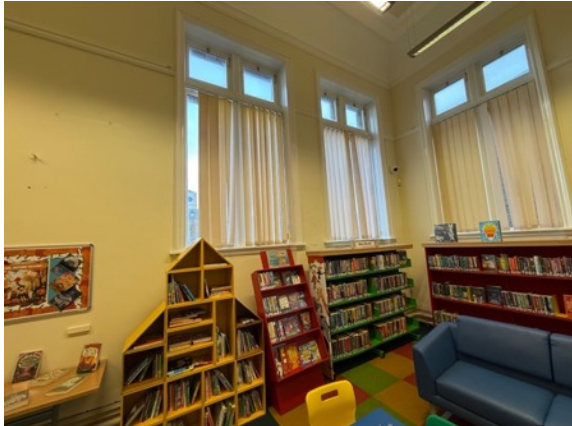
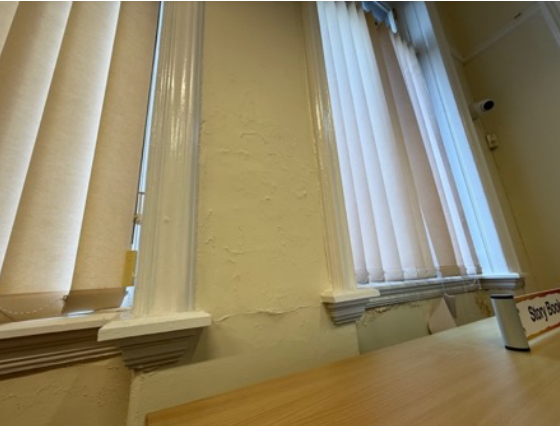
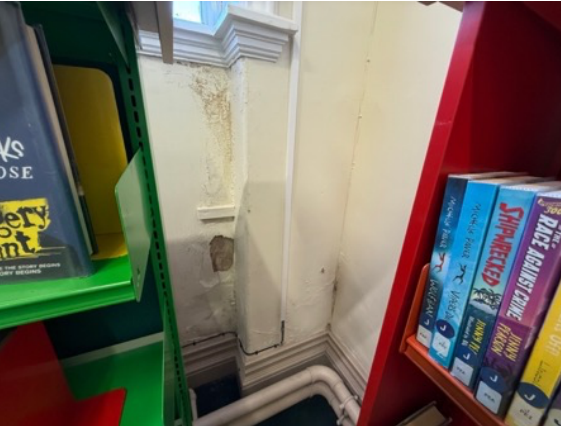
| <p>Internal – Rear Southwest elevation wall within the library, with extensive evidence of damp affected and defective plaster finishes.</p> | <p>Internal – Rear Southwest elevation wall within the library, with extensive evidence of damp affected and defective plaster finishes.</p> | <p>Internal – Rear Southwest elevation wall within the library, with extensive evidence of damp affected and defective plaster finishes.</p> |

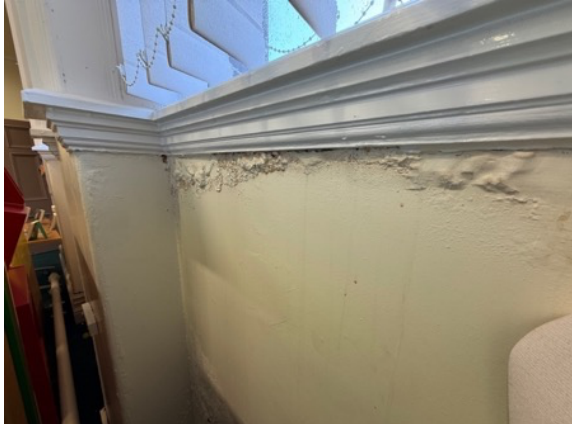
| <p>Internal – Rear Southwest elevation wall within the library, with extensive evidence of damp affected and defective plaster finishes.</p> | <p>Internal – Rear Southwest elevation wall within the library, high levels of moisture recorded.</p> | |
