Project Ref: 6046

## The Hub – External & Internal Condition Examples

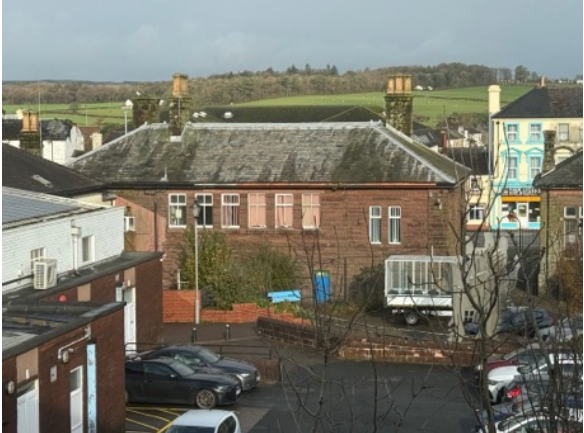
| <b>Northwest Elevation - General</b> | Central Lead Covered Roof Area – To be renewed. | Central Lead Covered Roof Area – Within roof void. |

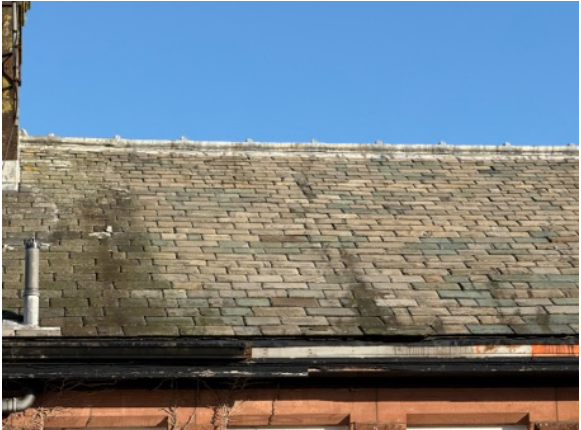
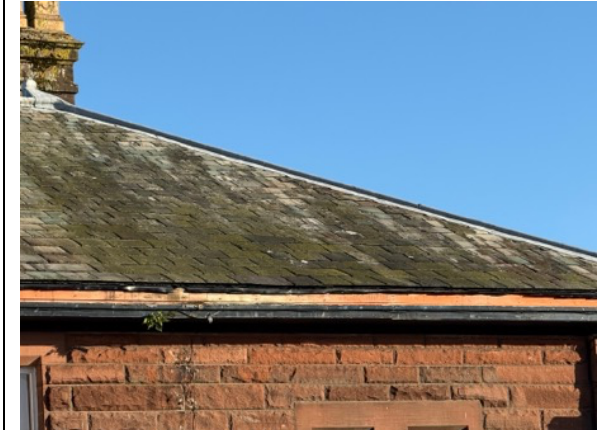
| <p>Roof Slate Pitched Roofs – Roof covering to be renewed with salvaged slate set aside for re-use.</p> | <p>Roof Slate Pitched Roofs – Roof covering to be renewed with salvaged slate set aside for re-use.</p> | <p>Above Ground Rainwater Goods – Missing rainwater guttering and downpipe.</p> |

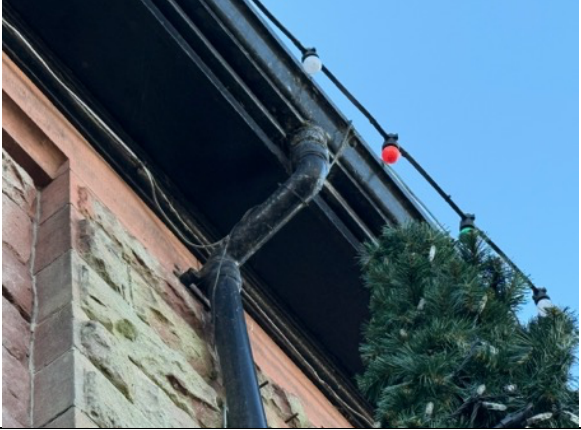
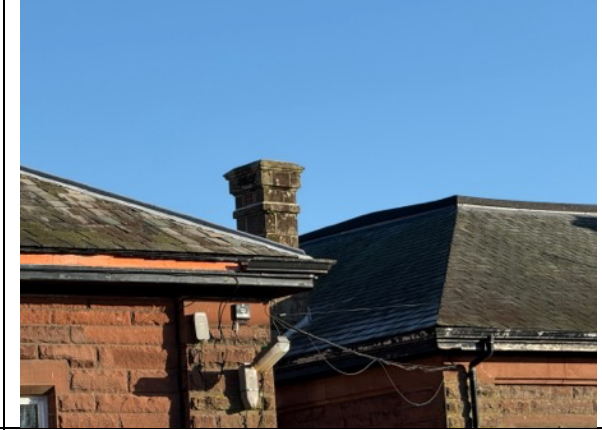
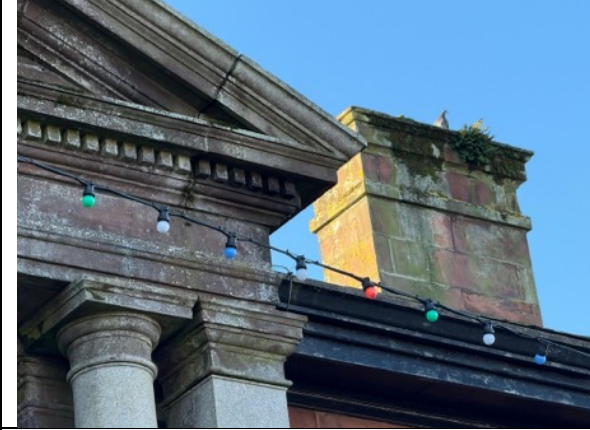
| <p>Above Ground Rainwater Goods – Defective guttering &amp; downpipe.</p> | <p>Timber Fascia's &amp; Soffits – Defective fascia and soffit.</p> | <p>Timber Fascia's &amp; Soffits – Unmaintained soffits and fascias.</p> |

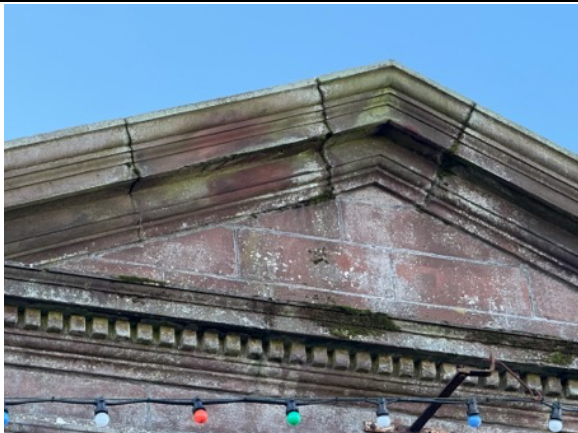
Stonework Cleaning – Sandstone façade greening with moss and algae.

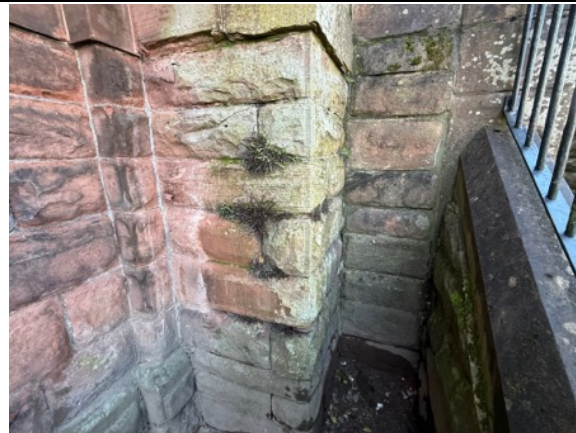
Stonework Cleaning – Sandstone façade greening with moss and algae.

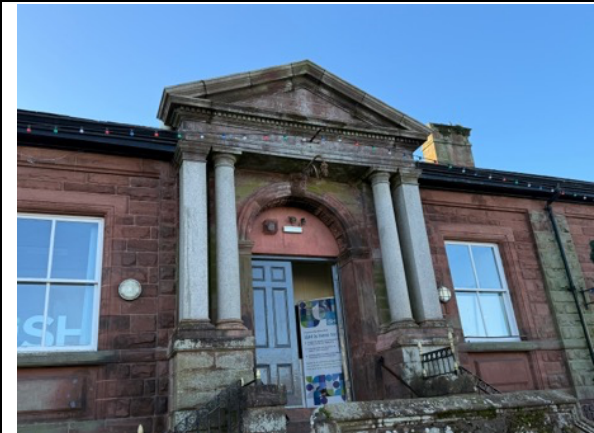
Stonework Repairs – Essential pointing repairs required to portico.

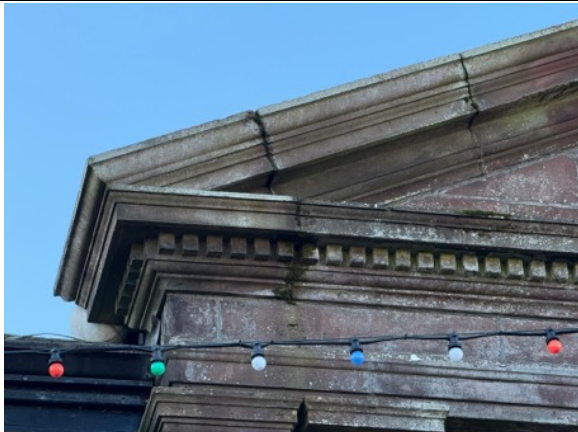
Stonework Repairs – Essential pointing repairs required to portico.

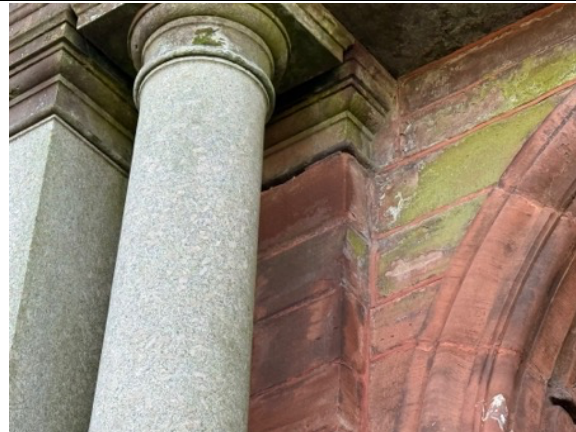
Stonework Repairs – Essential pointing repairs required to portico and sandstone façade.

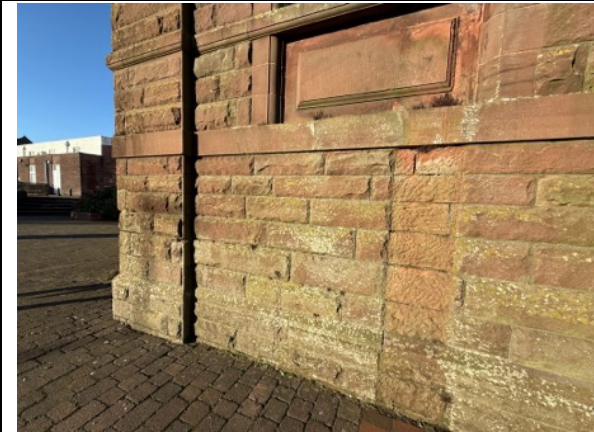
General Masonry Pointing – Deleterious mortar pointing.

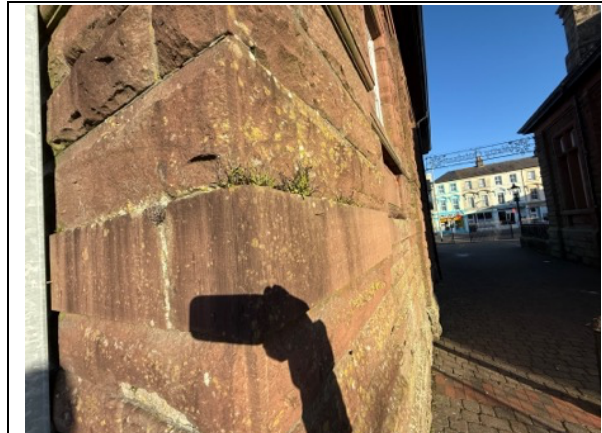
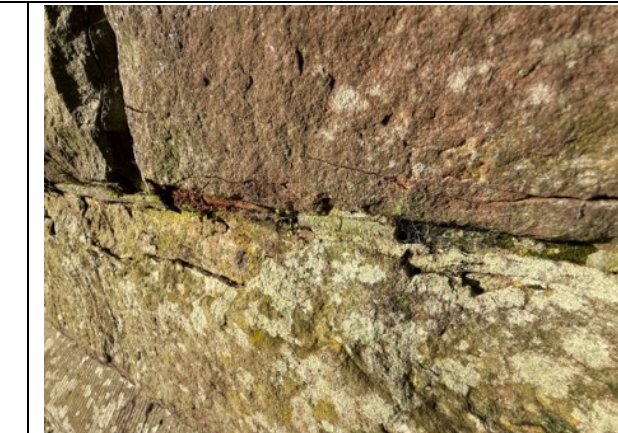
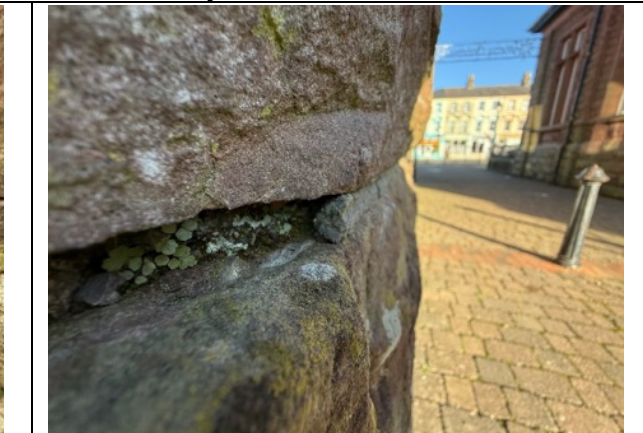
| <p>General Masonry Pointing – Deleterious mortar pointing.</p> | <p>General Masonry Pointing – Deleterious mortar pointing.</p> | <p>General Masonry Pointing – Previous repointing was poor and used unsuitable material.</p> |

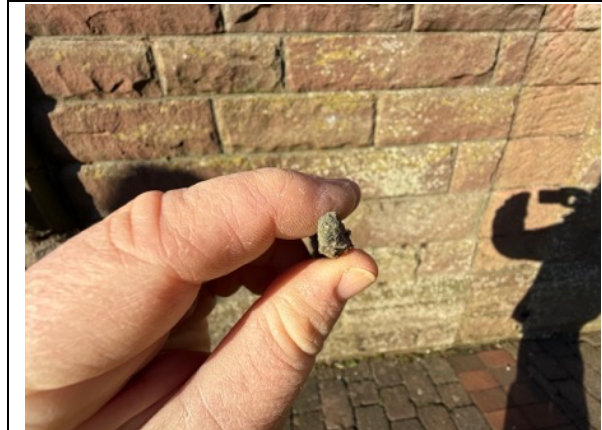
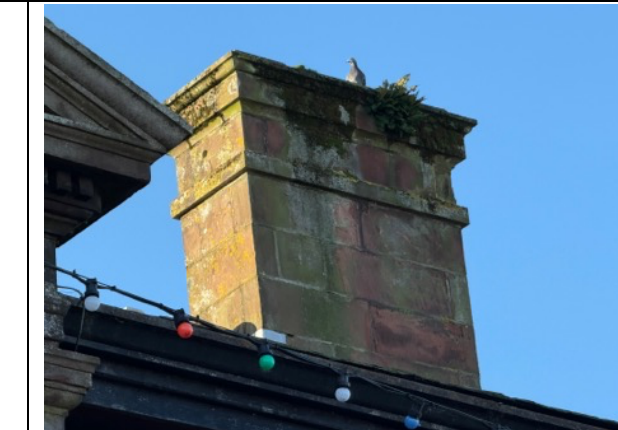
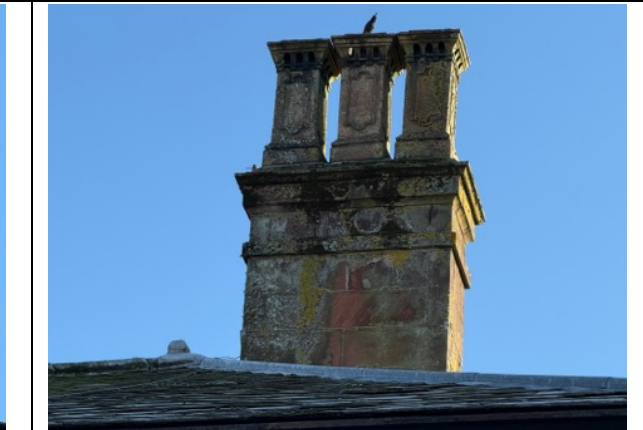
| <p>General Masonry Pointing – Previous repointing was poor and used unsuitable material.</p> | <p>General Masonry Pointing – Deleterious mortar pointing.</p> | <p>General Masonry Pointing – Deleterious mortar pointing.</p> |

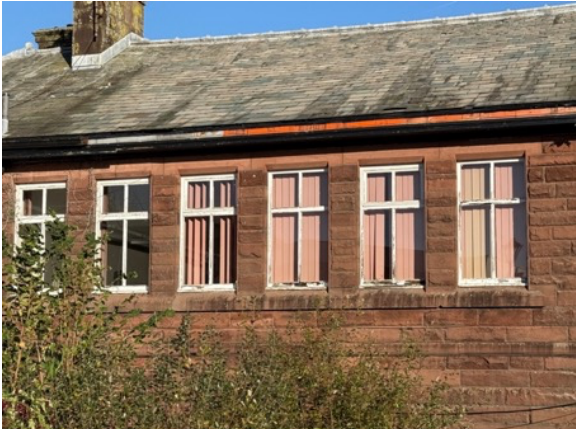
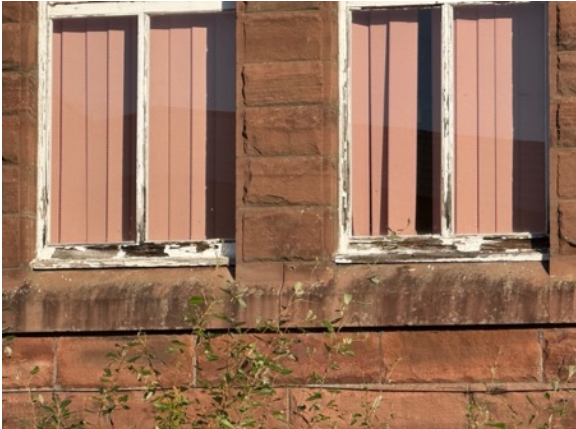
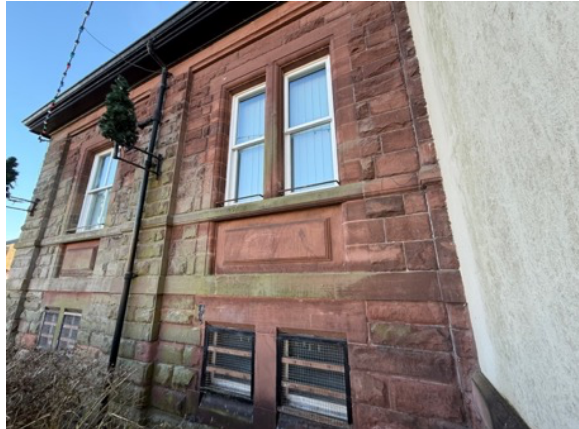
| <p>External Joinery – Failed and life expired upper floor windows.</p> | <p>External Joinery – Failed and life expired upper floor windows.</p> | <p>External Joinery – Typical condition of unmaintained timber framed windows.</p> |
