# TWEDDELL & SLATER

## Structural Assessment Report Town Head Farm Nethertown

## Structural Assessment Report

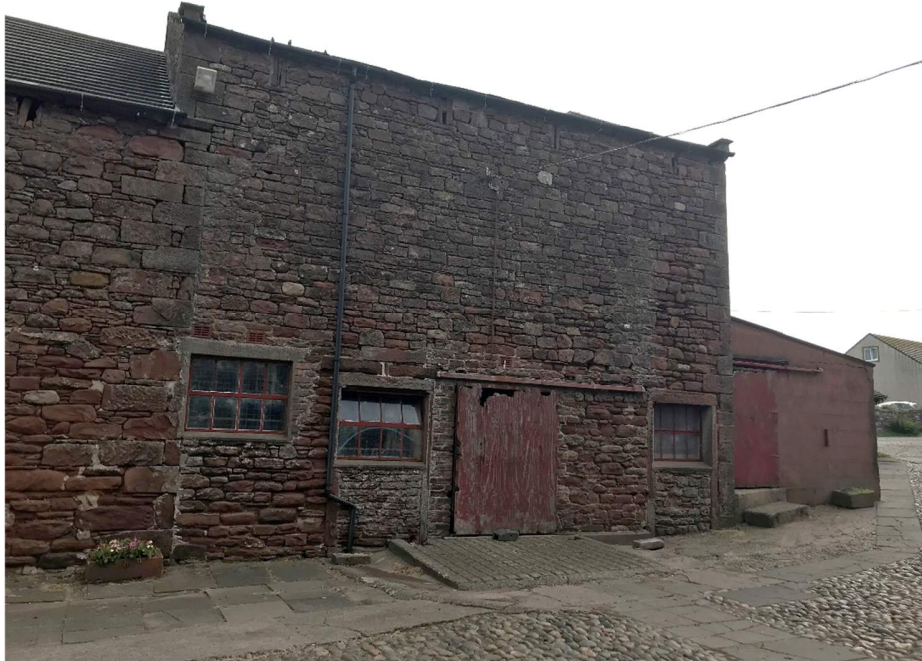
There were some undulations in the yard side wall, with an outwards lean of up to 35mm in a 1.2m length over the barn door. There were areas of missing mortar and heavily weathered stones and some areas of cement pointing were noted, with some spalling off. A straight joint was observed between Barn One and Barn Two.

*Figure 3.2 – Yard side wall of Barn One*

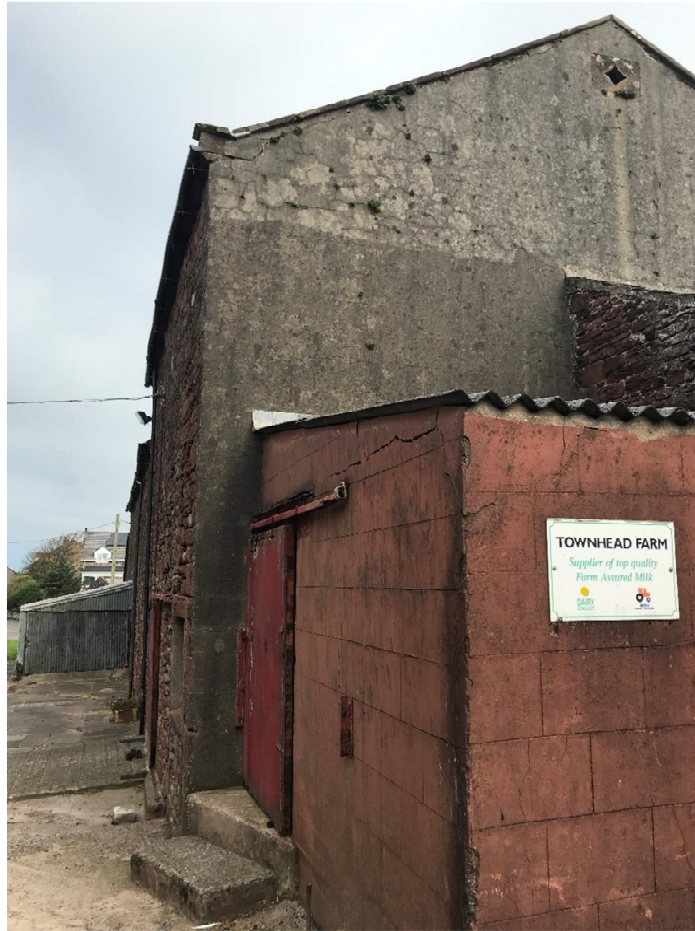
*Figure 3.4 – Loose stones at eaves and cracking to extension*

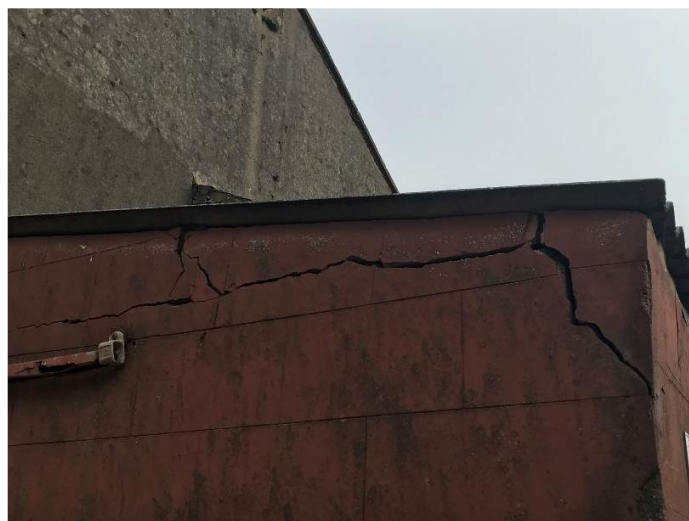
There was cracking to the blockwork along the eaves of the yard side lean to. The steel angle purlins supporting the roof sheeting appeared to have corroded and broken the blockwork at the bearings. Corrosion of the purlins and cracking at bearings was also noted internally, as well as some water staining on the internal wall.

*Figure 3.5 – Cracking at purlin bearings*

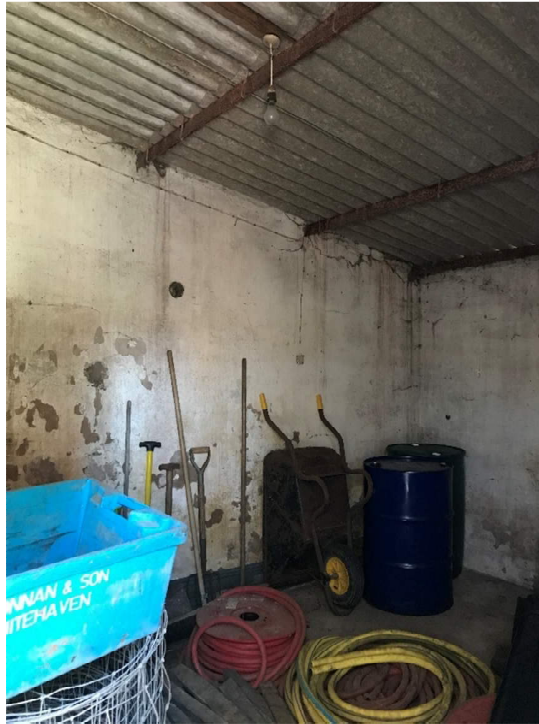
*Figure 3.6 – Water staining and cracking to internal wall*

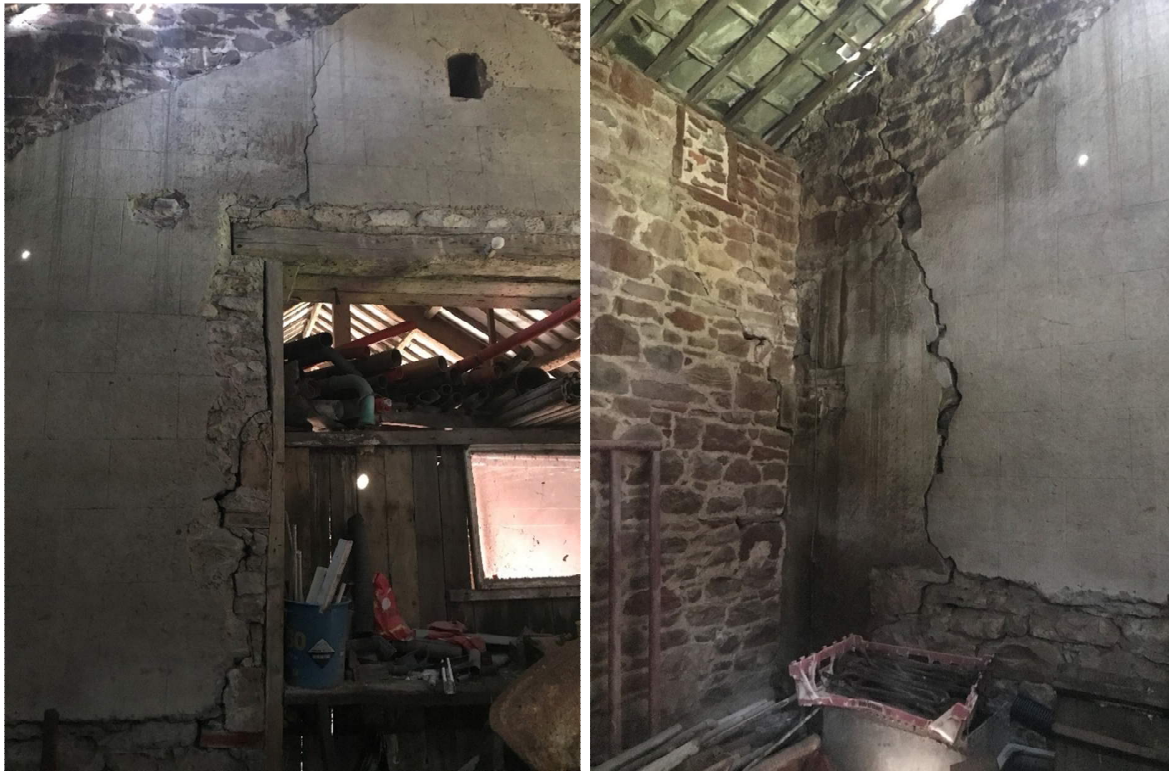
There was a large opening in the internal cross wall with cement render around, that had cracked and spalled. A large diagonal crack was noted at the internal wall/yard wall junction. There was an outwards lean on the yard side wall, measured at approximately 10-15mm in a 1.2m length.

*Figure 3.12 – Cracking in internal wall*

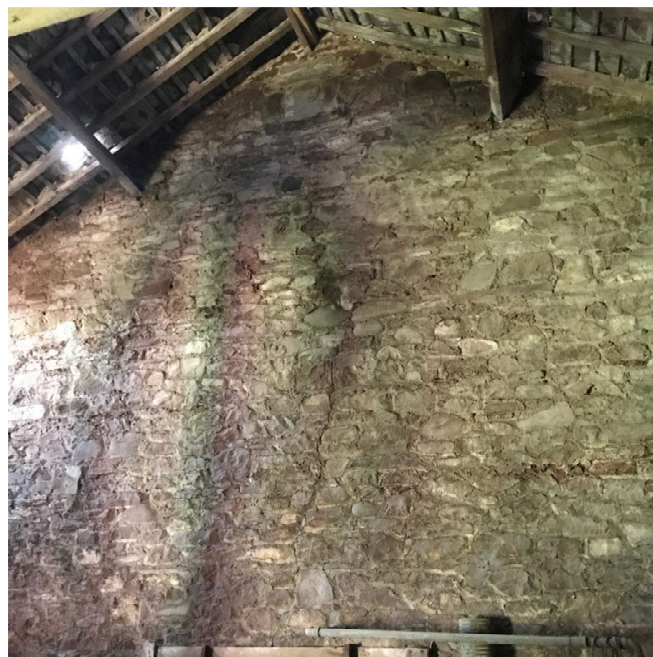
A vertical crack was noted in the gable wall up to the ridge, widening towards the top.

*Figure 3.13 – Vertical crack in gable*

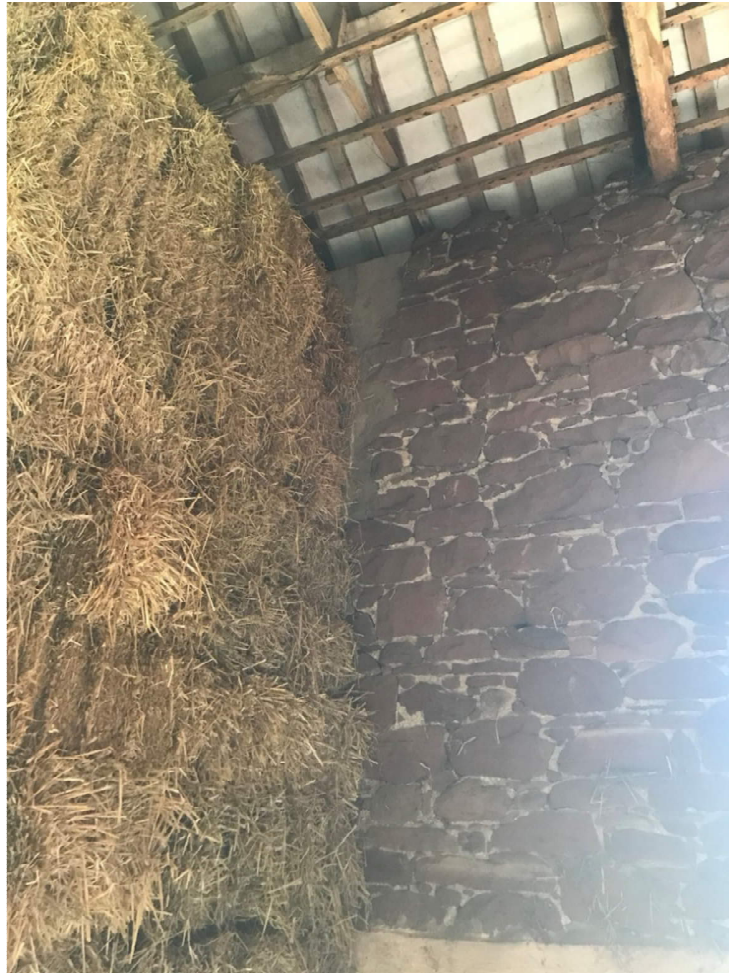
The inspection of Barn Two began at the road side wall. The tenant advised us that the northern end of the roadside wall had been previously rebuilt in blockwork and faced with stone after a collapse (date unknown). The edge of this blockwork could just be viewed internally, but the majority was obstructed by straw bales.

*Figure 3.14 – Edge of blockwork rebuild*
