**Project****Project Name:** 2024-06-30014 RG Parkins Queens Park Drive Millom**Project Date:** 09/07/2024**Inspection Standard:** MSCC5 Sewers & Drainage GB (SRM5 Scoring)

**R. G. PARKINS & PARTNERS LTD**  
CONSULTING CIVIL & STRUCTURAL ENGINEERS

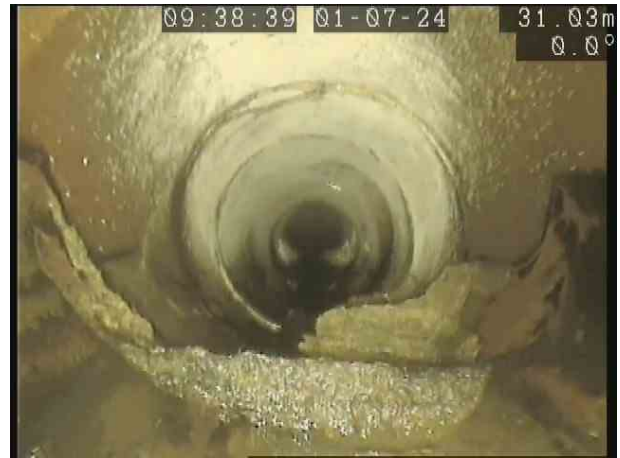
UU MH  
 6102X\_054b9233-0eb6-4d59-b32b-33d4f6c33e59\_20240710\_114500\_483.jpg, 00:02:16, 31.03 m  
 Settled deposits, hard or compacted, 15% cross-sectional area loss

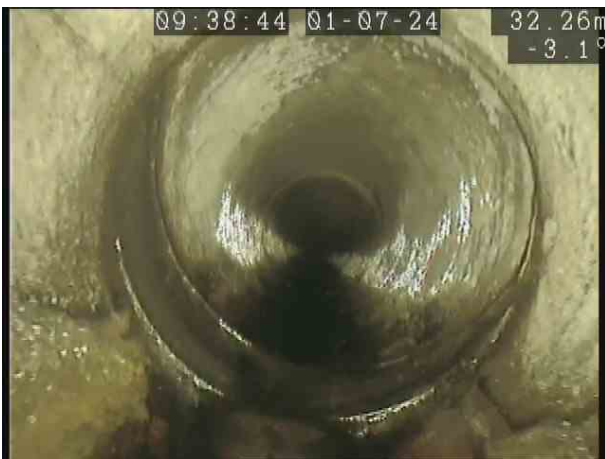
| Scale: | 1:390 | Position [m] | Code | Observation | MPEG | Photo | Grade |
|---|---|---|---|---|---|---|---|
| | | 32.26 | CCJ | Crack, circumferential at joint from 4 o'clock to 10 o'clock | 00:02:22 | UU MH 6102X_8a a0c46d-9a | 2 / 2 |

UU MH  
 6102X\_8aa0c46d-9a96-4dd7-baeb-a9c16474a47f\_20240710\_114547\_387.jpg, 00:02:22, 32.26 m  
 Crack, circumferential at joint from 4 o'clock to 10 o'clock

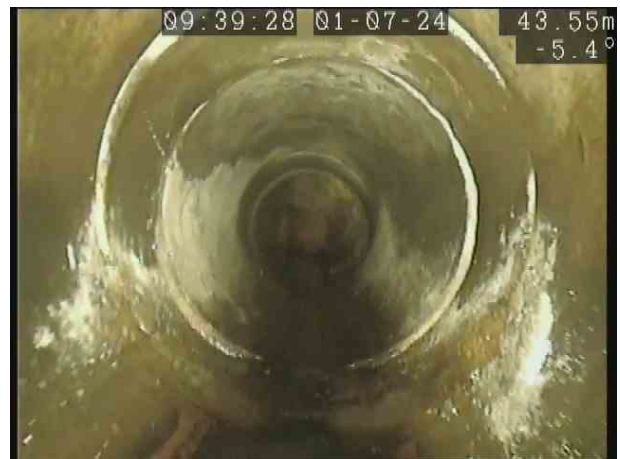
| Scale: | 1:390 | Position [m] | Code | Observation | MPEG | Photo | Grade |
|---|---|---|---|---|---|---|---|
| | | 43.55 | CC | Crack, circumferential from 9 o'clock to 3 o'clock | 00:03:06 | UU MH 6102X_5fa 5dfff-6f48- | 2 / 2 |

UU MH  
 6102X\_5fa5dfff-6f48-417e-b0eb-d9ced27bb390\_20240710\_114839\_437.jpg, 00:03:06, 43.55 m  
 Crack, circumferential from 9 o'clock to 3 o'clock

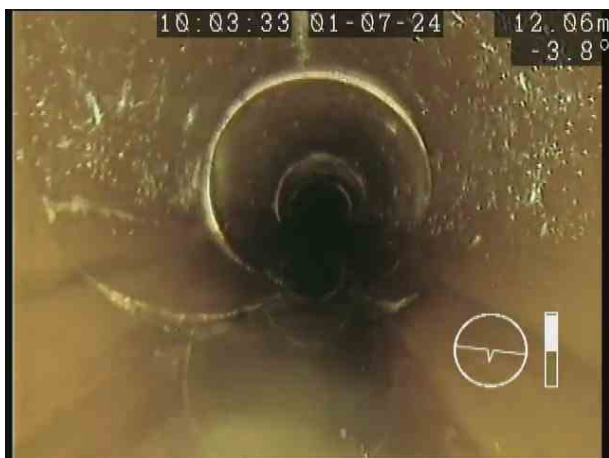
<table><tr><td>MH</td><td>Start node, manhole, reference: UU MH 5100</td><td>00:00:00</td><td></td><td></td><td></td></tr><tr><td>BJ</td><td>Broken pipe at joint from 5 o'clock to 12 o'clock</td><td>00:01:05</td><td>UU MH 6100X_1f1 a0399-e9c</td><td>4</td><td></td></tr></table>

UU MH  
 6100X\_1f1a0399-e9c0-4ff8-963c-9b5585b60a92\_20240709\_1  
 61947\_196.jpg, 00:01:05, 12.06 m  
 Broken pipe at joint from 5 o'clock to 12 o'clock

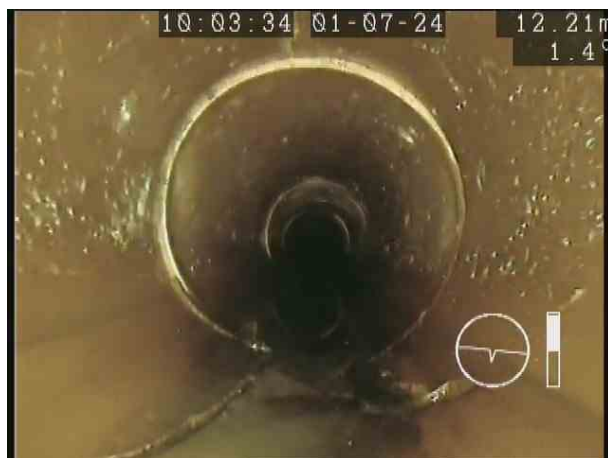
UU MH  
 6100X\_a692a75b-395e-47d1-98bd-1d2c88121c61\_20240709  
 \_161949\_595.jpg, 00:01:05, 12.06 m  
 Broken pipe at joint from 5 o'clock to 12 o'clock

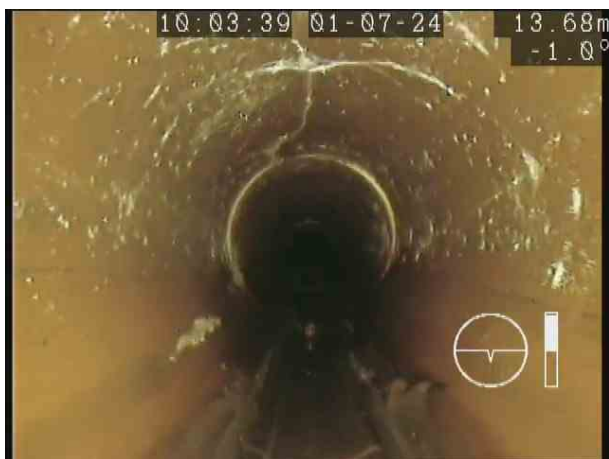
<table><tr><td>MH</td><td>Start node, manhole, reference: UU MH 5100</td><td>00:00:00</td><td></td><td></td><td></td></tr><tr><td>B</td><td>Broken pipe from 5 o'clock to 1 o'clock</td><td>00:01:12</td><td>UU MH 6100X_14 517ef8-5c</td><td>4</td><td></td></tr></table>

UU MH  
 6100X\_14517ef8-5c0a-41a8-a929-72107e33c6fc\_20240709\_  
 162107\_885.jpg, 00:01:12, 13.68 m  
 Broken pipe from 5 o'clock to 1 o'clock

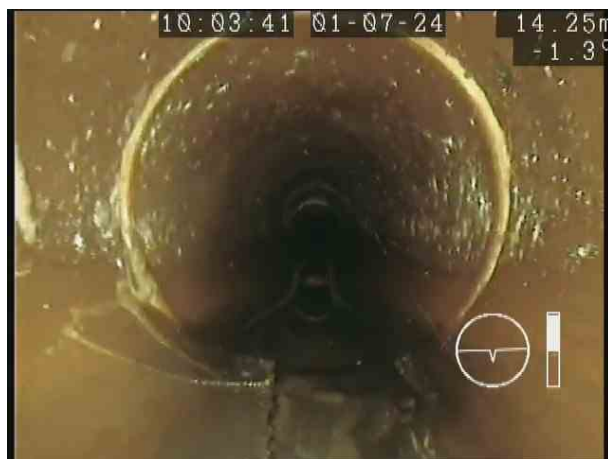
UU MH  
 6100X\_98c78042-5e67-4379-a07d-c180488df7fa\_20240709\_  
 162110\_829.jpg, 00:01:12, 13.68 m  
 Broken pipe from 5 o'clock to 1 o'clock

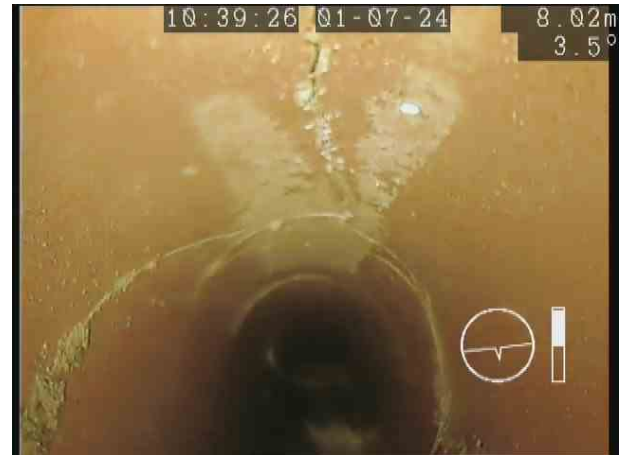
| Section | PLR | Grade | Description |
|---|---|---|---|
| 6 | UU MH 6207X | 3 | Fracture, longitudinal at 12 o'clock |

| Scale: | 1:72 | Position [m] | Code | Observation | MPEG | Photo | Grade |
|---|---|---|---|---|---|---|---|
| | | 8.00 | FL | Fracture, longitudinal at 12 o'clock | 00:00:48 | UU MH 6207X_3a 821584-15 | 3 / 2 |

UU MH  
 6207X\_3a821584-1566-4f41-872c-9b977f35cb0d\_20240710\_130722\_547.jpg, 00:00:48, 8.00 m  
 Fracture, longitudinal at 12 o'clock

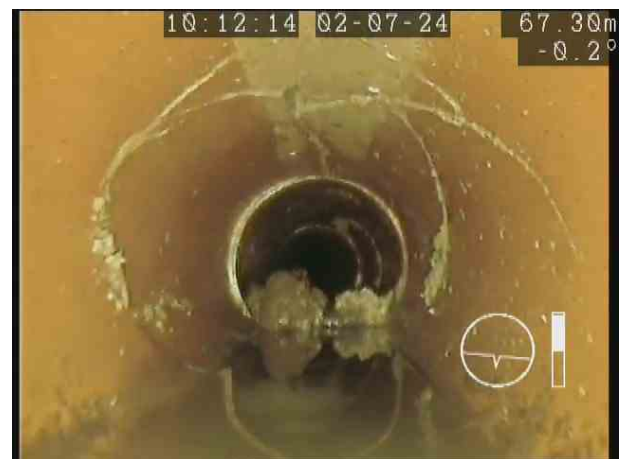
| Section | PLR | Grade | Description |
|---|---|---|---|
| 7 | UU MH 6207X | 3 | Cracks, multiple from 9 o'clock to 3 o'clock |

| | 67.30 | CM | Cracks, multiple from 9 o'clock to 3 o'clock | 00:06:37 | UU MH<br>6207X_a5f<br>aa638-d1e | 3 / 2 | | | |

UU MH  
 6207X\_a5faa638-d1eb-480c-9e4c-966253962b1d\_20240710\_103655\_804.jpg, 00:06:37, 67.30 m  
 Cracks, multiple from 9 o'clock to 3 o'clock

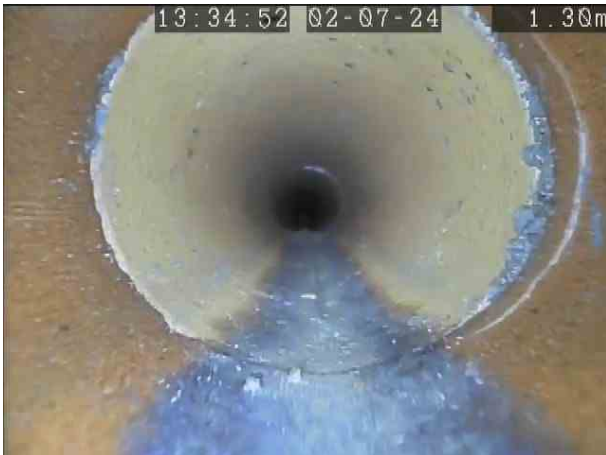
| Scale: | 1:50 | Position [m] | Code | Observation | MPEG | Photo | Grade |
|---|---|---|---|---|---|---|---|
| | | 1.30 | CCJ | Crack, circumferential at joint from 2 o'clock to 6 o'clock | 00:00:17 | UTPX_4f8e55af-1345-4262-96 | 2 / 2 |

UTPX\_4f8e55af-1345-4262-9642-64bc344ad2c4\_20240710\_105337\_545.jpg, 00:00:17, 1.30 m  
 Crack, circumferential at joint from 2 o'clock to 6 o'clock

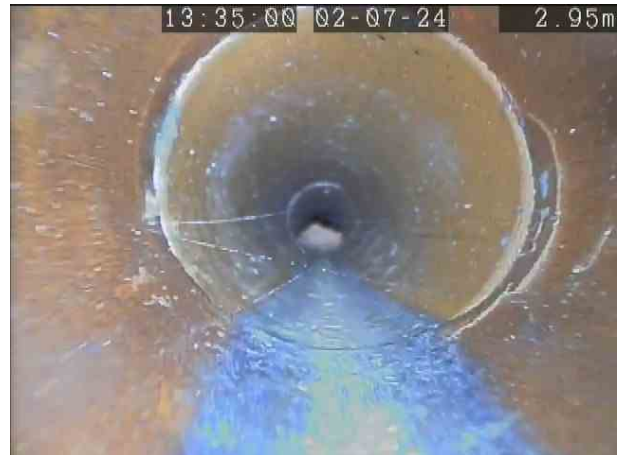
| Scale: | 1:50 | Position [m] | Code | Observation | MPEG | Photo | Grade |
|---|---|---|---|---|---|---|---|
| | | 2.95 | CCJ | Crack, circumferential at joint from 3 o'clock to 6 o'clock | 00:00:24 | UTPX_49d29612-f96e-424b-bc | 2 / 2 |

UTPX\_49d29612-f96e-424b-bc3e-f3279f944a80\_20240710\_105417\_702.jpg, 00:00:24, 2.95 m  
 Crack, circumferential at joint from 3 o'clock to 6 o'clock

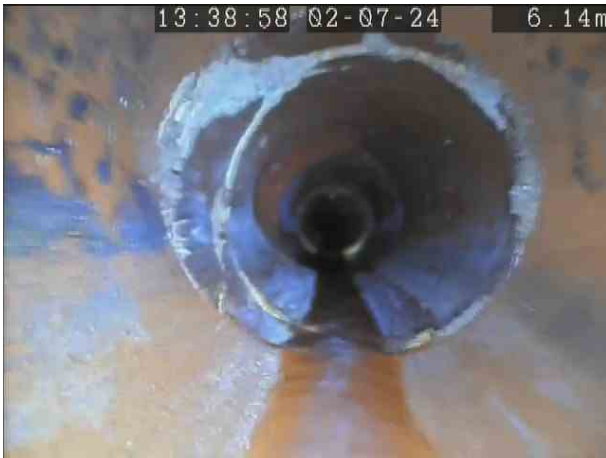
| Section | PLR | Grade | Description |
|---|---|---|---|
| 11 | UU MH 5211X | 3 | Cracks, multiple at joint from 7 o'clock to 2 o'clock |

<table><tr><td>0.00</td><td>MH</td><td>Start node, manhole, reference: UU MH 5211</td><td>00:00:00</td><td></td><td></td></tr><tr><td>6.14</td><td>CMJ</td><td>Cracks, multiple at joint from 7 o'clock to 2 o'clock</td><td>00:00:34</td><td>UU MH 5211X_9e 05bcb6-a4</td><td>3 / 2</td></tr></table>

UU MH  
 5211X\_9e05bcb6-a4fe-41b7-afef-8320a649b797\_20240710\_1  
 11844\_421.jpg, 00:00:34, 6.14 m  
 Cracks, multiple at joint from 7 o'clock to 2 o'clock

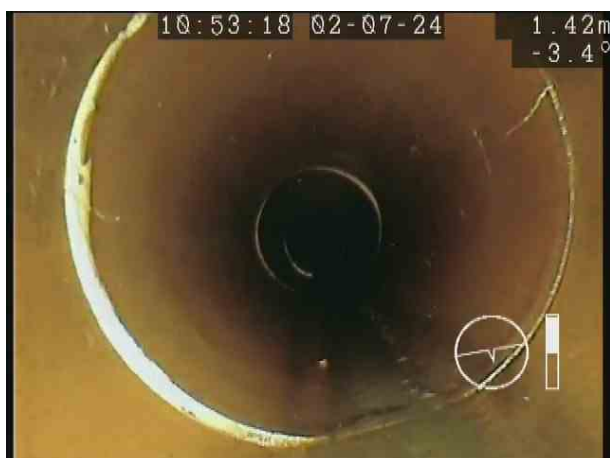
| Scale: 1:555 | Position [m] | Code | Observation | MPEG | Photo | Grade |
|---|---|---|---|---|---|---|
| | 1.42 | CLJ | Crack, longitudinal at joint at 3 o'clock | 00:00:24 | UU MH 5200X_12 29c7db-bf | 2 / 2 |

UU MH  
 5200X\_1229c7db-bf6d-4902-bab0-a17b022407d6\_20240709\_162809\_308.jpg, 00:00:24, 1.42 m  
 Crack, longitudinal at joint at 3 o'clock

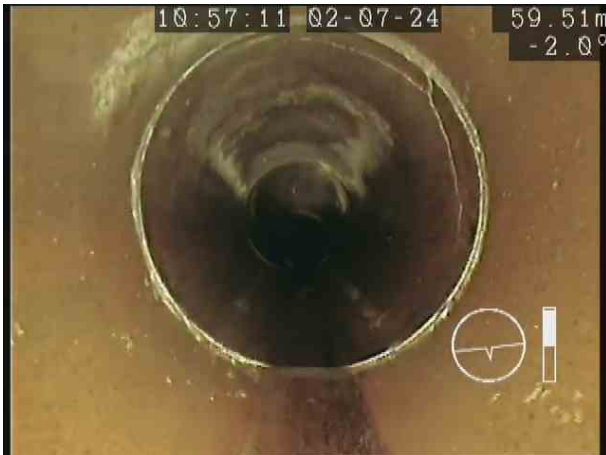
| Scale: 1:555 | Position [m] | Code | Observation | MPEG | Photo | Grade |
|---|---|---|---|---|---|---|
| | 59.51 | CCJ | Crack, circumferential at joint from 11 o'clock to 4 o'clock | 00:04:18 | UU MH 5200X_96 9b0da7-90 | 2 / 2 |

UU MH  
 5200X\_969b0da7-9035-4c91-a55d-c4febf79c8eb\_20240709\_165040\_872.jpg, 00:04:18, 59.51 m  
 Crack, circumferential at joint from 11 o'clock to 4 o'clock

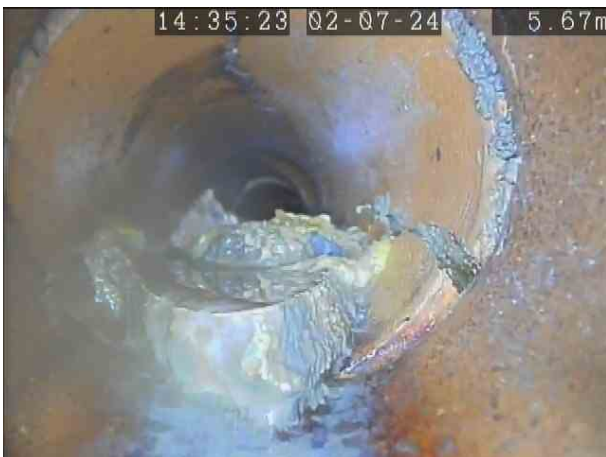
| Section | PLR | Grade | Description |
|---|---|---|---|
| 19 | UU MH 6106X | 4 | Broken pipe at joint from 12 o'clock to 4 o'clock |

| Scale: | 1:50 | Position [m] | Code | Observation | MPEG | Photo | Grade |
|---|---|---|---|---|---|---|---|
| | | 5.67 | BJ | Broken pipe at joint from 12 o'clock to 4 o'clock | 00:00:43 | UU MH 6106X_57 b8d791-92 | 4 |

UU MH  
 6106X\_57b8d791-92cf-455c-ada4-c0295a4073fb\_20240710\_121757\_623.jpg, 00:00:43, 5.67 m  
 Broken pipe at joint from 12 o'clock to 4 o'clock

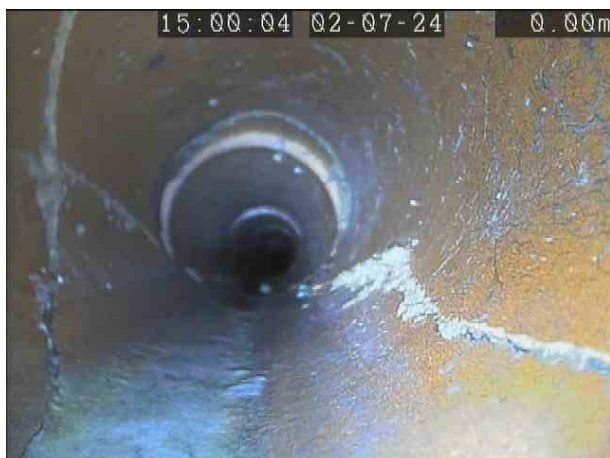
| Section | PLR | Grade | Description |
|---|---|---|---|
| 21 | UU MH6107BX | 4 | Broken pipe from 7 o'clock to 4 o'clock |

| Scale: 1:202 | Position [m] | Code | Observation | MPEG | Photo | Grade |
|---|---|---|---|---|---|---|
| | 0.01 | B | Broken pipe from 7 o'clock to 4 o'clock | 00:00:11 | UU MH6107B X_8185fbb | 4 |

UU  
 MH6107BX\_8185fbb7-5422-4a1c-a5e6-f5a7c50f3fd5\_202407  
 10\_125314\_203.jpg, 00:00:11, 0.01 m  
 Broken pipe from 7 o'clock to 4 o'clock

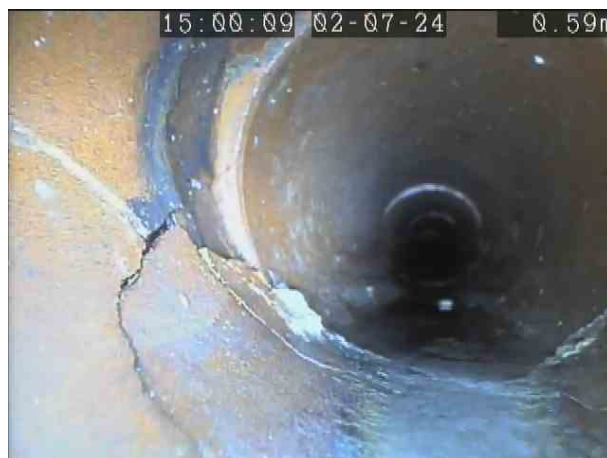
UU  
 MH6107BX\_f90ce274-0e12-4431-be83-153d4d29fdcc\_20240  
 710\_125427\_483.jpg, 00:00:11, 0.01 m  
 Broken pipe from 7 o'clock to 4 o'clock

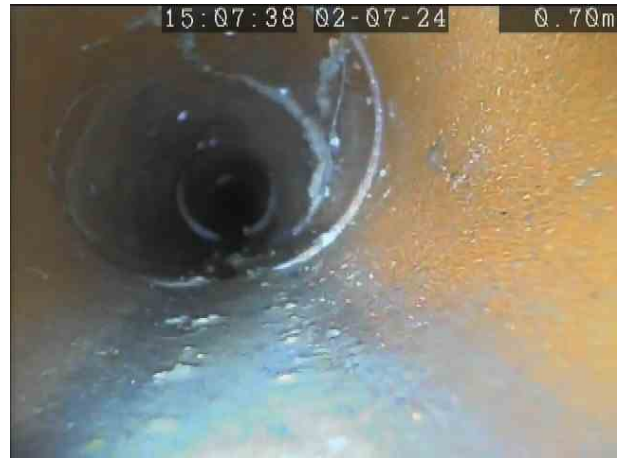
| Section | PLR | Grade | Description |
|---|---|---|---|
| 22 | UU MH6107AX | 4 | Fractures, multiple at joint from 8 o'clock to 5 o'clock |

| Scale: 1:147 | Position [m] | Code | Observation | MPEG | Photo | Grade |
|---|---|---|---|---|---|---|
| | 0.94 | FMJ | Fractures, multiple at joint from 8 o'clock to 5 o'clock | 00:00:19 | UU MH6107A X_4a8c77 | 4 / 2 |

UU  
 MH6107AX\_4a8c7710-511d-4ea7-817a-04986cc7a9de\_20240710\_123428\_172.jpg, 00:00:19, 0.94 m  
 Fractures, multiple at joint from 8 o'clock to 5 o'clock

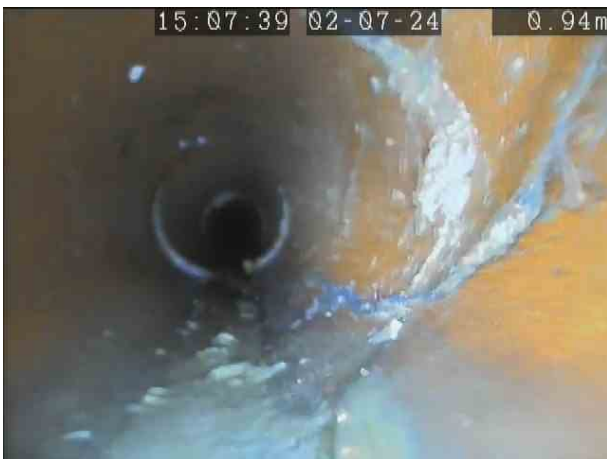
UU  
 MH6107AX\_b2cc1fb5-382e-4a3d-8aec-3e866c16732f\_20240710\_123432\_764.jpg, 00:00:19, 0.94 m  
 Fractures, multiple at joint from 8 o'clock to 5 o'clock

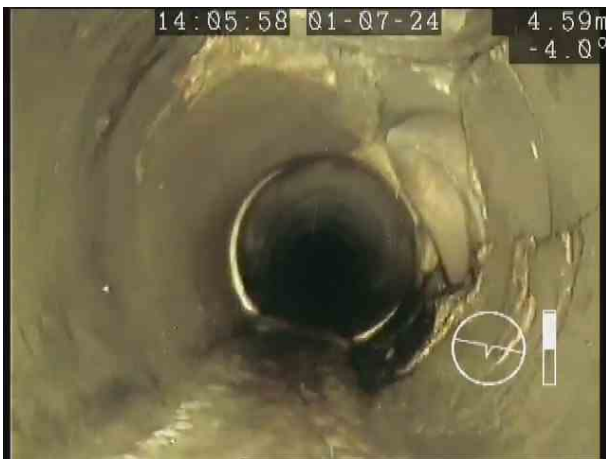
| Section | PLR | Grade | Description |
|---|---|---|---|
| 27 | UU MH 7003X | 3 | Cracks, multiple from 1 o'clock to 5 o'clock |

| Scale: 1:332 | Position [m] | Code | Observation | MPEG | Photo | Grade |
|---|---|---|---|---|---|---|
| | 4.60 | CM | Cracks, multiple from 1 o'clock to 5 o'clock | 00:00:38 | UU MH 7003X_21 045095-d4 | 3 / 2 |

UU MH  
 7003X\_21045095-d4f2-4fdc-ba61-c9b5a75b6702\_20240710\_131251\_216.jpg, 00:00:38, 4.60 m  
 Cracks, multiple from 1 o'clock to 5 o'clock
