**VISUAL STRUCTURAL INSPECTION**

**OUTBUILDINGS  
GREENMOORSIDE FARM  
BECKERMET  
CUMBRIA**

**AVISON YOUNG**

**Reference - WDS/05/9858/REP01**

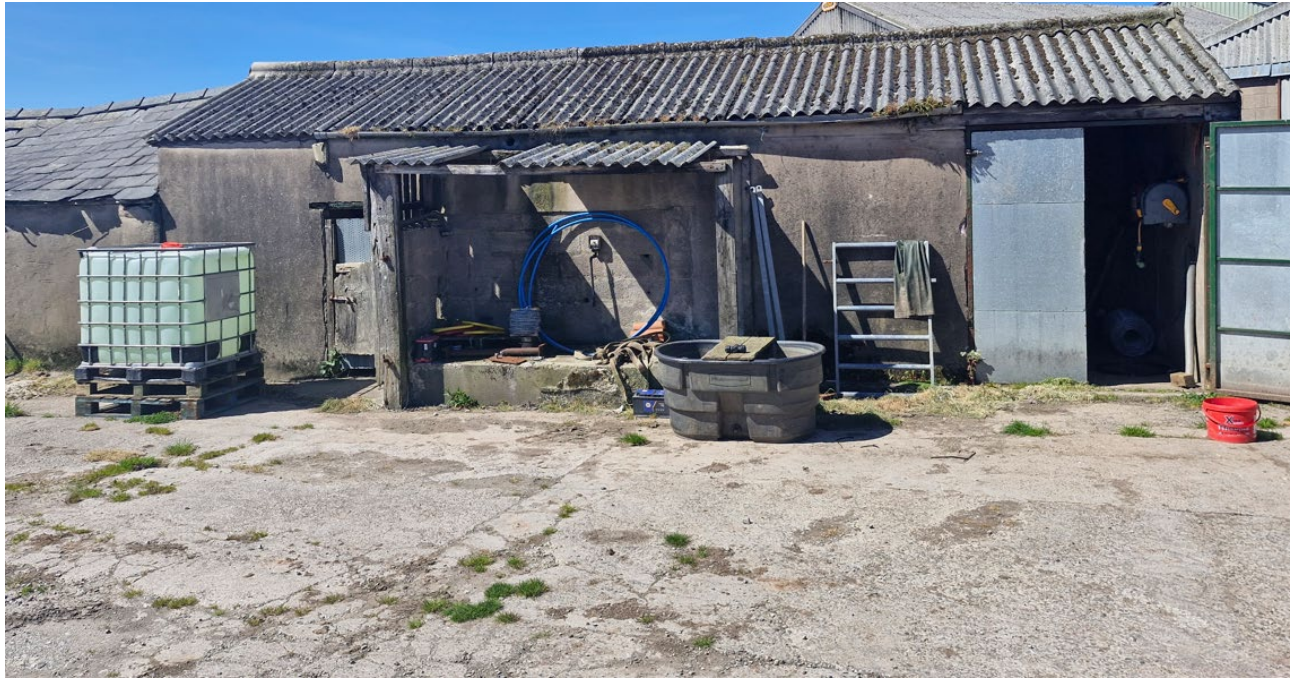
PHOTO 1 FRONT ELEVATION, BLUE OUTLINED BUILDING

- 2.1** The random stone masonry building (outlined in blue on Fig 1) is in an adequate condition. The walls are slightly out of plumb and in need of repointing with historic cracking apparent to all elevations. The timber rafter, purlins and truss roof structure has been affected by woodworm and has suffered from creep leading to a deflection on the roof finish. See photographs 01 and 02 attached. The lean to roof off the front of the building is at risk of collapse and needs replaced, see photograph 03 attached.
- 2.2** The masonry buildings off the left hand gable of the building noted above are derelict, the roof has partially collapsed and the walls have suffered excessive movement. See photographs 04 and 05 attached.

**3.1** The front masonry building (outlined in blue on Figure 1) is in an adequate structural condition. The roof structure needs some strengthening works and some of the timbers will need replaced where loss of section is excessive. The roof trusses and purlins where sat into the walls need strapped down the walls using 1500mm long Bat straps. The walls need pointed and the cracks sealed to ensure the walls remain structurally adequate. The lean-to canopy roof to the front elevation needs replaced.

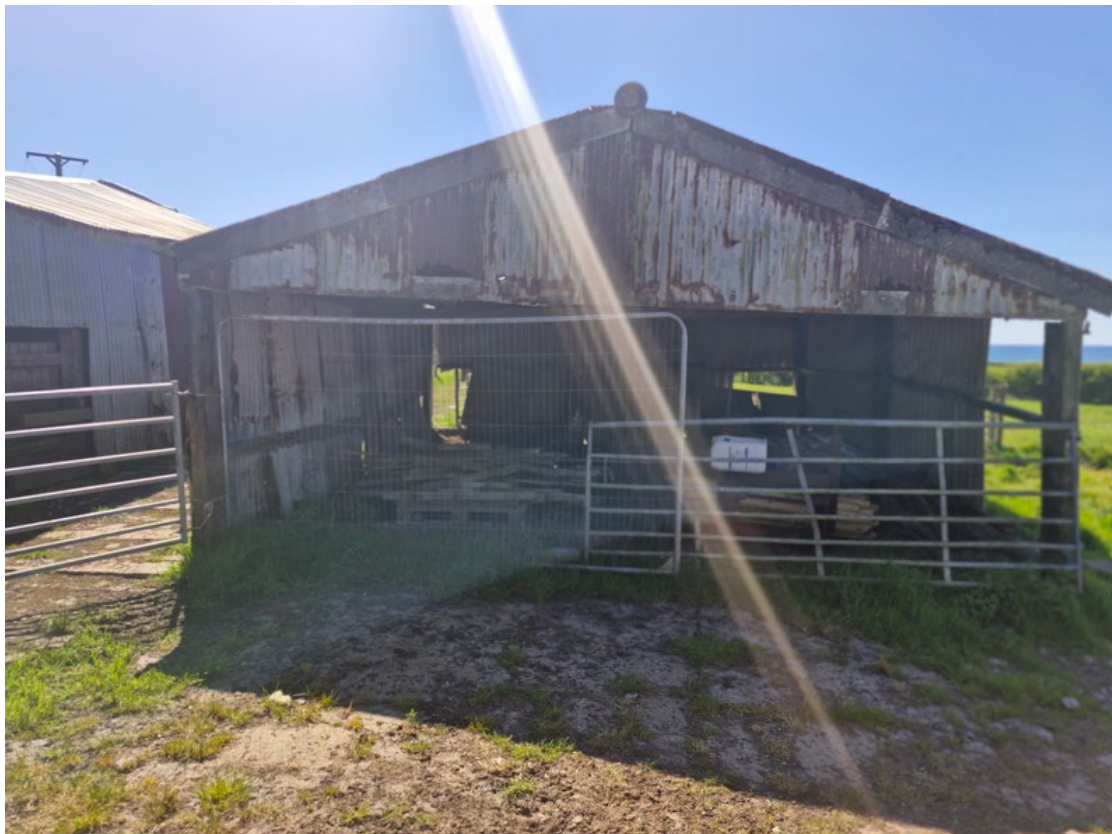
PHOTO 06 DETACHED TIMBER PORTAL SHED

**2.3** The timber framed portal buildings to the rear of the site are structurally inadequate. These have not been erected to any design criteria, but merely just 'put up'. The buildings have both suffered sway due to wind loading, the roof truss and column connections have failed in a number of locations and the cladding is loose. See photographs 06-08 attached. The buildings are disused. They are at risk of collapse in high wind or heavy snow conditions.

**3.2** All other buildings noted are beyond repair due to a lack of maintenance over many years combined with inadequate construction. Partial collapse has occurred to a number of the roofs and the rear timber portals are at risk of collapse during high wind or heavy snow conditions. We recommend that these buildings are demolished as soon as possible and should be cordoned off until removal has taken plac.. The removal of these buildings will not have an adverse effect on the building noted in 3.1 above.

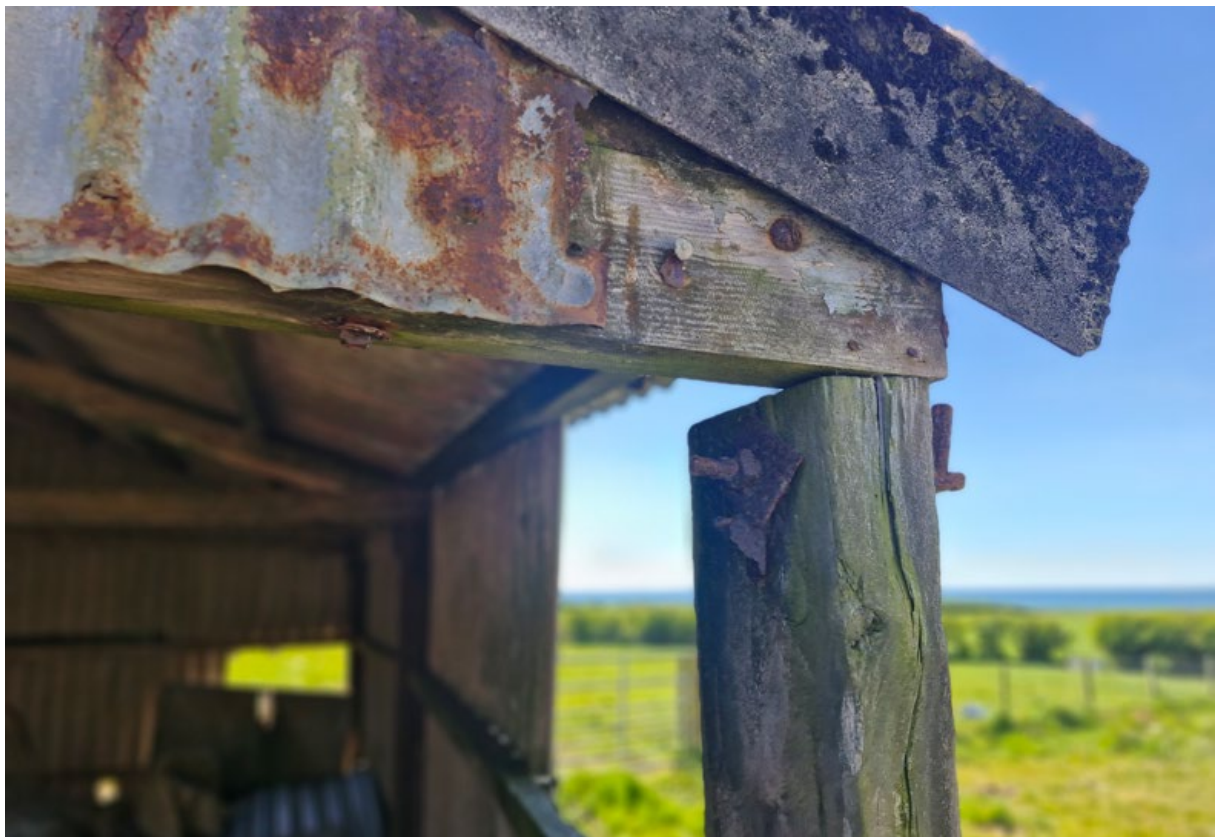
PHOTO 08 TIMBER PORTAL COLUMN/TRUSS CONNECTION (TYPICAL)

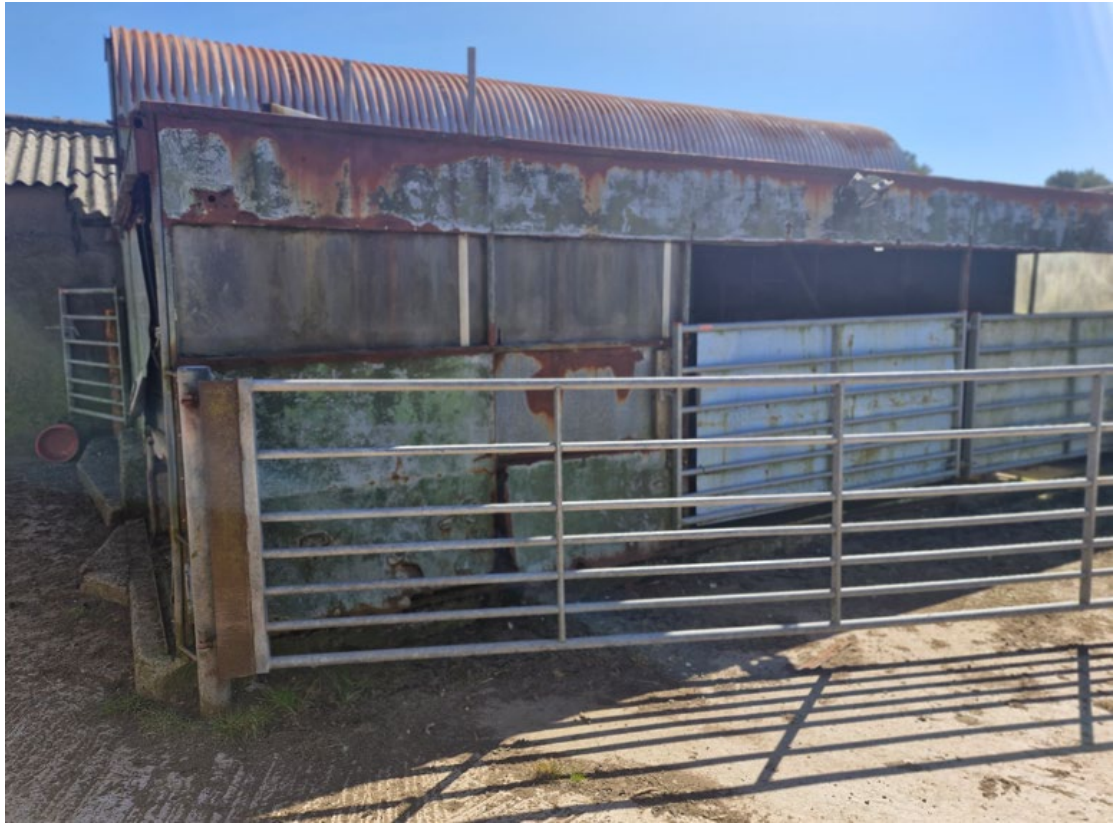
PHOTO 09 REPURPOSED STEEL CONTAINER

**2.4** The buildings between the front stone structures and rear portal frames are in a very poor condition. The structures erected were probably built by the farmer in a sequential order as more buildings were necessary. They comprise timber canopies which have rotted and partially collapsed. A lightweight steel framed container has been repurposed, but the steel has been excessively affected by rust and is at risk of collapse. See photographs 09-11 attached

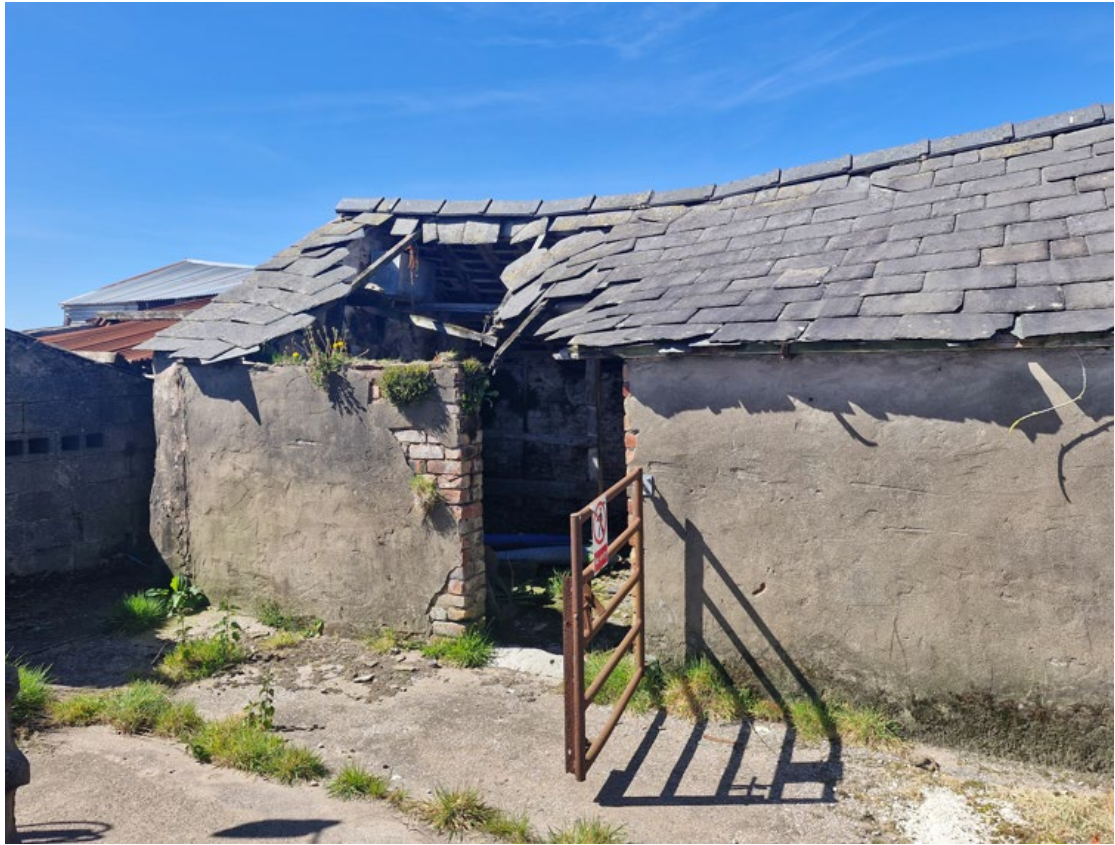
PHOTO 11 COLLAPSED ROOF
