**PROPOSED HOUSING**

**BARFS ROAD, DISTINGTON**

**TREE SURVEY REPORT**

**HOME GROUP HOUSING**

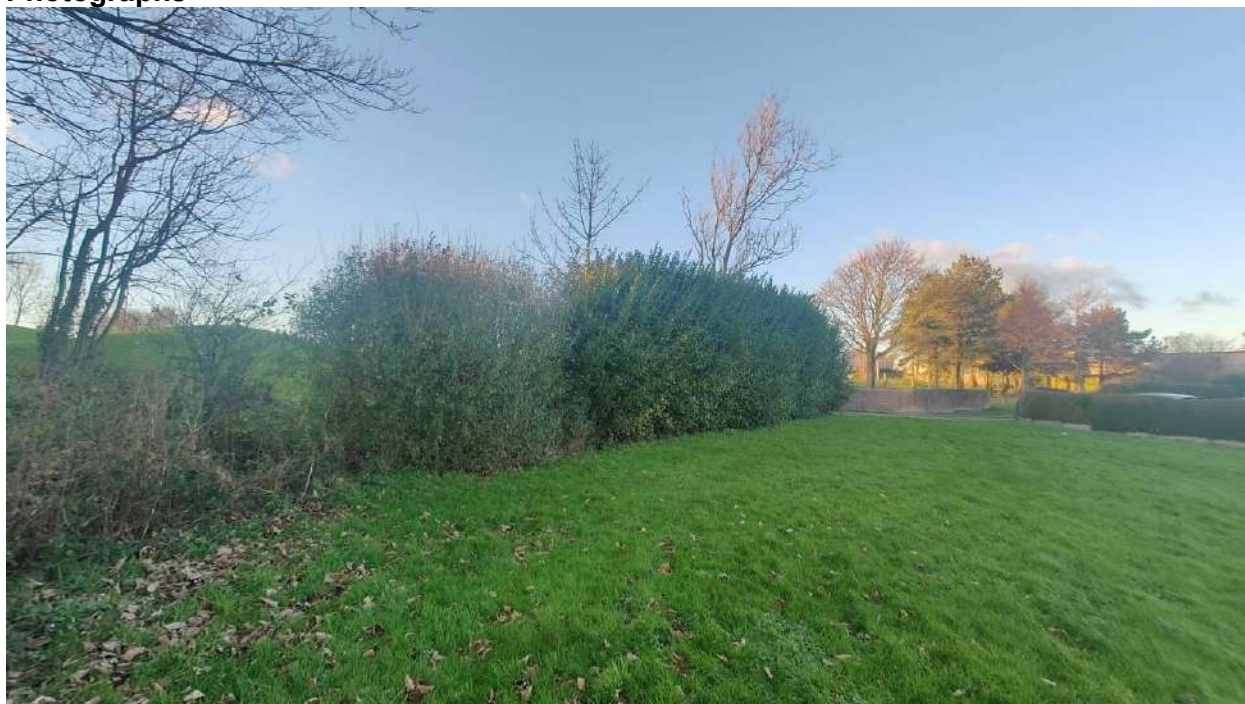
1. Hedge H1 Privet to be retained

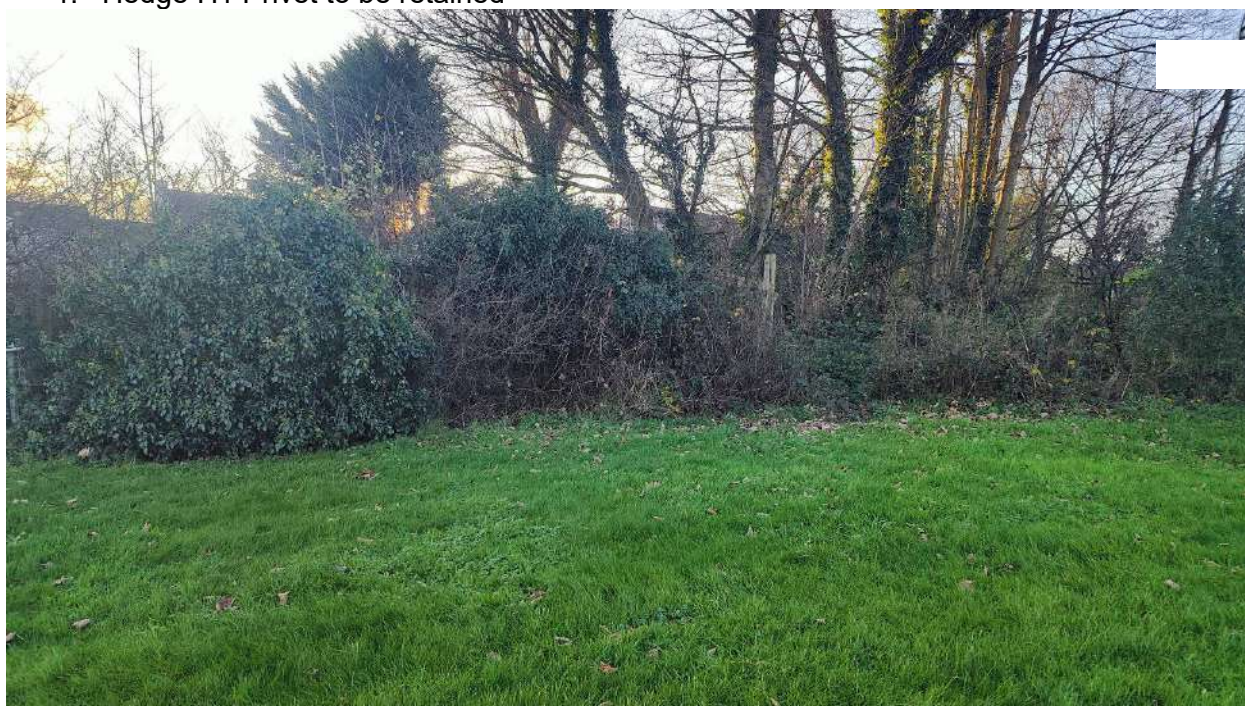
2. Hedge H2 native species to be retained.

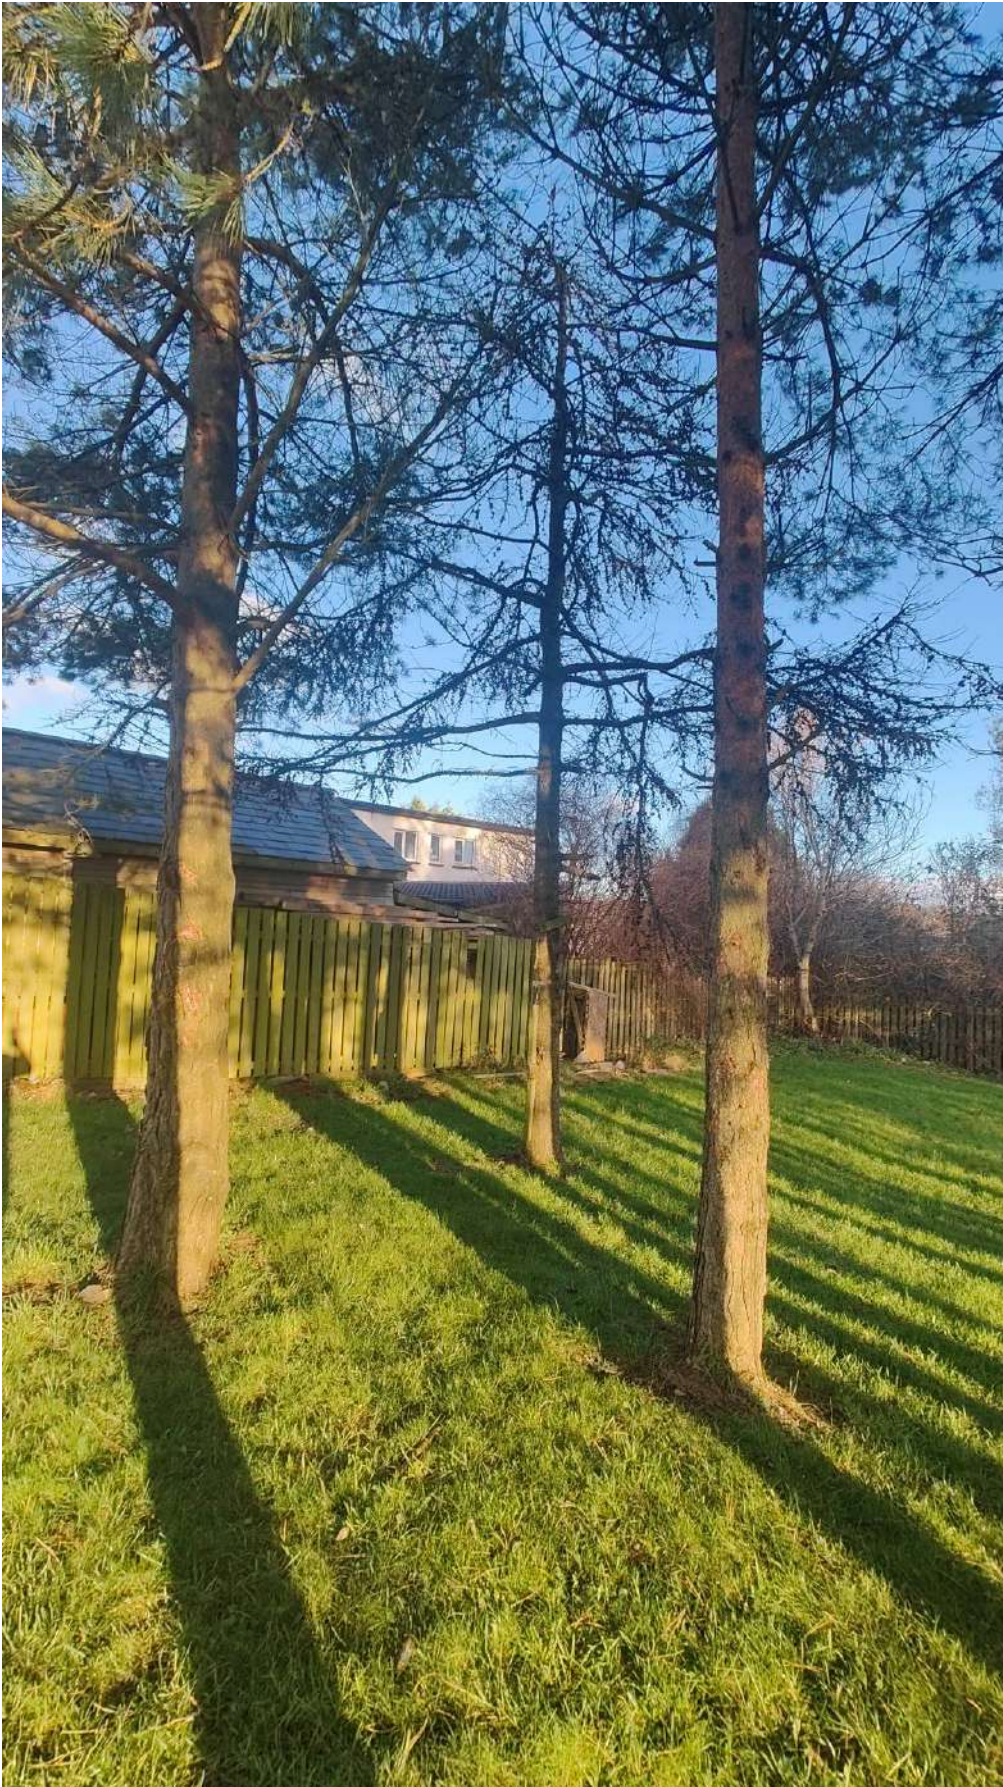
3. Group G1

| Group ID | Common Names | Est. No. of Trees | Average Height (m) | Calc. / Actual Stem Dia. (mm) | Crown spread (m) | | | | Life Stage | General Observations | Preliminary Recommendations | Estimated Remaining Contribution (Years) | BS5837: 2012 Category |
|---|---|---|---|---|---|---|---|---|---|---|---|---|---|
| G1 | Scots pine, Japanese larch, yew, holly, sycamore, silver birch, alder | 30 | 15m | 250 | | | | | Middle aged | Mainly a Scots pine group of trees of similar age and size. Two yew trees within are both poor in condition having been badly pruned. Larch tree on far west with wood nailed to the stem for a tree house. | No work required. | 10 - 20 | C |

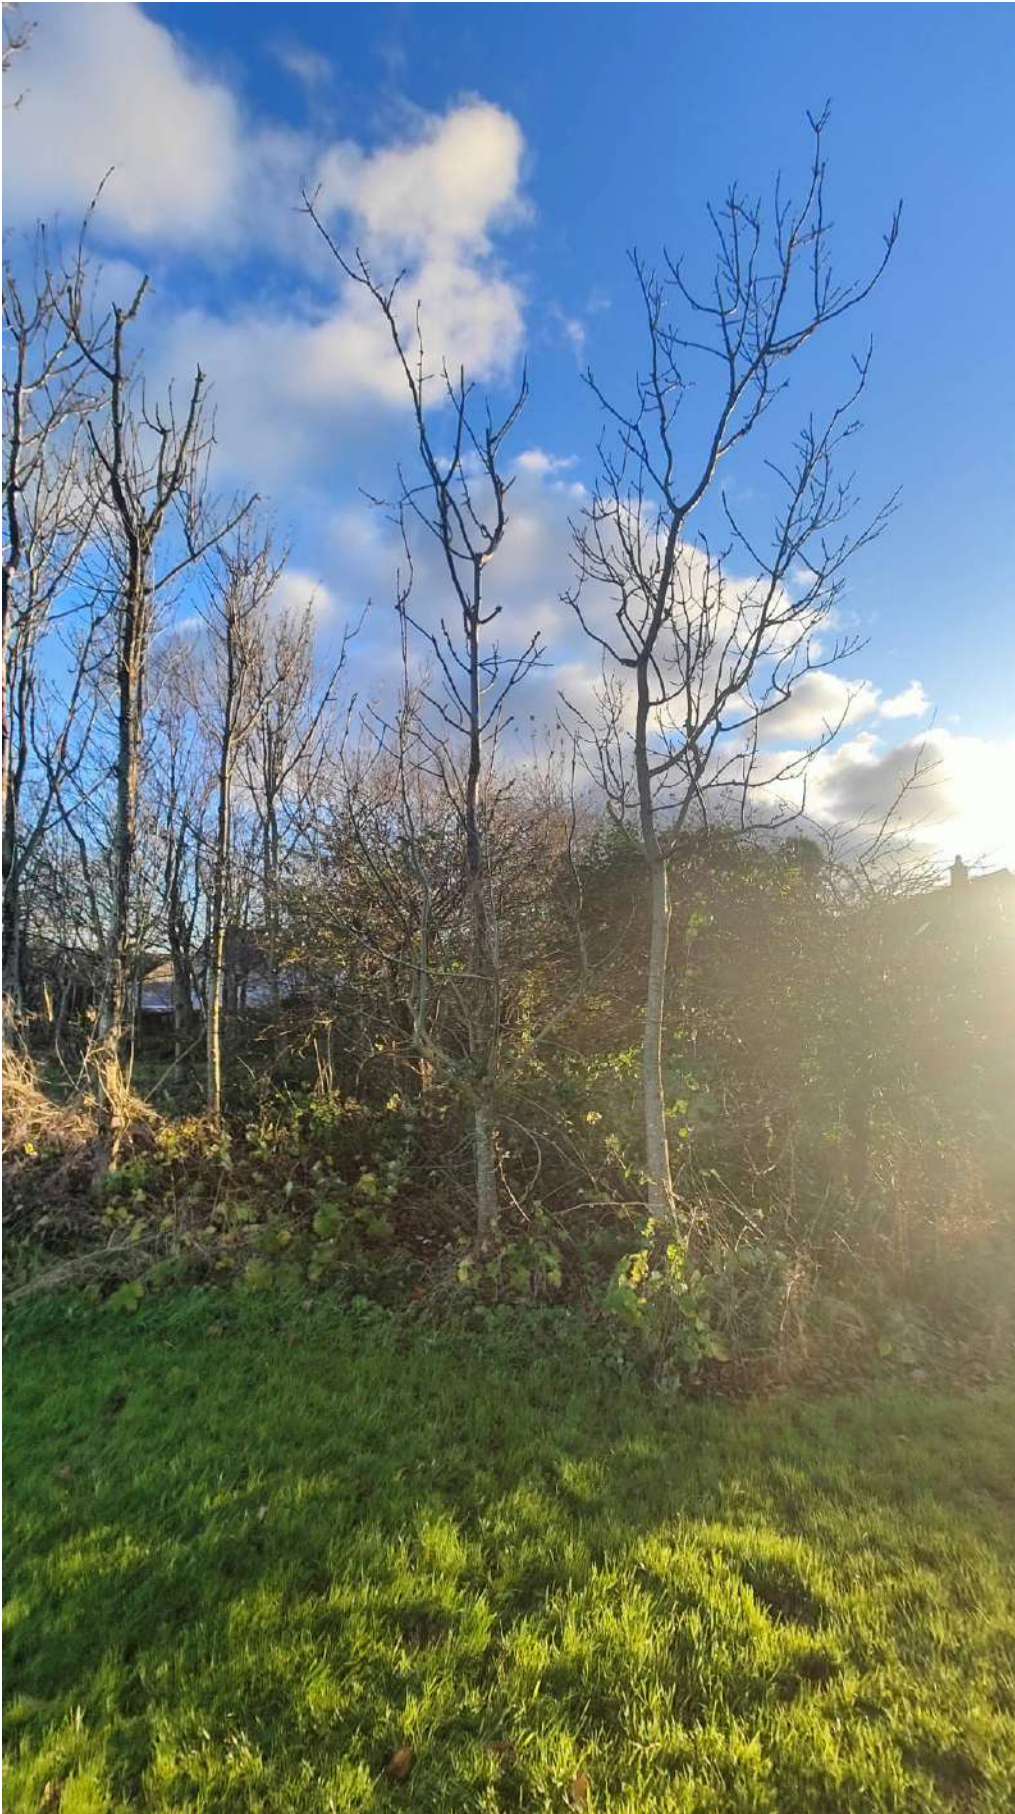
| Group ID | Common Names | Est. No. of Trees | Average Height (m) | Calc. / Actual Stem Dia. (mm) | Crown spread (m) | | | | Life Stage | General Observations | Preliminary Recommendations | Estimated Remaining Contribution (Years) | BS5837: 2012 Category |
|---|---|---|---|---|---|---|---|---|---|---|---|---|---|
| G2 | Largely ash with a few beech and hazel | ~20 | 12m | 100 | | | | | Young | Ash trees with dieback. Class 3/4. Beech tree with stem damage. | Fell ash and damaged beech tree. | <10 | U |

5. Group G2 young Ash which are likely to get diseased with Ash Dieback.

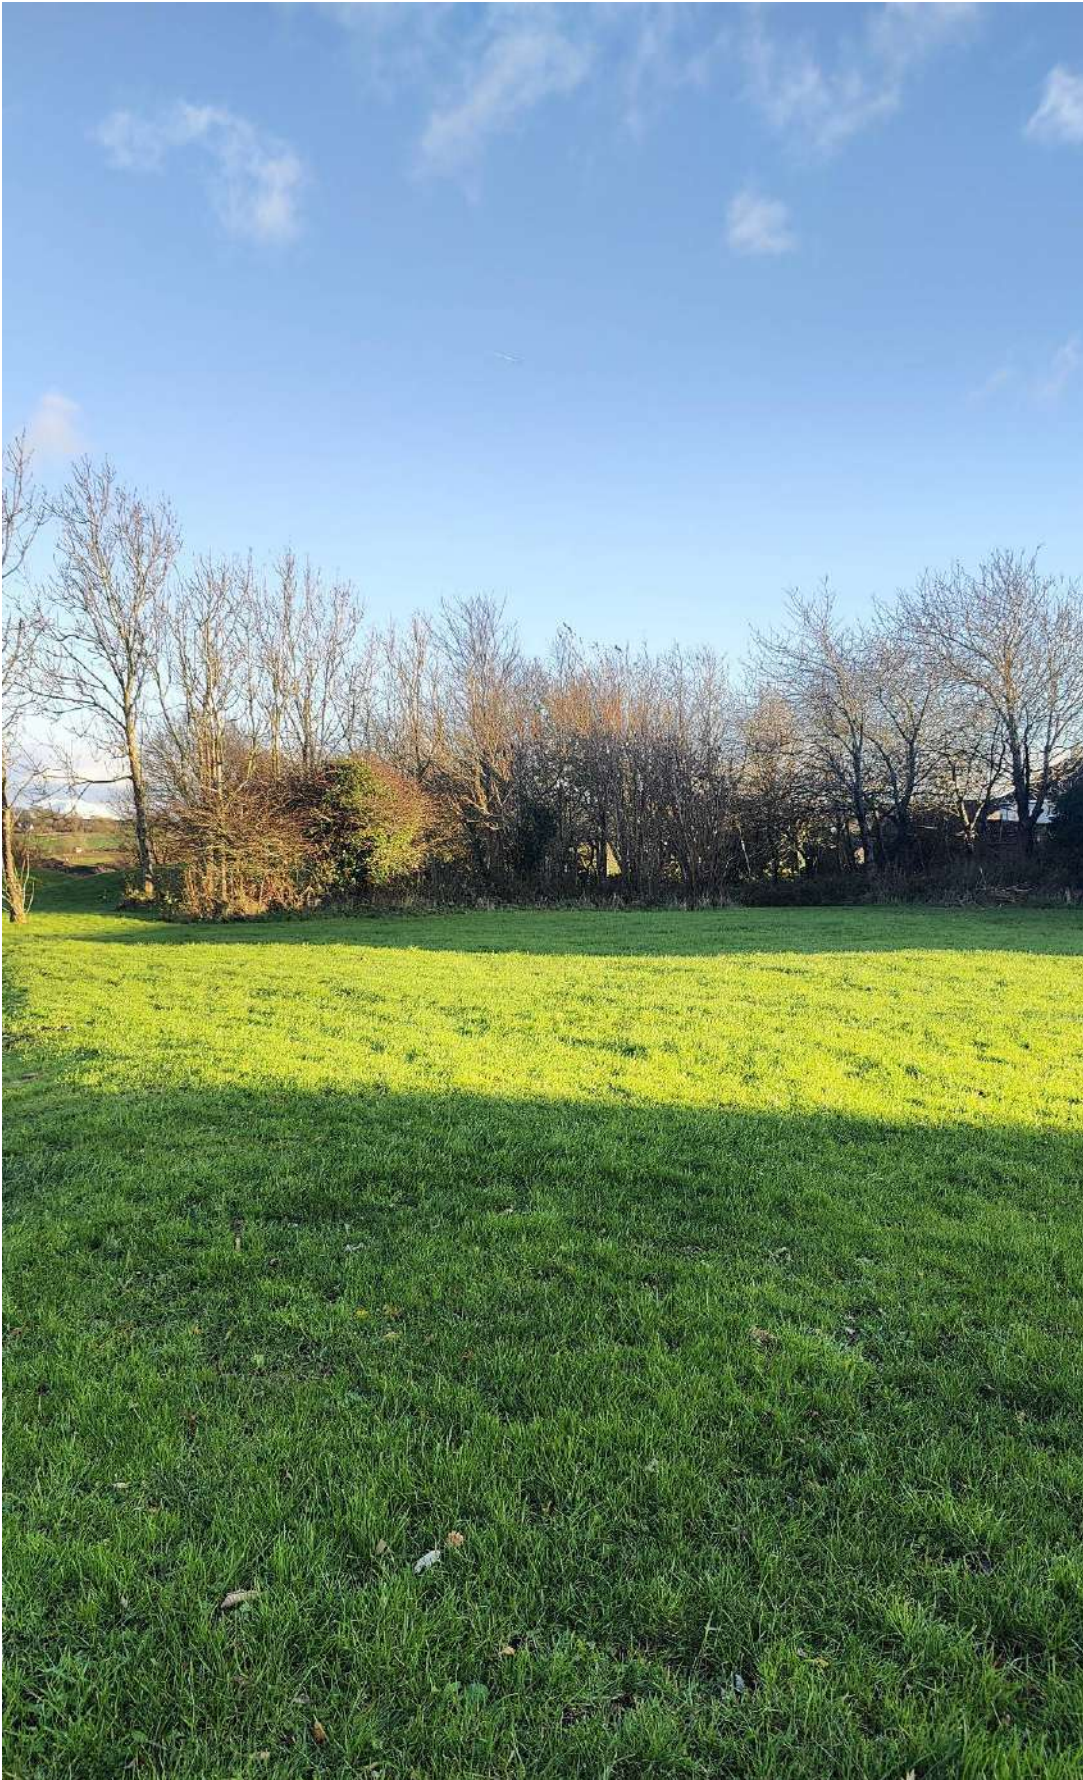
6. Group G3 most of which will be removed.

- Pruning of group G3 to accommodate the proposed houses and rear gardens at the southern boundary. All trees can be retained.
- Removal of 10 Category 'C' trees which conflict with a proposed houses or will be too close to houses to allow growth to maturity.

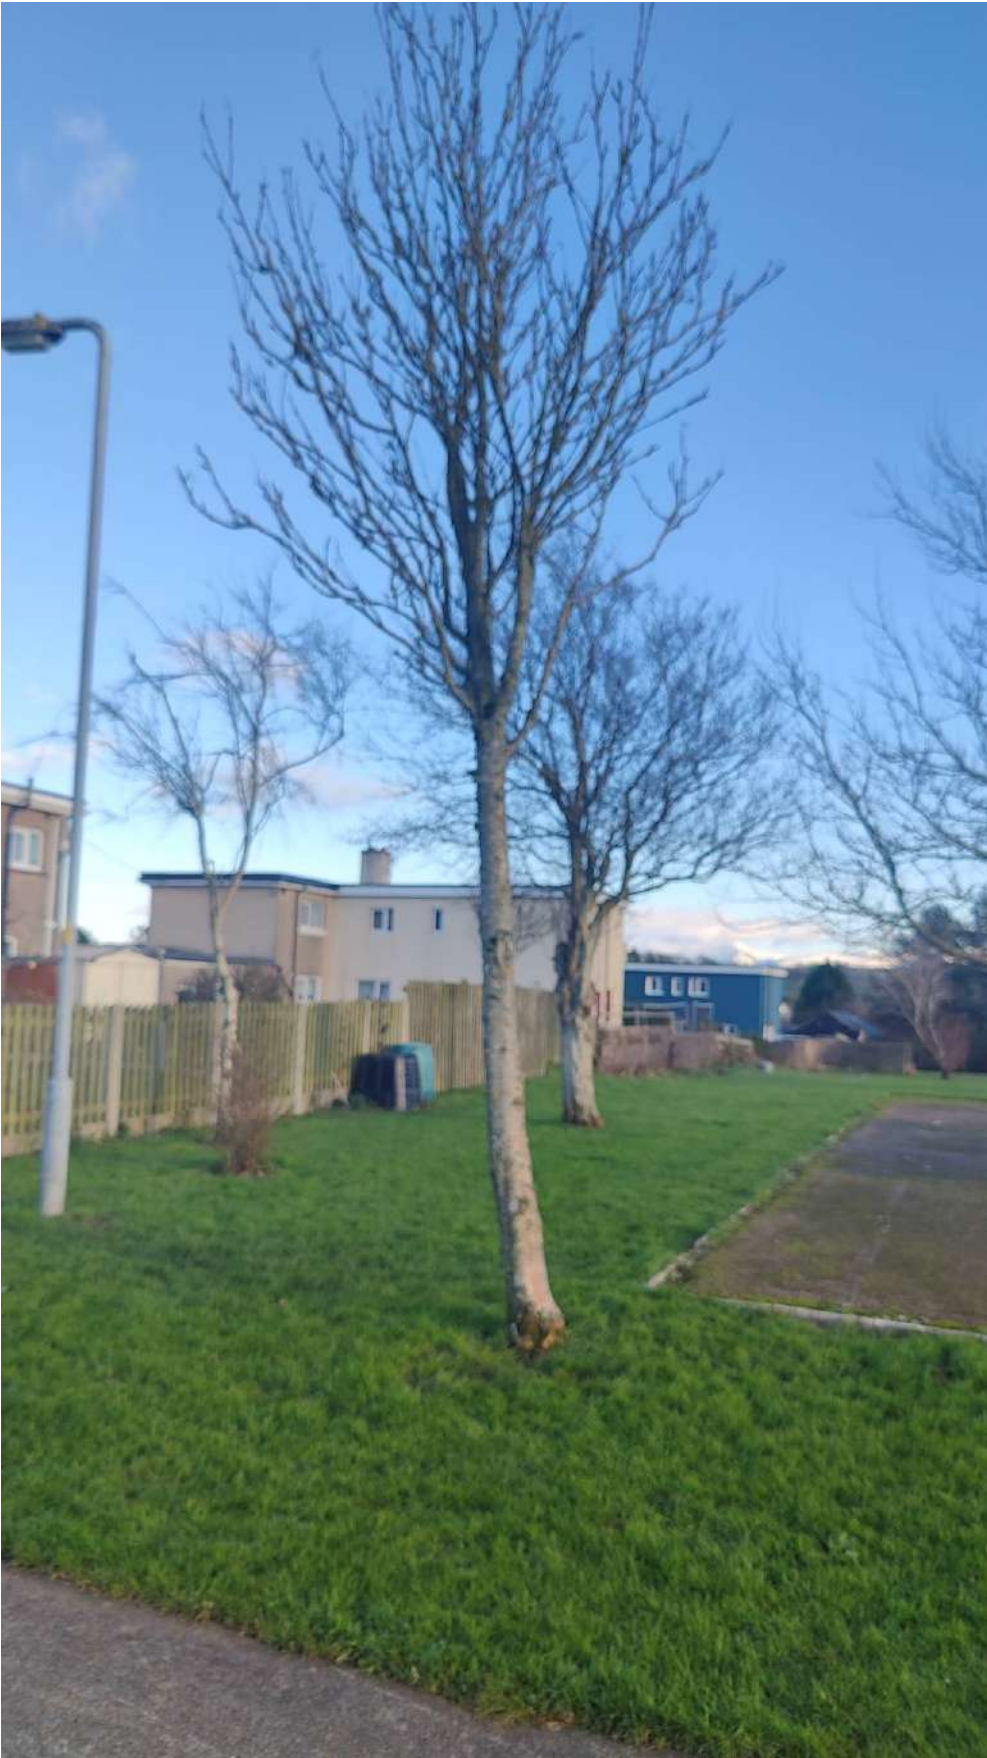
8. Tree T1 Rowan

| Tree ID | Common Name | Botanical Name | Height (m) | Calc. / Actual Stem Dia. (mm) | Crown spread (m) | | | | Height (m) & Orientation of First Significant Branch | Life Stage | General Observations | Preliminary Recommendations | Estimated Remaining Contribution (Years) | BS5837: 2012 Category |
|---|---|---|---|---|---|---|---|---|---|---|---|---|---|---|
| T1 | Mountain ash | <i>Sorbus aucuparia</i> | 8m | 140 | 0.5 | 0.5 | 0.5 | 0.5 | 2m East | Young | Basal trimmer damage. | No work required. | 10 - 20 | C |

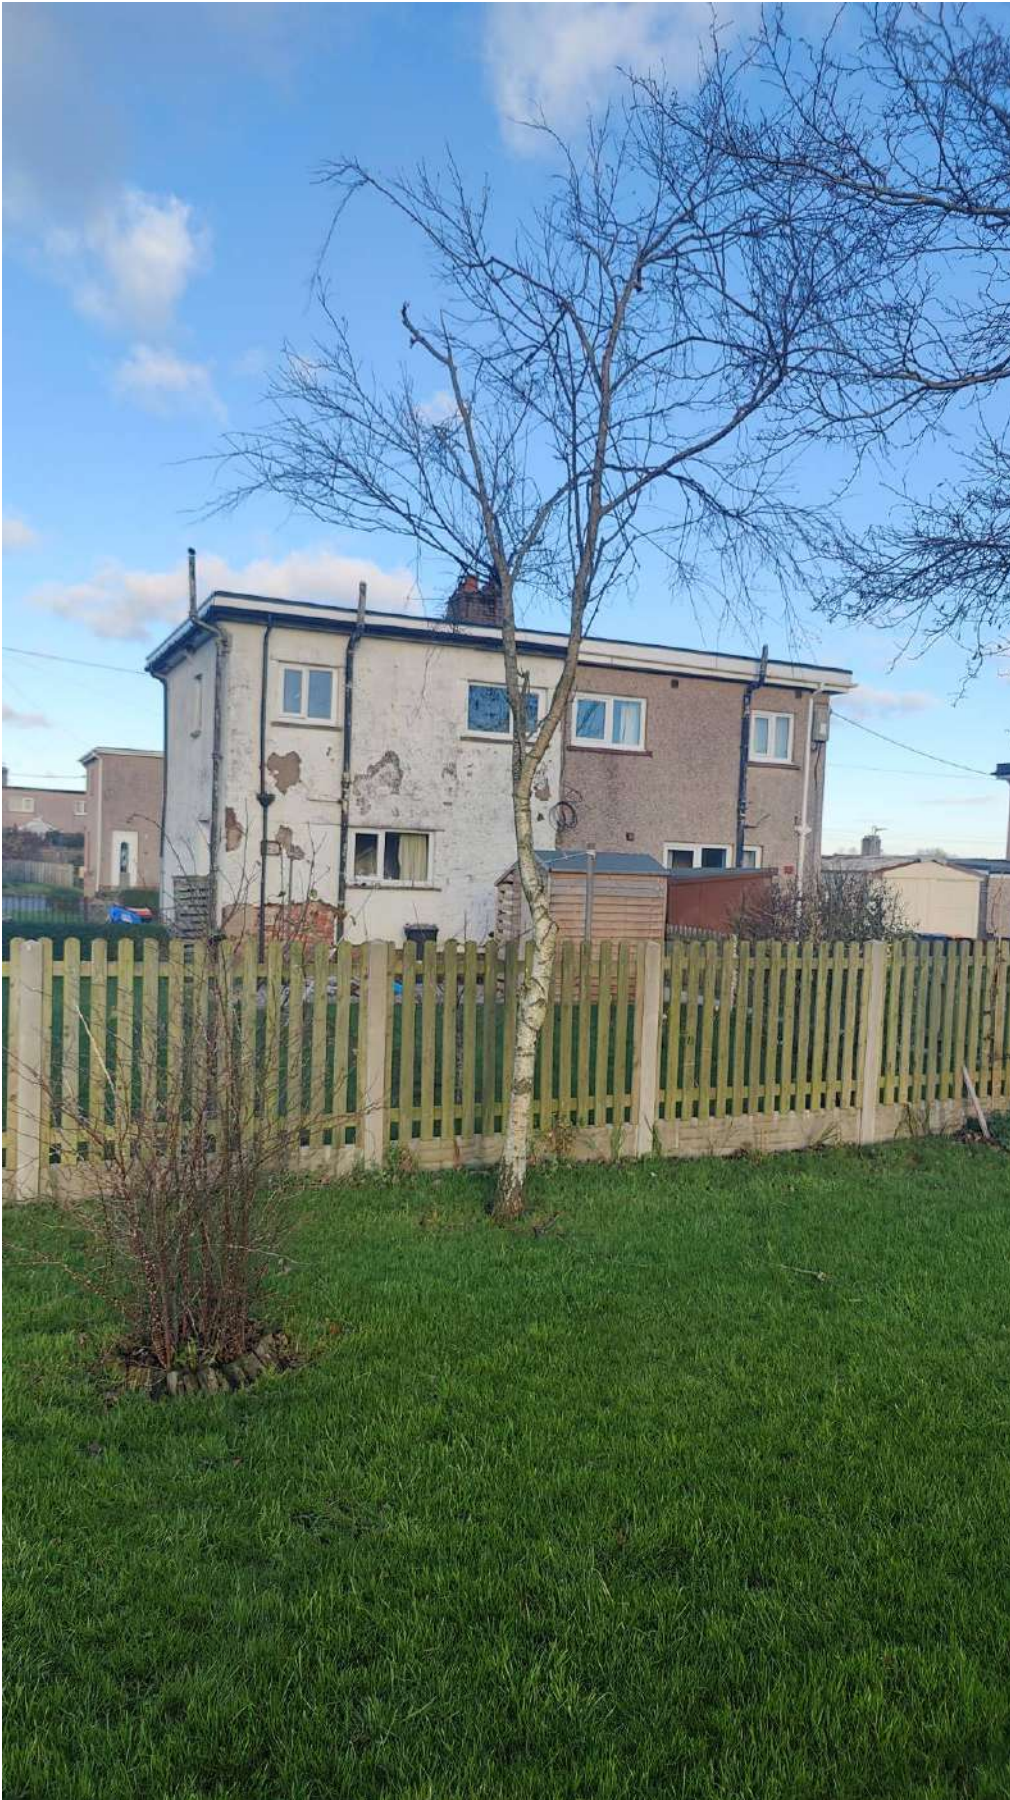
9. T2 Silver Birch

| Tree ID | Common Name | Botanical Name | Height (m) | Calc. / Actual Stem Dia. (mm) | Crown spread (m) | | | | Height (m) & Orientation of First Significant Branch | Life Stage | General Observations | Preliminary Recommendations | Estimated Remaining Contribution (Years) | BS5837: 2012 Category |
|---|---|---|---|---|---|---|---|---|---|---|---|---|---|---|
| T2 | Silver birch | <i>Betula pendula</i> | 9m | 110 | 1.5 | 1.5 | 1.5 | 1.5 | 2.5m North | Young | Growing on property boundary. Dieback in the crown, deadwood. Basal trimmer damage. | Fell. | <10 | U |

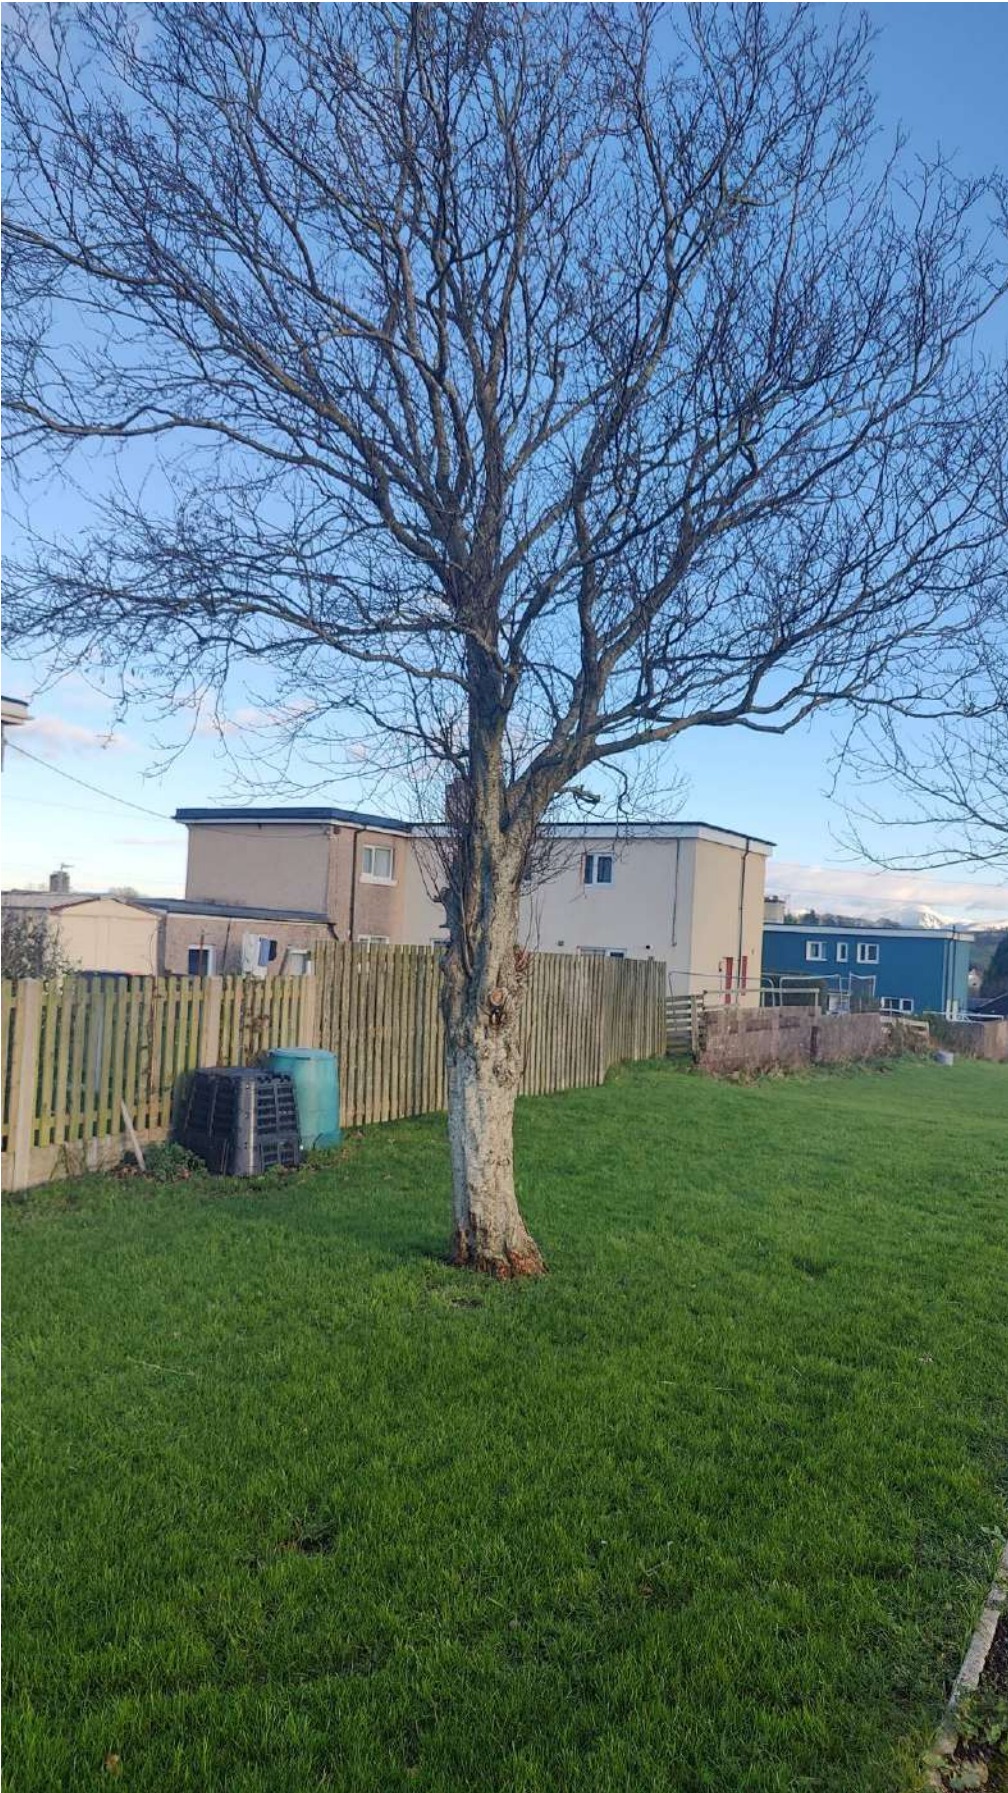
10. T3 Whitebeam

| Tree ID | Common Name | Botanical Name | Height (m) | Calc. / Actual Stem Dia. (mm) | Crown spread (m) | | | | Height (m) & Orientation of First Significant Branch | Life Stage | General Observations | Preliminary Recommendations | Estimated Remaining Contribution (Years) | BS5837: 2012 Category |
|---|---|---|---|---|---|---|---|---|---|---|---|---|---|---|
| T3 | Whitebeam | <i>Sorbus arla</i> | 14m | 350 | 3 | 3 | 3 | 3 | 2.5m <u>South east</u> | Middle aged | Significant basal trimmer / mower damage. | No work required. | 10 - 20 | C |

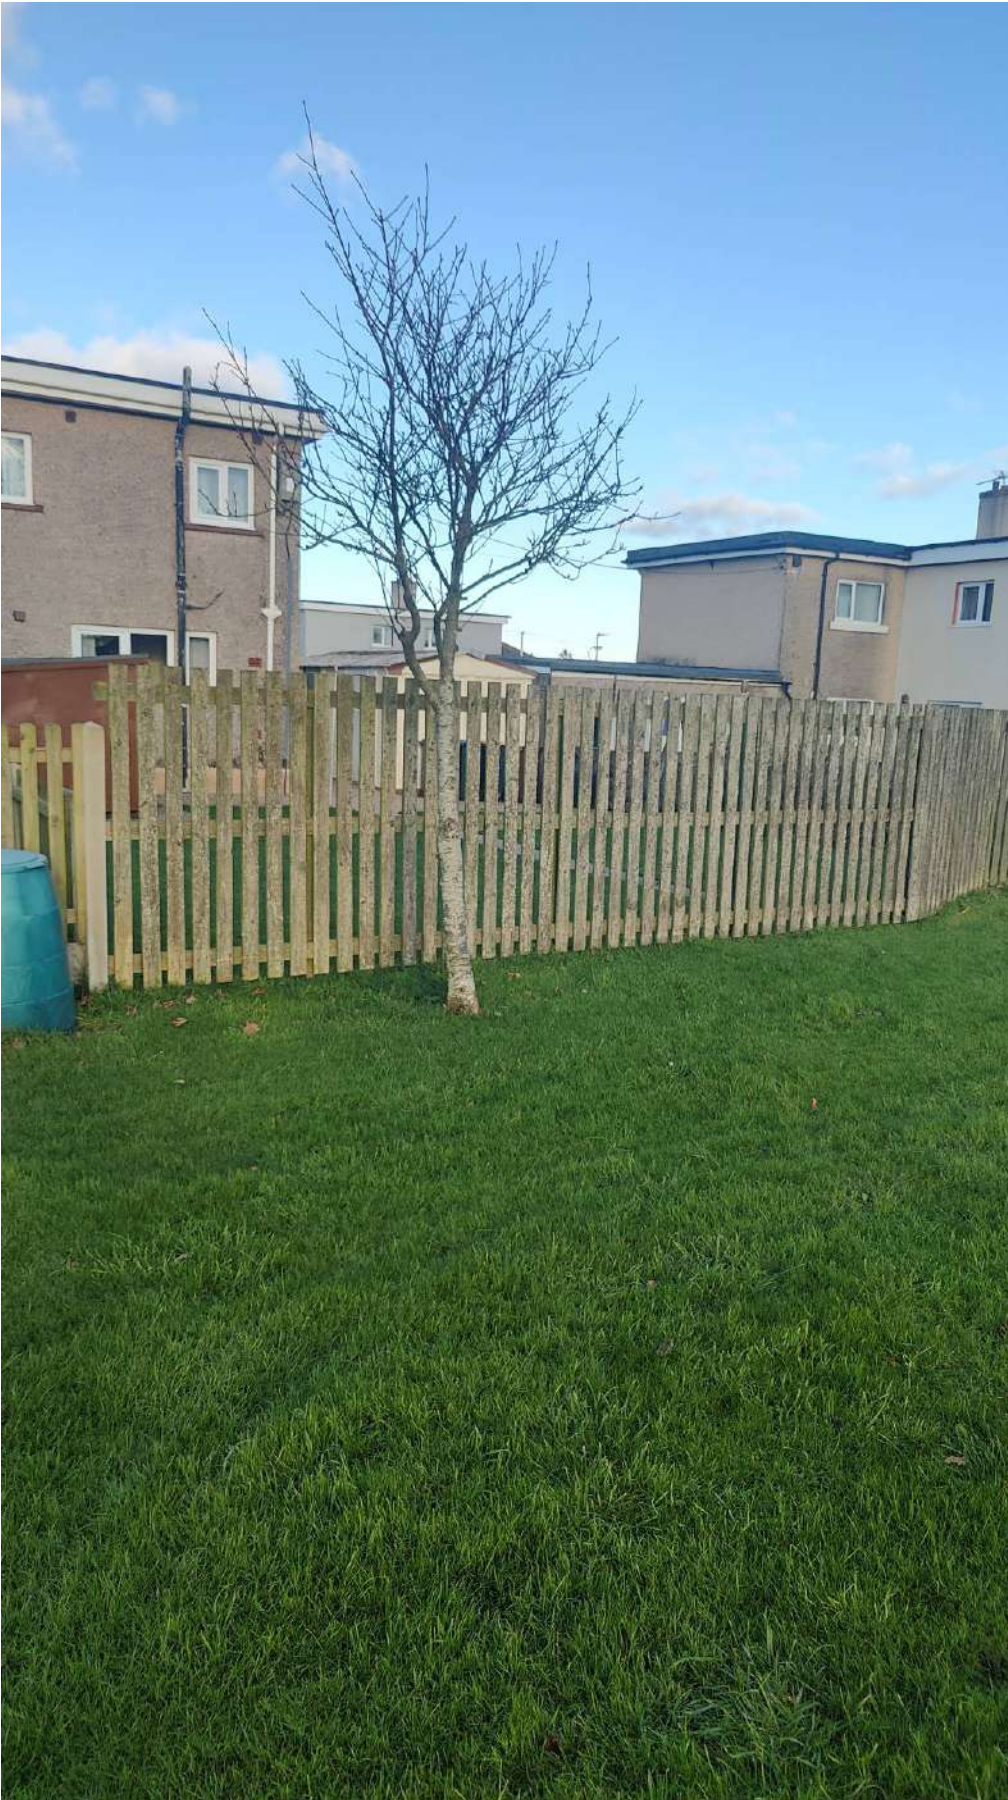
11. T4 Rowan

| Tree ID | Common Name | Botanical Name | Height (m) | Calc. / Actual Stem Dia. (mm) | Crown spread (m) | | | | Height (m) & Orientation of First Significant Branch | Life Stage | General Observations | Preliminary Recommendations | Estimated Remaining Contribution (Years) | BS5837: 2012 Category |
|---|---|---|---|---|---|---|---|---|---|---|---|---|---|---|
| T4 | Mountain ash | <i>Sorbus aucuparia</i> | 6m | 100 | 1 | 1 | 1 | 1 | 1.5m West | Young | Basal trimmer damage. | No work required. | 10 - 20 | C |

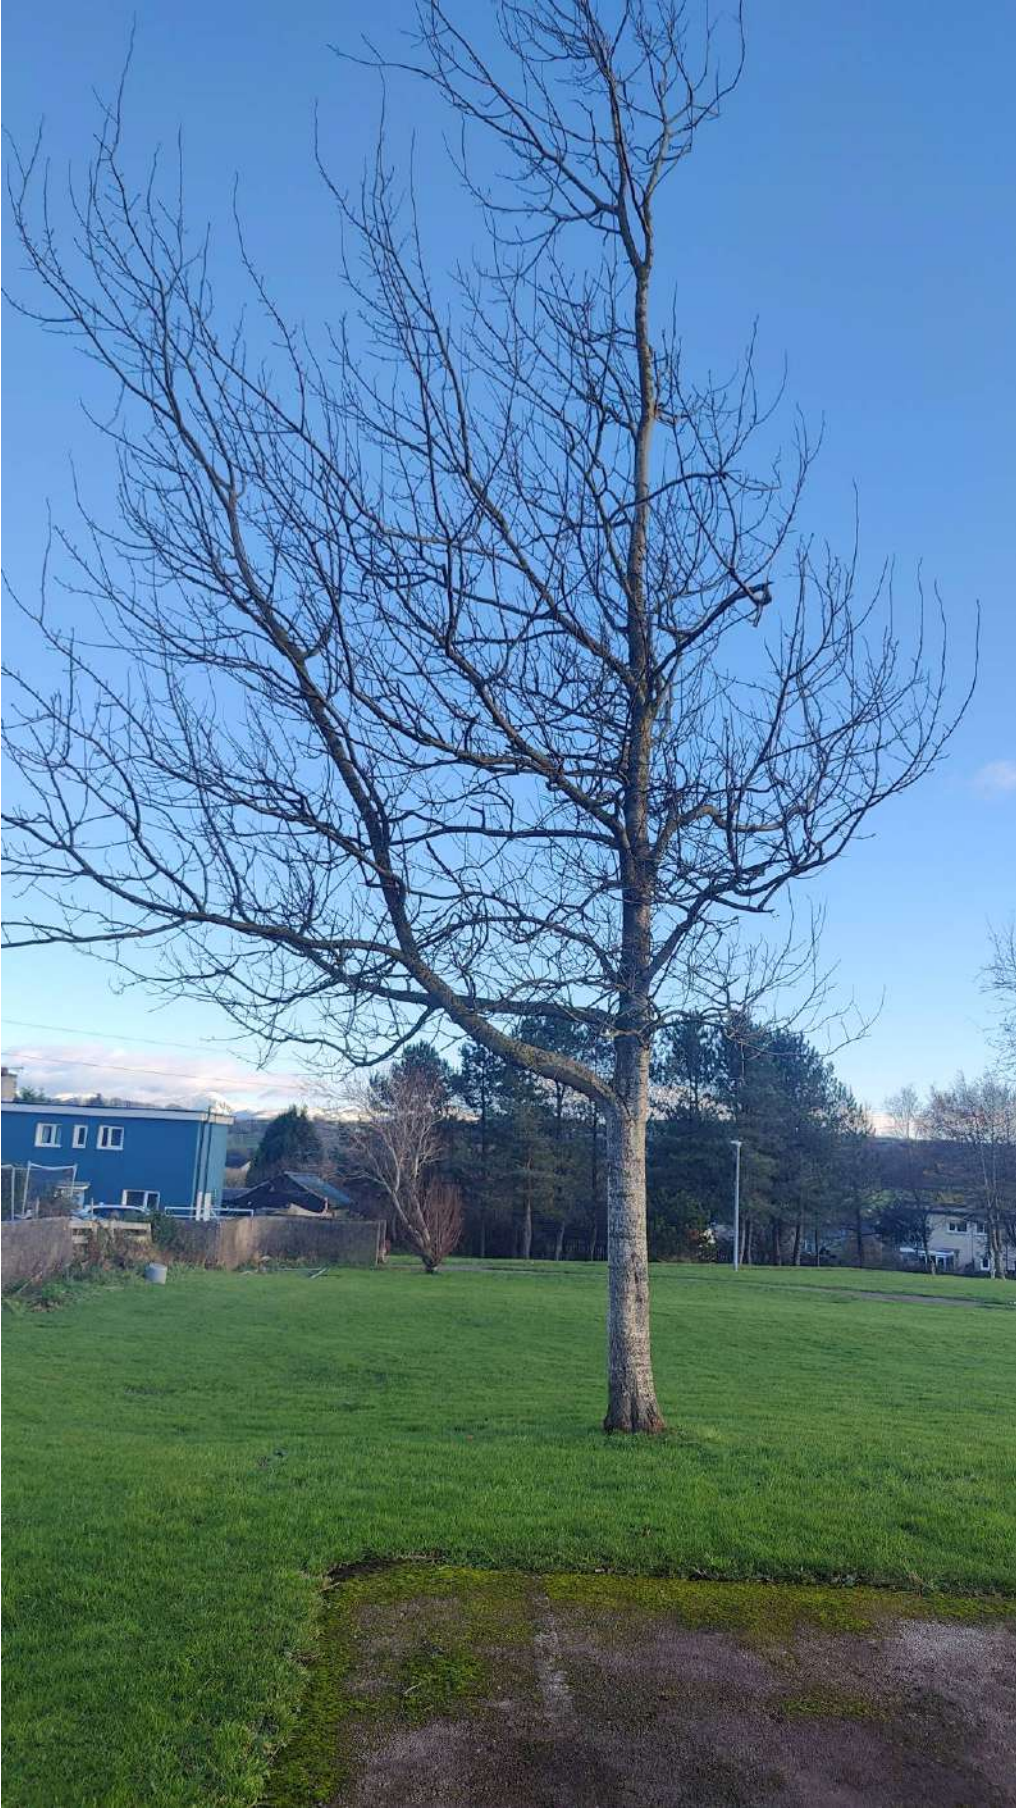
12. T5 Poplar

| Tree ID | Common Name | Botanical Name | Height (m) | Calc. / Actual Stem Dia. (mm) | Crown spread (m) | | | | Height (m) & Orientation of First Significant Branch | Life Stage | General Observations | Preliminary Recommendations | Estimated Remaining Contribution (Years) | BS5837: 2012 Category |
|---|---|---|---|---|---|---|---|---|---|---|---|---|---|---|
| T5 | Poplar | <i>Populus spp.</i> | 12m | 340 | 3 | 3 | 2 | 3 | 1.9m North | Middle aged | Basal trimmer damage. | No work required. | 10 - 20 | C |

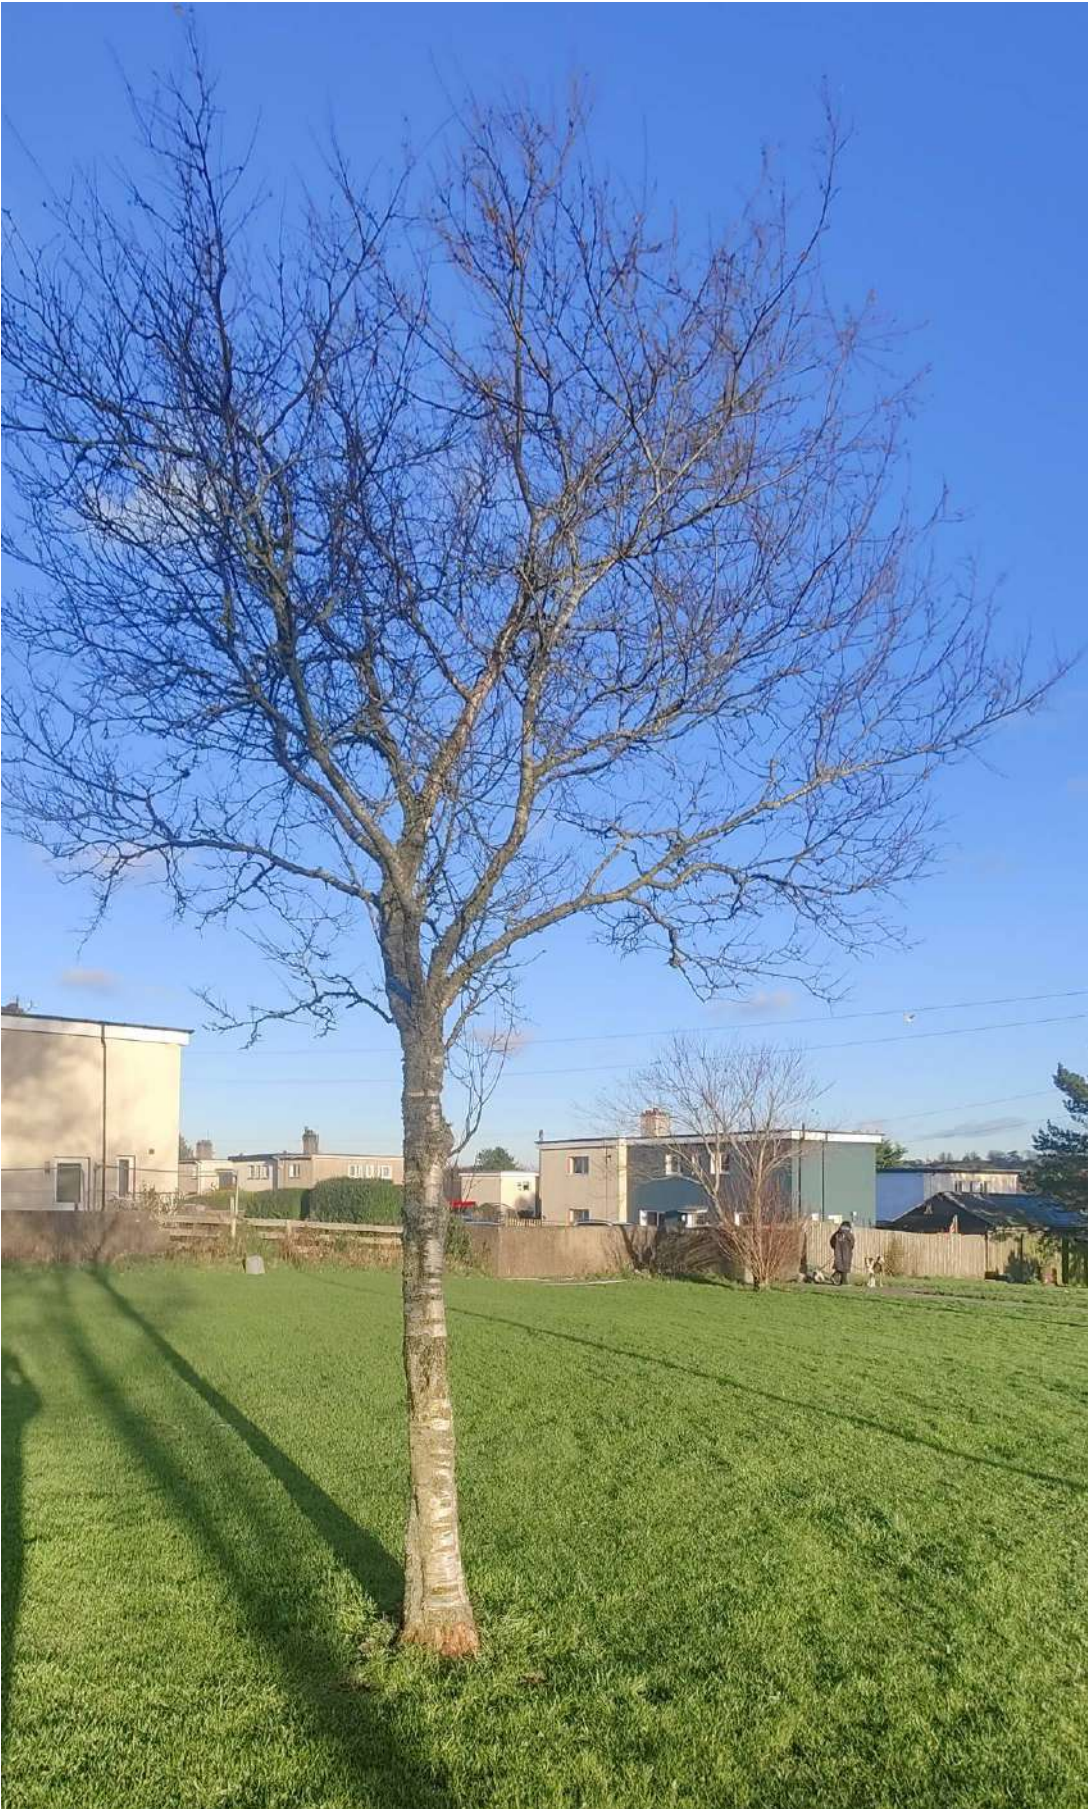
13. T6 Silver Birch

| Tree ID | Common Name | Botanical Name | Height (m) | Calc. / Actual Stem Dia. (mm) | Crown spread (m) | | | | Height (m) & Orientation of First Significant Branch | Life Stage | General Observations | Preliminary Recommendations | Estimated Remaining Contribution (Years) | BS5837: 2012 Category |
|---|---|---|---|---|---|---|---|---|---|---|---|---|---|---|
| T6 | Silver birch | <i>Betula pendula</i> | 5m | 160 | 2 | 2.5 | 2 | 2 | 2.2m South | Young | Good form tree, Basal trimmer damage. | No work required. | 10 - 20 | C |

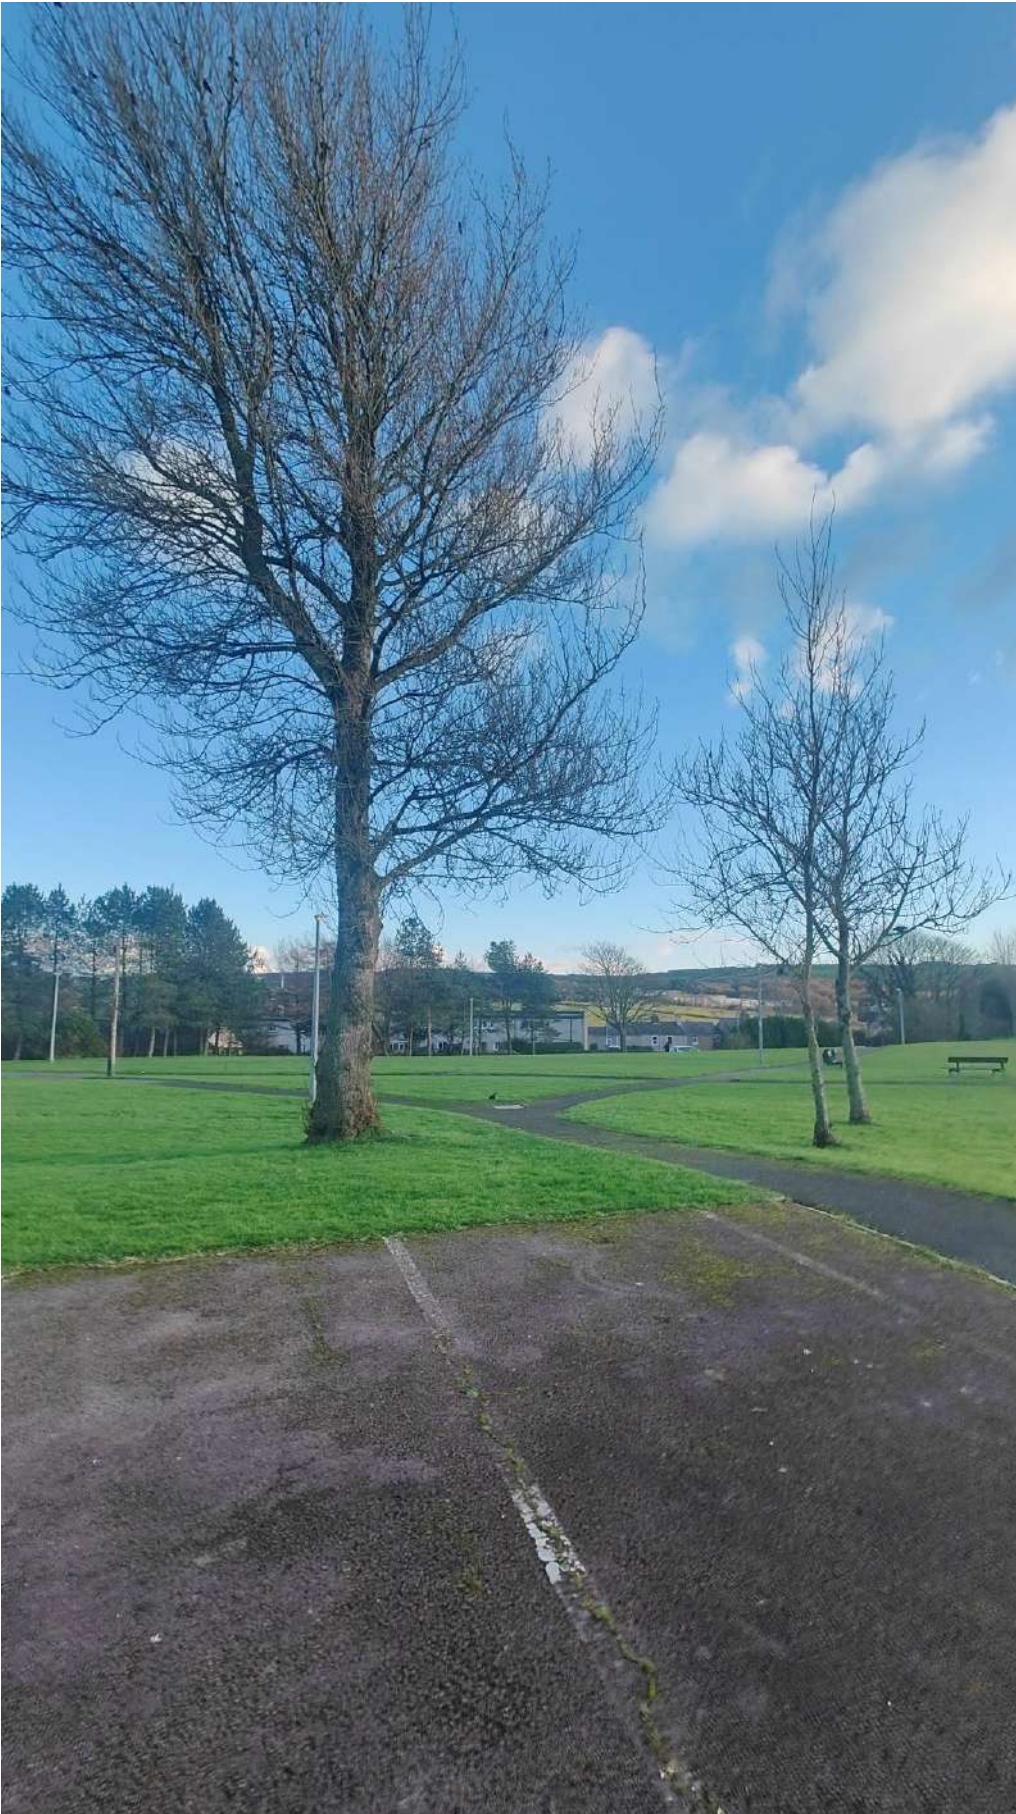
14. Trees T7, T8 and T9.

| Tree ID | Common Name | Botanical Name | Height (m) | Calc. / Actual Stem Dia. (mm) | Crown spread (m) | | | | Height (m) & Orientation of First Significant Branch | Life Stage | General Observations | Preliminary Recommendations | Estimated Remaining Contribution (Years) | BS5837: 2012 Category |
|---|---|---|---|---|---|---|---|---|---|---|---|---|---|---|
| T7 | Hybrid Poplar | <i>Populus x canadensis</i> | 17m | 730 | 5 | 6 | 5.5 | 6 | 3m South | Middle aged | Large tree, some minor stem damage. | No work required. | 10 - 20 | C |

| Tree ID | Common Name | Botanical Name | Height (m) | Calc. / Actual Stem Dia. (mm) | Crown spread (m) | | | | Height (m) & Orientation of First Significant Branch | Life Stage | General Observations | Preliminary Recommendations | Estimated Remaining Contribution (Years) | BS5837: 2012 Category |
|---|---|---|---|---|---|---|---|---|---|---|---|---|---|---|
| T8 | Ash | <i>Fraxinus excelsior</i> | 7.5m | 230 | 2 | 2 | 1.5 | 2 | 2m North | Young | Low vigour noted, reasonable form. Basal damage. | Monitor for ash dieback. | 10 - 20 | C |
| T9 | Poplar | <i>Populus alba</i> | 6m | 140 | 2 | 2 | 2 | 2 | 2m South | Young | Basal damage. | No work required. | 10 - 20 | C |
