**PROPOSED HOUSING**

**BARFS ROAD, DISTINGTON**

**TREE SURVEY REPORT**

**HOME GROUP HOUSING**

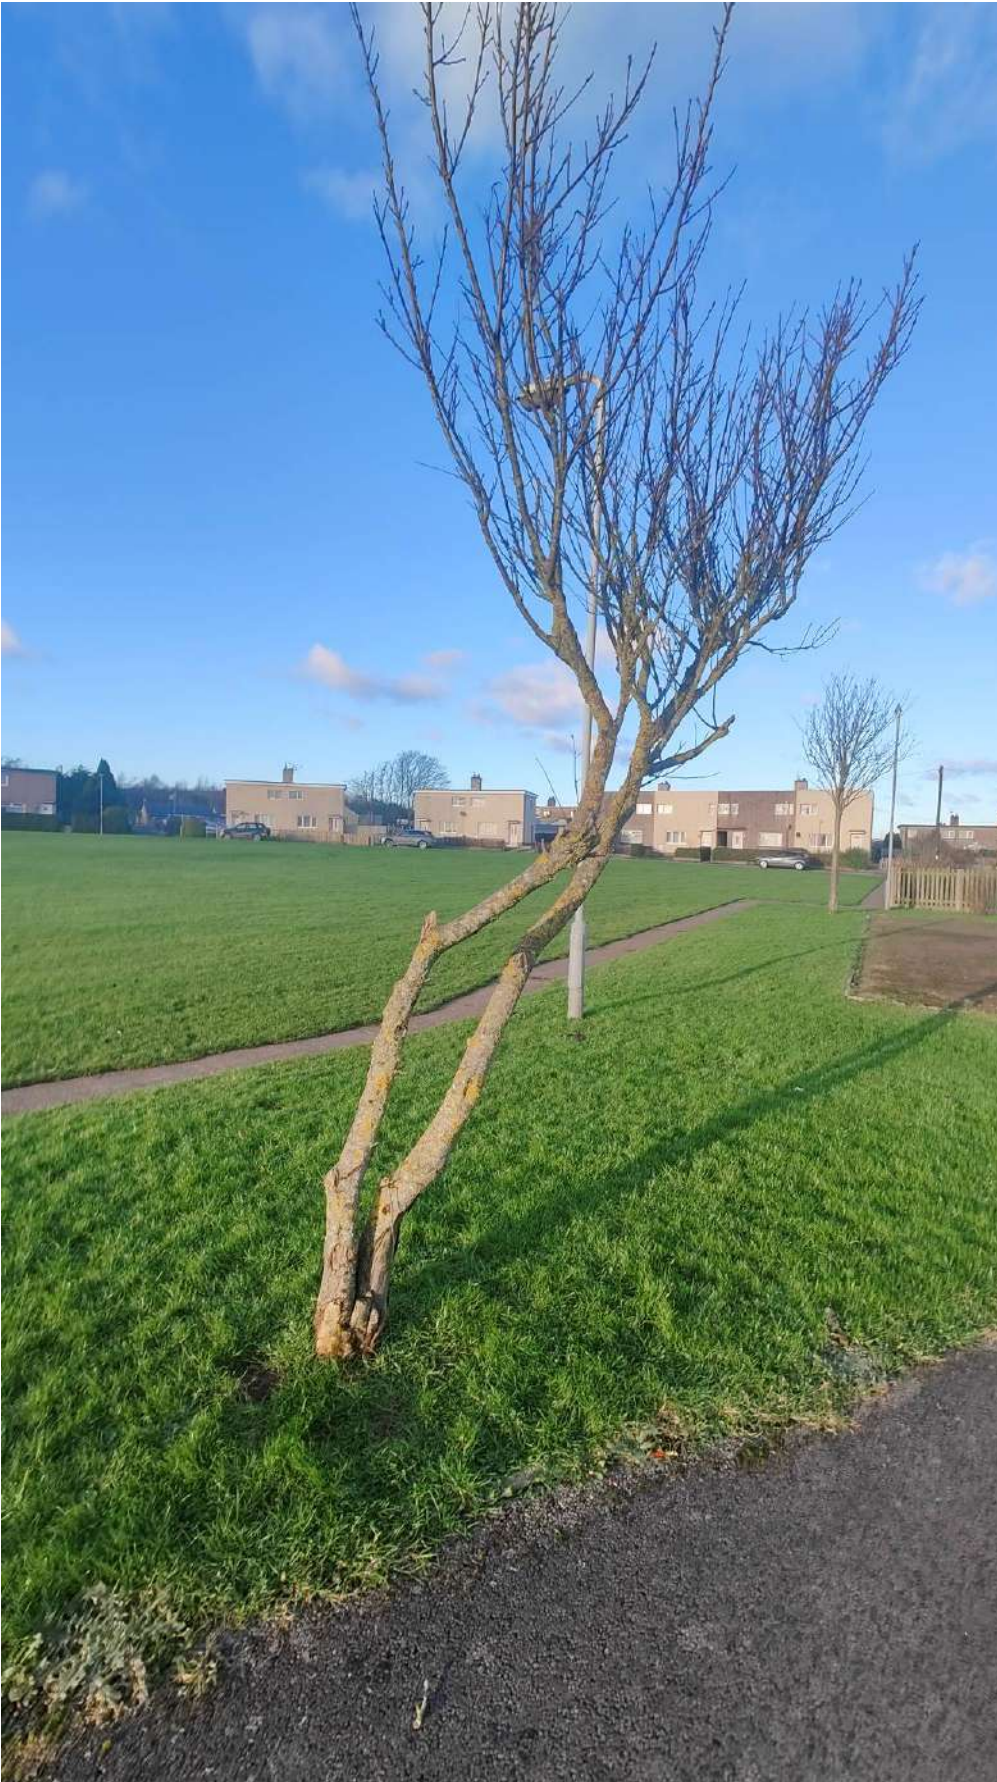
15. Tree T10 Rowan

| Tree ID | Common Name | Botanical Name | Height (m) | Calc. / Actual Stem Dia. (mm) | Crown spread (m) | | | | Height (m) & Orientation of First Significant Branch | Life Stage | General Observations | Preliminary Recommendations | Estimated Remaining Contribution (Years) | BS5837: 2012 Category |
|---|---|---|---|---|---|---|---|---|---|---|---|---|---|---|
| T10 | Mountain ash | <i>Sorbus aucuparia</i> | 4m | 80; 100 | 2 | 1 | 1 | 1 | 2m North | Young | Leaning heavily to the north, extensive bark damage at the base from mower/trimmers. Poor form. | Fell & replant | <10 | U |

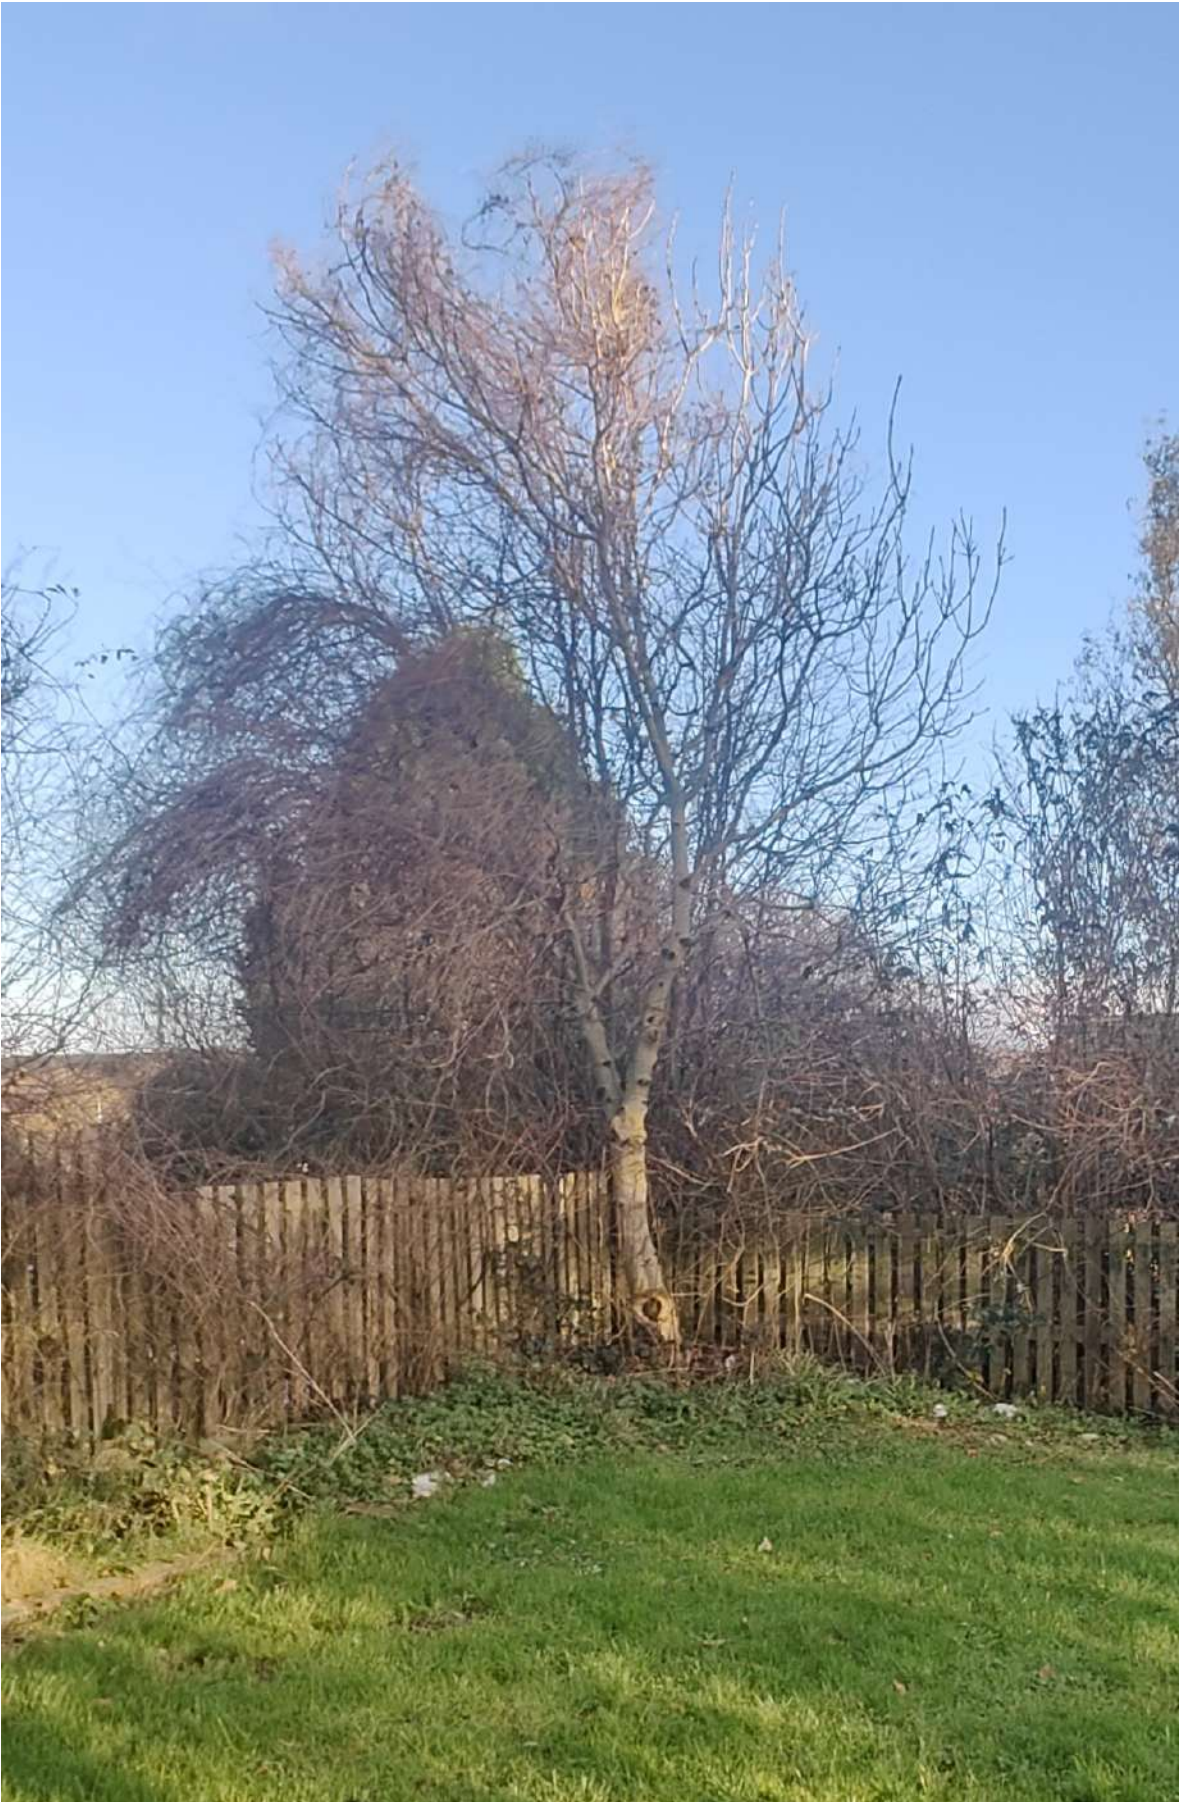
17. Tree T12 Ash

| Tree ID | Common Name | Botanical Name | Height (m) | Calc. / Actual Stem Dia. (mm) | Crown spread (m) | | | | Height (m) & Orientation of First Significant Branch | Life Stage | General Observations | Preliminary Recommendations | Estimated Remaining Contribution (Years) | BS5837: 2012 Category |
|---|---|---|---|---|---|---|---|---|---|---|---|---|---|---|
| T12 | Ash | <i>Fraxinus excelsior</i> | 10m | 240 | 3 | 3 | 3 | 3 | 2m North | Young | Stem wound on <u>south west</u> side, bacterial canker noted. Twin @ 1.9m | Fell & replant | <10 | U |

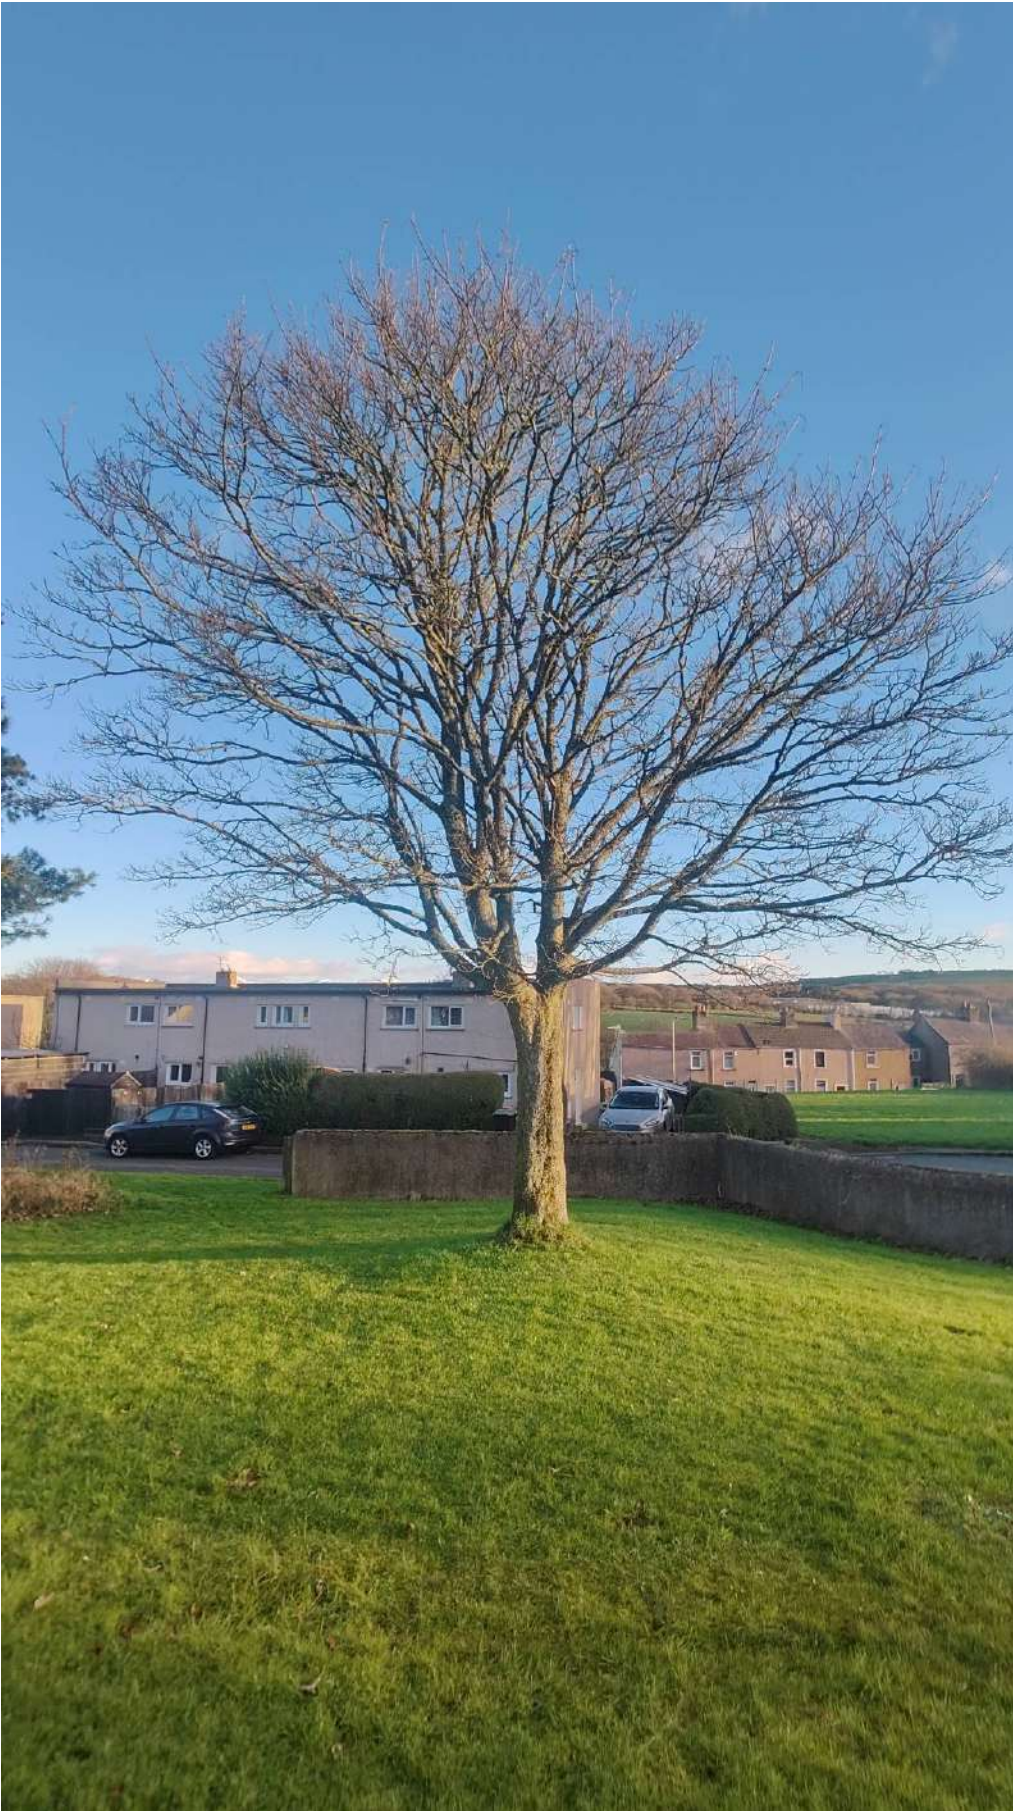
3.3. There are no Category 'A' trees and only one Category 'B' tree T13; a middle-aged Sycamore which can be retained in a rear garden. Group G3 is also Category 'B' comprising young native trees planted as a shelterbelt and natural screen. Part of this group will need to be pruned back along the boundary within the rear gardens.

| Tree ID | Common Name | Botanical Name | Height (m) | Calc. / Actual Stem Dia. (mm) | Crown spread (m) | | | | Height (m) & Orientation of First Significant Branch | Life Stage | General Observations | Preliminary Recommendations | Estimated Remaining Contribution (Years) | BS5837: 2012 Category |
|---|---|---|---|---|---|---|---|---|---|---|---|---|---|---|
| T13 | Sycamore | <i>Acer pseudoplatanus</i> | 12m | 530 | 5 | 5 | 5 | 5 | 2m East | Middle aged | Good form and condition. No visible defects. | No work required. | 20 - 40 | B |

18. Tree T13 Sycamore- the only Category 'B' individual tree.

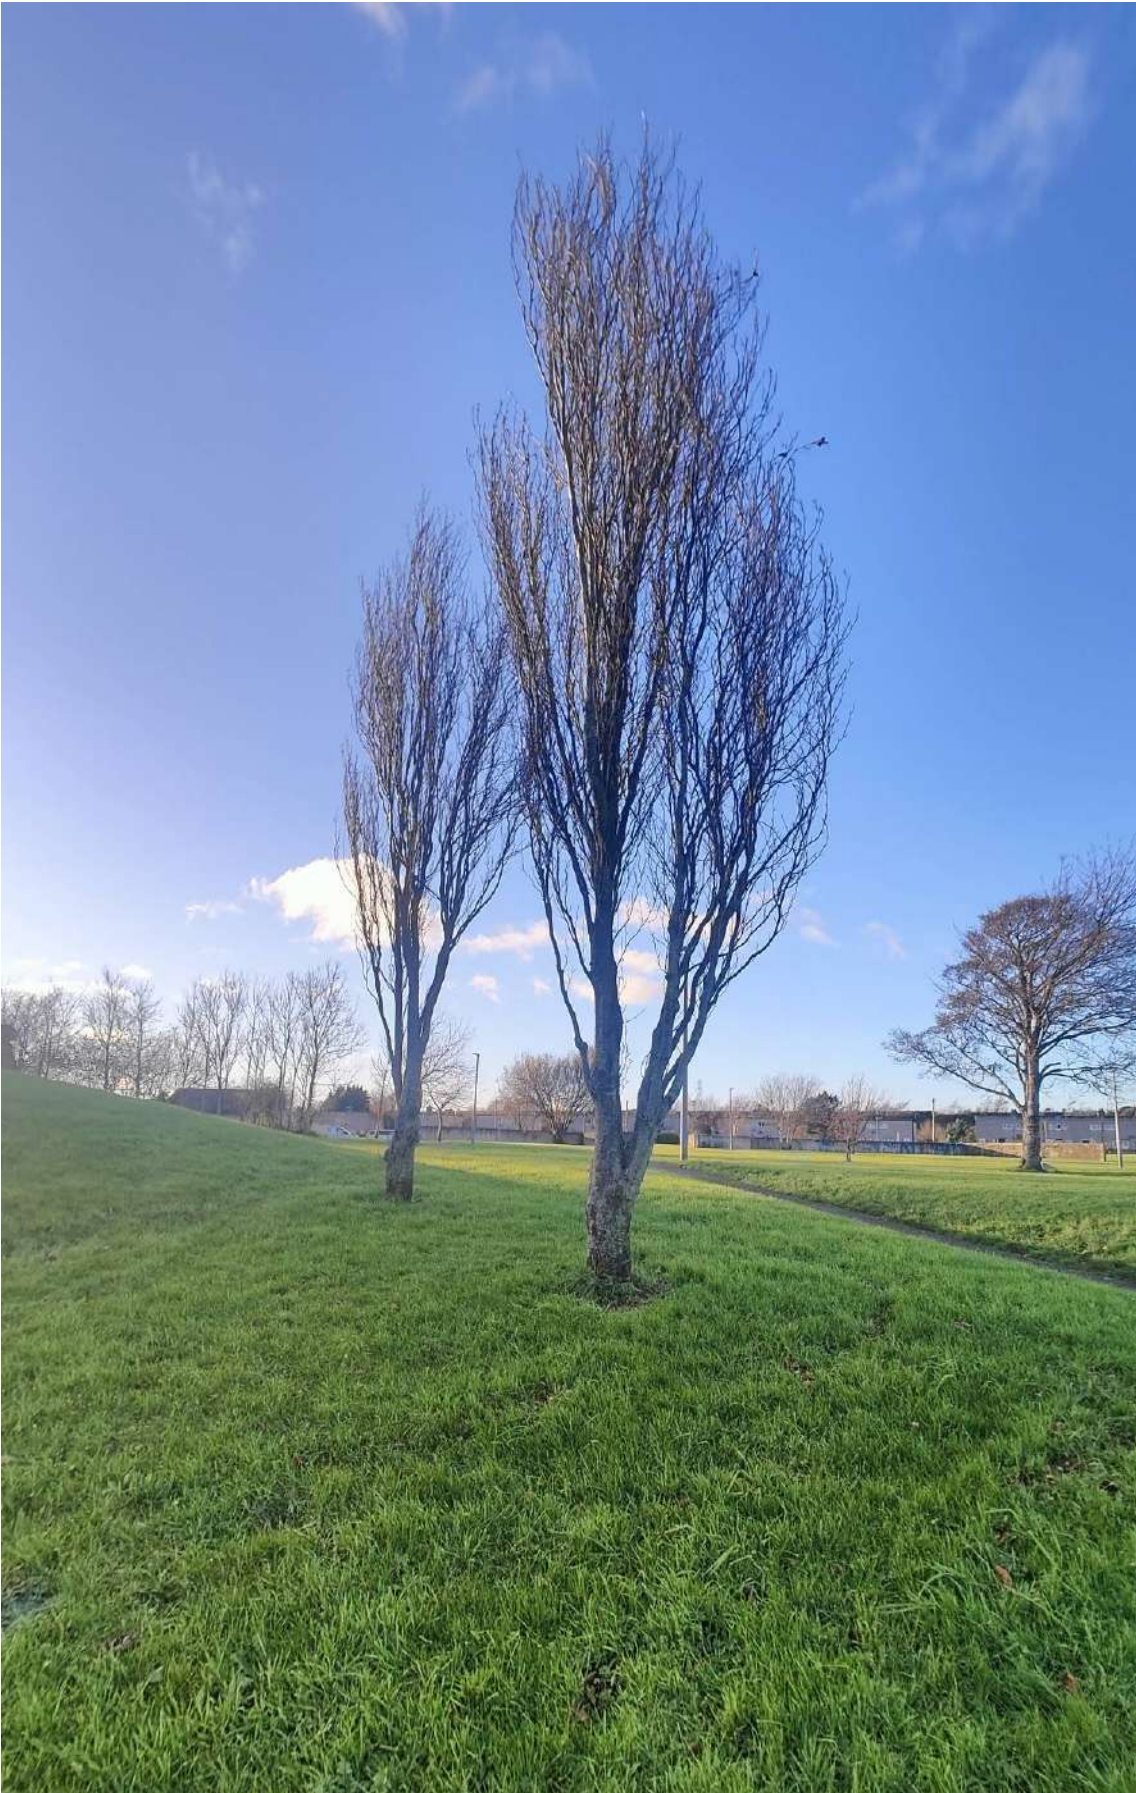
19. Trees T14 and T15 Fastigate Beech

| Tree ID | Common Name | Botanical Name | Height (m) | Calc. / Actual Stem Dia. (mm) | Crown spread (m) | | | | Height (m) & Orientation of First Significant Branch | Life Stage | General Observations | Preliminary Recommendations | Estimated Remaining Contribution (Years) | BS5837: 2012 Category |
|---|---|---|---|---|---|---|---|---|---|---|---|---|---|---|
| T14 | Beech fastigate | <i>Fagus sylvatica 'Dawyck'</i> | 8m | 100; 60; 80 | 1 | 1 | 1 | 1 | N/A | Young | Upright formed tree, stem damage noted. | No work required. | 10 - 20 | C |

| Tree ID | Common Name | Botanical Name | Height (m) | Calc. / Actual Stem Dia. (mm) | Crown spread (m) | | | | Height (m) & Orientation of First Significant Branch | Life Stage | General Observations | Preliminary Recommendations | Estimated Remaining Contribution (Years) | BS5837: 2012 Category |
|---|---|---|---|---|---|---|---|---|---|---|---|---|---|---|
| T15 | Beech fastigiate | <i>Fagus sylvatica</i><br><i>'Dawyck'</i> | 7.5m | 140; 60 | 1 | 1 | 1 | 1 | N/A | Young | Upright formed tree, stem damage noted. | No work required. | 10 - 20 | C |

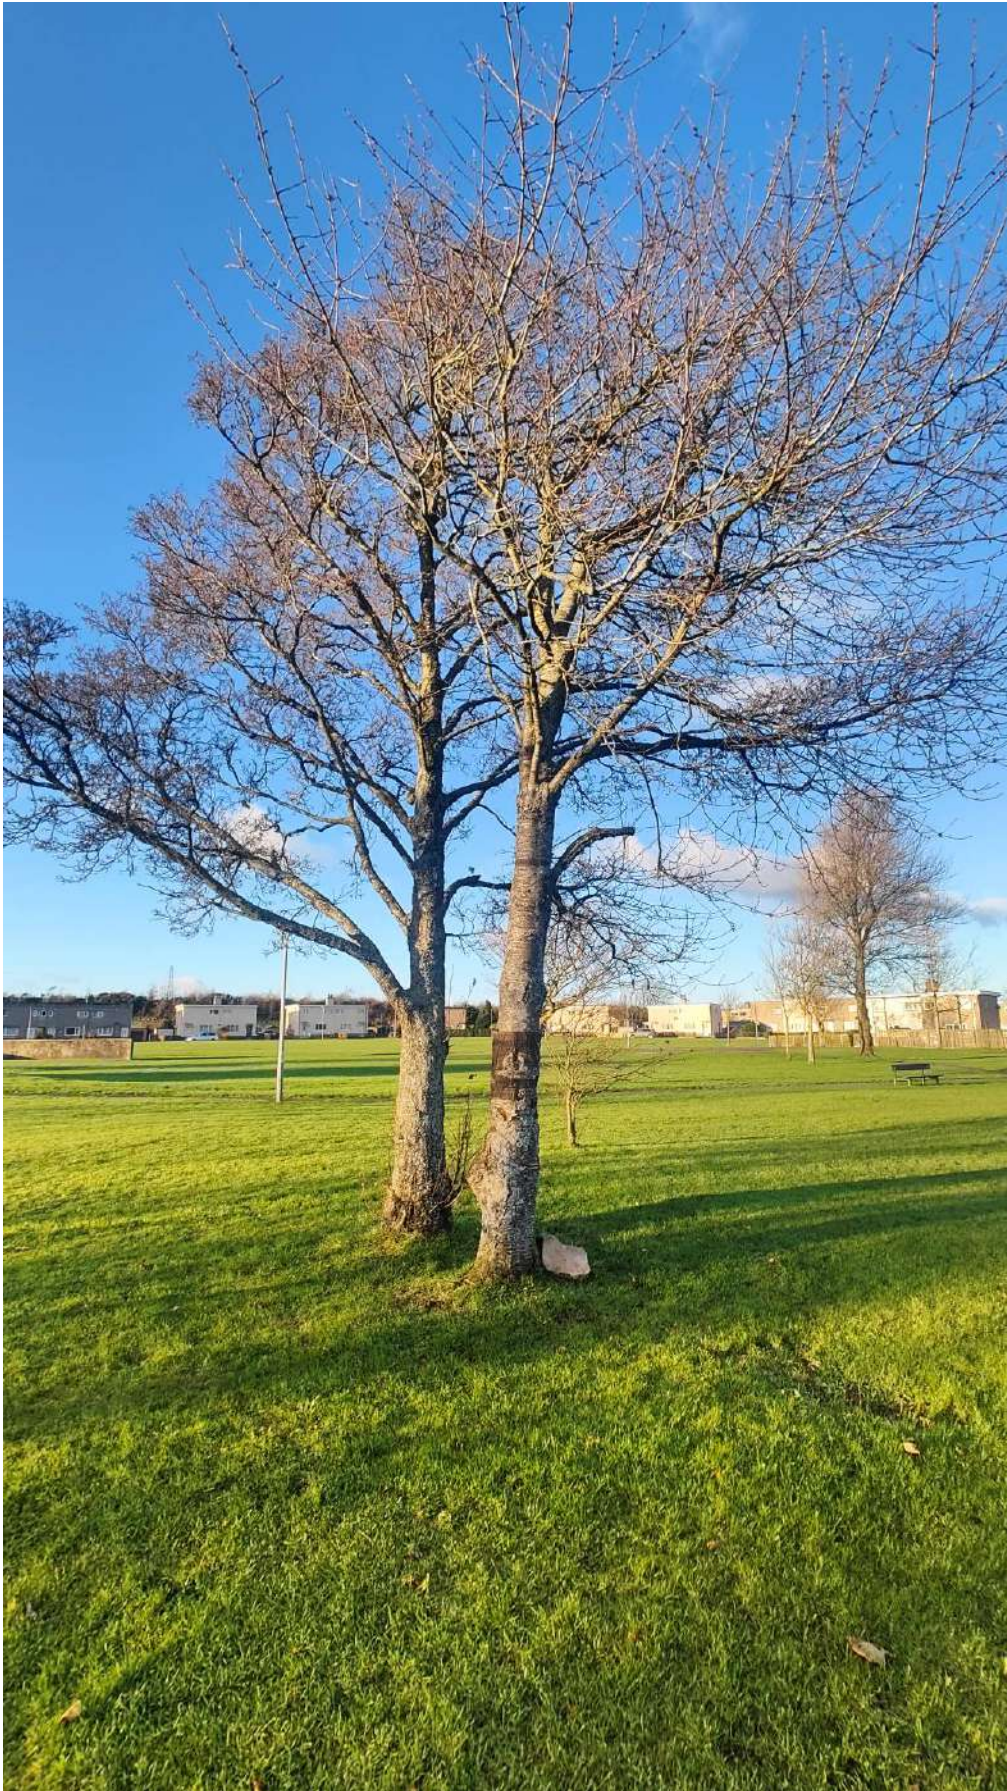
20. Trees T16 (front) Cherry and T17 Alder.

| Tree ID | Common Name | Botanical Name | Height (m) | Calc. / Actual Stem Dia. (mm) | Crown spread (m) | | | | Height (m) & Orientation of First Significant Branch | Life Stage | General Observations | Preliminary Recommendations | Estimated Remaining Contribution (Years) | BS5837: 2012 Category |
|---|---|---|---|---|---|---|---|---|---|---|---|---|---|---|
| T16 | Cherry | <i>Prunus avium</i> | 11m | 380 | 2 | 3 | 3 | 3 | 2.5m South | Middle aged | Bark removed through vandalism. Significant stem damage, open wound. | Fell & replant. | <10 | U |
| T17 | Alder | <i>Alnus glutinosa</i> | 12m | 360 | 3 | 3 | 2 | 3 | 1.9m West | Middle aged | Good formed tree, no visible defects. | No work required. | 10 - 20 | C |

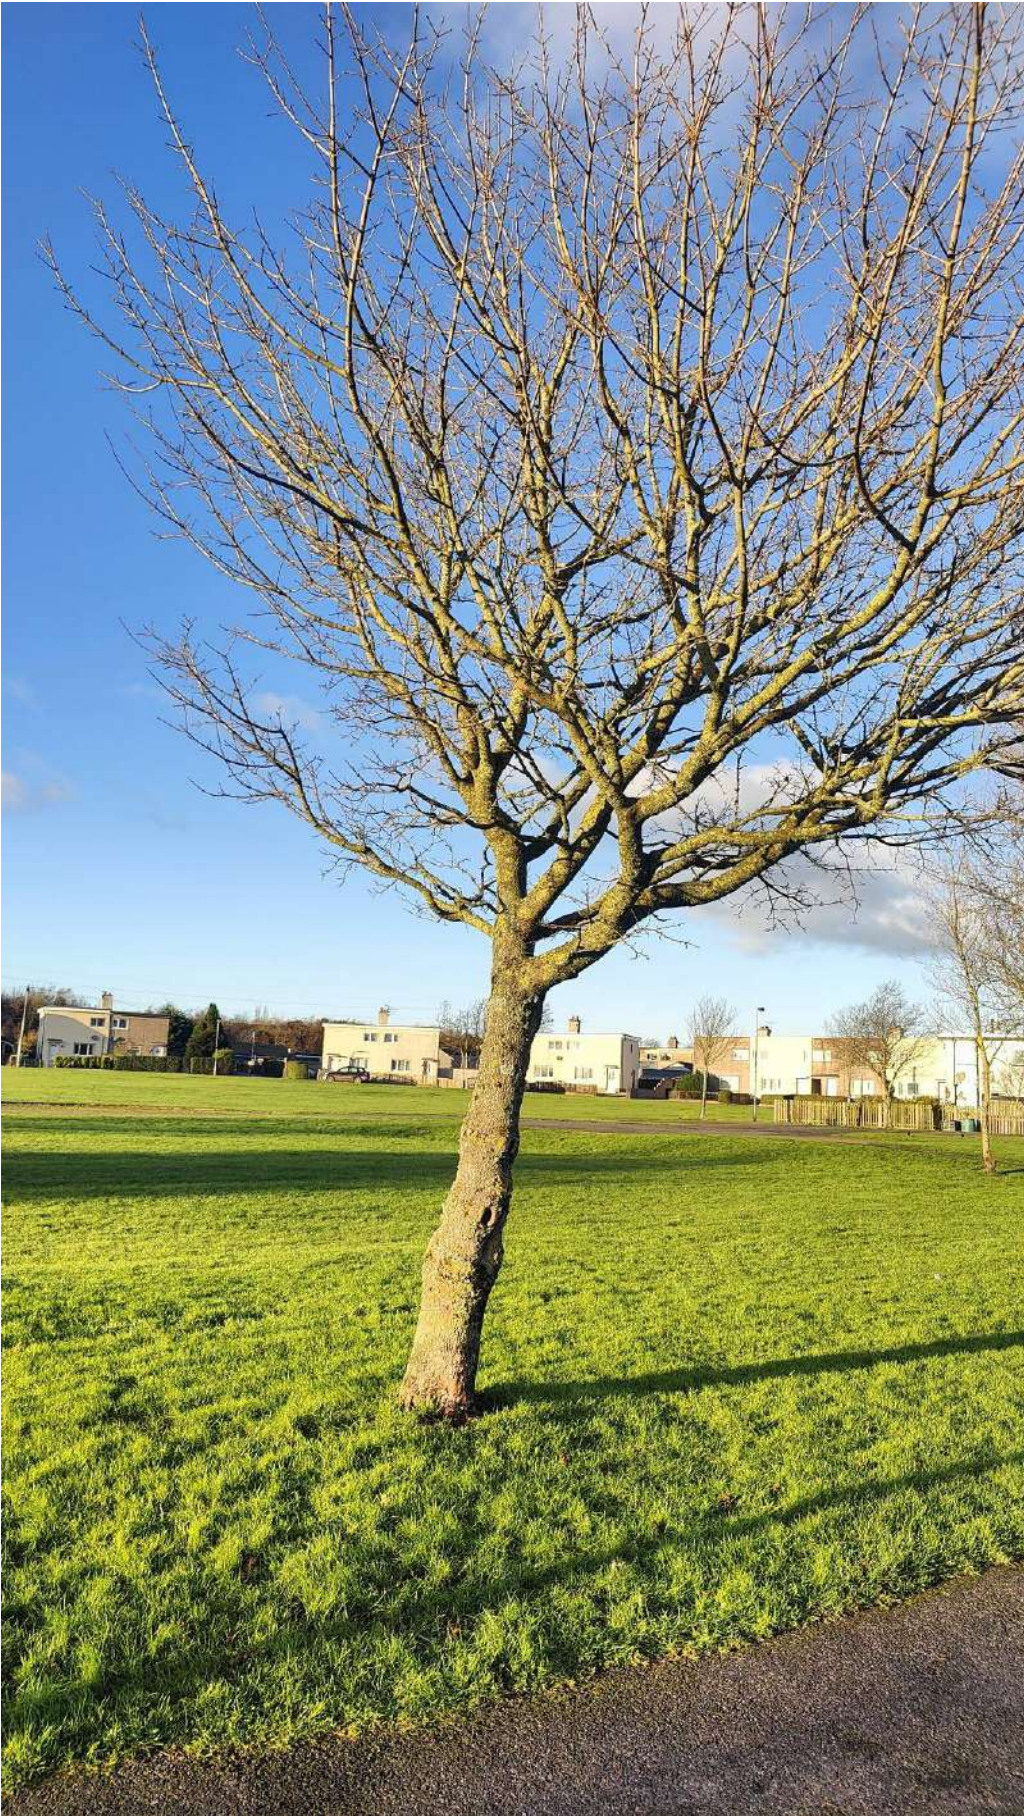
21. Tree T18 Field Maple

| Tree ID | Common Name | Botanical Name | Height (m) | Calc. / Actual Stem Dia. (mm) | Crown spread (m) | | | | Height (m) & Orientation of First Significant Branch | Life Stage | General Observations | Preliminary Recommendations | Estimated Remaining Contribution (Years) | BS5837: 2012 Category |
|---|---|---|---|---|---|---|---|---|---|---|---|---|---|---|
| T18 | Field maple | <i>Acer campestre</i> | 10m | 310 | 2.5 | 4 | 3 | 2 | 2.2m East | Middle aged | Leaning slightly to the east crown weighted to the east. Stem damage. | No work required. | 10 - 20 | C |

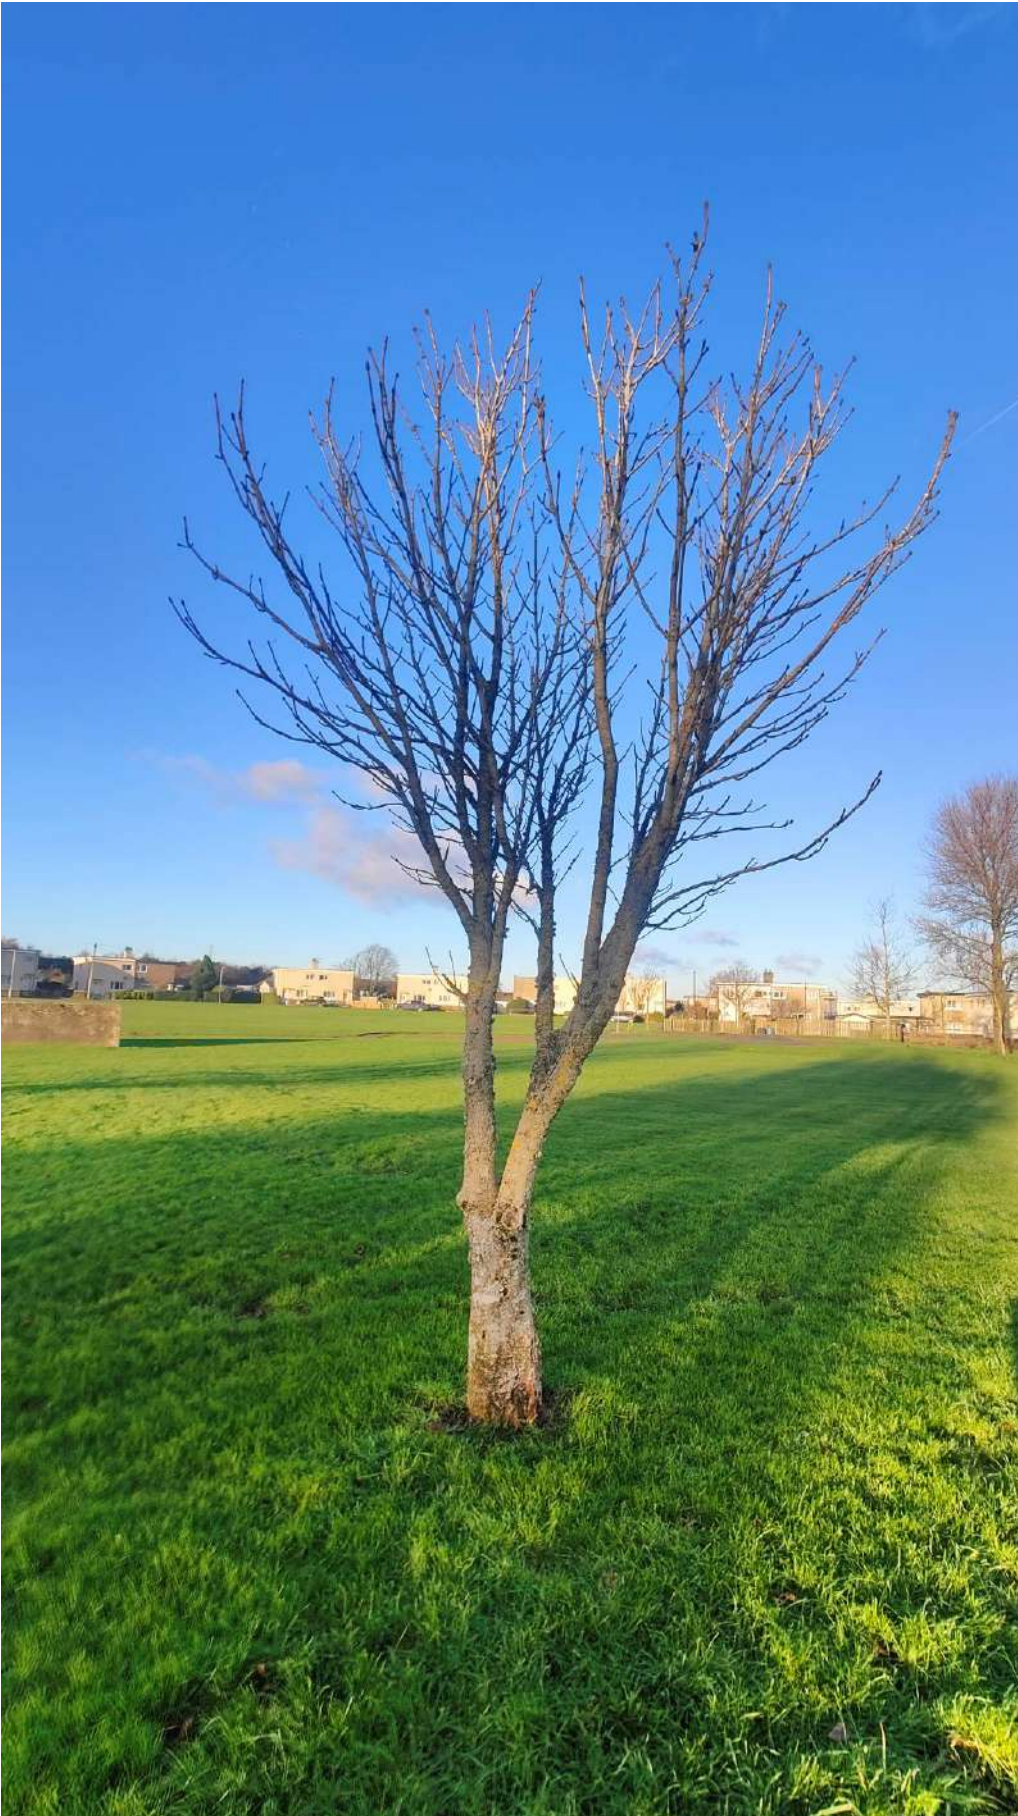
22. Tree T19 Horse Chestnut

| Tree ID | Common Name | Botanical Name | Height (m) | Calc. / Actual Stem Dia. (mm) | Crown spread (m) | | | | Height (m) & Orientation of First Significant Branch | Life Stage | General Observations | Preliminary Recommendations | Estimated Remaining Contribution (Years) | BS5837: 2012 Category |
|---|---|---|---|---|---|---|---|---|---|---|---|---|---|---|
| T19 | Horse chestnut | <i>Aesculus hippocastanum</i> | 6m | 140; 150; 120 | 1.5 | 1.5 | 2 | 2 | 2m West | Young | Basal stem damage from strimmer. | No work required. | 10 - 20 | C |

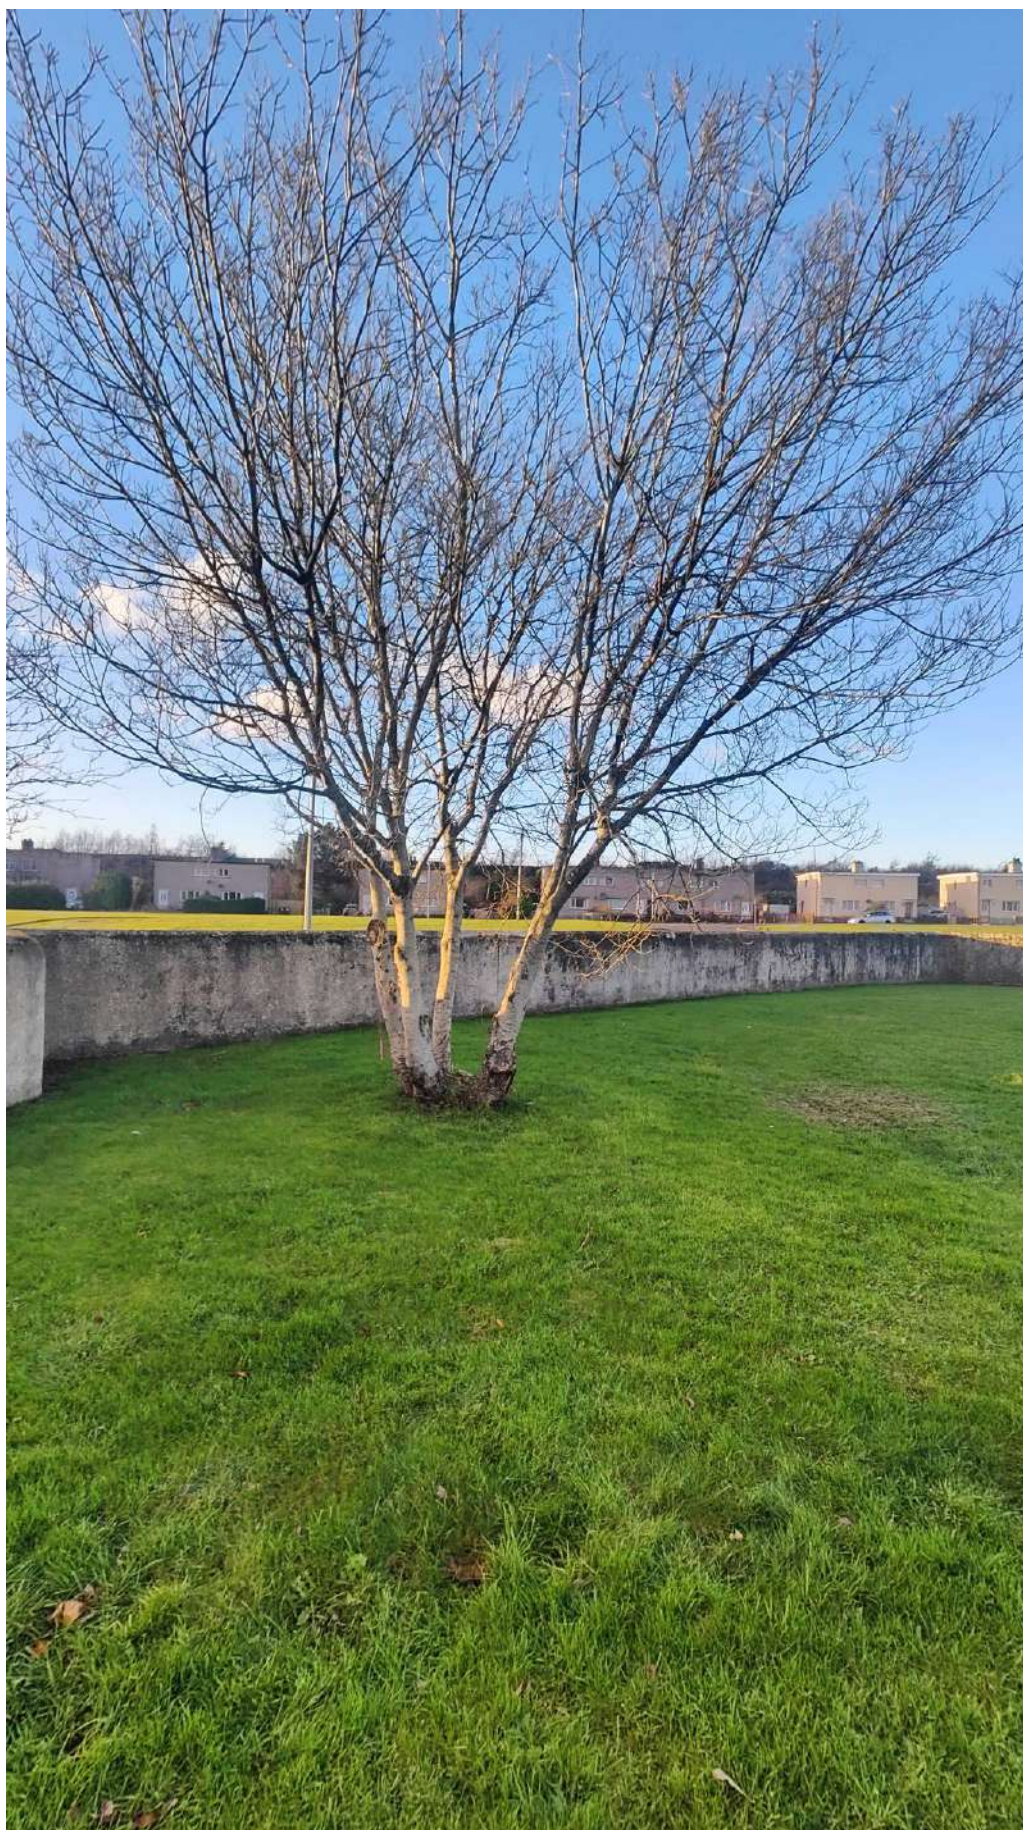
23. T20 White Poplar.

| Tree ID | Common Name | Botanical Name | Height (m) | Calc. / Actual Stem Dia. (mm) | Crown spread (m) | | | | Height (m) & Orientation of First Significant Branch | Life Stage | General Observations | Preliminary Recommendations | Estimated Remaining Contribution (Years) | BS5837: 2012 Category |
|---|---|---|---|---|---|---|---|---|---|---|---|---|---|---|
| T20 | White poplar | <i>Populus alba</i> | 8m | 150; 160; 170; 160 | 3.5 | 4 | 4 | 4 | 1.8m East | Middle aged | Multi stem tree with significant stem damage. | Coppice. | 10 - 20 | C |

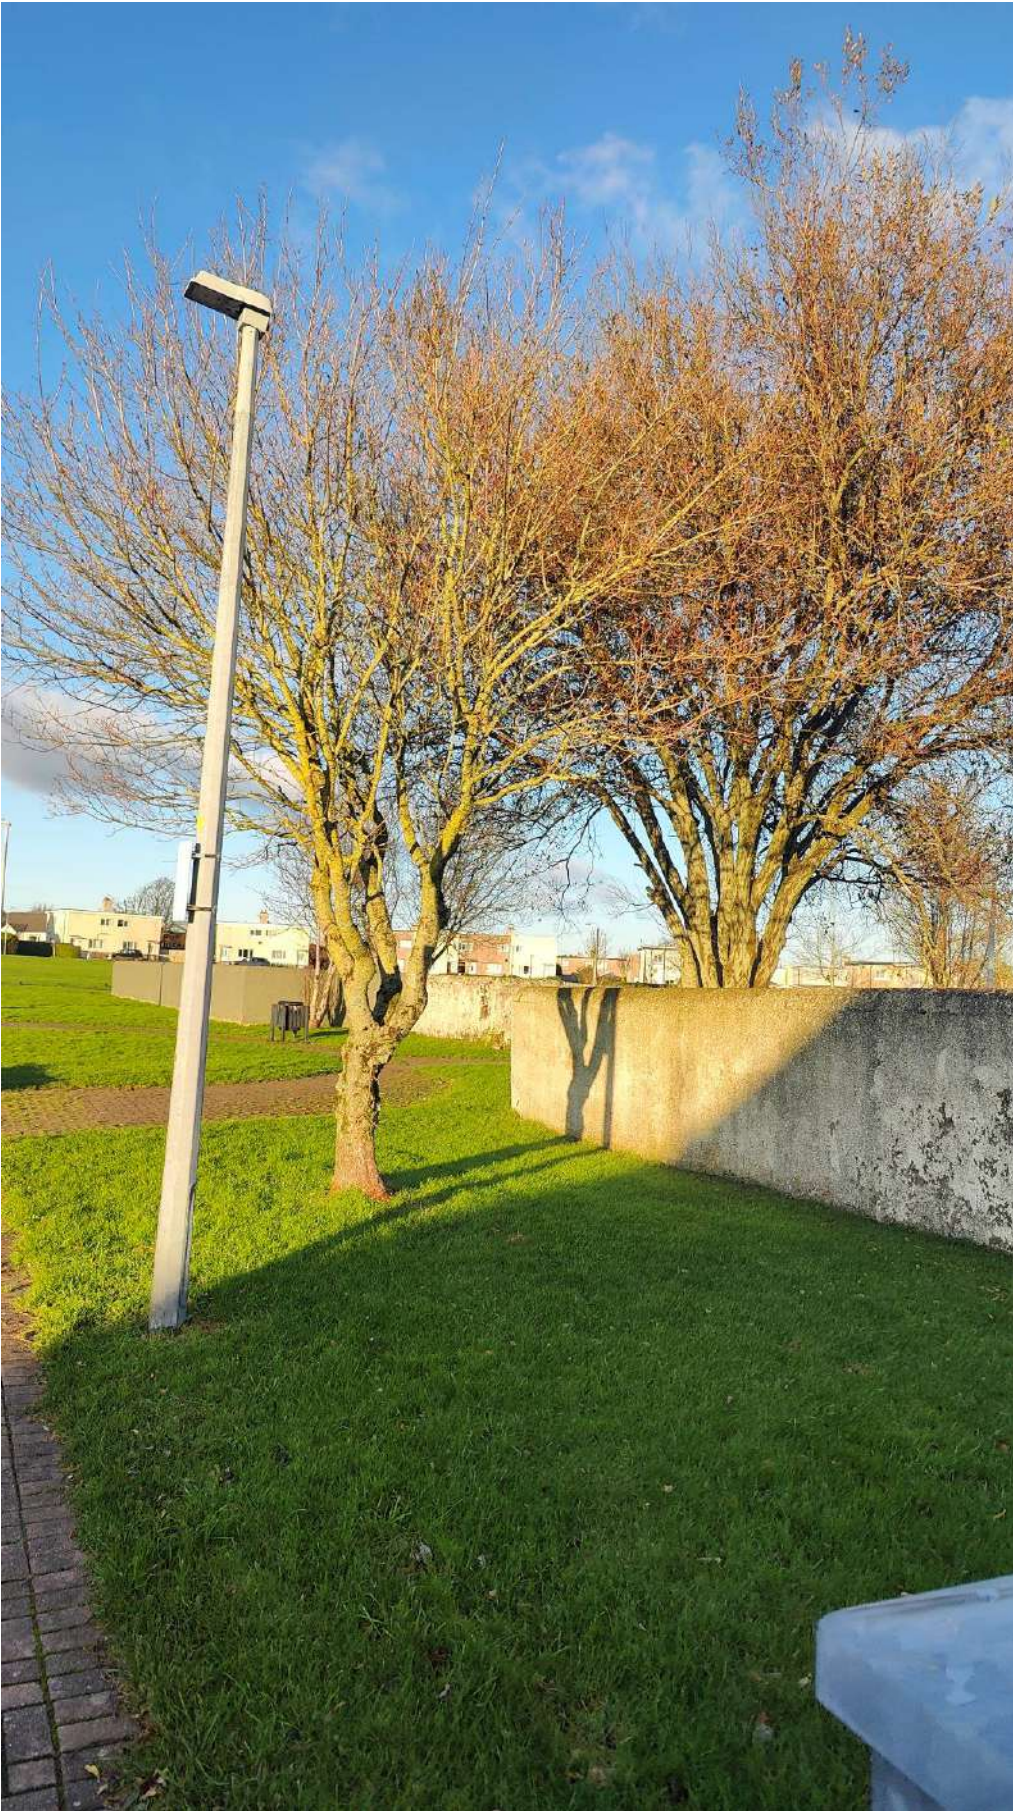
25. Trees T22 Field Maple and T23 Goat Willow (right).

| Tree ID | Common Name | Botanical Name | Height (m) | Calc. / Actual Stem Dia. (mm) | Crown spread (m) | | | | Height (m) & Orientation of First Significant Branch | Life Stage | General Observations | Preliminary Recommendations | Estimated Remaining Contribution (Years) | BS5837: 2012 Category |
|---|---|---|---|---|---|---|---|---|---|---|---|---|---|---|
| T22 | Field maple | <i>Acer campestre</i> | 10m | 180; 140; 160 | 3.5 | 2 | 4 | 3 | 2m South west | Middle aged | Suppressed by T23. Stem damage. | No work required. | 10 - 20 | C |

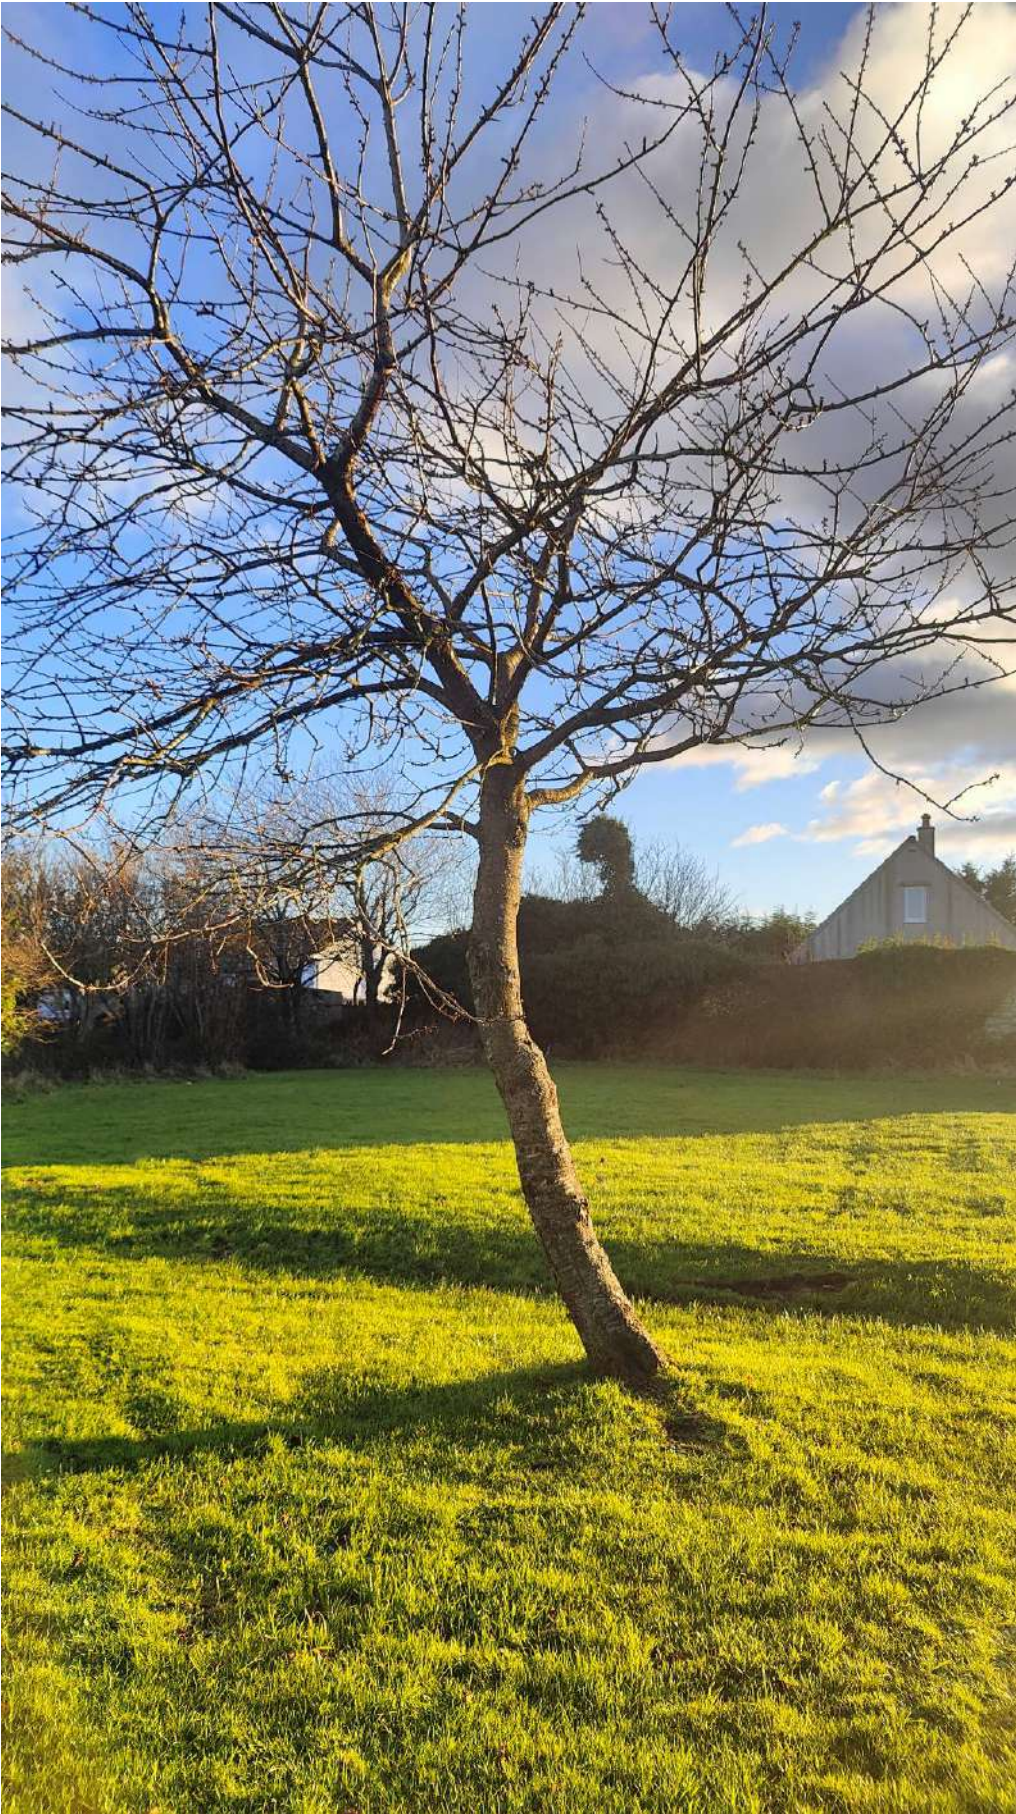
26. Tree T24 Cherry

| Tree ID | Common Name | Botanical Name | Height (m) | Calc. / Actual Stem Dia. (mm) | Crown spread (m) | | | | Height (m) & Orientation of First Significant Branch | Life Stage | General Observations | Preliminary Recommendations | Estimated Remaining Contribution (Years) | BS5837: 2012 Category |
|---|---|---|---|---|---|---|---|---|---|---|---|---|---|---|
| T24 | Cherry | <i>Prunus avium</i> | 8m | 300 | 2.5 | 2.5 | 2.5 | 2.5 | 1.8m North | Middle aged | Leaning north, stem damage. | No work required. | 10 - 20 | C |

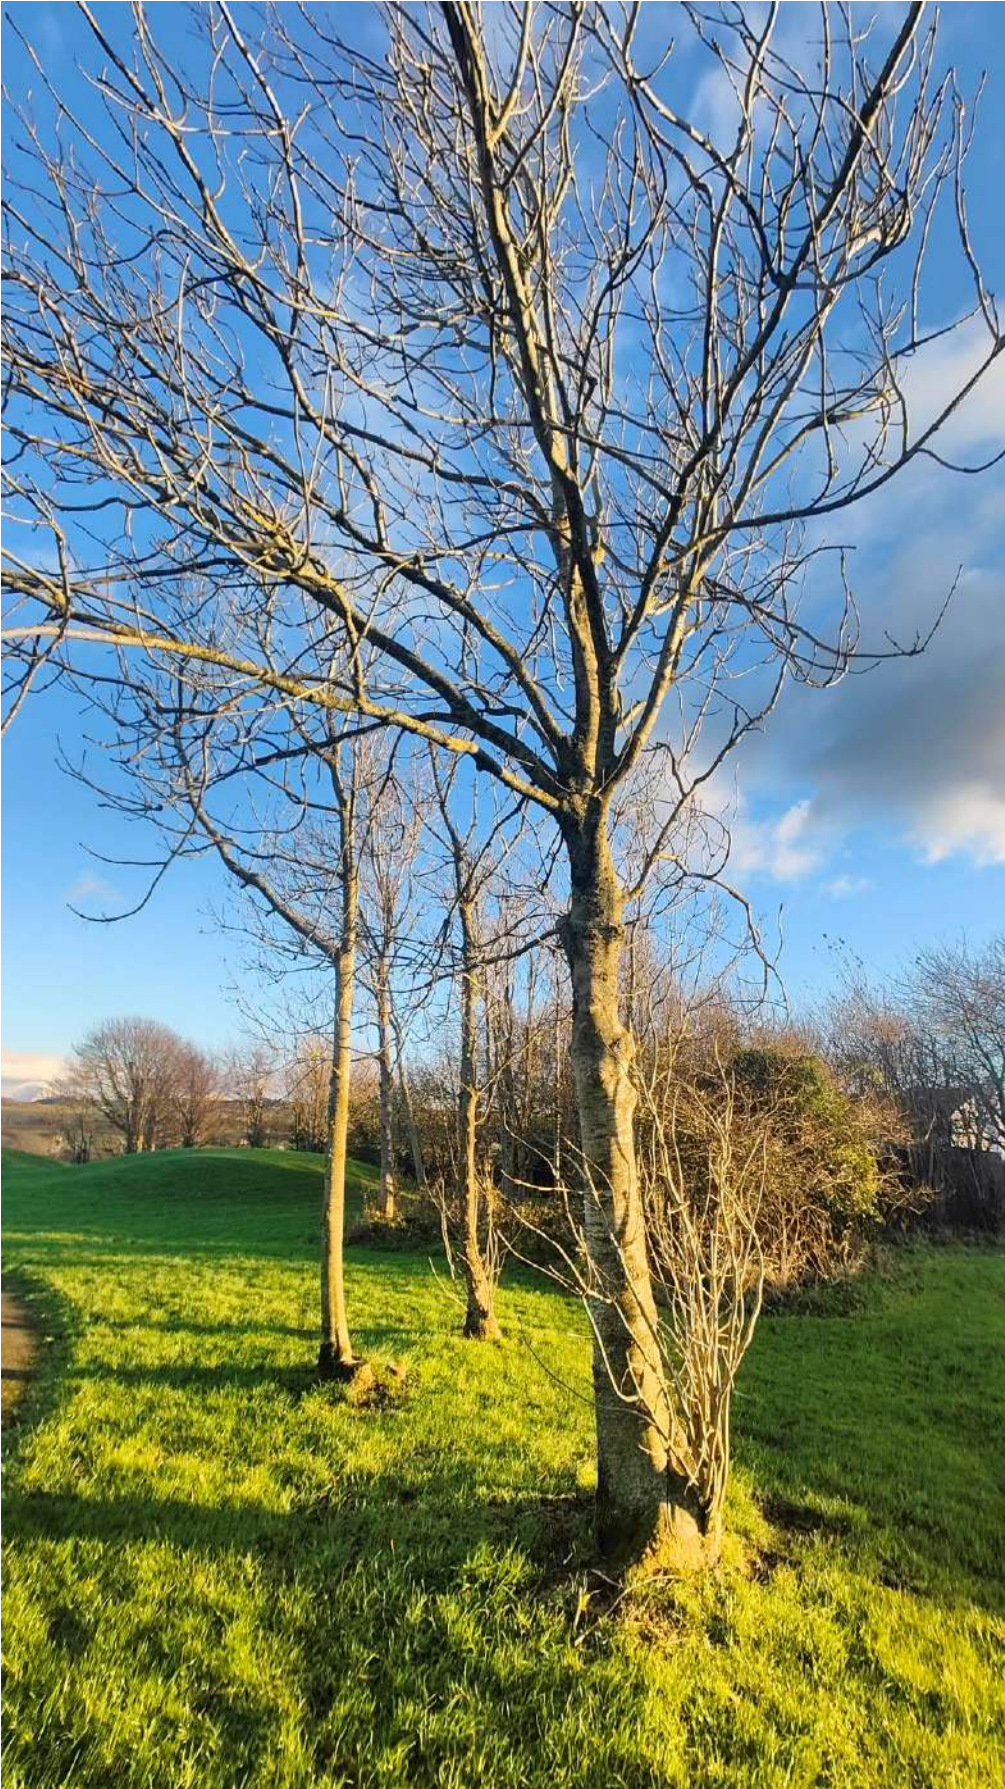
27. Trees T25, T26 and T27 Ash (front to back)

| Tree ID | Common Name | Botanical Name | Height (m) | Calc. / Actual Stem Dia. (mm) | Crown spread (m) | | | | Height (m) & Orientation of First Significant Branch | Life Stage | General Observations | Preliminary Recommendations | Estimated Remaining Contribution (Years) | BS5837: 2012 Category |
|---|---|---|---|---|---|---|---|---|---|---|---|---|---|---|
| T25 | Ash | <i>Fraxinus excelsior</i> | 10m | 270 | 4 | 3.5 | 4 | 3 | 1.7m East | Middle aged | Larger ash tree than the two adjacent, dominant and reasonable form and condition. | No work required. | 10 - 20 | C |
| T26 | Ash | <i>Fraxinus excelsior</i> | 8m | 140 | 2 | 1.5 | 1 | 1.5 | 2m South | Young | Poor condition, some deadwood. | No work required. | 10 - 20 | C |
