**PROPOSED HOUSING**

**BARFS ROAD, DISTINGTON**

**TREE SURVEY REPORT**

**HOME GROUP HOUSING**

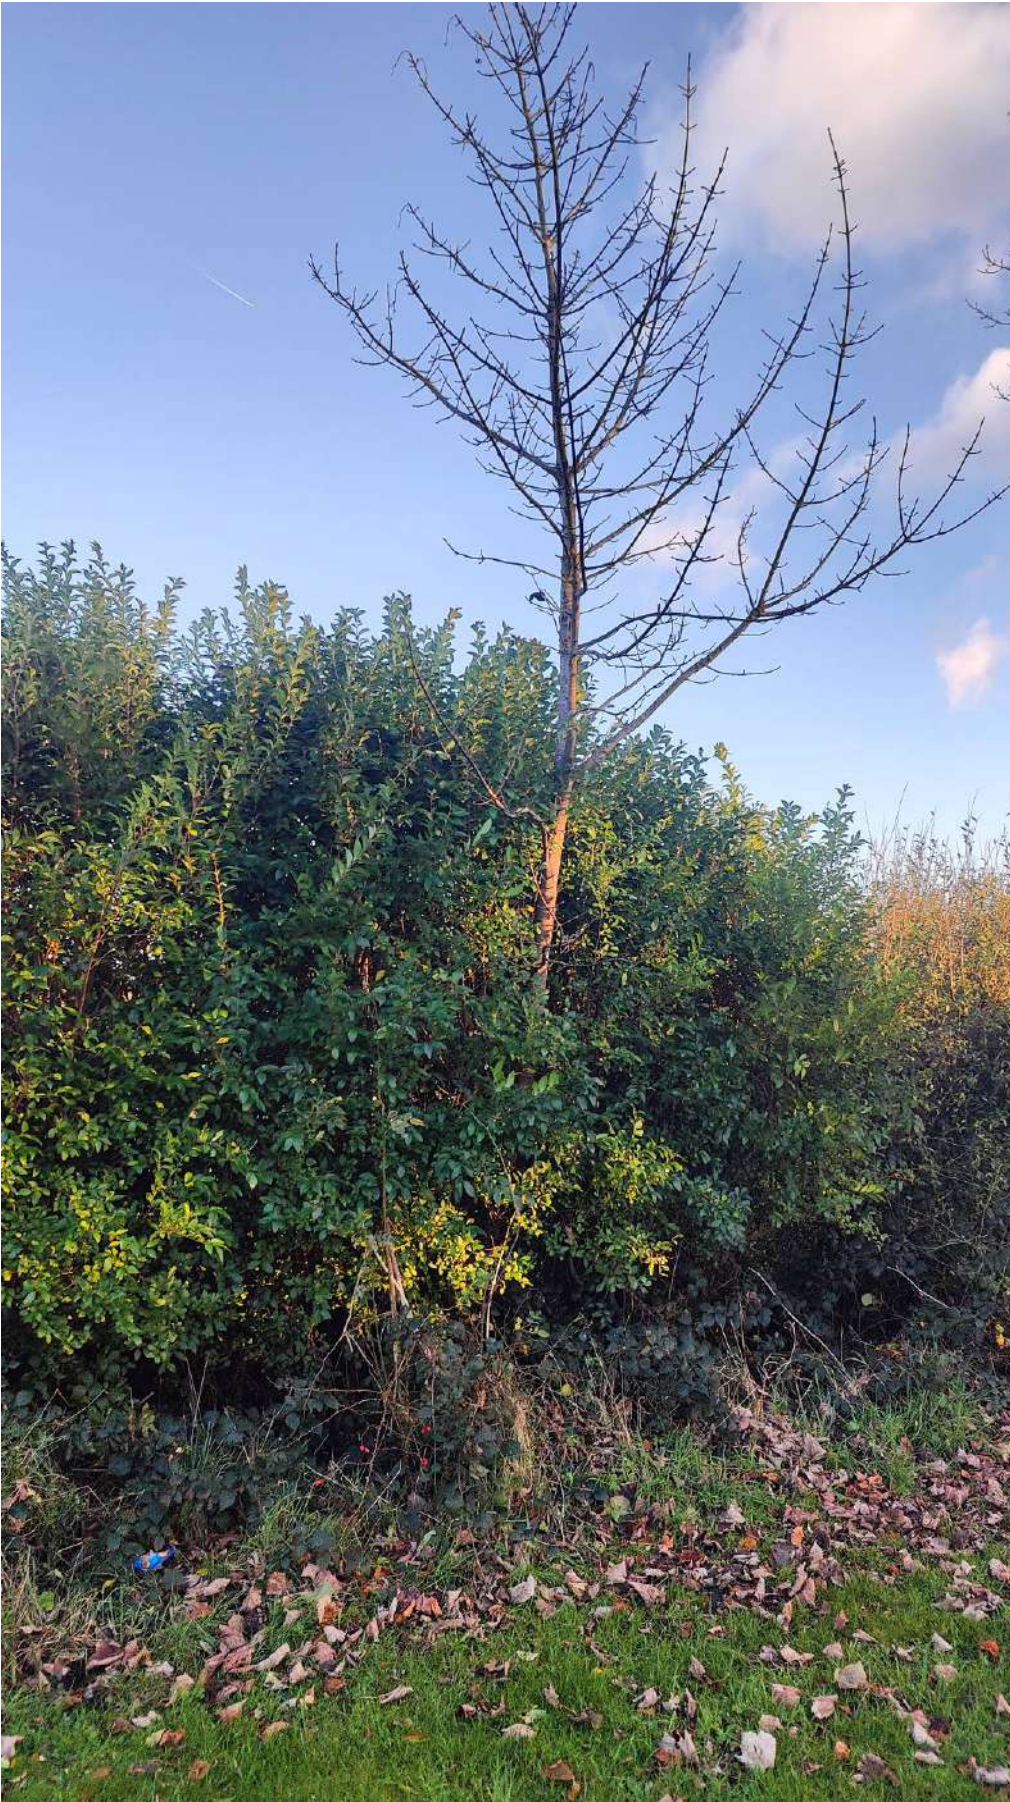
29. Tree T29 Sycamore

| Tree ID | Common Name | Botanical Name | Height (m) | Calc. / Actual Stem Dia. (mm) | Crown spread (m) | | | | Height (m) & Orientation of First Significant Branch | Life Stage | General Observations | Preliminary Recommendations | Estimated Remaining Contribution (Years) | BS5837: 2012 Category |
|---|---|---|---|---|---|---|---|---|---|---|---|---|---|---|
| T29 | Sycamore | <i>Acer pseudoplatanus</i> | 7m | 85 | 1 | 1 | 1 | 2 | 2m West | Young | Growing within Hedge H1. No visible defects. | No work required. | 10 - 20 | C |

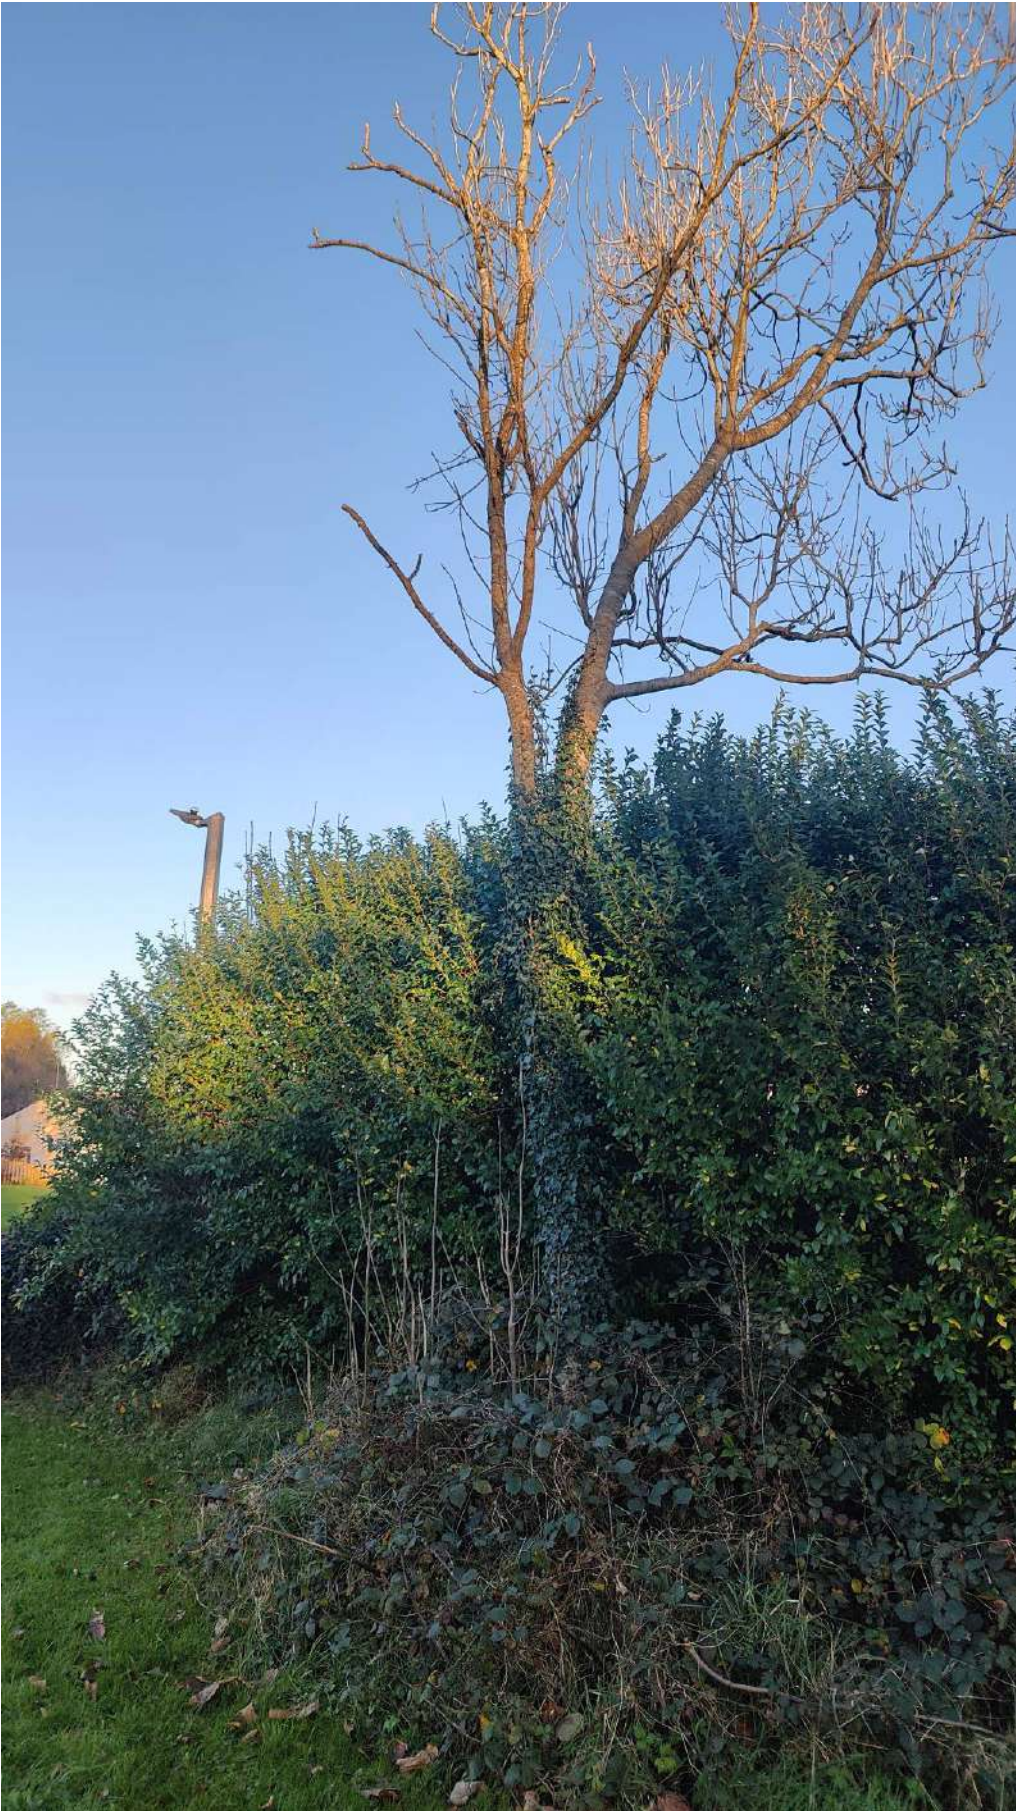
30. Tree T30 Ash.

| Tree ID | Common Name | Botanical Name | Height (m) | Calc. / Actual Stem Dia. (mm) | Crown spread (m) | | | | Height (m) & Orientation of First Significant Branch | Life Stage | General Observations | Preliminary Recommendations | Estimated Remaining Contribution (Years) | BS5837: 2012 Category |
|---|---|---|---|---|---|---|---|---|---|---|---|---|---|---|
| T30 | Ash | <i>Fraxinus excelsior</i> | 11m | 200 | 1 | 1 | 1 | 1 | 2.5m East | Young | Ash dieback noted. Poor condition. Large amount of deadwood. Ivy on stem. | Fell. | <10 | U |
