## **FLOOD RISK AND DRAINAGE ASSESSMENT**

### **Cleator Mill, Proposed Residential Development, Flood Risk Assessment.**

# Cleator Flood Asset Condition Assessment

23 MAR 2022  
Version 1.0  
RAB: 2869

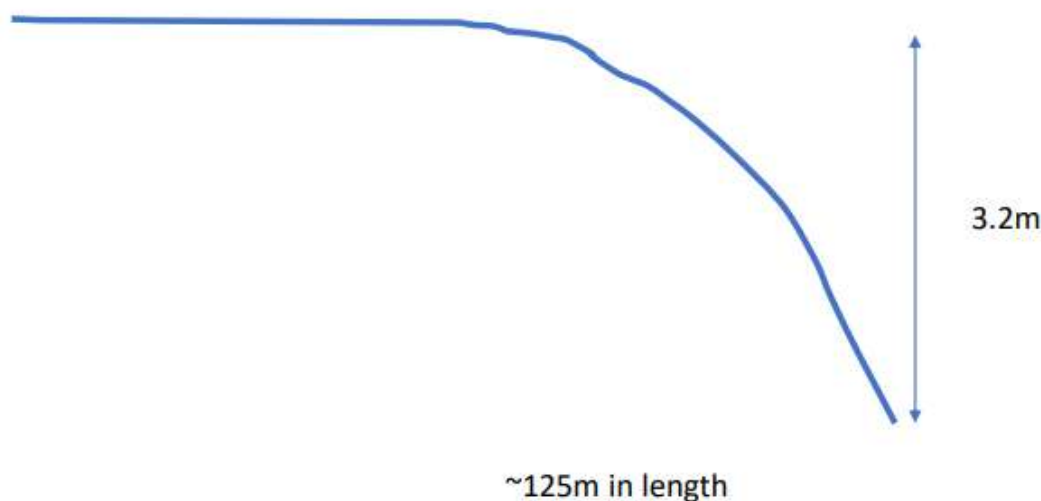
## CL13 – Natural High Ground

Significant undermining, erosion, and presence of light foreign objects on channel side. High ground in good condition.

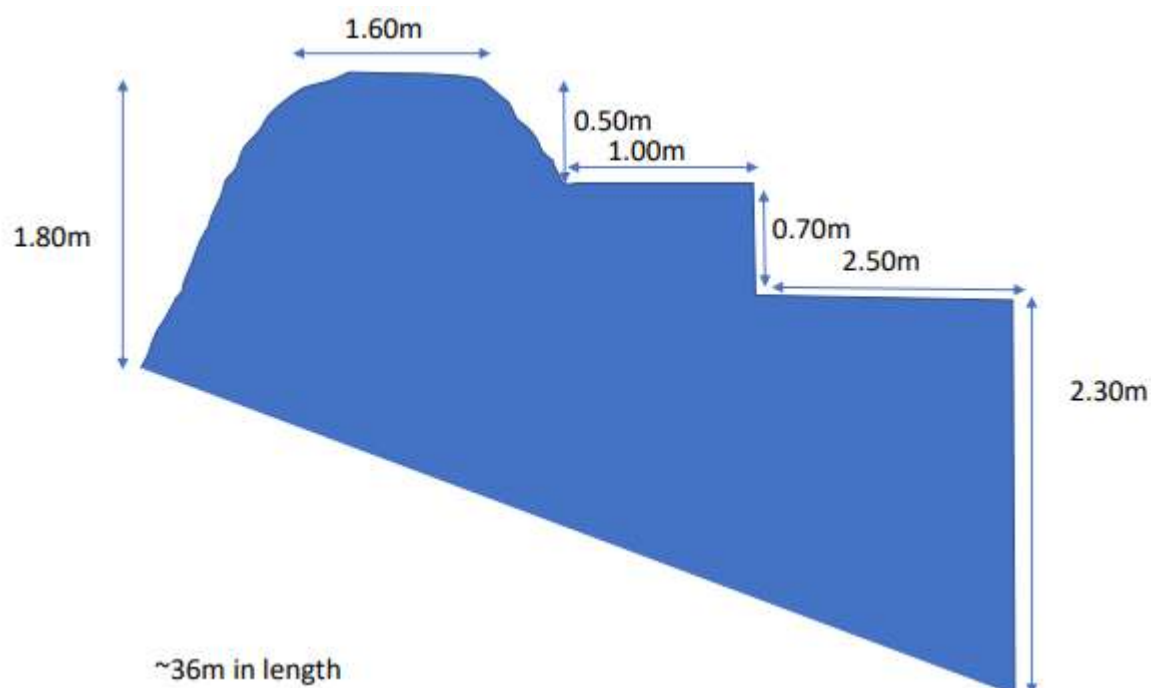
## CL21 – Embankment

Berm 2 and channel side in good condition with minor cosmetic defects to sheet piles. Vegetation growth through gabion baskets with a few broken wires but no gabion displacement. Uneven ground on exposed face 1 and landward face but well vegetated. Rutting and low spots in isolated places on crest. Variants used on crest as less than 4m wide and landward face due to steepness.

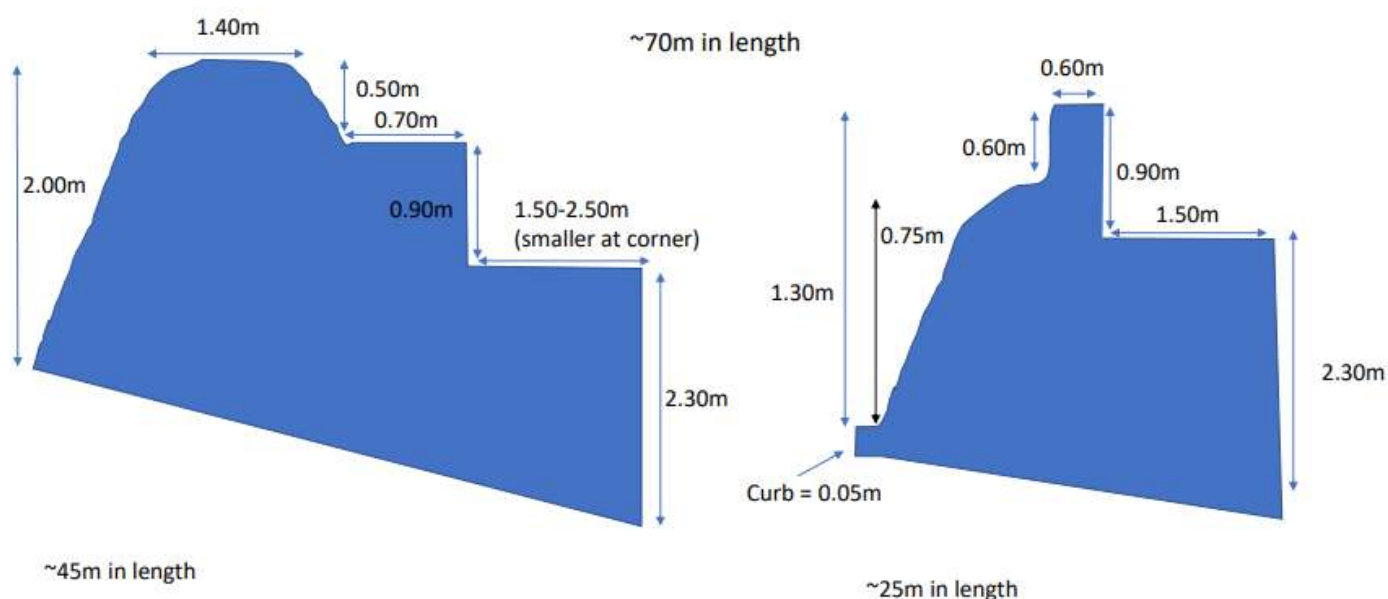
## CL22 – Embankment

Minor vegetation growth within berm 1 and exposed face 2 with minor mortar loss. Uneven crest with some low spots but well vegetated. Berm 2 and channel side in good condition with minor cosmetic defects to sheet piling. Landward face and exposed face 1 are well vegetated but uneven. Landward face 2 around corner and has minor vegetation growing through stone and minor mortar loss.

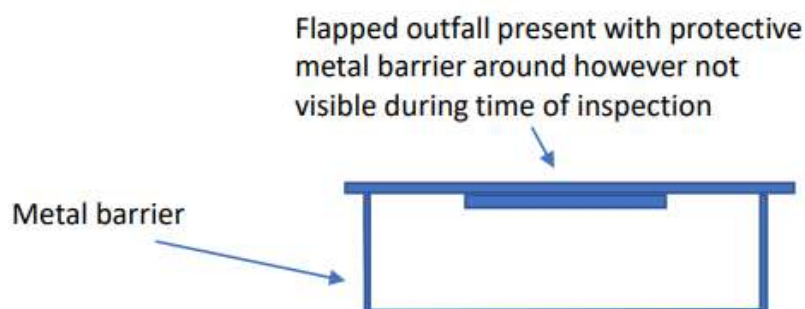
## CL23 – Outfall

Minor corrosion to barrier. Unable to see headwall and pipe due to high water level and barrier around.

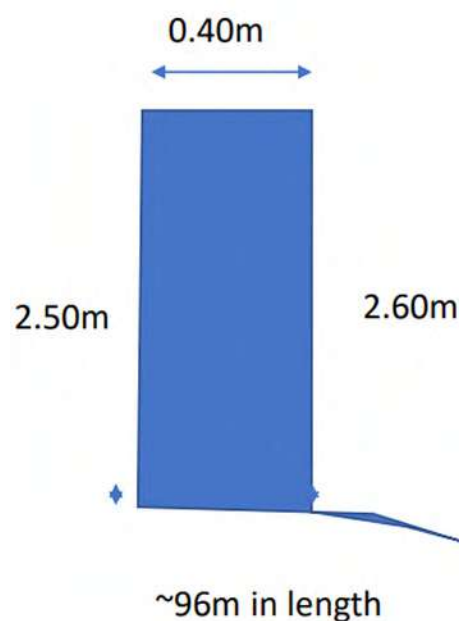
## CL24 – Wall

Minor vegetation growth through crest. Minor mortar loss on exposed face and a couple of holes on both faces, not whole way though. Few bricks missing for drainage

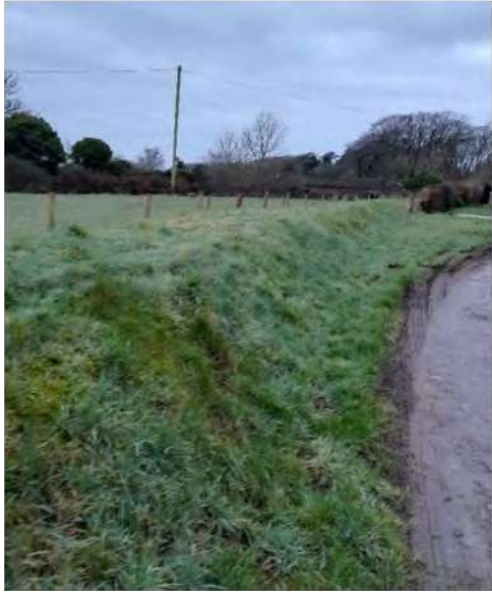
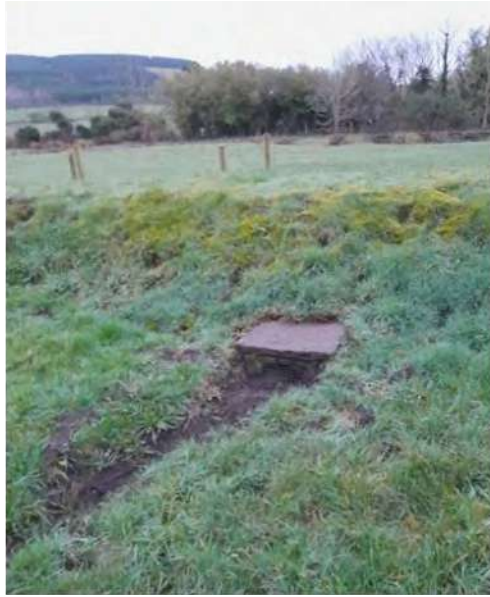
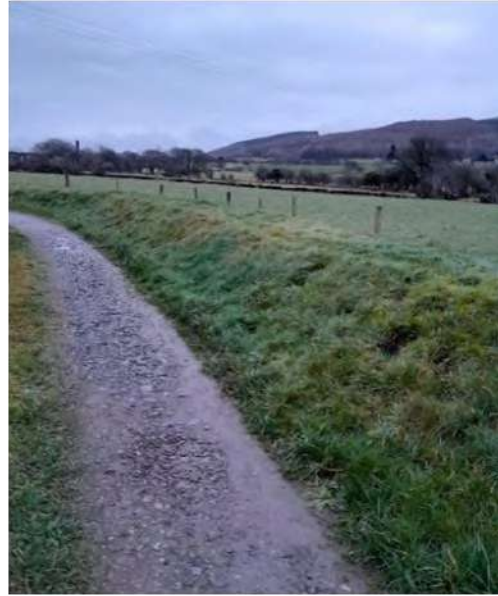
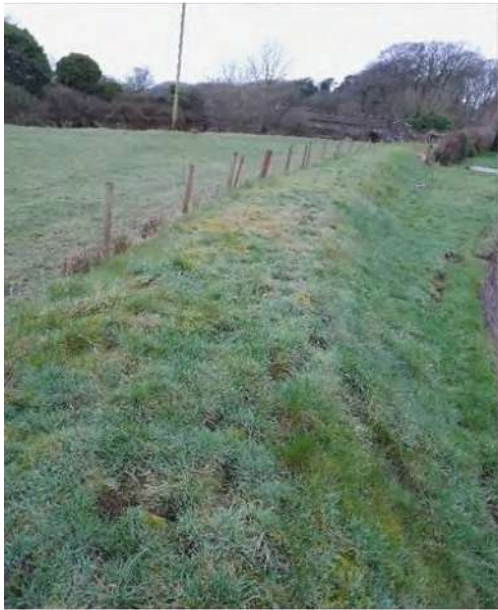
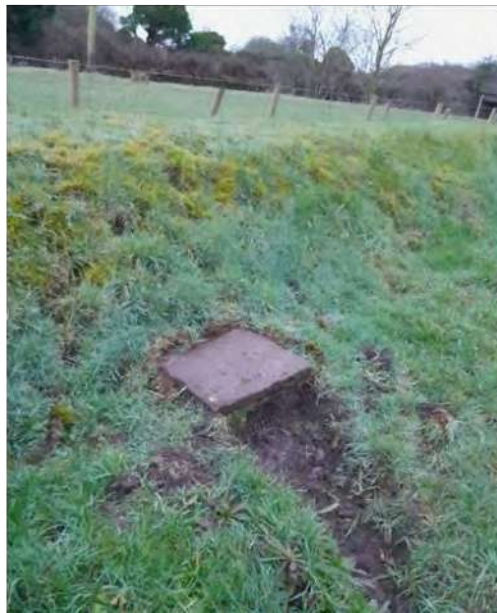
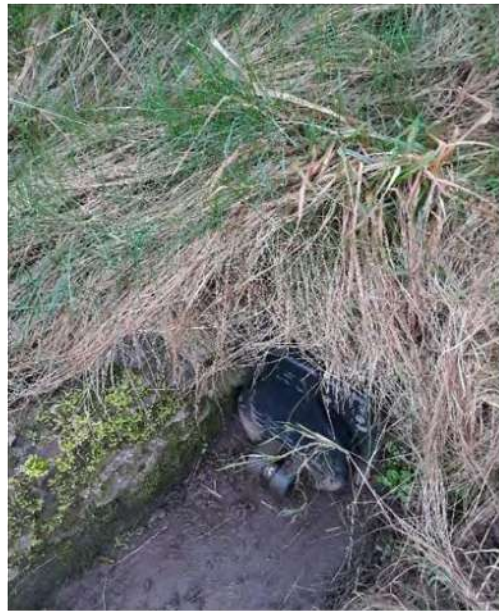
| <b>Comments</b> | Variant weighting used for crest as <4m wide. Drainage pipe running through entire width of embankment, low spots, some animal holes and rutting on crest, Landward face and exposed face have some holes and uneven slopes but are well vegetated. Undermining, minor erosion and light foreign objects present on channel side but currently stable. | | | | | | |

| <b>Recommendations</b> | Infill low spots on crest, remove drainage pipe from embankment and consider pest control. | | | | | | |

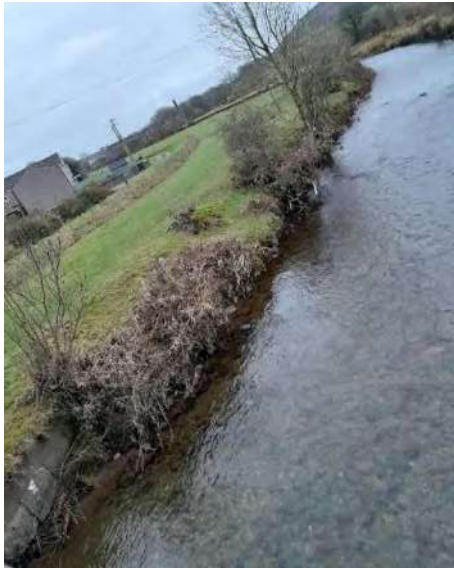
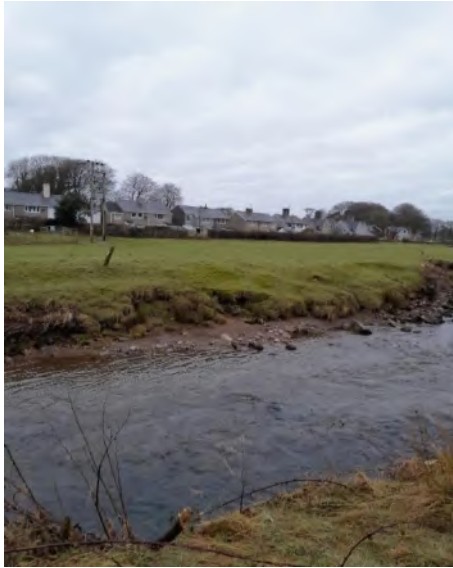
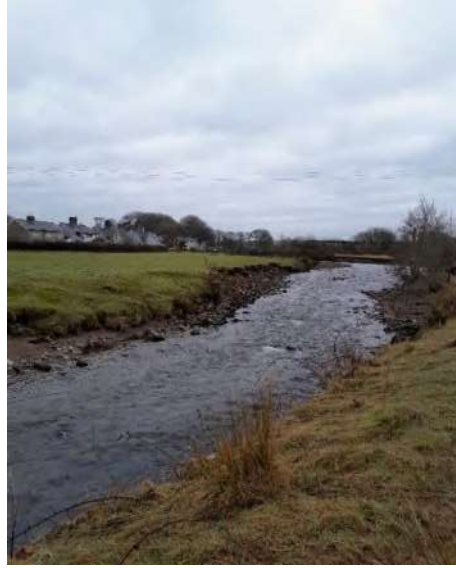
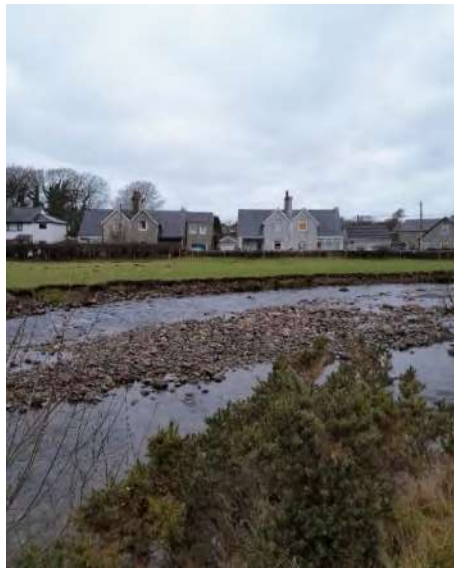
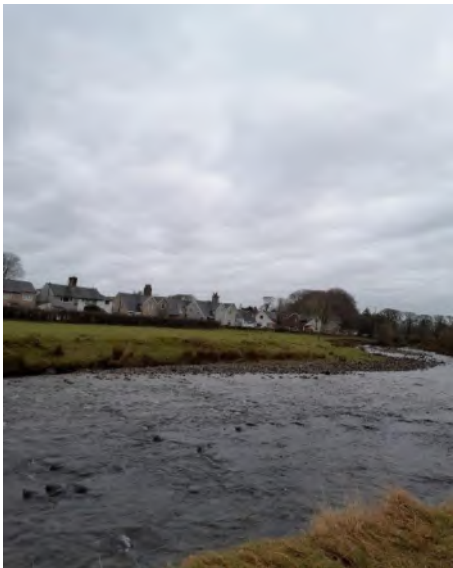
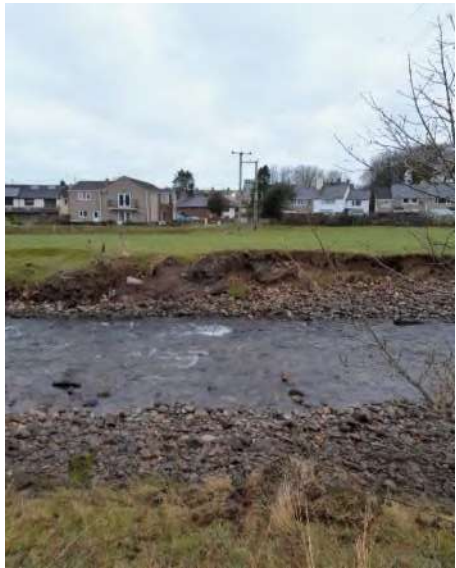
| <b>Comments</b> | Significant undermining, erosion and presence of light foreign objects on channel side. High ground in good condition. | | | | | | |

| <b>Recommendations</b> | Monitor erosion, consider installing erosion protection layer to channel side. | | | | | | |

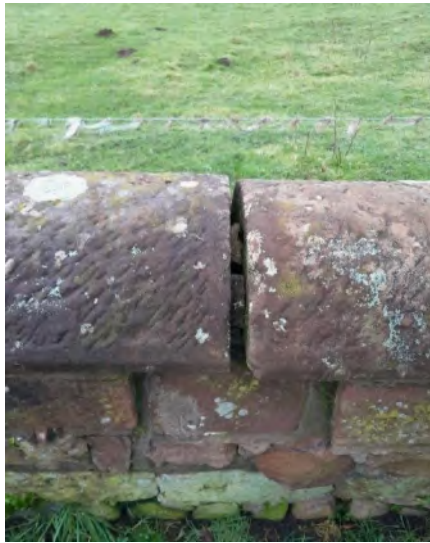
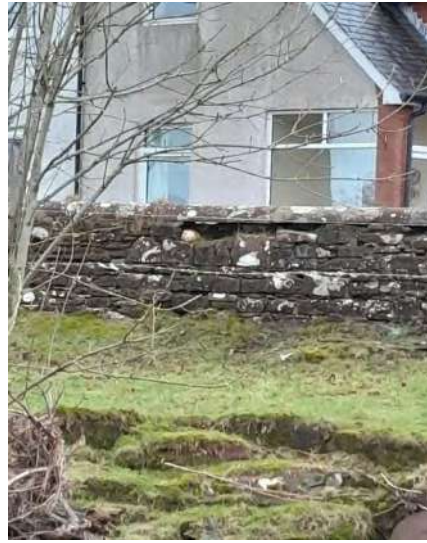
| Asset ID | CL3 | Frequency | | | | | |
|---|---|---|---|---|---|---|---|
| Comments | Variant weightings used for both faces as no revetments. Significant mortar loss to crest, holes through wall, bulging of wall where light foreign objects are growing in front on wall, distorting its shape and minor erosion to channel side. | | | | | | |

| Asset ID | CL3 | Frequency | | | | | |
|---|---|---|---|---|---|---|---|
| Recommendations | Rebuild wall and remove trees in front of wall. | | | | | | |

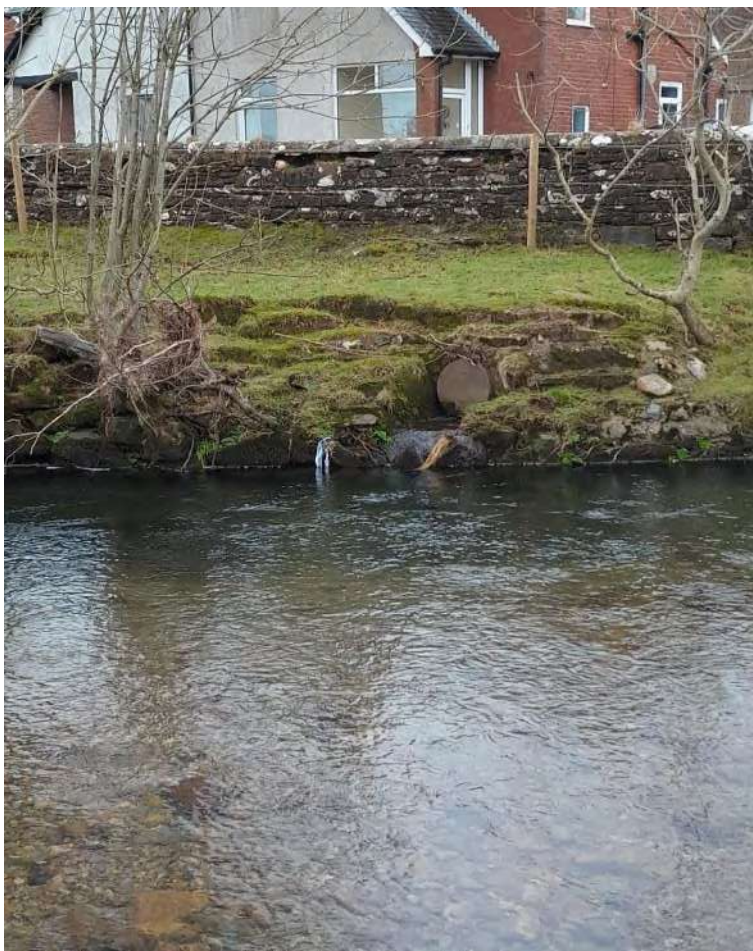
| <b>Comments</b> | Vegetation around headwall. Unable to see through pipe and no CCTV footage available. | | | | | | |

| <b>Recommendations</b> | Conduct a CCTV survey to inspect pipe and remove vegetation around headwall. | | | | | | |

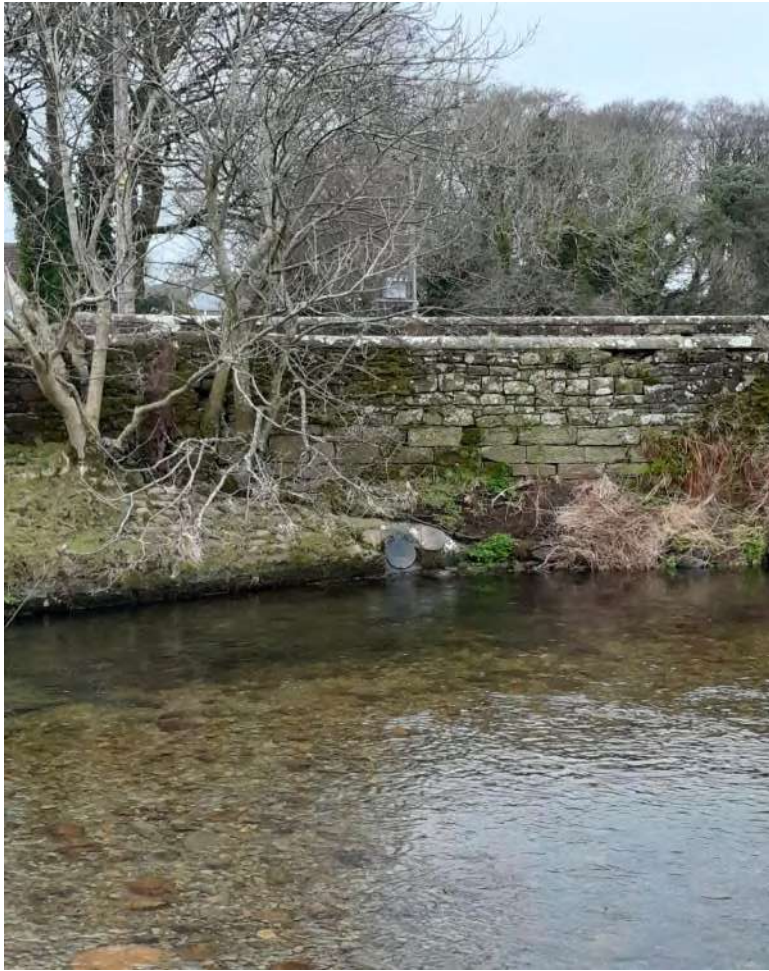
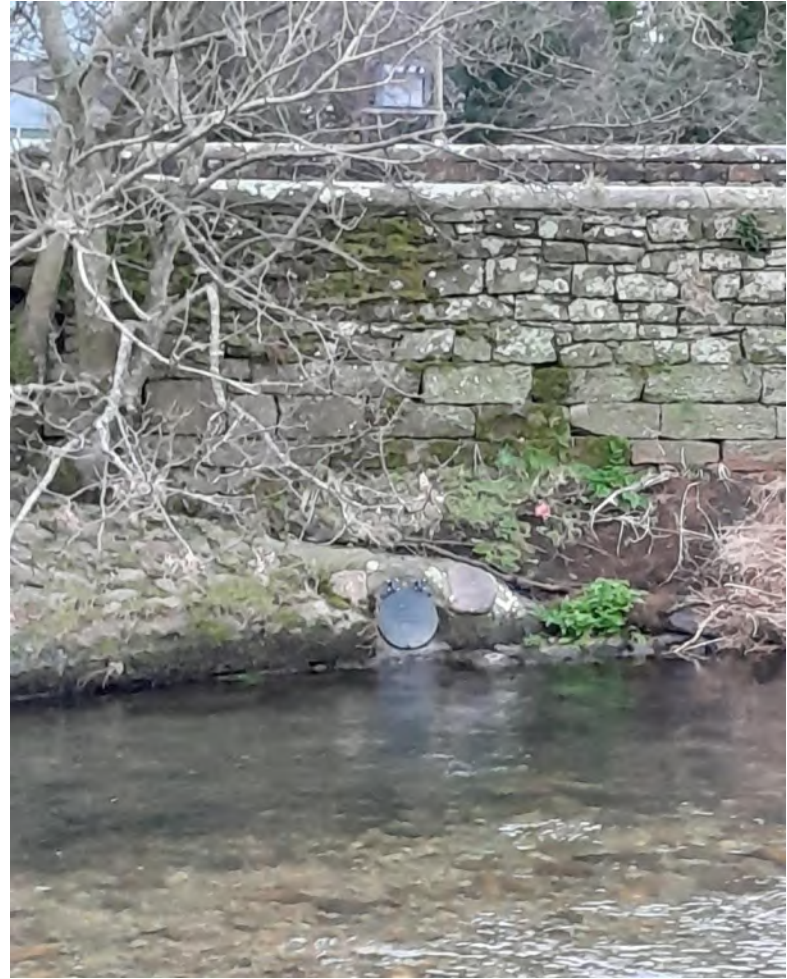
| <b>Comments</b> | Outfall in good condition, very minor corrosion present on frame and flap valve. Unable to see through pipe and no CCTV footage available. | | | | | | |

| <b>Recommendations</b> | Conduct a CCTV survey to inspect pipe. | | | | | | |

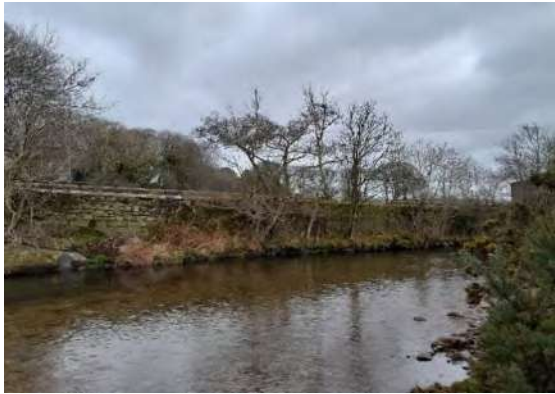
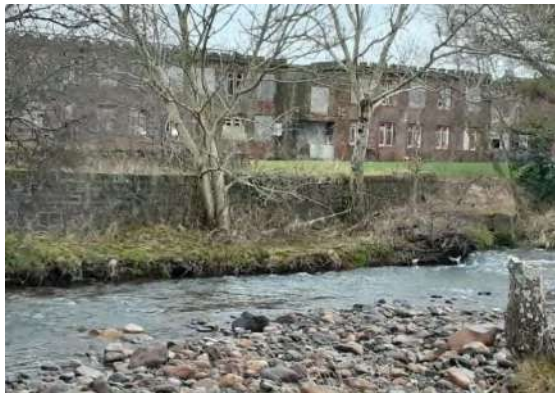
| Asset ID | CL6 | Frequency | | | | | |
|---|---|---|---|---|---|---|---|
| Comments | Heavy foreign objects growing towards channel on berm and channel side and undermining on channel side causing channel side to be unstable. Ivy growth on wall, heavy foreign objects growing close to wall causing bulging to wall and capping stones lost from crest halfway across wall. | | | | | | |

| Asset ID | CL6 | Frequency | | | | | |
|---|---|---|---|---|---|---|---|
| Recommendations | Rebuild wall, remove unstable trees and remove trees next to wall. | | | | | | |

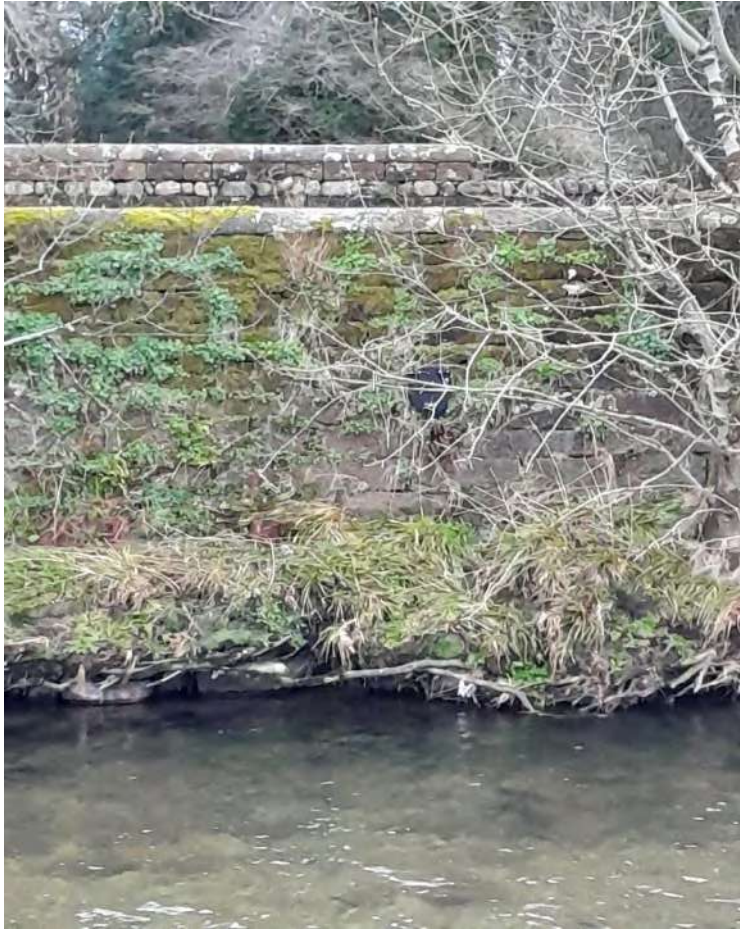
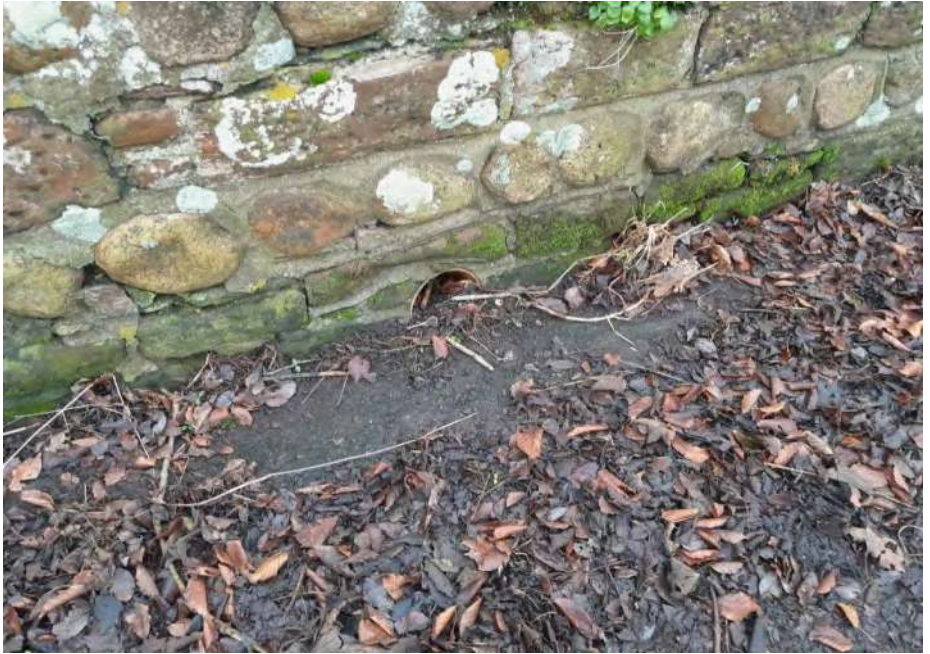
| Asset ID | CL7 | Frequency | | | | | |
|---|---|---|---|---|---|---|---|
| Comments | No signs of corrosion to flap valve or frame, pipe has minor leaf debris but no blockages or damage. Downstream headwall has some cracks, vegetation growth and mortar loss. | | | | | | |

| Asset ID | CL7 | Frequency | | | | | |
|---|---|---|---|---|---|---|---|
| Recommendations | Continue with ongoing vegetation maintenance. | | | | | | |

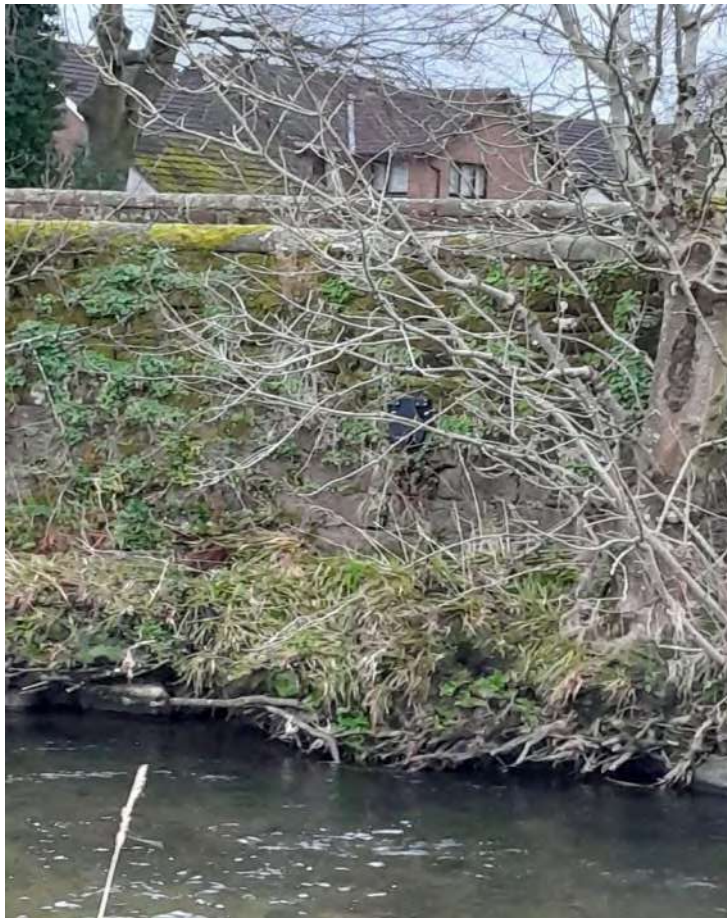
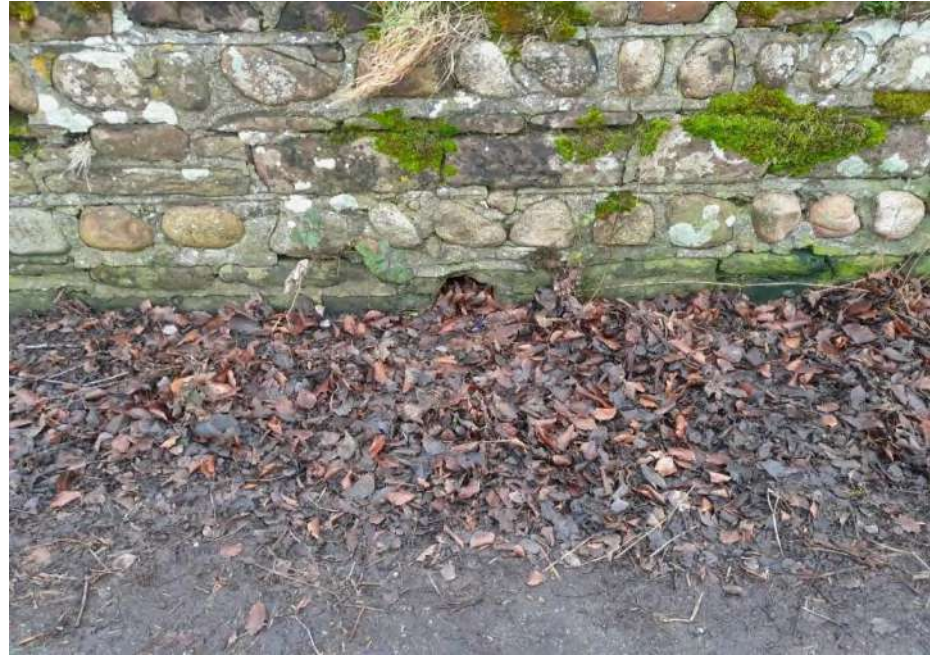
| <b>Comments</b> | No signs of corrosion to flap valve or frame, pipe has minor leaf debris but no blockages or damage. Minor crack to downstream headwall, vegetation growth and mortar loss. | | | | | | |

| <b>Recommendations</b> | Continue with ongoing vegetation maintenance. | | | | | | |

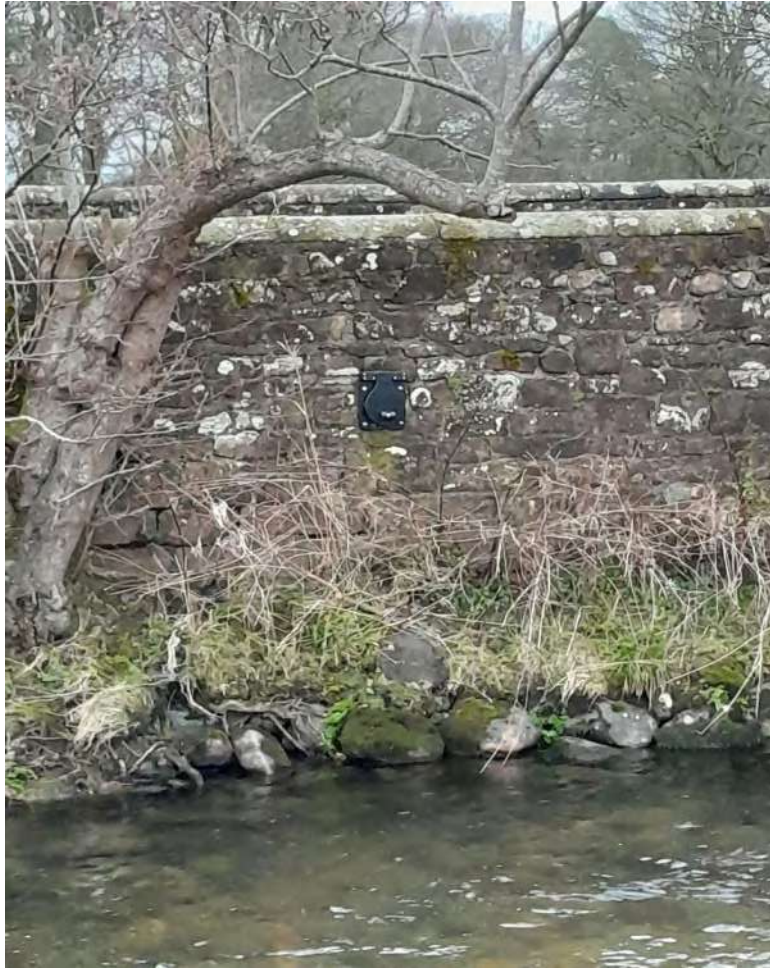
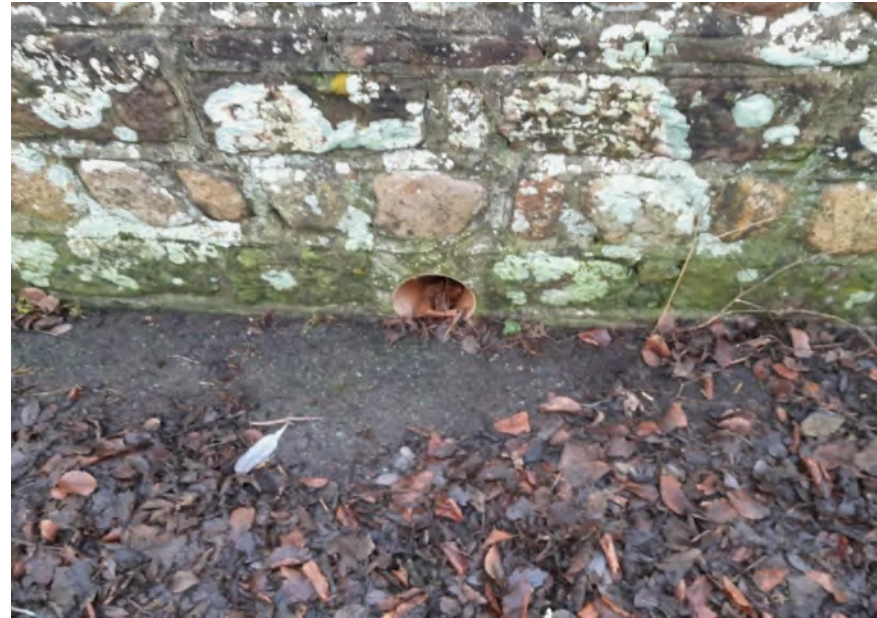
| <b>Comments</b> | No corrosion to flap valve or frame. Cracks and mortar loss on headwall. Pipe has minor leaf debris but no blockages or damage. | | | | | | |

| <b>Recommendations</b> | Remove vegetation and continue with vegetation maintenance. | | | | | | |

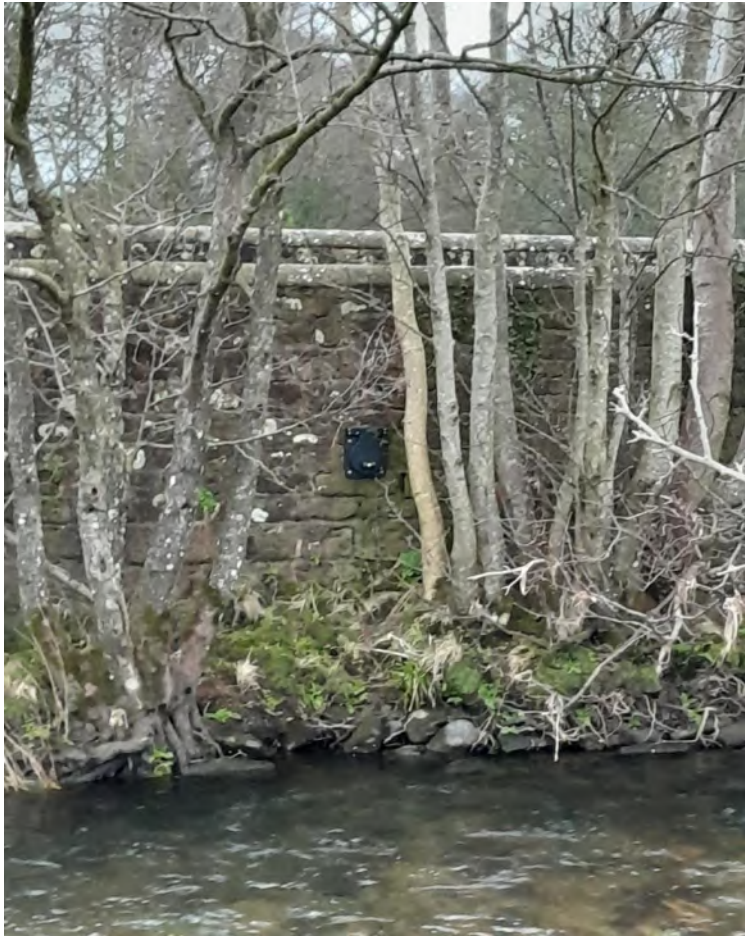
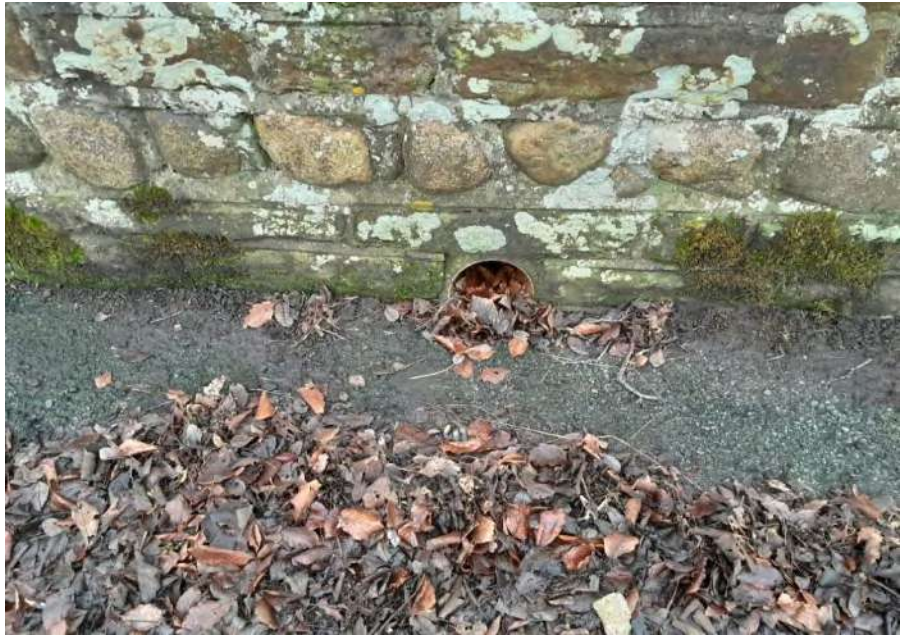
| <b>Comments</b> | Ivy growth around frame and headwall. No corrosion to flap valve. Cracks and vegetation growth on headwall. Pipe has minor leaf debris but no blockages or damage. | | | | | | |

| <b>Recommendations</b> | Remove vegetation and continue with vegetation maintenance. | | | | | | |

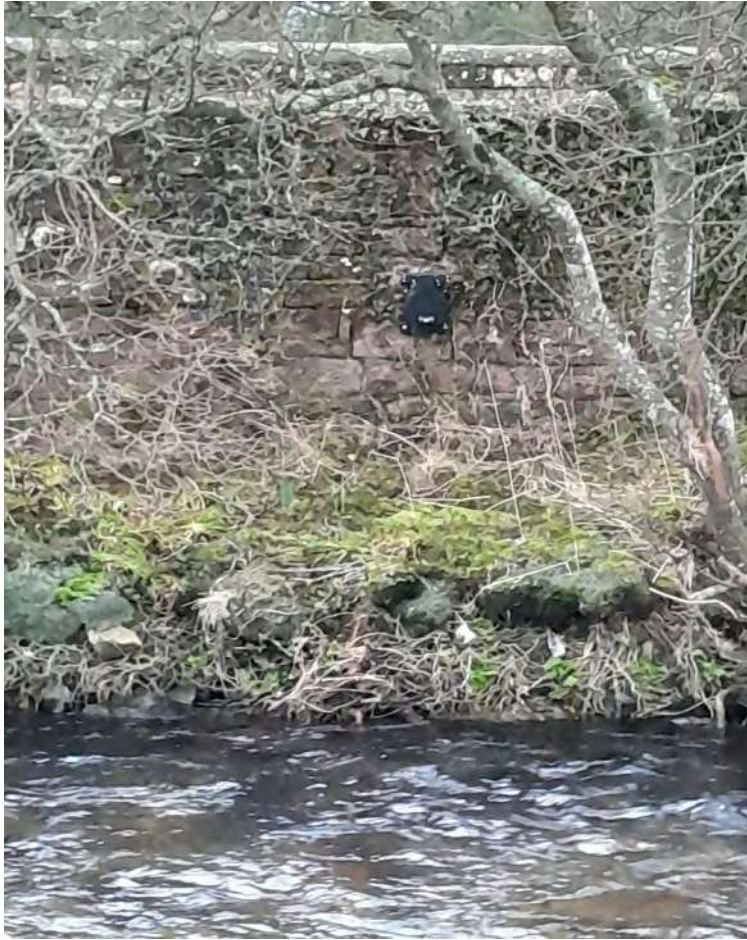
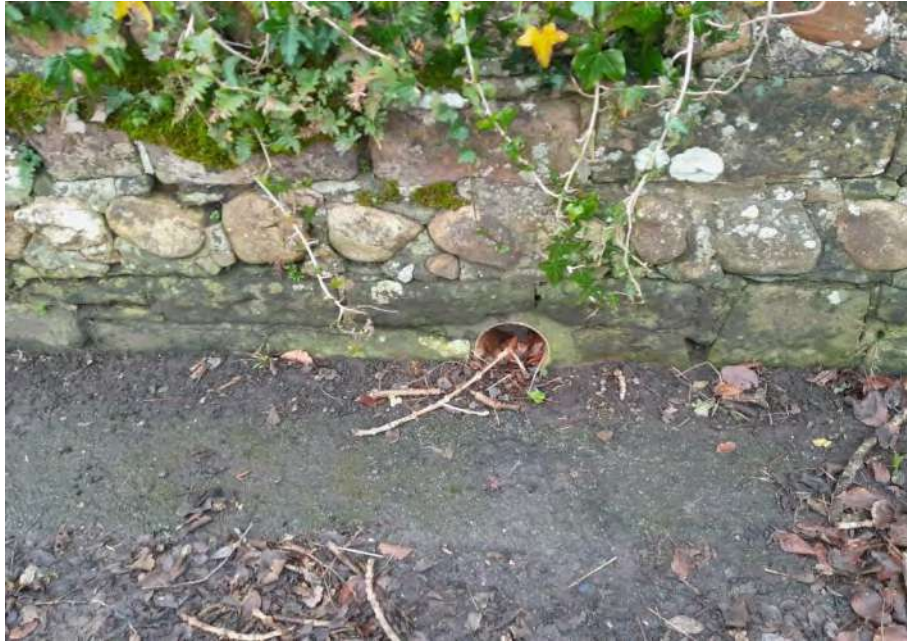
| Asset ID | CL11 | Frequency | | | | | |
|---|---|---|---|---|---|---|---|
| Comments | Ivy growth around frame and headwall. No corrosion to flap valve. Minor cracks and vegetation growth on headwall. Pipe has vegetation debris but no blockages or damage. | | | | | | |

| Asset ID | CL11 | Frequency | | | | | |
|---|---|---|---|---|---|---|---|
| Recommendations | Remove vegetation and continue with vegetation maintenance. | | | | | | |

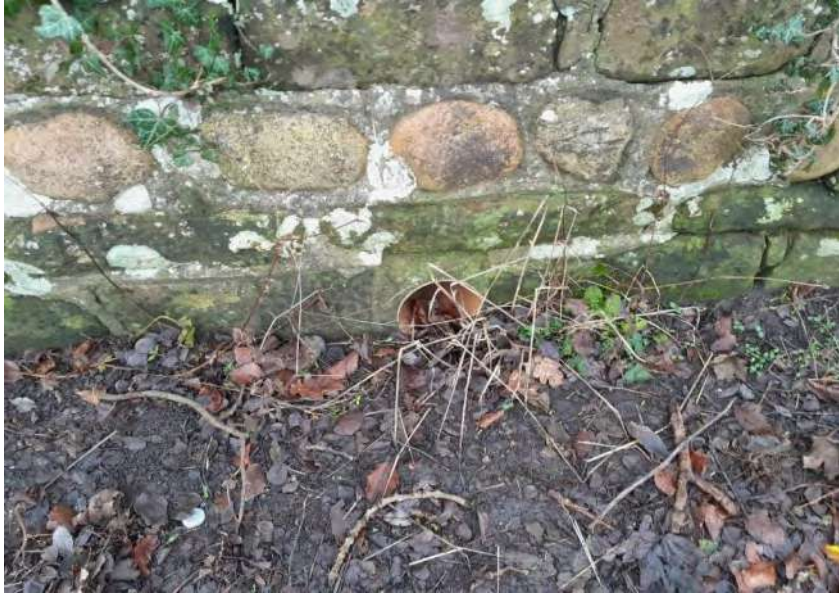
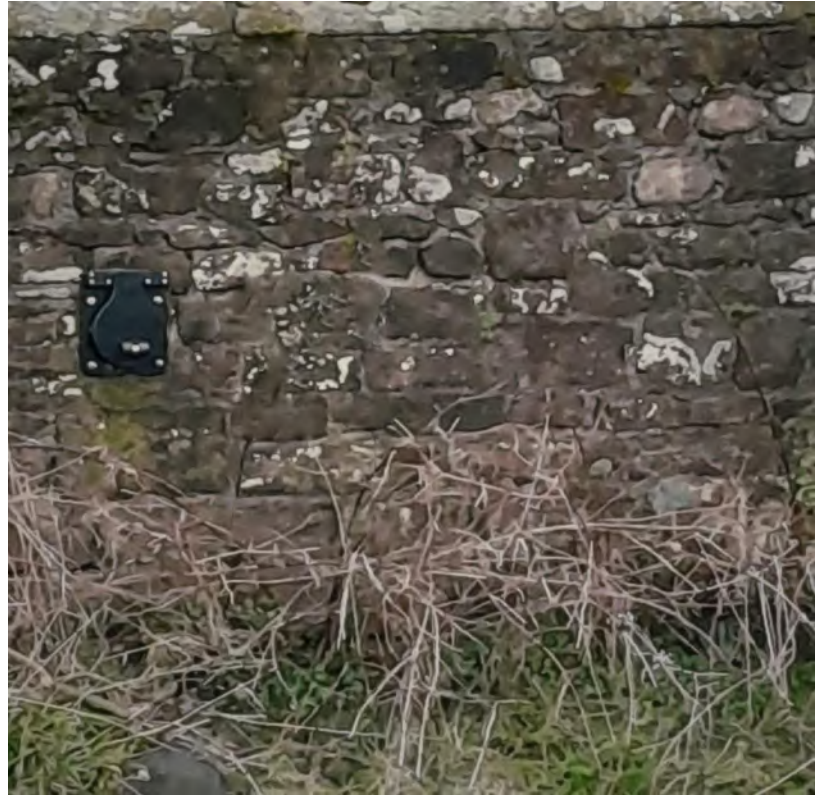
| <b>Comments</b> | No corrosion to flap valve or frame. Minor cracks, mortar loss and minor vegetation growth on headwall. Pipe has minor leaf debris but no blockages or damage. | | | | | | |

| <b>Recommendations</b> | Remove vegetation and continue with vegetation maintenance. | | | | | | |

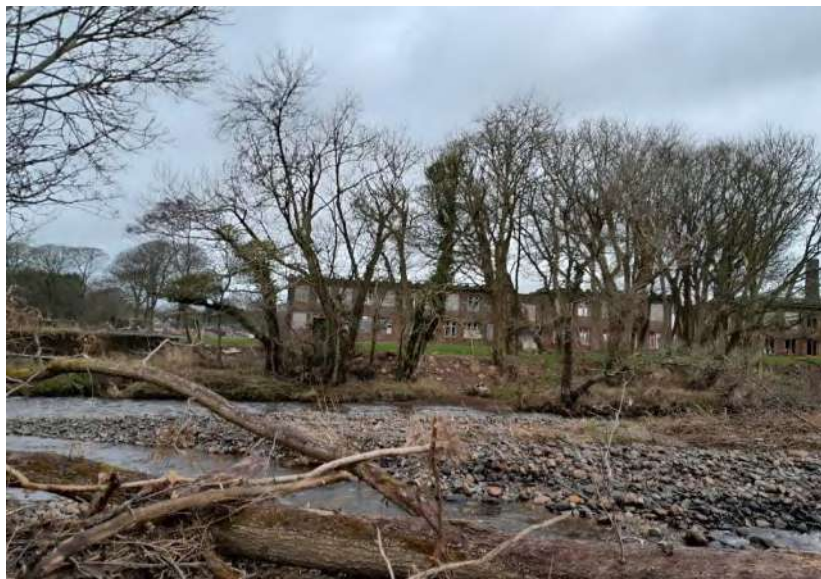
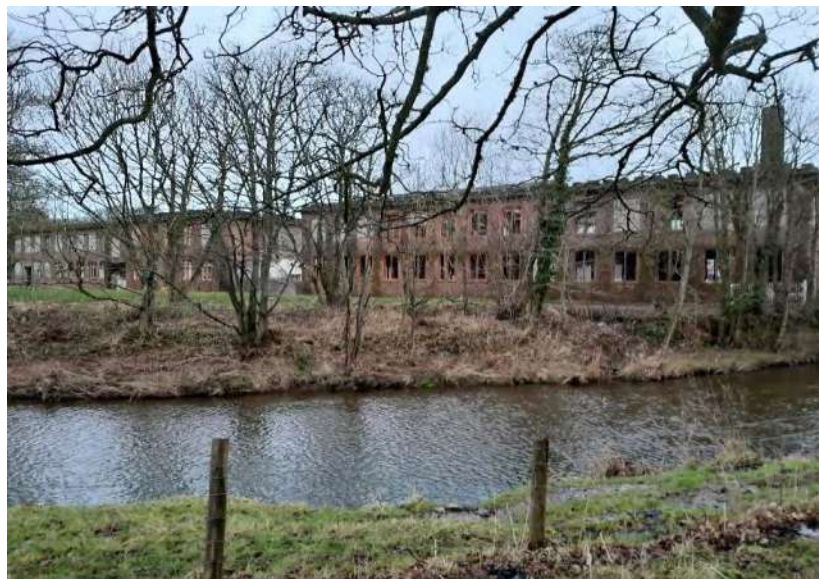
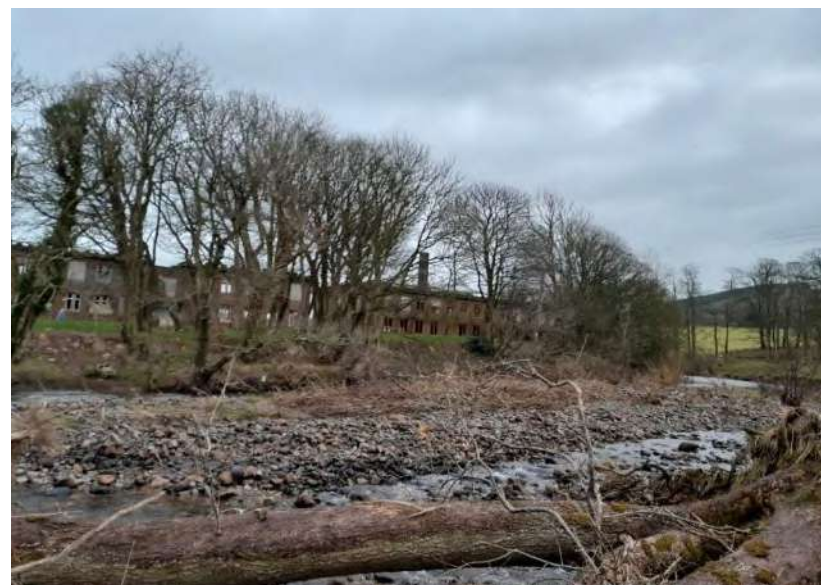
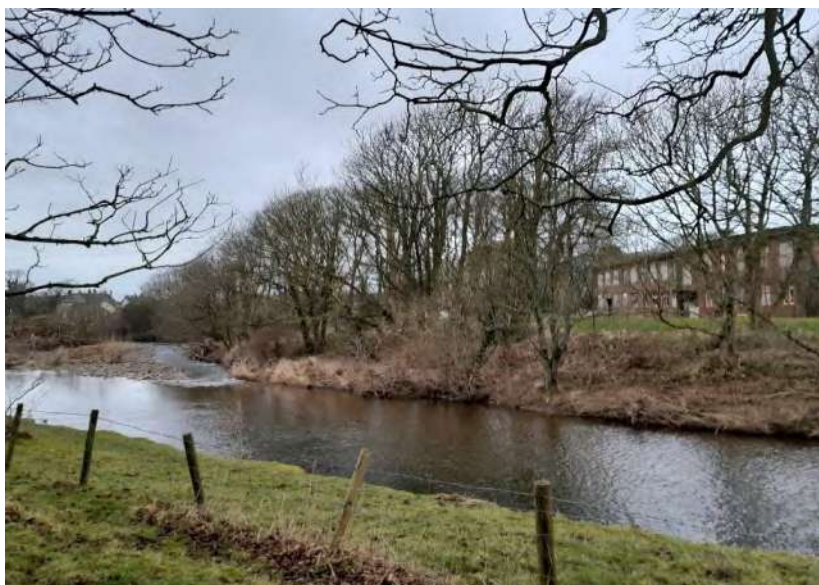
| <b>Comments</b> | Significant undermining, erosion and presence of light foreign objects on channel side. High ground in good condition. | | | | | | | |

| <b>Recommendations</b> | Monitor erosion, consider installing erosion protection layer to channel side. | | | | | | | |

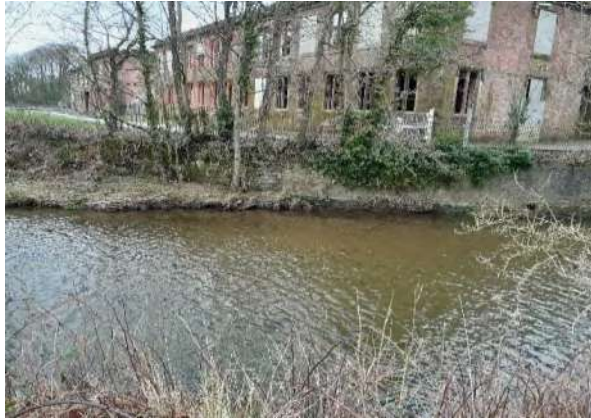
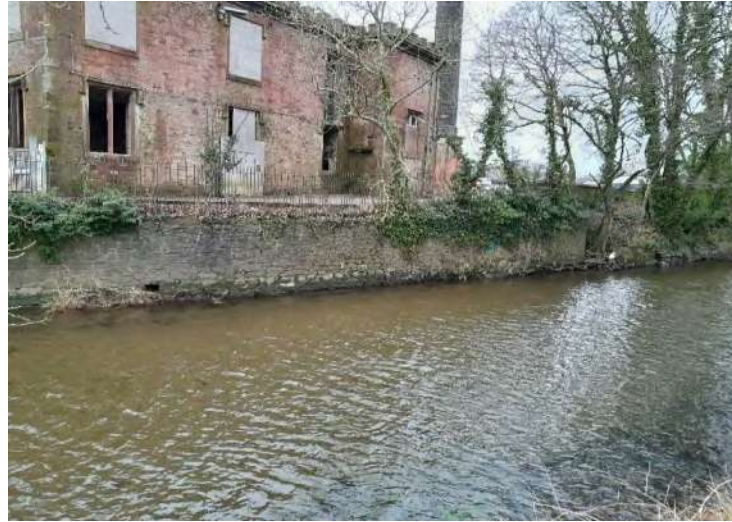
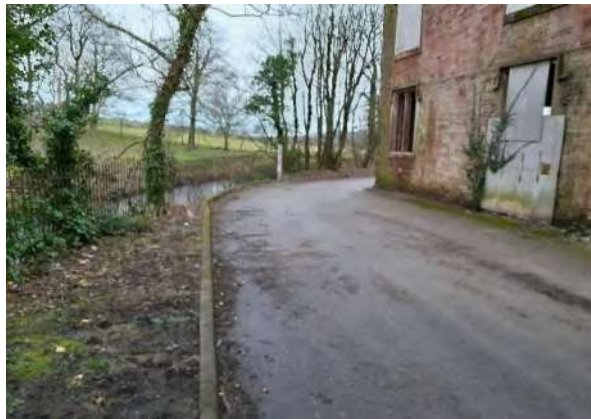
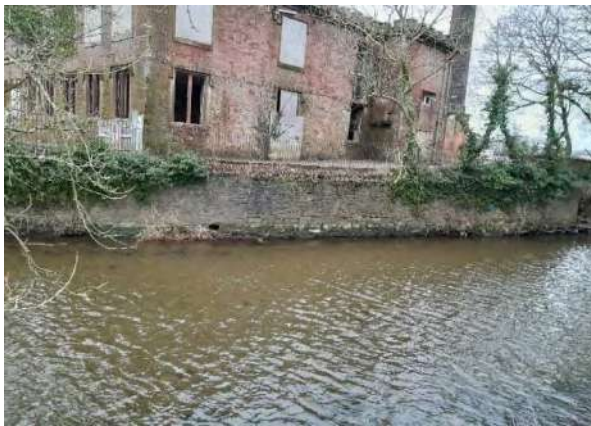
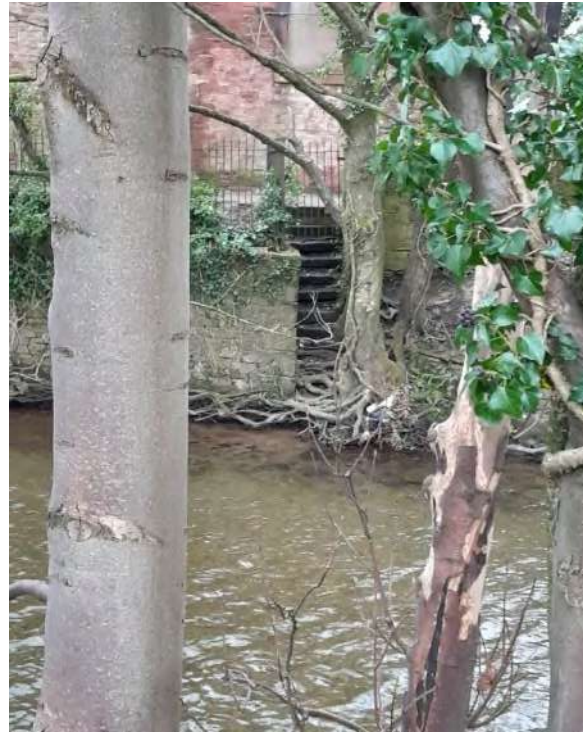
| Asset ID | CL14 | Frequency | | | | | |
|---|---|---|---|---|---|---|---|
| Comments | Light foreign objects and ivy growing in front of and on top of channel side wall. High ground is road in good condition. Heavy foreign object upstream with roots growing into channel side brickwork. | | | | | | |

| Asset ID | CL14 | Frequency | | | | | |
|---|---|---|---|---|---|---|---|
| Recommendations | Remove trees on top of and in front of channel side brickwork. Remove ivy. | | | | | | |
