## **FLOOD RISK AND DRAINAGE ASSESSMENT**

### **Cleator Mill, Proposed Residential Development, Flood Risk Assessment.**

# Cleator Flood Asset Condition Assessment

23 MAR 2022  
Version 1.0  
RAB: 2869

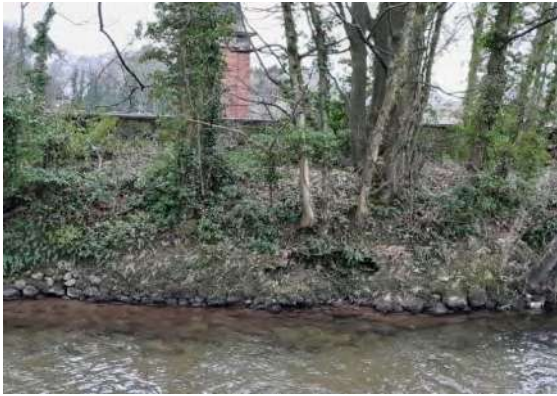
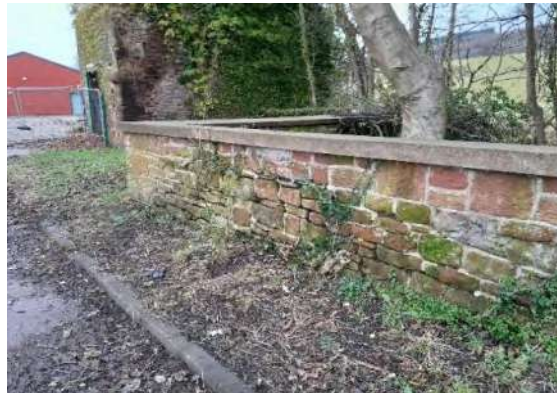
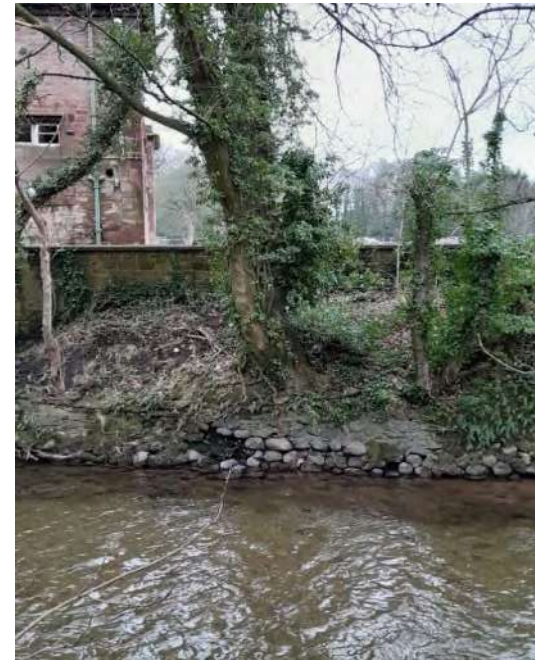
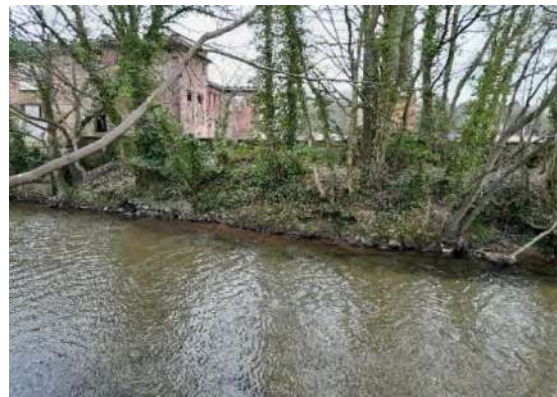
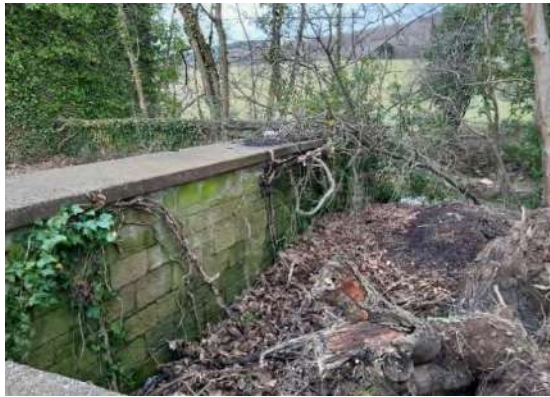
| Asset ID | CL15 | Frequency | | | | | |
|---|---|---|---|---|---|---|---|
| Comments | Several heavy foreign objects on berm and channel side. Severe mortar loss in landward face, exposed face difficult to inspect but wall covered in ivy and some tree roots and growing through it. Crest is uneven where ivy has grown around it. | | | | | | |

| Asset ID | CL15 | Frequency | | | | | |
|---|---|---|---|---|---|---|---|
| Recommendations | Rebuild wall, remove ivy and remove trees growing into wall. | | | | | | |

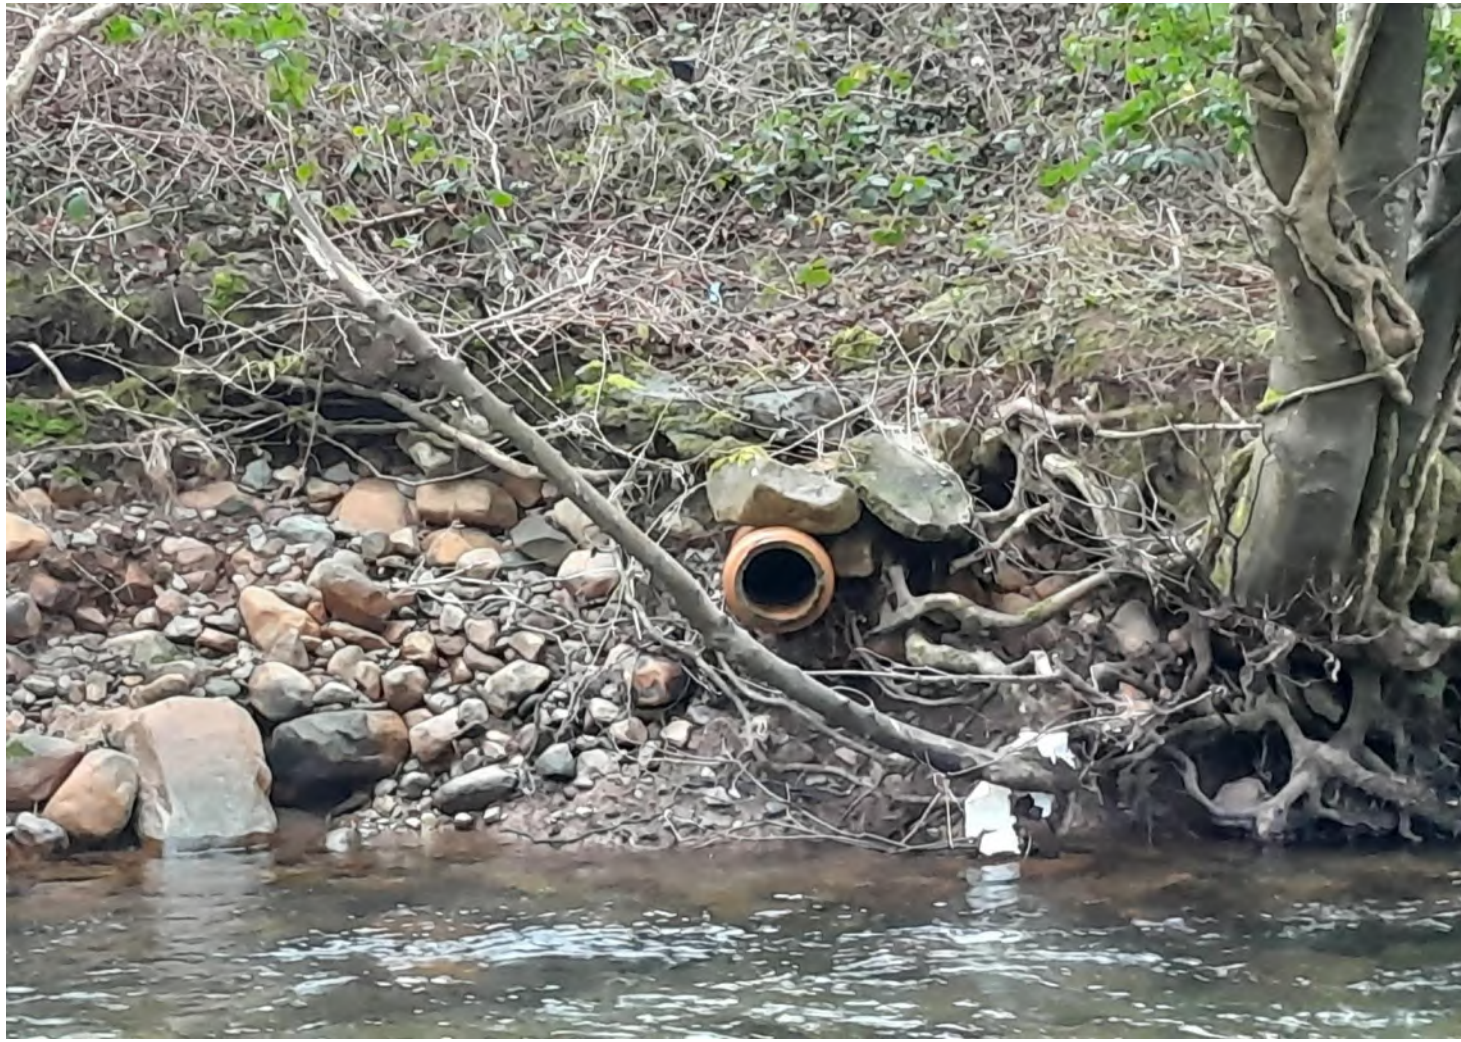
| Asset ID | CL20 | Frequency | | | | | |
|---|---|---|---|---|---|---|---|
| Comments | Downstream headwall in pieces. Unable to see through pipe and no CCTV footage available. | | | | | | |

| Asset ID | CL20 | Frequency | | | | | |
|---|---|---|---|---|---|---|---|
| Recommendations | Rebuild headwall and conduct CCTV inspection of pipe. | | | | | | |
