# Replacement roof works at 47 Duke Street, Whitehaven, CA28 7NU

## Location and site photos of works undertaken at 47 Duke Street,

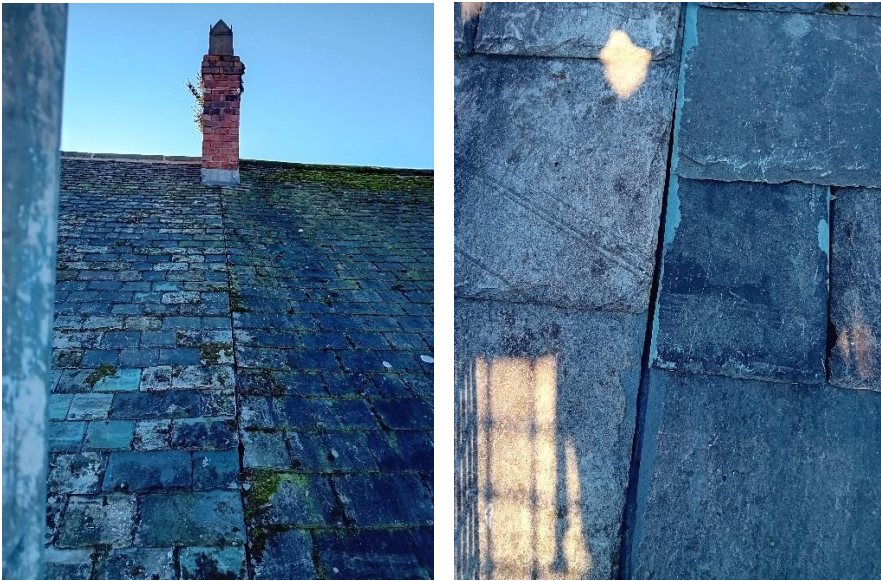
*Site photos 1 and 2 of roof bonding detail that was discovered with neighbouring address to be installed when scaffolding access gave full sight of the roof. This allowed the new replacement roof to finish to the existing roof bond.*

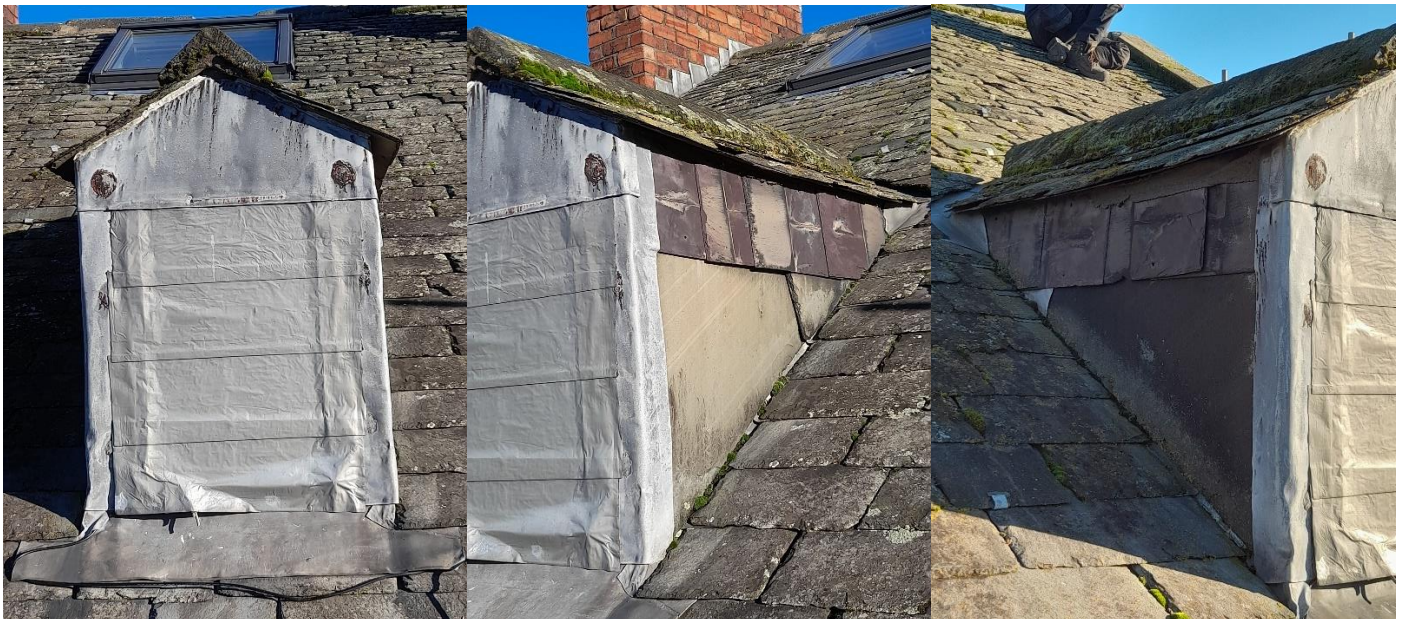
*Site photos 3, 4 and 5 External view of the dormer detail that was agreed to be removed due to it not serving any purpose other than been a source of water penetration from time to time.*

The roof was earmarked for replacement as part of Riversides programmed works for 2023/24. A prestart visit and discussion was undertaken in advance of works starting with Samuel Woodford the conservation officer for this area with the property been located in Whithaven`s conservation zone. There was agreement that the roof could be replaced in a like for like manner with the same materials been used for the replacement work i.e. matched slate, traditional methods of installation etc. The only change to the roof been the removal of the front dormer detail that was serving no purpose internally to the property as it was wrapped in flash banding from historical repairs therefore no internal light was been gained into the loft area. The loft area is not used for any purpose other than that of a normal loft space in that there is a water tank, pipework and cables but no domestic walls, flooring etc. The reasoning for the removal is to leave the roof without a detail that could potentially leak, was serving no use to the property and with the replacement of the roof covering the opportunity was gained to remove the detail and leave the the roof in a better condition with less future risk of water ingress for many years to come. Visually the impact on the property is little different as the dormer detail could only been seen when far across the road and in its state was not of an attractive apperance therefore the removal of this detail improves the overall appearance of the property.

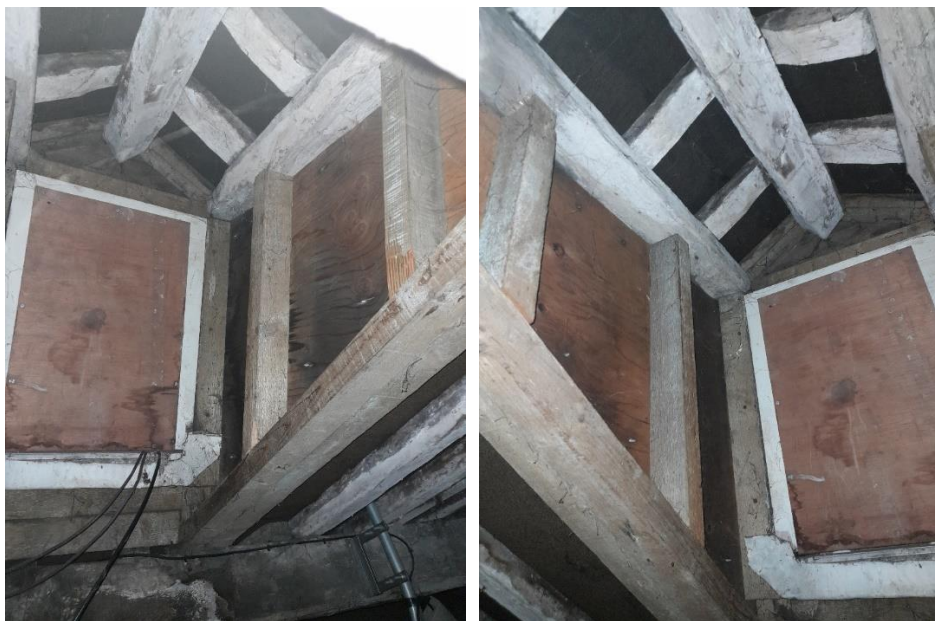
*Site photos 6 and 7 of internal view of dormer detail on the original roof.*

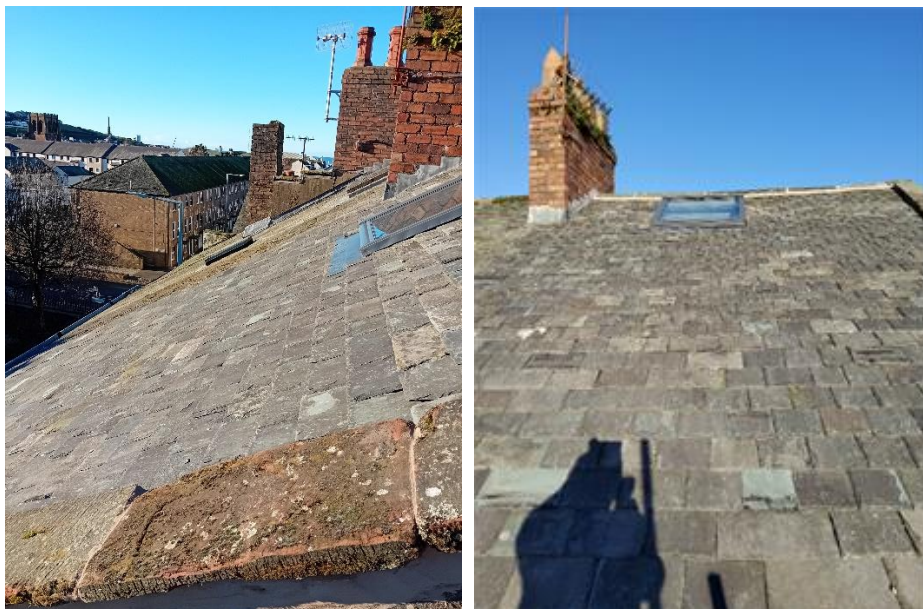
*Site photos 8 and 9 of new replacement roof with dormer removed.*
