## Demolition Survey (with MA + PA)

Millom School  
Salthouse Road  
Millom  
Cumbria  
LA18 5AB

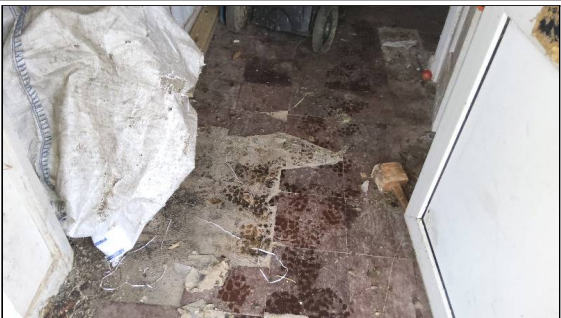
| | Survey Date: | Lead Surveyor | Survey Type | Floor | Analysis |
|---|---|---|---|---|---|
| | CL002526 (S) | Reinforced Composite (1) | Completely Sealed (0) | High Damage (3) | Routinely disturbed (3) |

| Normal Occupancy | Score | Likelihood of disturbance | Score | Exposure Potential | Score | Maintenance Activity | Score |
|---|---|---|---|---|---|---|---|
| Surveyor comments | Found in poor condition the asbestos containing material should be removed under semi-controlled conditions by trained operatives and waste disposed of at a registered site. | | | | | | |

| Normal Occupancy | Score | Likelihood of disturbance | Score | Exposure Potential | Score | Maintenance Activity | Score |
|---|---|---|---|---|---|---|---|
| Recommendation | A - Urgent Removal | | | | | | |

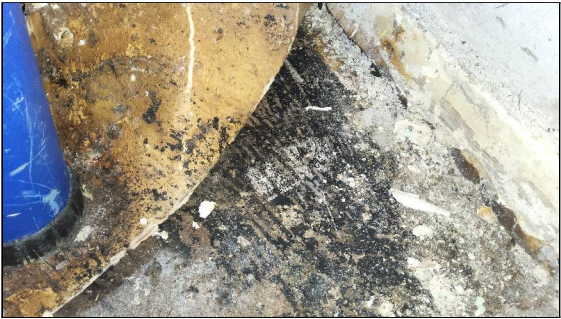
| | Survey Date: | Lead Surveyor | Survey Type | Floor | Analysis |
|---|---|---|---|---|---|
| | CL002528 (S) | Reinforced Composite (1) | Completely Sealed (0) | Low Damage (1) | Occasionally likely to be disturbed (1) |

| Normal Occupancy | Score | Likelihood of disturbance | Score | Exposure Potential | Score | Maintenance Activity | Score |
|---|---|---|---|---|---|---|---|
| Surveyor comments | If any planned maintenance/refurbishment works would disturb the asbestos containing material, it should be removed under semi controlled conditions by registered contractors and the hazardous waste disposed of at a registered site. | | | | | | |

| Normal Occupancy | Score | Likelihood of disturbance | Score | Exposure Potential | Score | Maintenance Activity | Score |
|---|---|---|---|---|---|---|---|
| Recommendation | D - No Attention Required, Label | | | | | | |
