## FLOOD RISK AND DRAINAGE ASSESSMENT

**Cleator Mill,  
Proposed Residential Development,  
Flood Risk Assessment.**

RO/FRA/RES/19002.1

# Cleator Flood Asset Condition Assessment

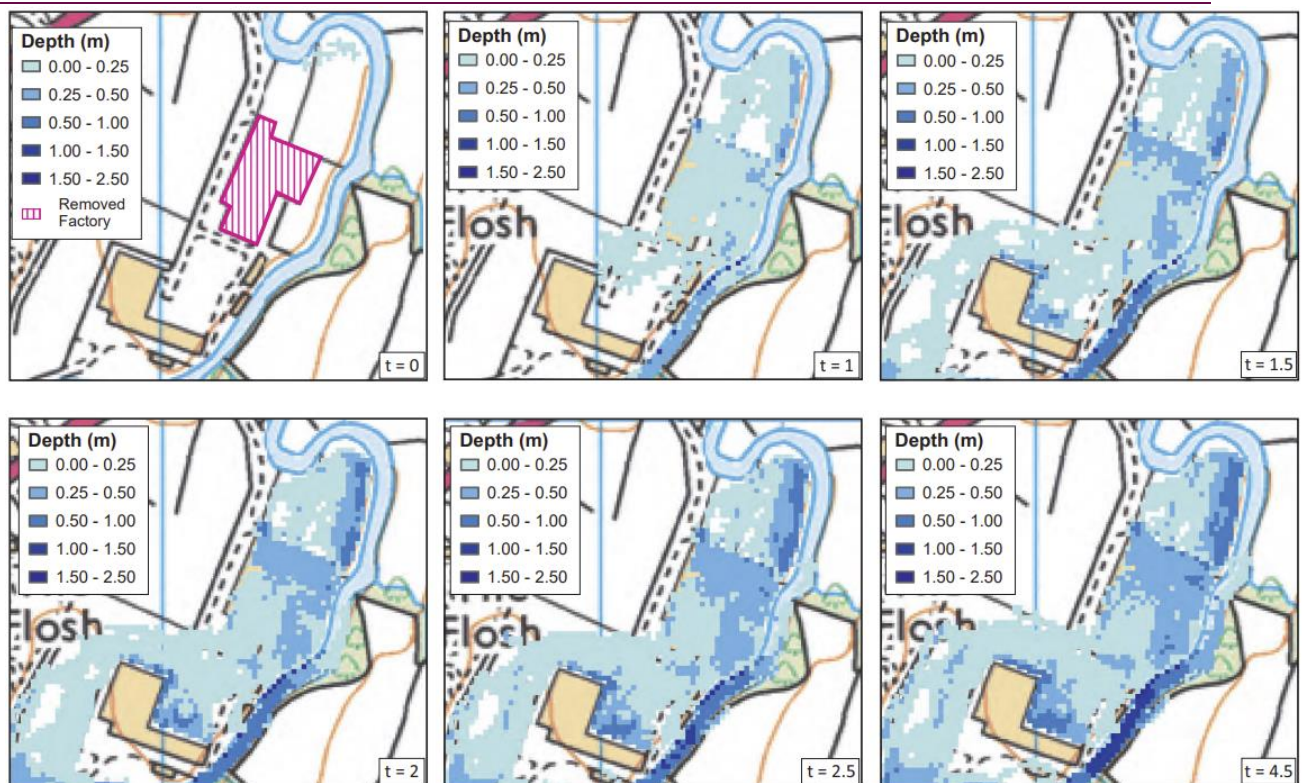
Figure 5 – Extract from Envireau Water of Breach 1

A breach in the gabion baskets north of the site has been considered for the 1:100 year plus climate change return period. The approximate location of the breach event is indicated in Figure 4. It should be noted

As this breach location does not impact the land within our clients ownerships a hazard rating has not been considered.

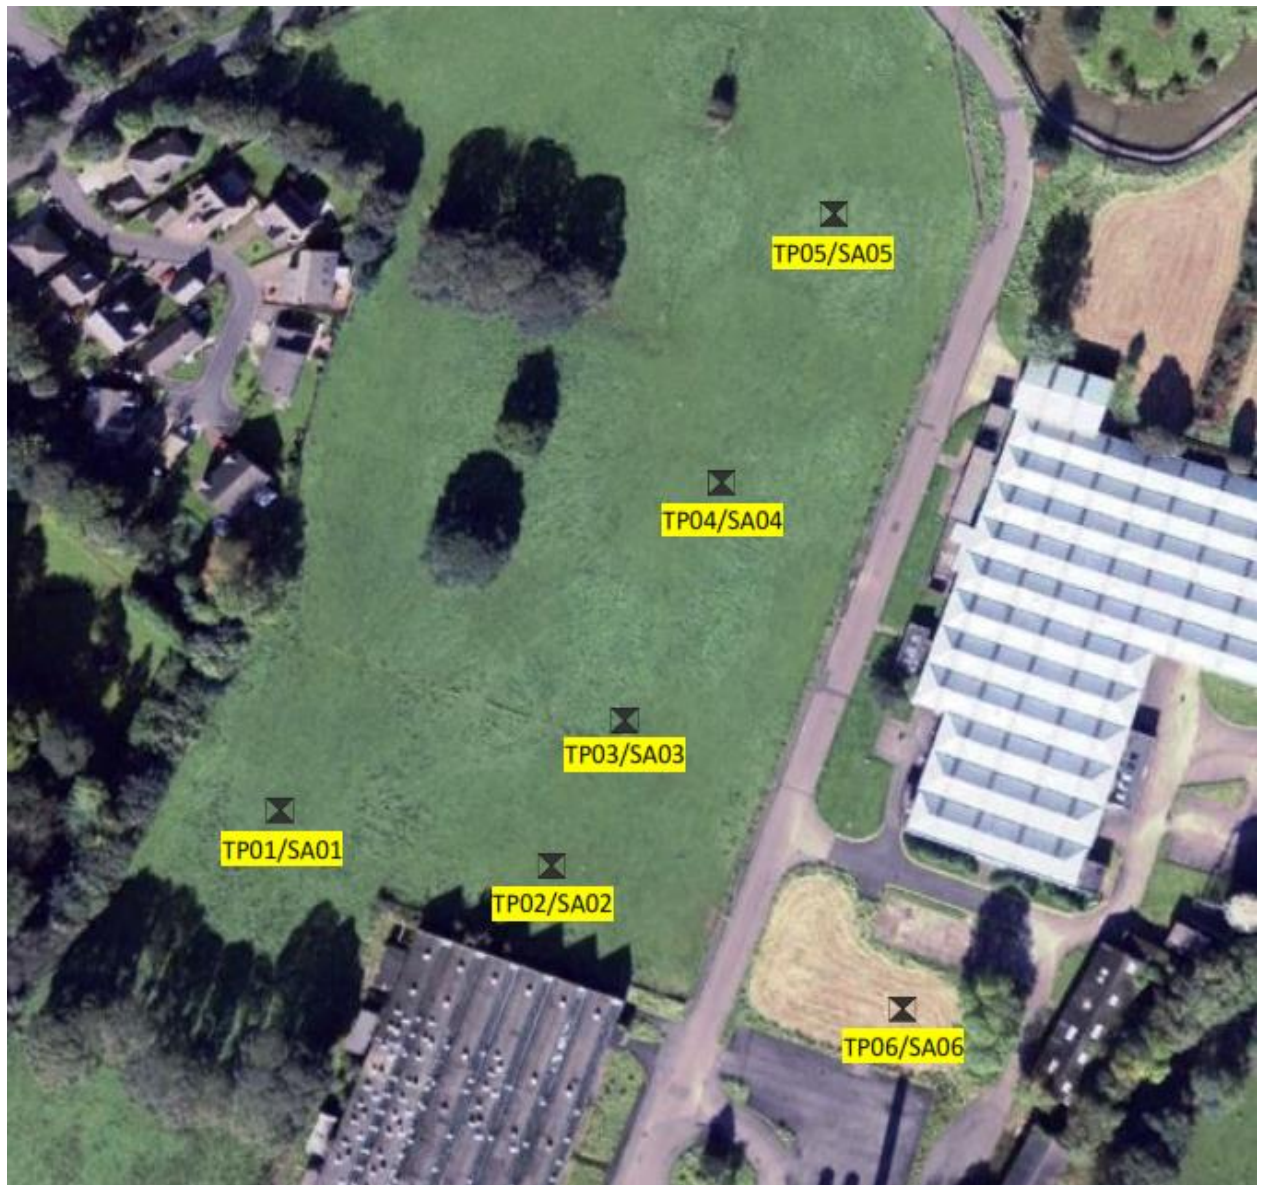
**Figure 2 – Soil Infiltration Test Locations**

SA01 recorded Topsoil from 0.00 – 0.40m with Sand & Gravel recorded from 0.40 – 2.00m, soil infiltration test results for this location have been calculated as  $6.04665^{\text{m/s}}$ .

SA02 recorded Topsoil from 0.00 – 0.30m, Sand from 0.30 – 0.70m and 0.70 – 2.00m Sand & Gravel, soil infiltration test results for this location have been calculated as  $4.97347^{\text{m/s}}$ .

SA03 recorded Topsoil from 0.00 – 0.20m with Sand recorded from 0.20 – 0.80m and Sand & Gravel from 0.80 – 2.00m, soil infiltration test results for this location have been calculated as  $2.39464^{\text{m/s}}$ .

SA04 recorded Topsoil from 0.00 – 0.30m with Sand & Gravel recorded from 0.30 – 1.50m, soil infiltration test results for this location have been calculated as  $2.27591^{\text{m/s}}$ .

SA05 recorded Topsoil from 0.00 – 0.35m with Sand recorded from 0.35 – 0.60m and Sand & Gravel from 0.60 – 2.00m, soil infiltration test results for this location have been calculated as 2.24551<sup>-5</sup> m/s.

SA06 recorded Topsoil from 0.00 – 0.50m with Sand & Gravel recorded from 0.50 – 0.90m and Sand & Gravel from 0.90 – 1.50m, soil infiltration test results for this location have been calculated as 4.22297<sup>-5</sup> m/s.

All of the recorded soil infiltration rates are well within the acceptable rates and as such the site will be suitable to utilise infiltration. Based upon this in accordance with Building Regulations and the CIRIA SuDS train, surface water should discharge into suitably designed soil infiltration drainage systems.

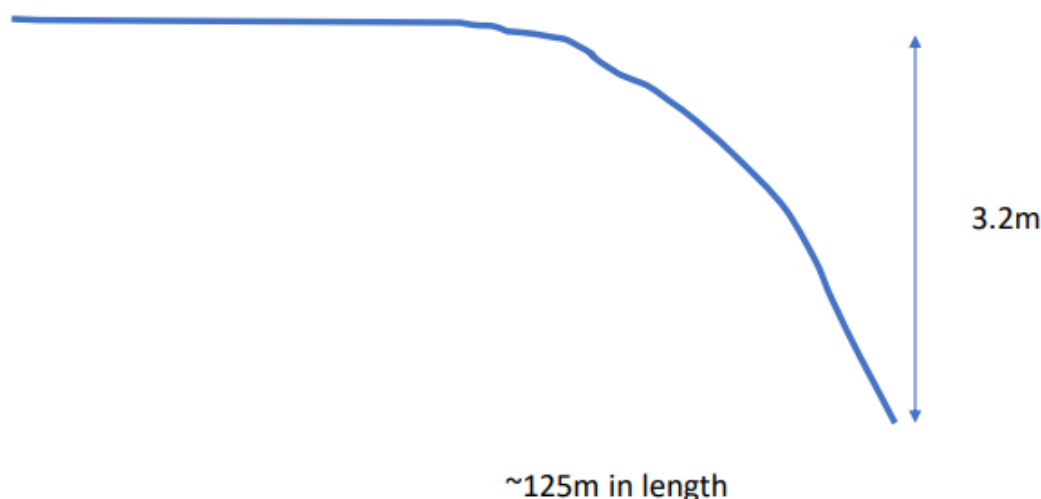
## CL13 – Natural High Ground

Stretch of natural high ground with vegetation and trees.

Significant undermining, erosion, and presence of light foreign objects on channel side. High ground in good condition.

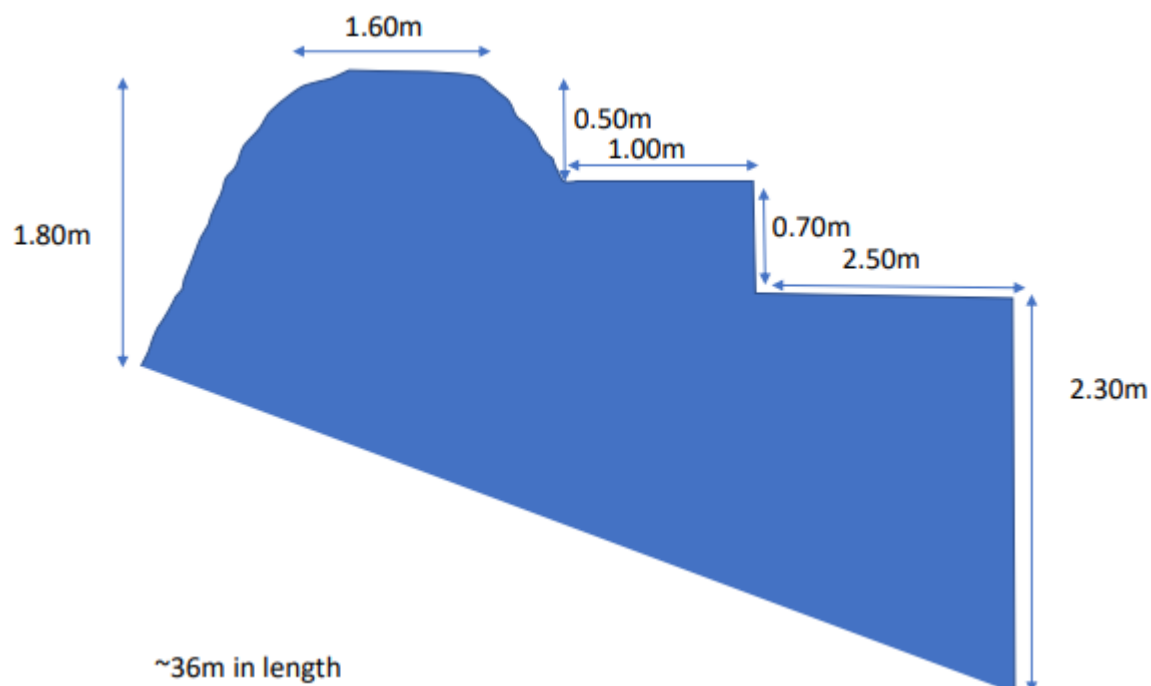
## CL21 – Embankment

Earth embankment with gabion basket and sheet piling exposed faces and concrete berm.

Berm 2 and channel side in good condition with minor cosmetic defects to sheet piles. Vegetation growth through gabion baskets with a few broken wires but no gabion displacement. Uneven ground on exposed face 1 and landward face but well vegetated. Rutting and low spots in isolated places on crest. Variants used on crest as less than 4m wide and landward face due to steepness.

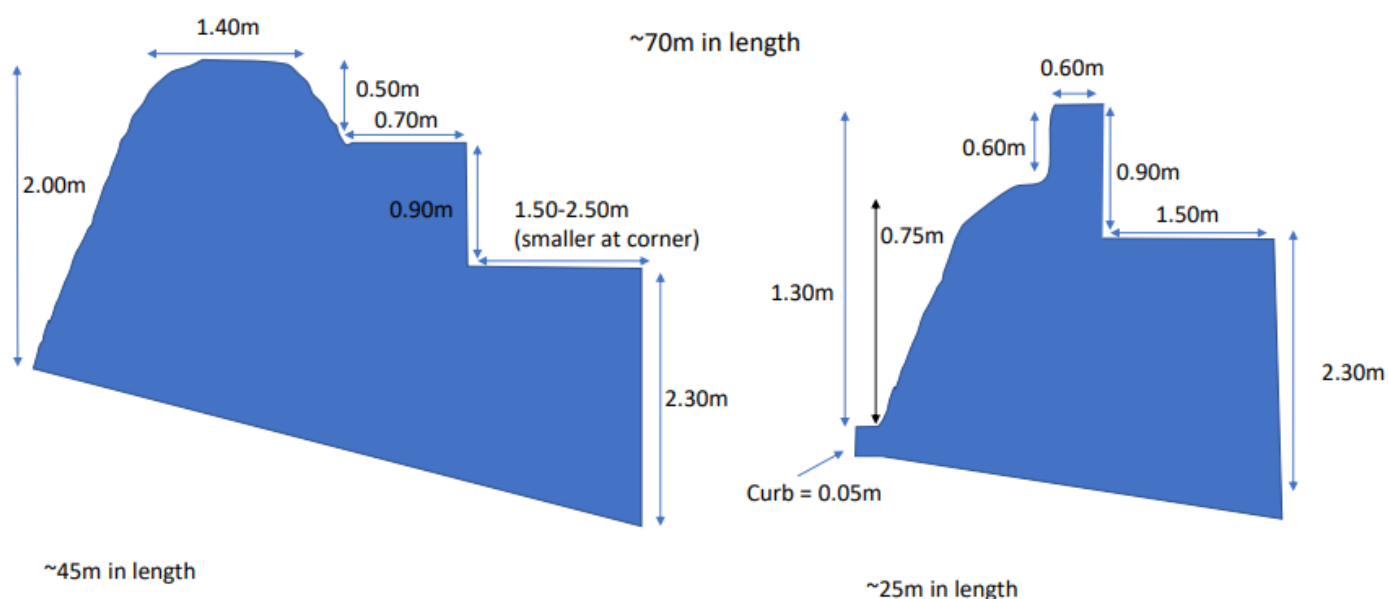
## CL22 – Embankment

Earth embankment with stone wall and sheet piling exposed faces and concrete berm. Crest height and embankment width reduce as earth landward face diminishes and crest changes to stone crest.

Minor vegetation growth within berm 1 and exposed face 2 with minor mortar loss. Uneven crest with some low spots but well vegetated. Berm 2 and channel side in good condition with minor cosmetic defects to sheet piling. Landward face and exposed face 1 are well vegetated but uneven. Landward face 2 around corner and has minor vegetation growing through stone and minor mortar loss.

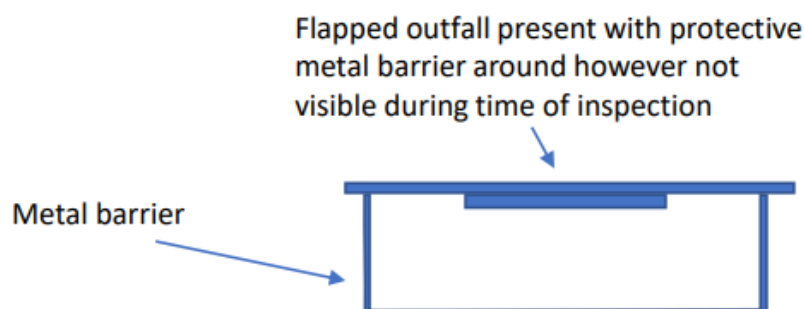
## CL23 – Outfall

Flapped outfall with unknown diameter located behind metal barrier which obstructs view of outfall.

Minor corrosion to barrier. Unable to see headwall and pipe due to high water level and barrier around.

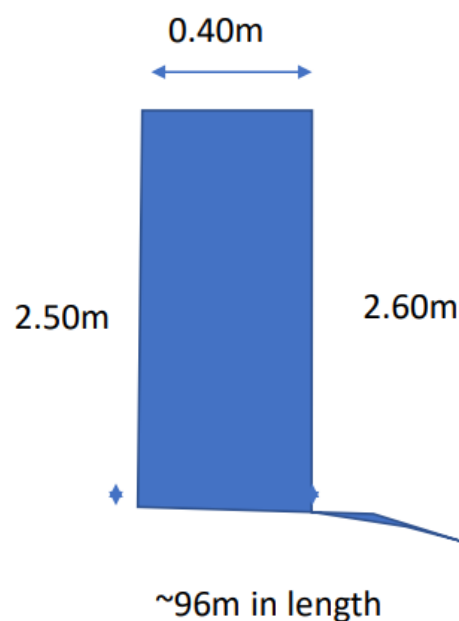
## CL24 – Wall

High stone wall with capping stones located off right bank and going away from main channel towards village.

Minor vegetation growth through crest. Minor mortar loss on exposed face and a couple of holes on both faces, not whole way though. Few bricks missing for drainage

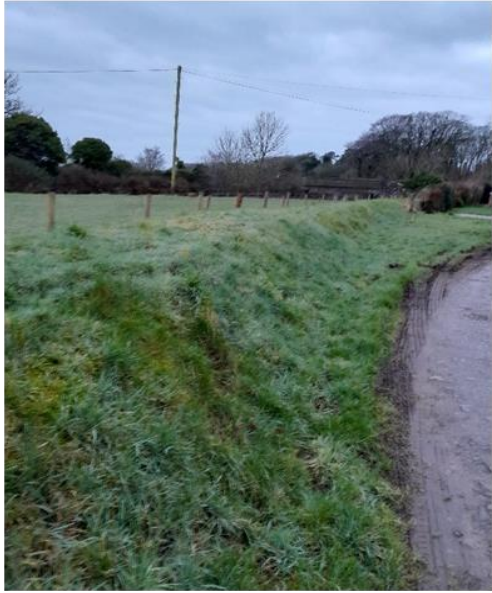
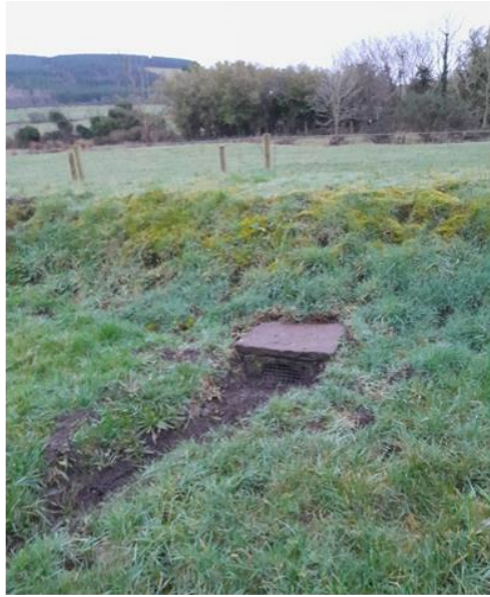
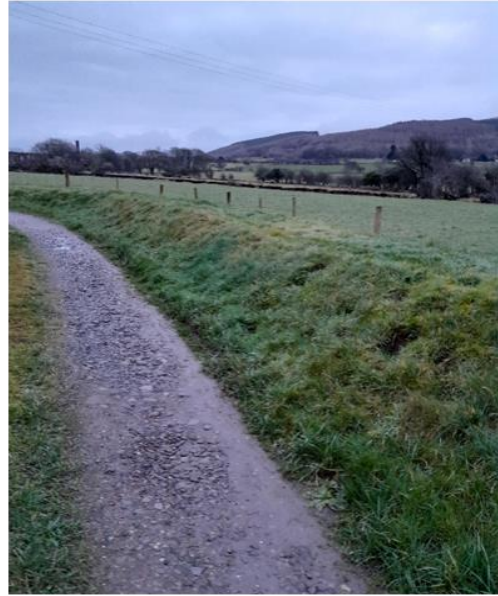
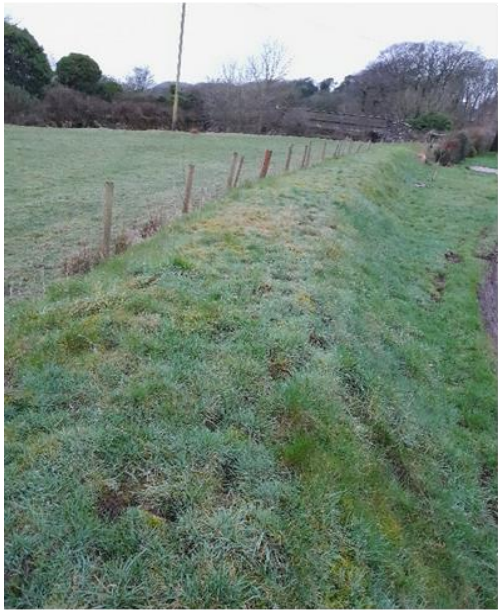
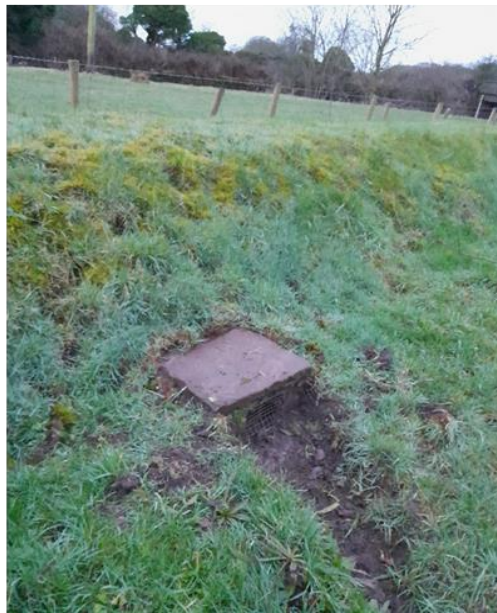
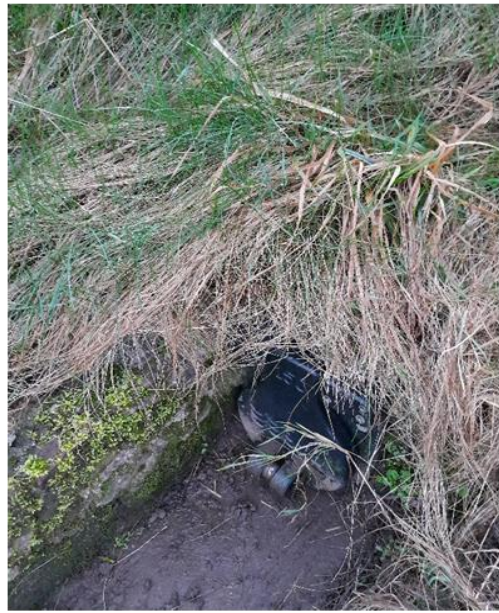
| <b>Comments</b> | Variant weighting used for crest as <4m wide. Drainage pipe running through entire width of embankment, low spots, some animal holes and rutting on crest, Landward face and exposed face have some holes and uneven slopes but are well vegetated. Undermining, minor erosion and light foreign objects present on channel side but currently stable. | | | | | | |

| <b>Recommendations</b> | Infill low spots on crest, remove drainage pipe from embankment and consider pest control. | | | | | | |

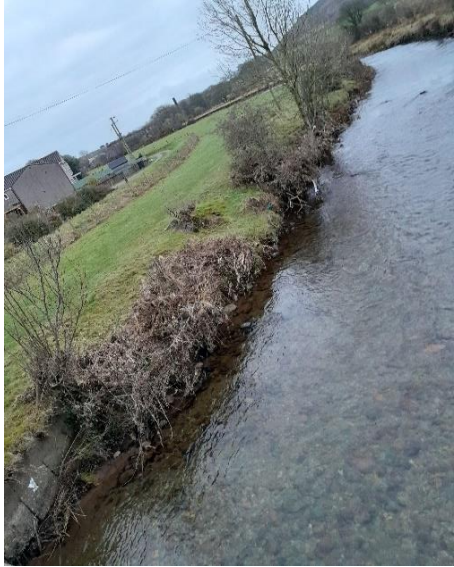
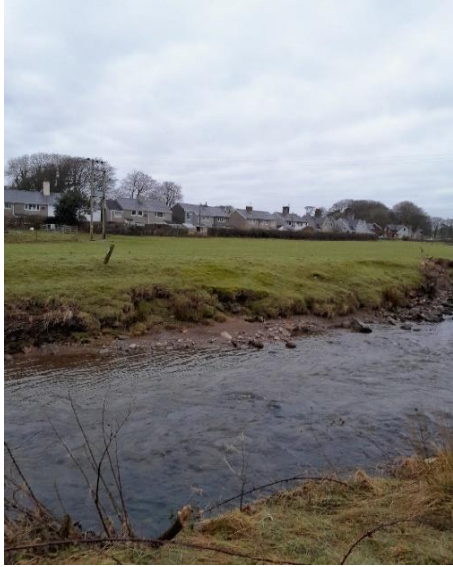
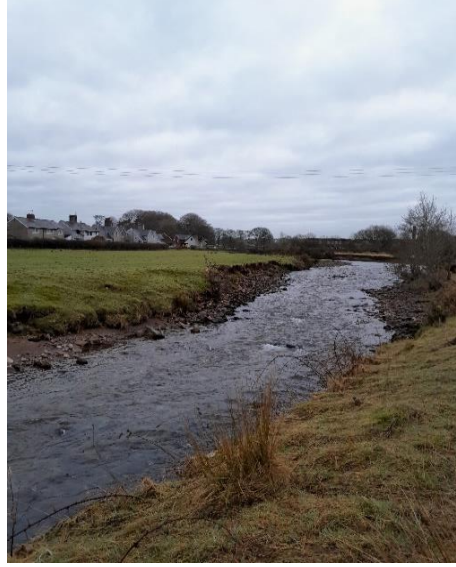
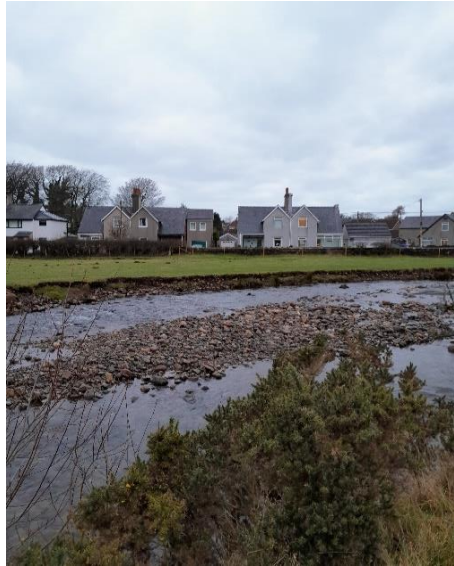
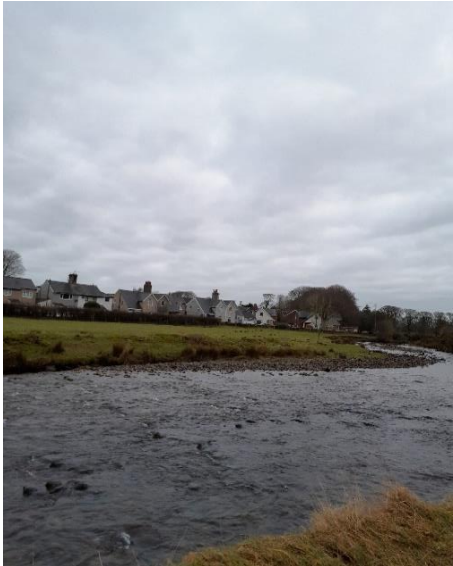
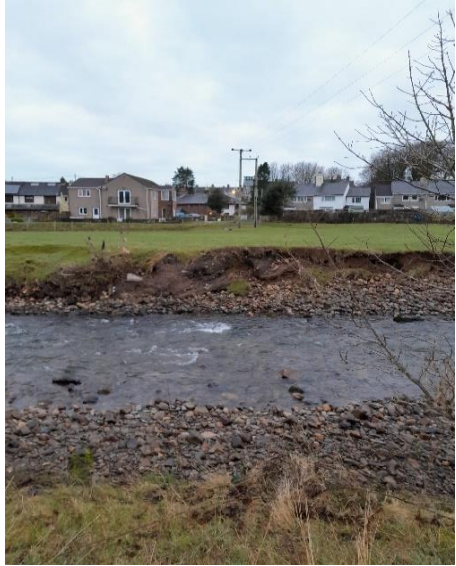
| Asset ID | | Frequency | | | | | |
|---|---|---|---|---|---|---|---|
| Comments | Significant undermining, erosion and presence of light foreign objects on channel side. High ground in good condition. | | | | | | |

| Asset ID | | Frequency | | | | | |
|---|---|---|---|---|---|---|---|
| Recommendations | Monitor erosion, consider installing erosion protection layer to channel side. | | | | | | |

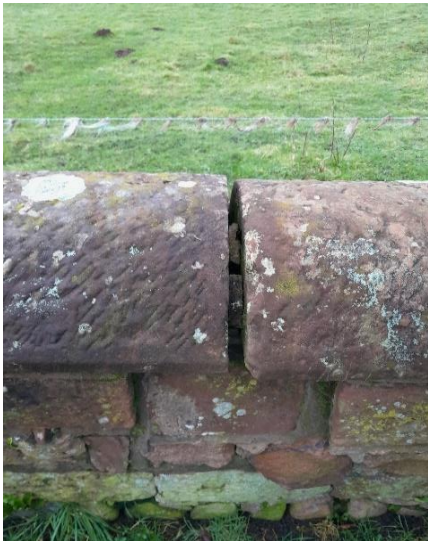
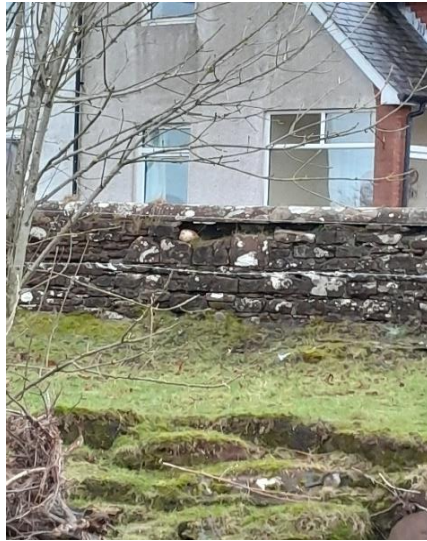
| Asset ID | CL3 | Frequency | | | | | |
|---|---|---|---|---|---|---|---|
| Comments | Variant weightings used for both faces as no revetments. Significant mortar loss to crest, holes through wall, bulging of wall where light foreign objects are growing in front on wall, distorting its shape and minor erosion to channel side. | | | | | | |

| Asset ID | CL3 | Frequency | | | | | |
|---|---|---|---|---|---|---|---|
| Recommendations | Rebuild wall and remove trees in front of wall. | | | | | | |
