## **PHASE 2: SUPPLEMENTARY GROUND INVESTIGATION**

**PROPOSED COMMERCIAL DEVELOPMENT OF LAND**

**ADJACENT TO ST THOMAS CROSS ROUNDABOUT**

**VALE VIEW, EGREMONT, CUMBRIA**

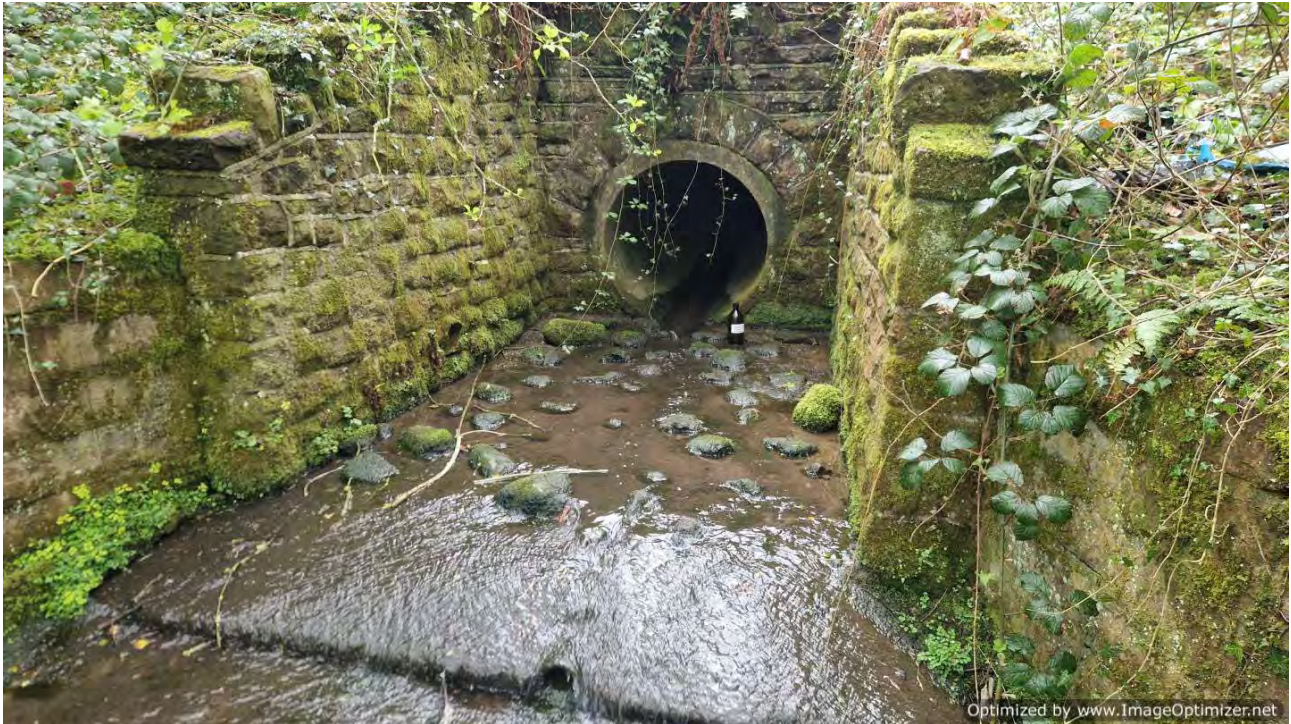
**Northern Watercourse – Upstream Sampling Location at Culvert Exit**

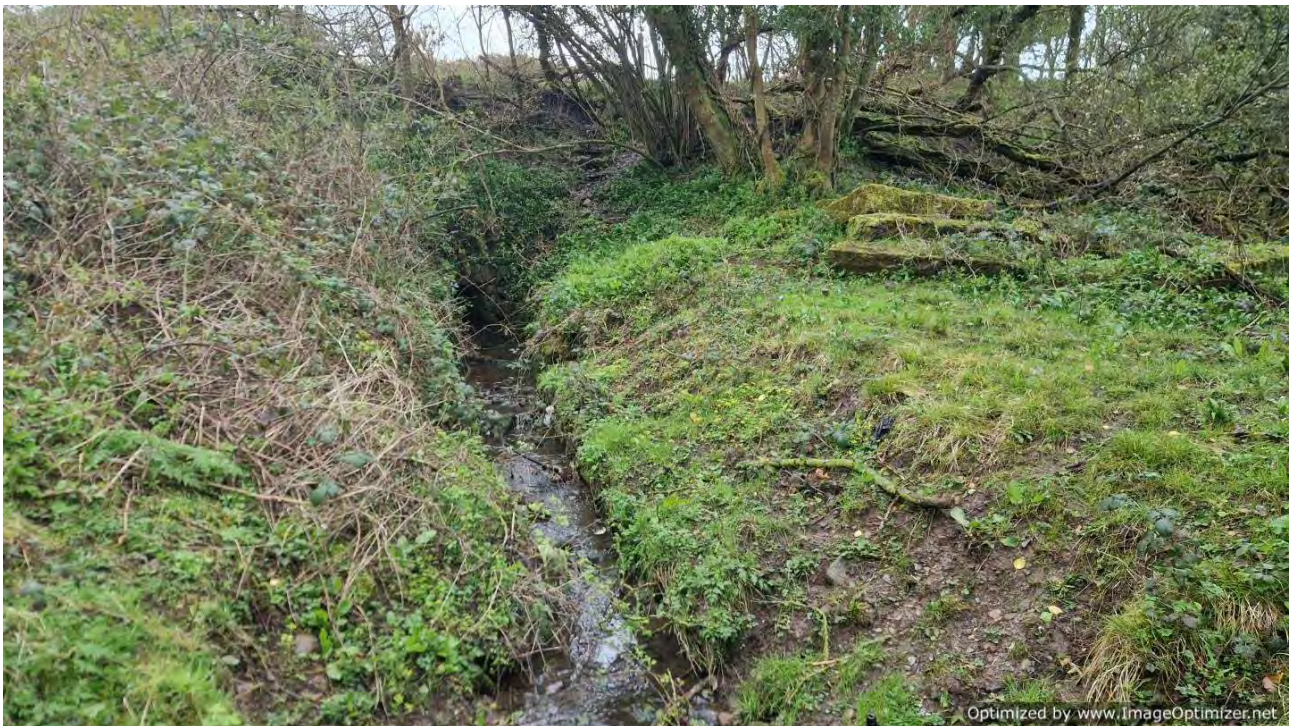
**Northern Watercourse – Downstream Sampling Location at Culvert Entry**

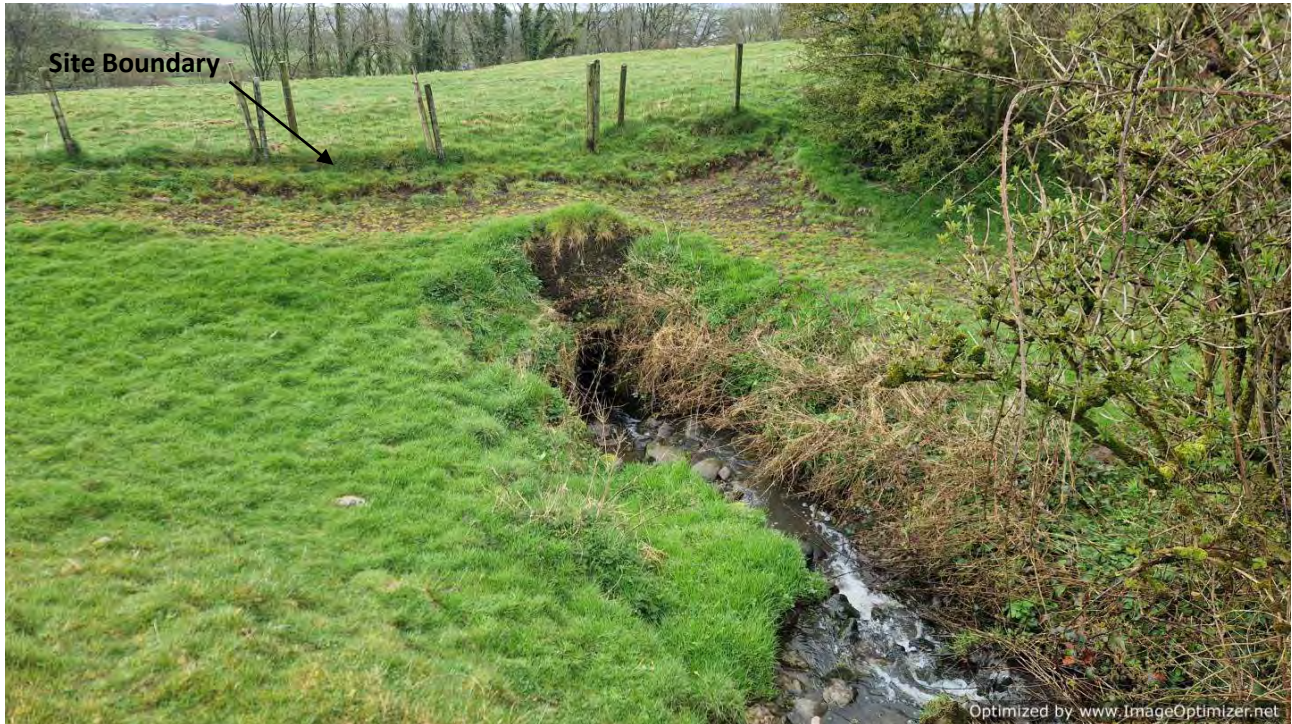
**Southern Watercourse – Upstream Sampling Location at Culvert Entry**

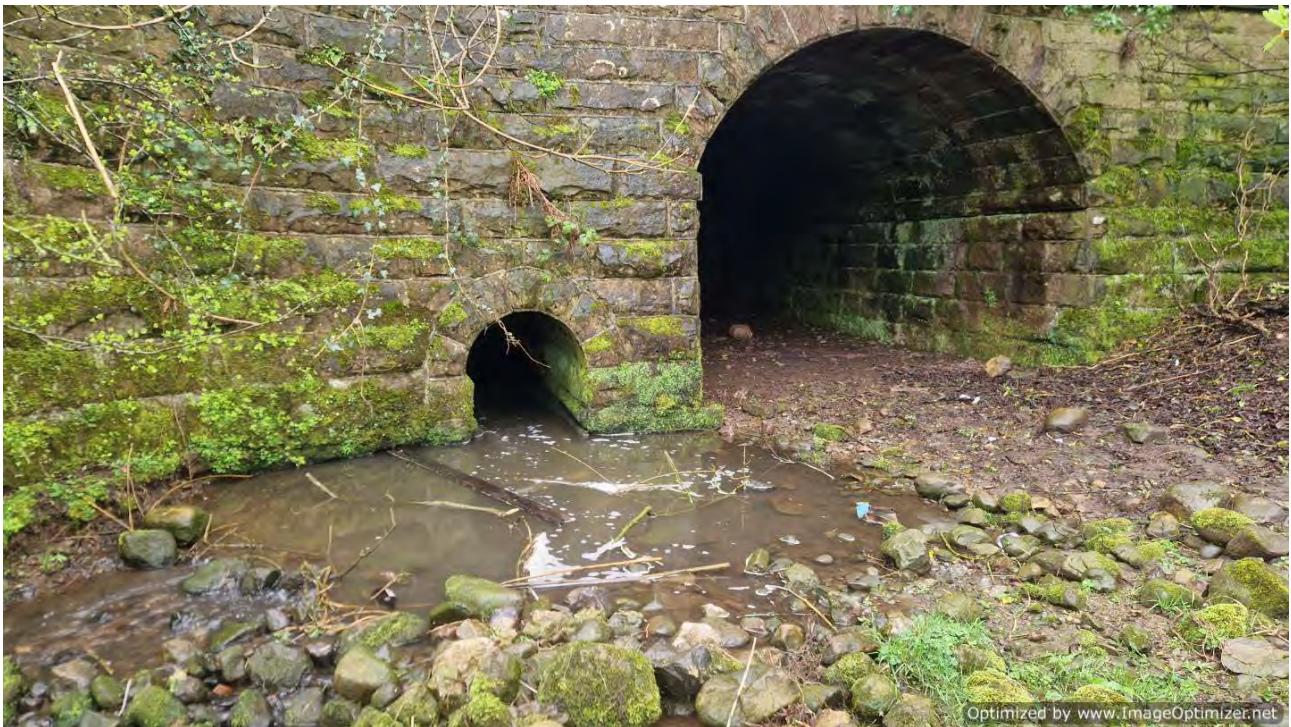
**Northern Watercourse – Downstream Sampling Location at Culvert Exit**
