Our Ref: **J487/D01**

21<sup>st</sup> October 2022

**RE: Bat Inspection Survey, The Walled Garden, Distington Cemetery**

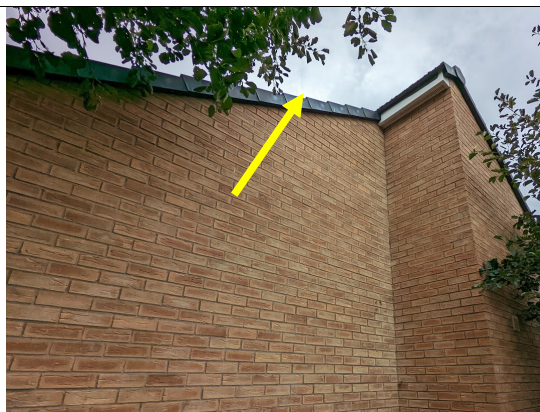
During the external inspection however, droppings were found adhering to the north-eastern wall. On inspection, a gap was visible between the soffit box and the adjacent gable caps. This appears to have allowed access for bats; the crevice was inspected with an endoscope and there was a sizable internal cavity in this location. However, no bats were observed.

Photograph 3: North-eastern elevations, showing roost entry point

- No works must be undertaken to the roof, such as a roof replacement;
- The roof void must not be converted as part of the proposed renovation;
- The gap between the soffit box and the pvc end caps at the rear of the building must not be sealed – this gap must be retained in order to preserve the roost site;

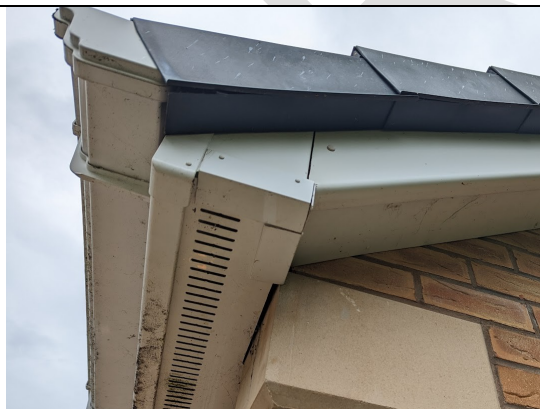
The elevations of the property are brick built, which is all well pointed; this therefore prevents bat access to the walls themselves. The roof is covered with ceramic tiles which have a relatively uniform shape and therefore are tight-fitting and appear to prevent any bat access. No broken or slipped tiles were observed during the inspection. In addition, the ridge tiles appeared to be well sealed with mortar, as well as featuring areas of moss, which is likely to grow between the tiles and block internal access. The gables of the roof are capped with pvc caps, which essentially prevents any access to bats.

Photograph 5: Sealed soffit boxes

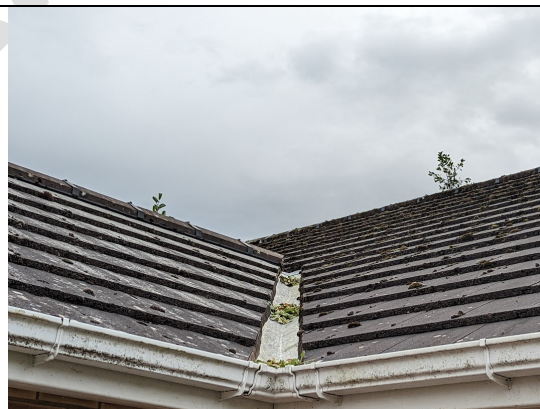
Photograph 6: Tight roof

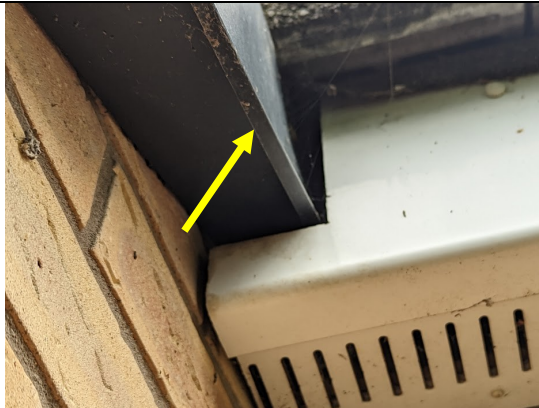
The access point for the roost has been found to be a gap between the plastic soffit and gable caps; droppings were found directly beneath this location. Pipistrelle bats tend to occupy crevices or small cavities within buildings. It is therefore likely that the roost was located along the wall-top or within the cavity of the wall.

Photograph 7: Roost entry point

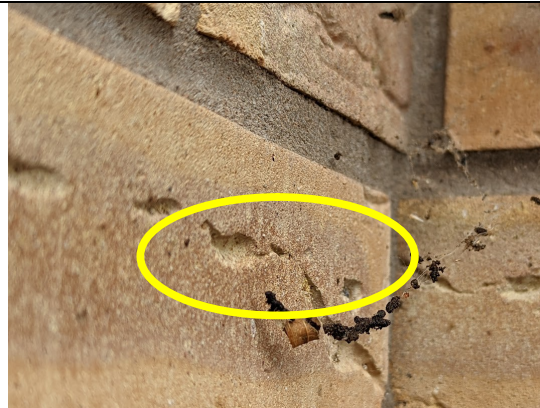
Photograph 8: Droppings beneath roost entry point

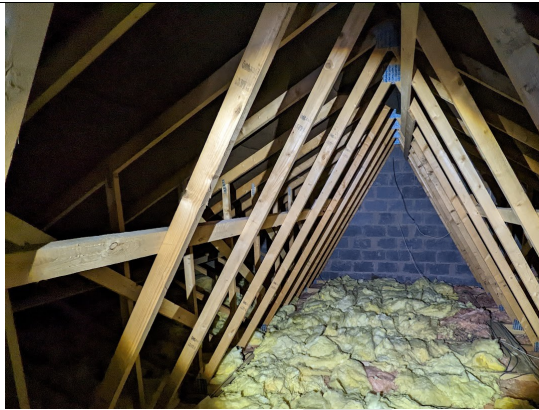
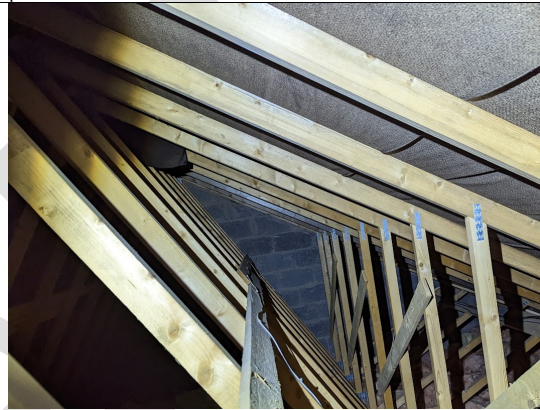
Internally, the building features a single roof void which covers the entire property. The roof trusses are arranged in a fink arrangement, which makes the roof relatively cluttered. There are exposed timber beams and fibreglass ceiling insulation.

Photograph 9: Roof void

Photograph 10: Roof void

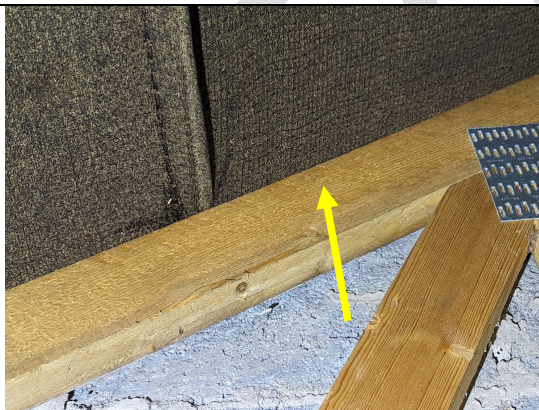
During the inspection, bat droppings were found along the north-eastern wall and on the insulation beneath. This collection of droppings corresponded with the droppings and opening found on the external elevation of the property. There was a relatively low number of droppings present within the roof void, which suggests the presence of single or low numbers of bats.

Photograph 11: Bat roost location

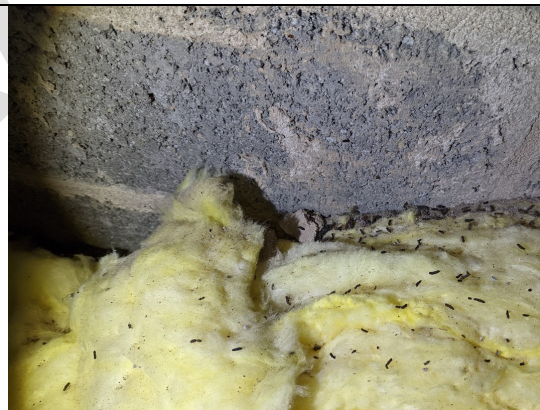
The site has been shown to contain an established bat roost, with droppings found both internally and externally along the north-eastern elevation. The droppings were morphologically similar to pipistrelle bat droppings, being small and fine-grained. A distinction between common and soprano pipistrelles cannot be determined from droppings alone.

Photograph 12: Droppings beneath roost location

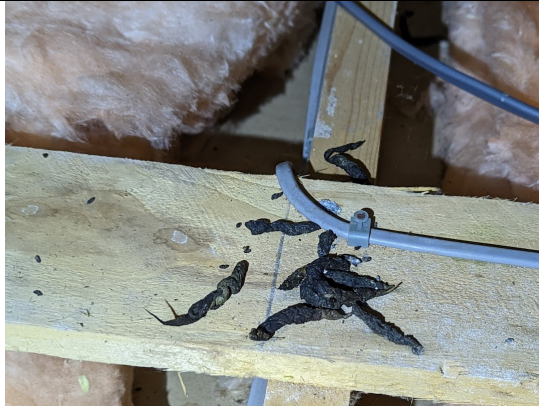
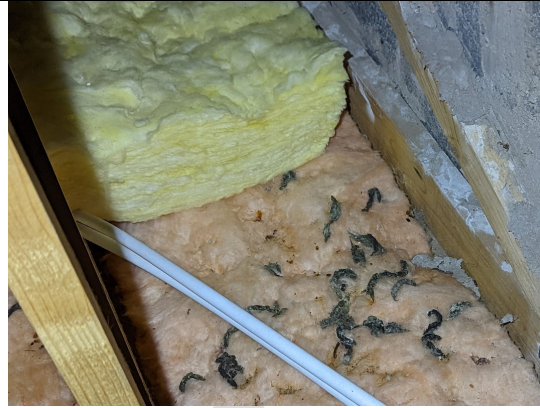
Also found within the roof void were two piles of stoat droppings (scat). No animals were seen in the void at the time, but some scats appeared to be fresh.

Photograph 13: Stoop droppings

Photograph 14: Stoop droppings
