| <b>Curtins Consulting Ltd</b><br><br>K Village, Riverside Place, Units<br>24-25, Lound Rd, Kendal LA9 7FH | <b>Subject</b><br><br>Cleator Moor Innovation Quarter<br>Photograph Survey Log | | <br><br>Sheet No: 01 |
| | <b>Job No:</b><br><b>085788</b> | <b>Made by:</b> JTS<br><b>Chkd by:</b> PT | |

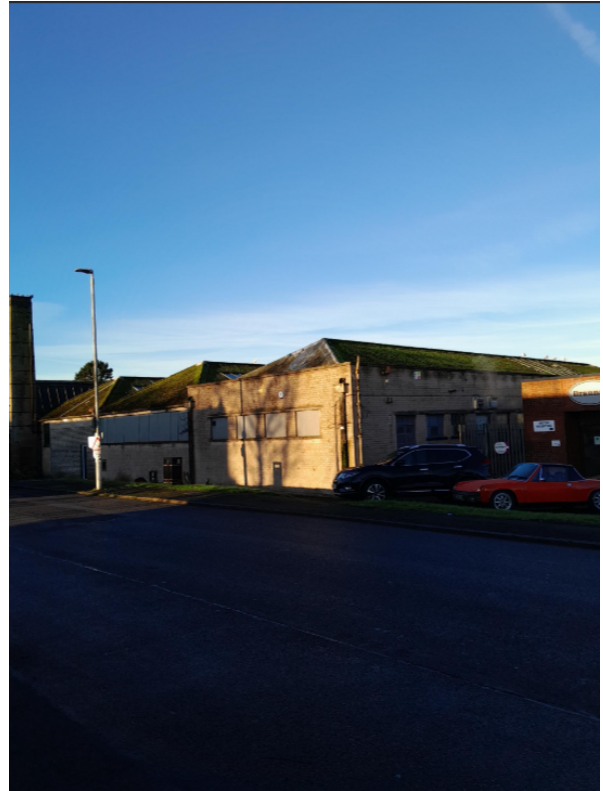
Figure 01 - existing buildings to remain up to chimney interface. Hipped roofs

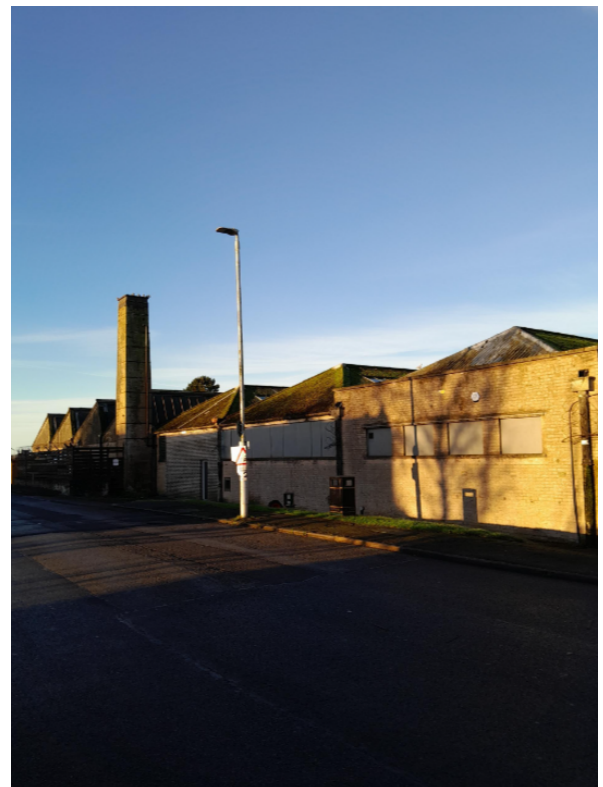
Figure 02 - existing buildings to remain up to chimney interface. Hipped roofs

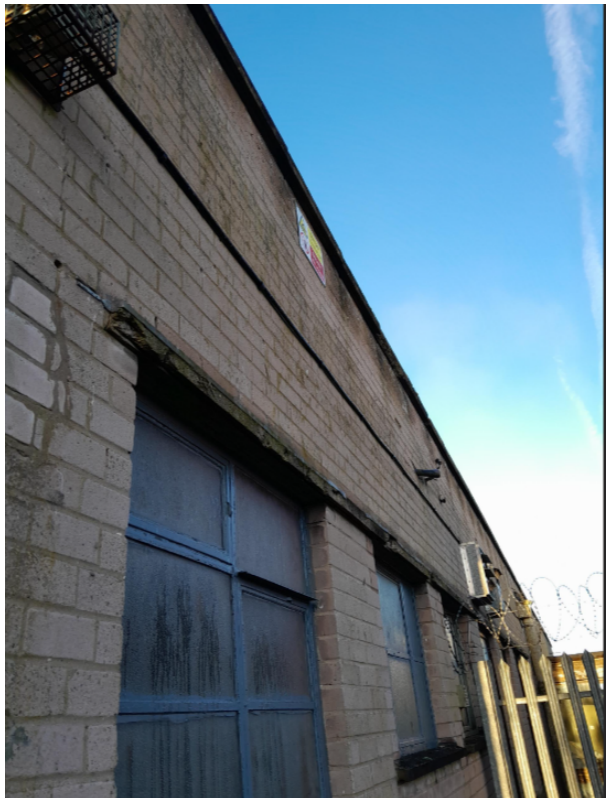
Figure 06 - existing buildings to remain, DAMAGED LINTELS

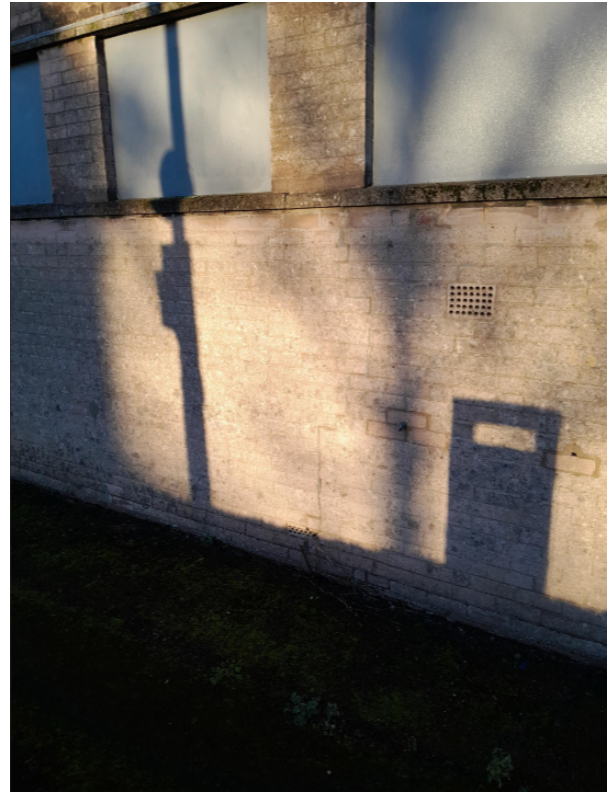
Figure 07 - existing buildings to remain, VERTICAL CRACKING TO MASONRY WALL. THROUGH BRICK AND JOINT

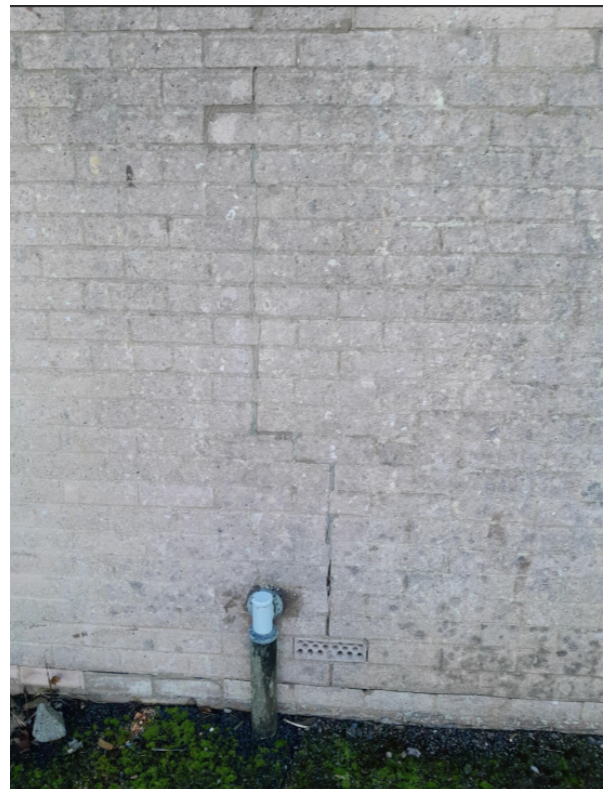
Figure 08 - existing buildings to remain, VERTICAL CRACKING TO MASONRY WALL. THROUGH BRICK AND JOINT

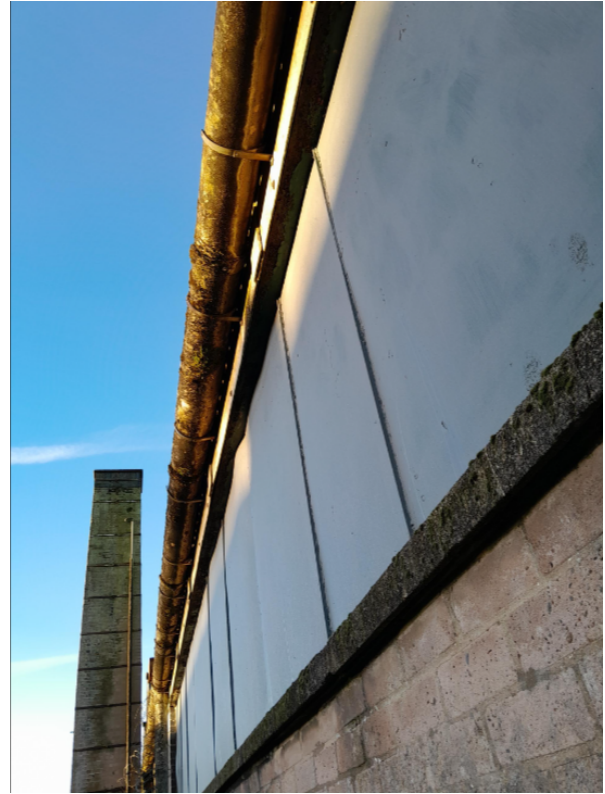
Figure 09 - existing buildings to remain, UNDERSIDE OF UNPROTECTED STEELWORK

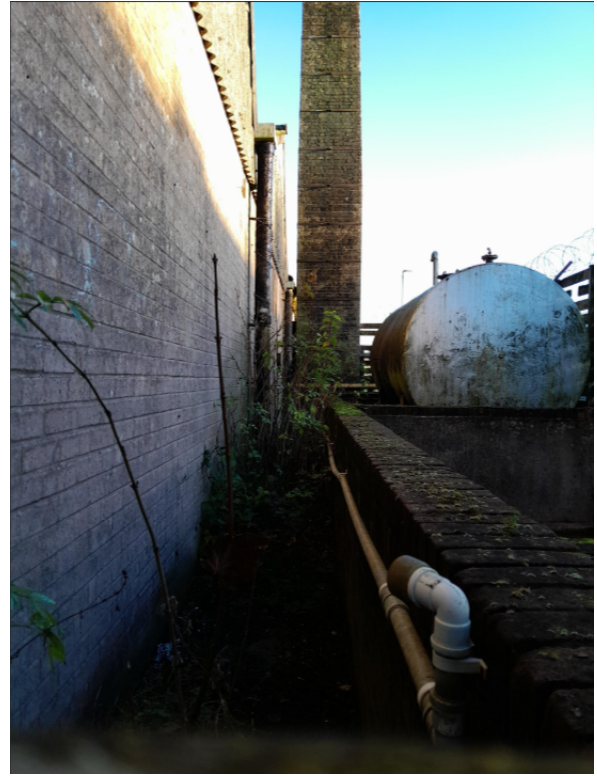
Figure 17 - interface between proposed demolition and potential existing tank zone. **Council to confirm.**

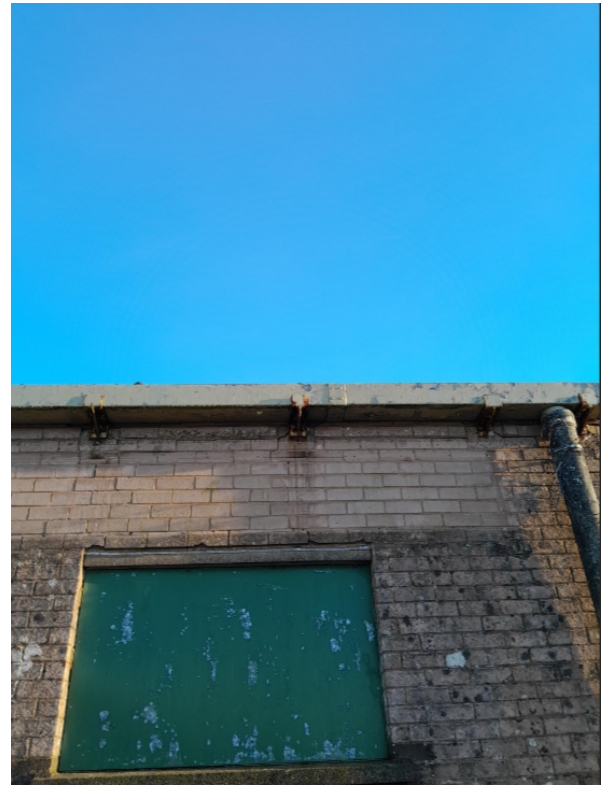
Figure 21 - existing buildings **to be demolished**, CORRODED GUTTER CLEATS JACKING MASONRY

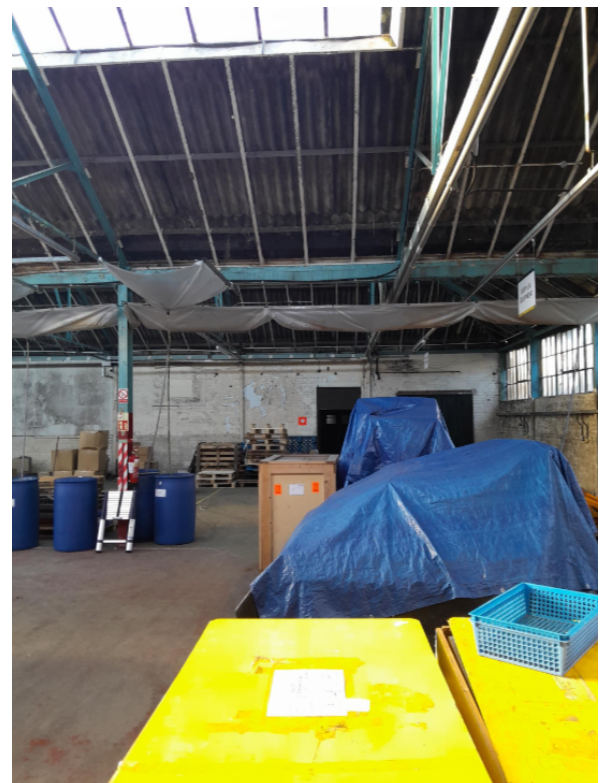
Figure 22 - existing buildings VIEW OF INTERNAL SPINE WALL which is to remain taken from retained side

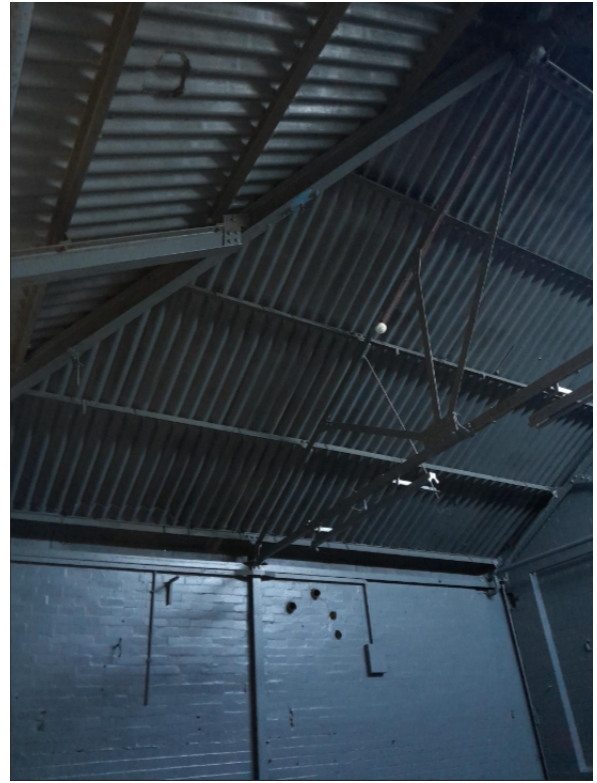
Figure 25 - view of hipped steelwork and truss system within retained outrigger roof. INT. SPINE WALL BEARS TRUSS

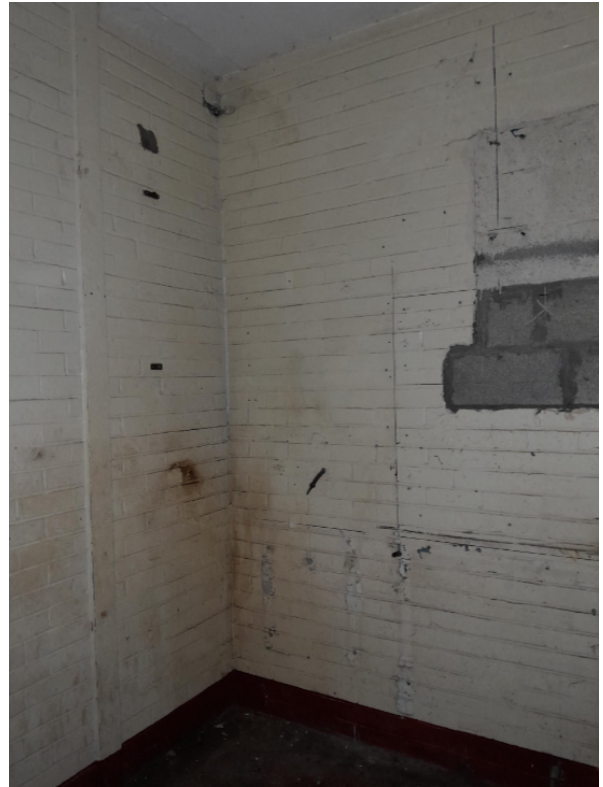
Figure 31 - internal spine wall and truss column (LEFT) to remain, **perpendicular wall to be demolished**

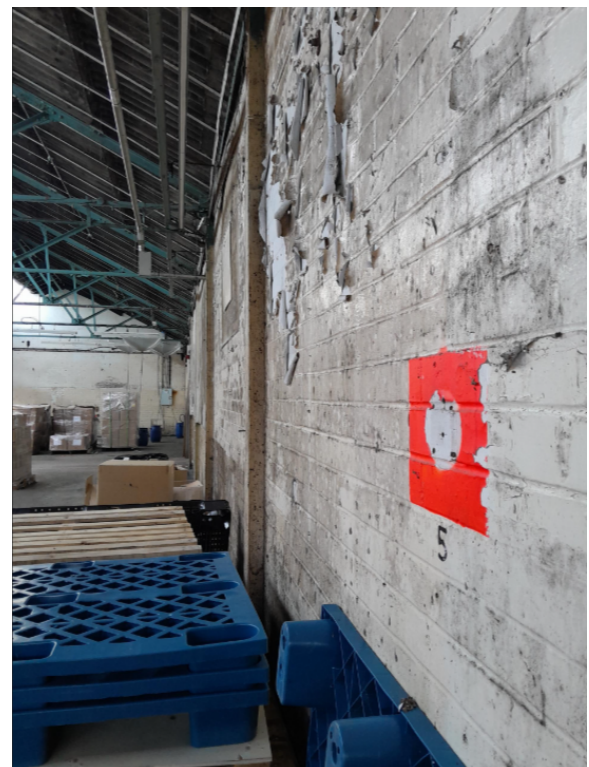
Figure 34 - existing buildings VIEW OF INTERNAL SPINE WALL which is to remain taken from retained side

INTERNAL SPINE WALL spans full height to valley gutter for the last three bays closest to NW elevation

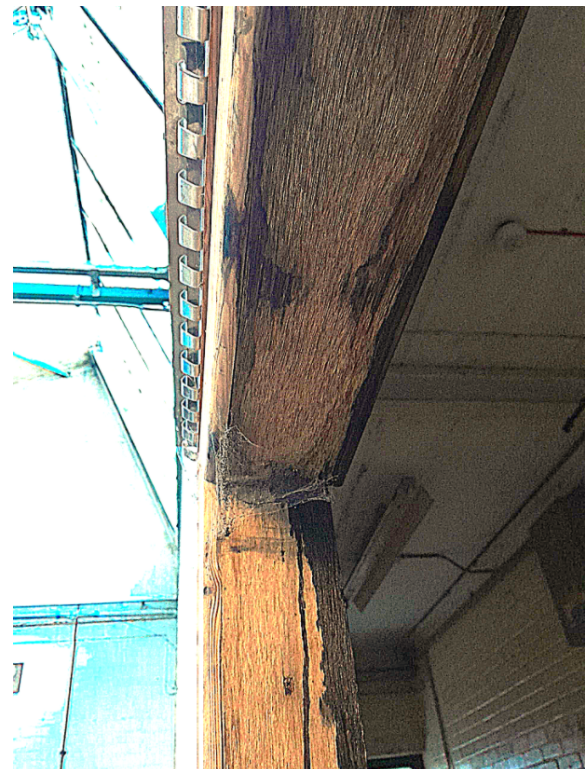
Figure 36 - existing buildings **to be demolished**, DOWNSTAND STEEL (A) CONNECTING INTO TRUSS COLUMN

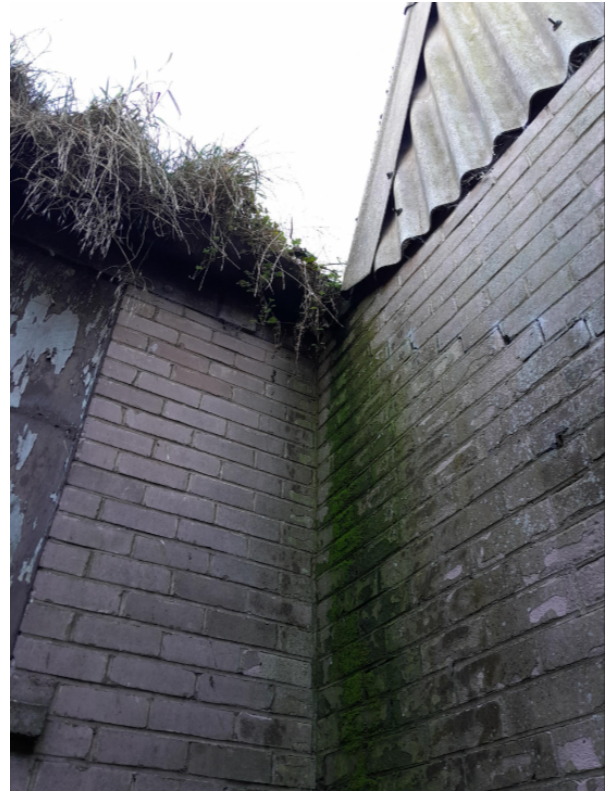
Figure 41 - internal spine wall and truss column (LEFT) to remain, **perpendicular wall to be demolished**

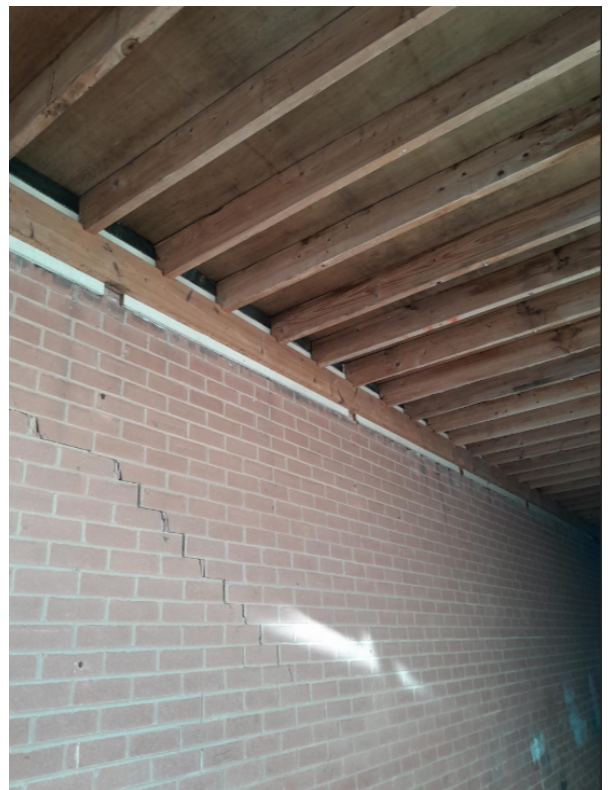
Figure 56 - existing buildings **to be demolished**, FLAT ROOF, TIMBER JOISTS, DIAGONAL CRACK

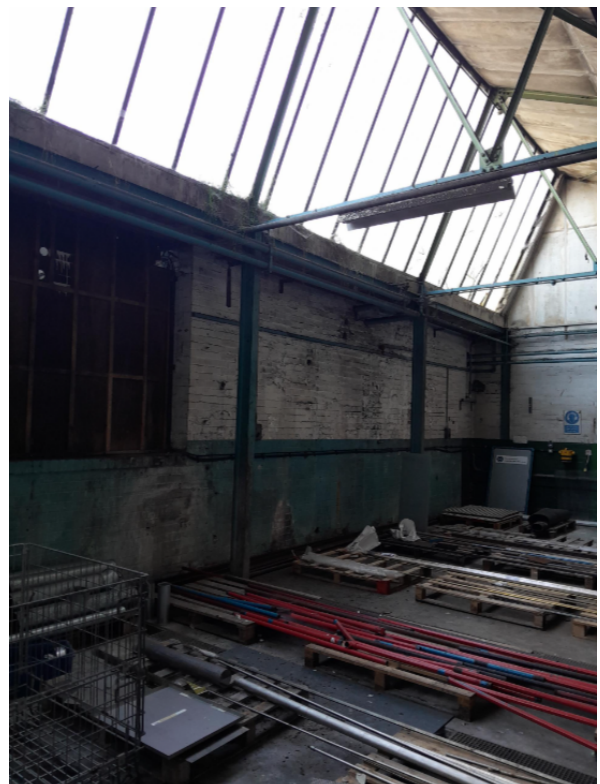
Figure 58 - INTERNAL SPINE WALL spans full height to valley gutter for the last TWO bays closest to SE elevation

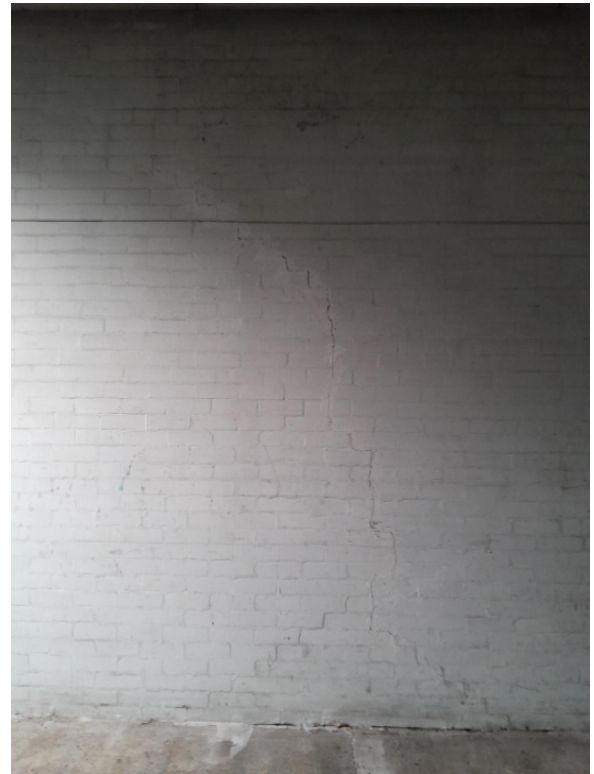
Figure 61 - DIAGONAL CRACK to zone 3 walls typically every 9m
