Our Ref: WDS/05/6942/LETT002

5<sup>th</sup> April 2021

**RE: Structural Inspection, Cattle Shed, New House Farm Drigg**

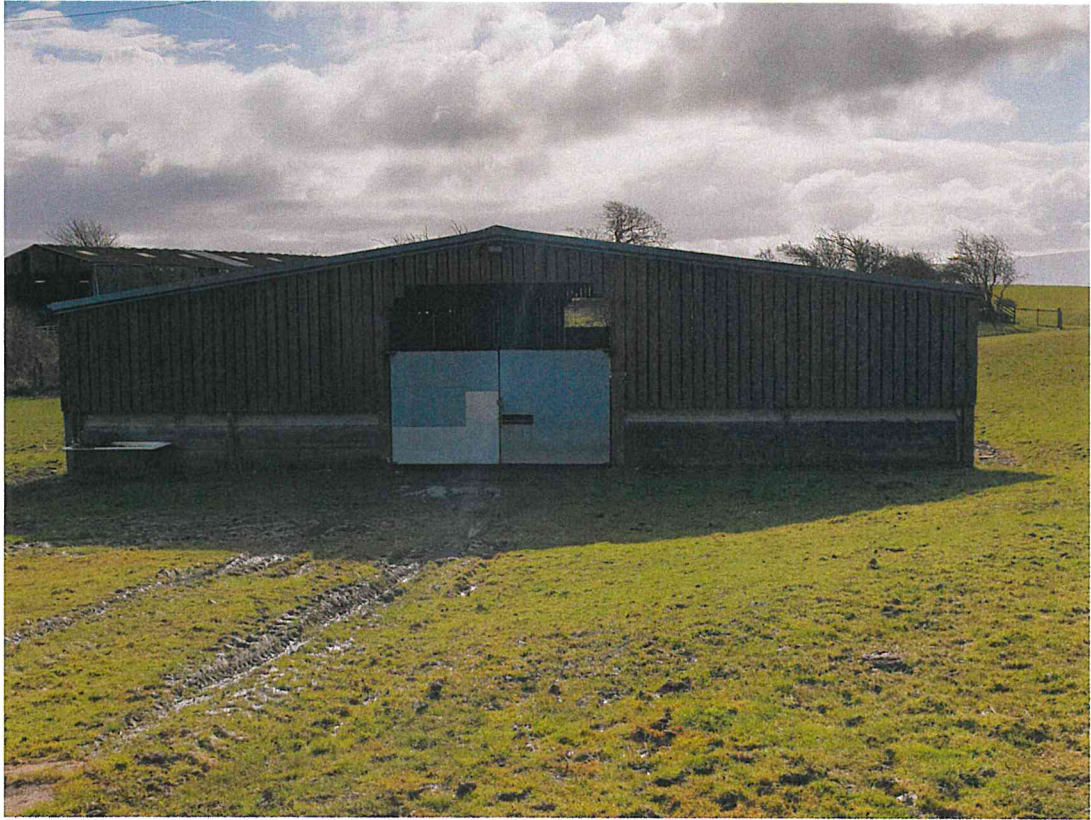
1. The inspection was carried out on the 26<sup>th</sup> March 2021 and was limited to a non-disruptive visual inspection of the property.
2. The cattle shed comprises a timber framed structure with metal profiled roof sheets and timber boarded side cladding. Photograph 01 attached shows a view on the front of the property. The building is almost 40 years old.

PHOTO 01 VIEW ON CATTLE SHED

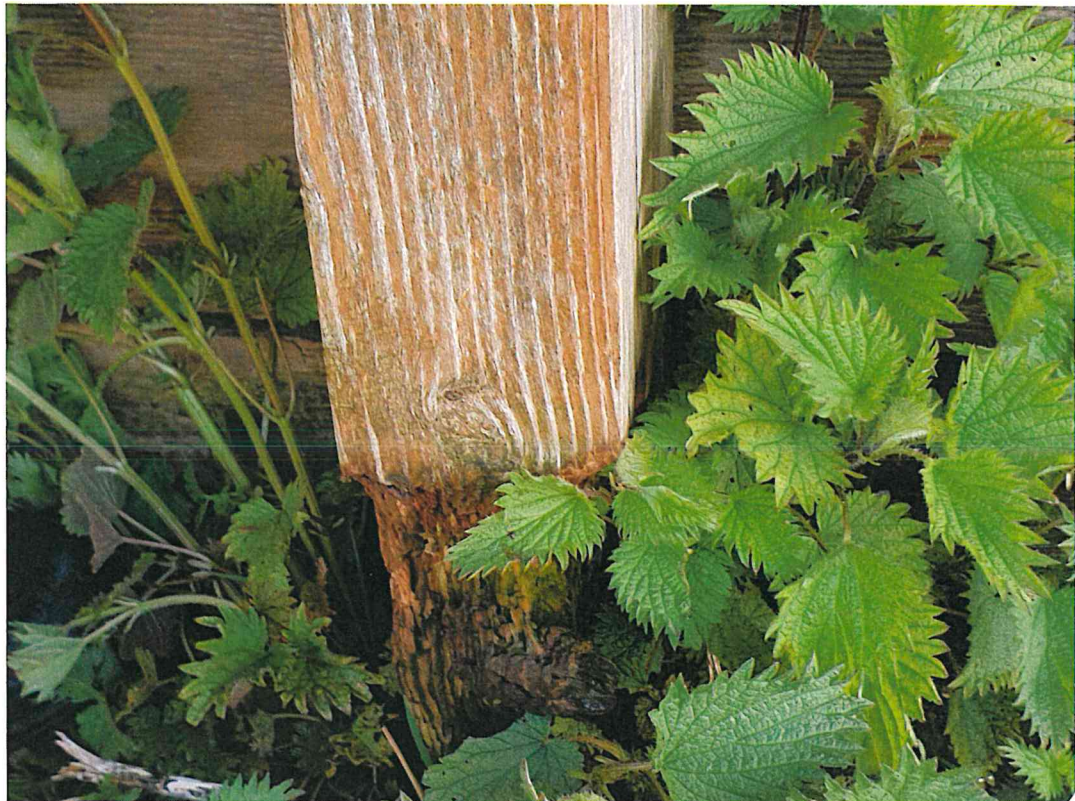
4. The base of the timber posts have been set into the ground into the foundation. This has allowed damp to affect the timber column bases which are starting to rot. Photograph 02 shows a typical view on a timber base.

PHOTO 02 TYPICAL VIEW ON AFFECTED COLUMN

Considering the above it is our opinion that the timber columns are nearing the end of their life. The rot will worsen with time and the sections will be compromised which will lead to failure of the timber elements. The columns could be fitted with steel shoes up to unaffected timber and the shoes bolted to the foundations however this will need to be carried out on each timber column.

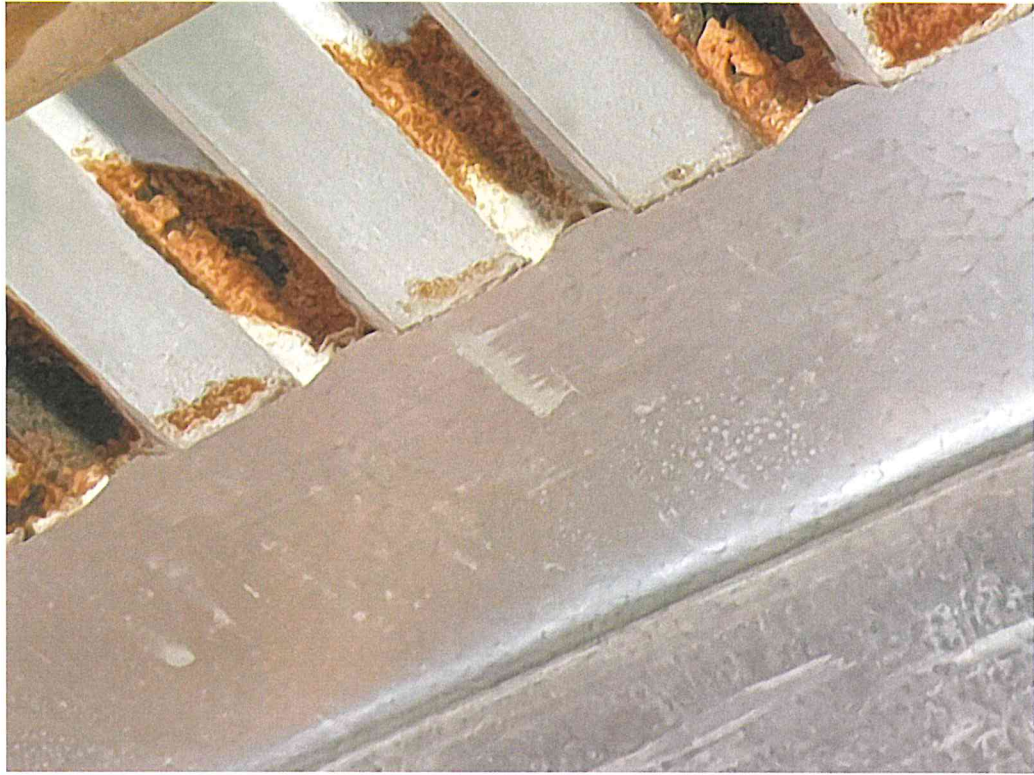
5. The roof cladding is rusting, the plastisol coating has been compromised in a number of areas; the steel is rusting and delaminating especially adjacent to the apex. The cladding is nearing the end of its life expectancy. Photograph 03 shows a typical view on the roof cladding.

This will result in the roof sheets detaching from the building. In addition the weathertightness of the roof will be compromised.

PHOTO 03 VIEW ON ROOF CLADDING

The roof cladding needs to be replaced in the near future. The rust will compromise the cladding fixings as the affected sheet will weaken and will pull over the fixings in high wind conditions.
