## **TREE SURVEY REPORT**

### **PROPOSED RESIDENTIAL DEVELOPMENT**

**Rheda Cross, Frizington, CA26 3TA**

#### **EAST SITE**

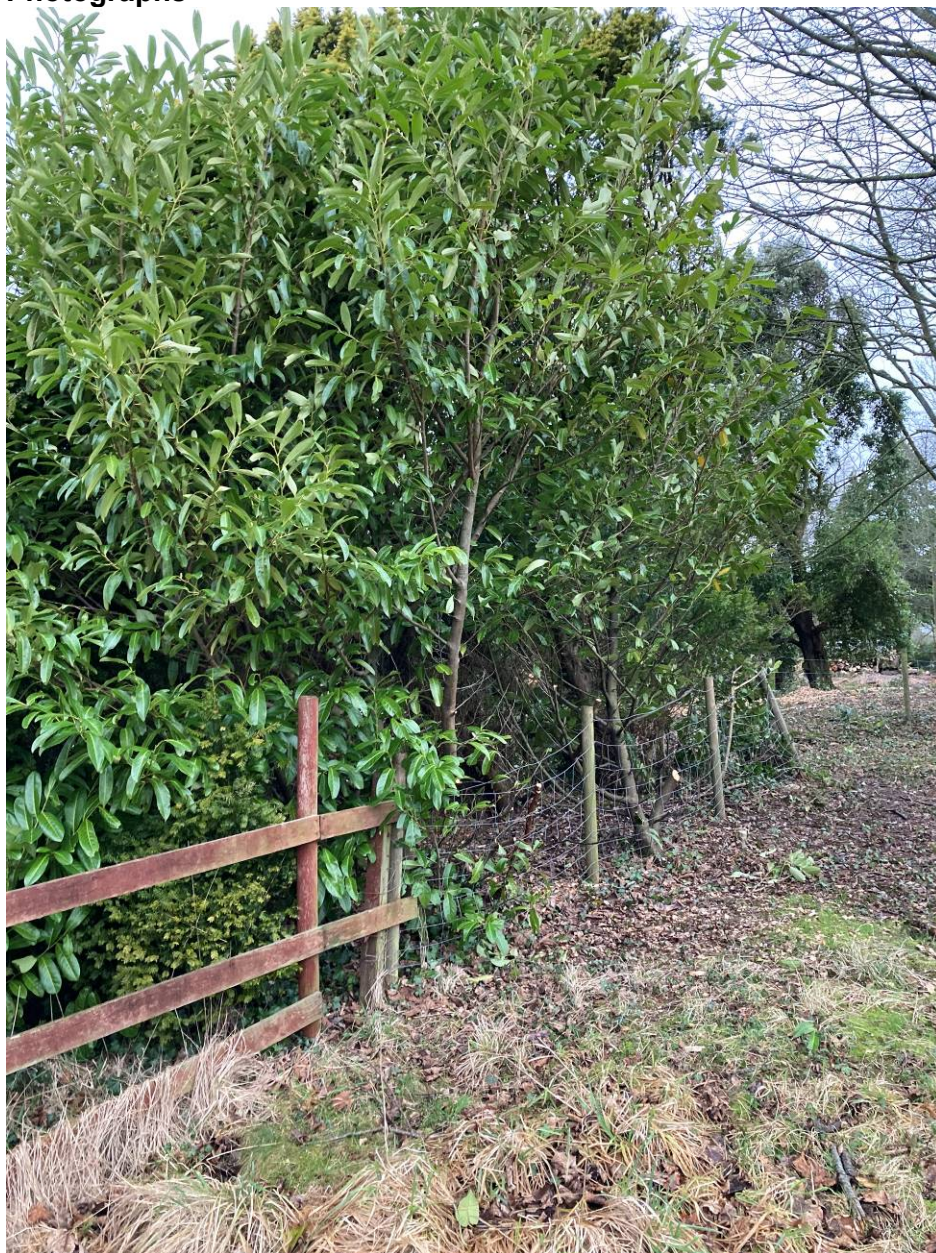
**1. Group G1 Laurels at the east boundary.**

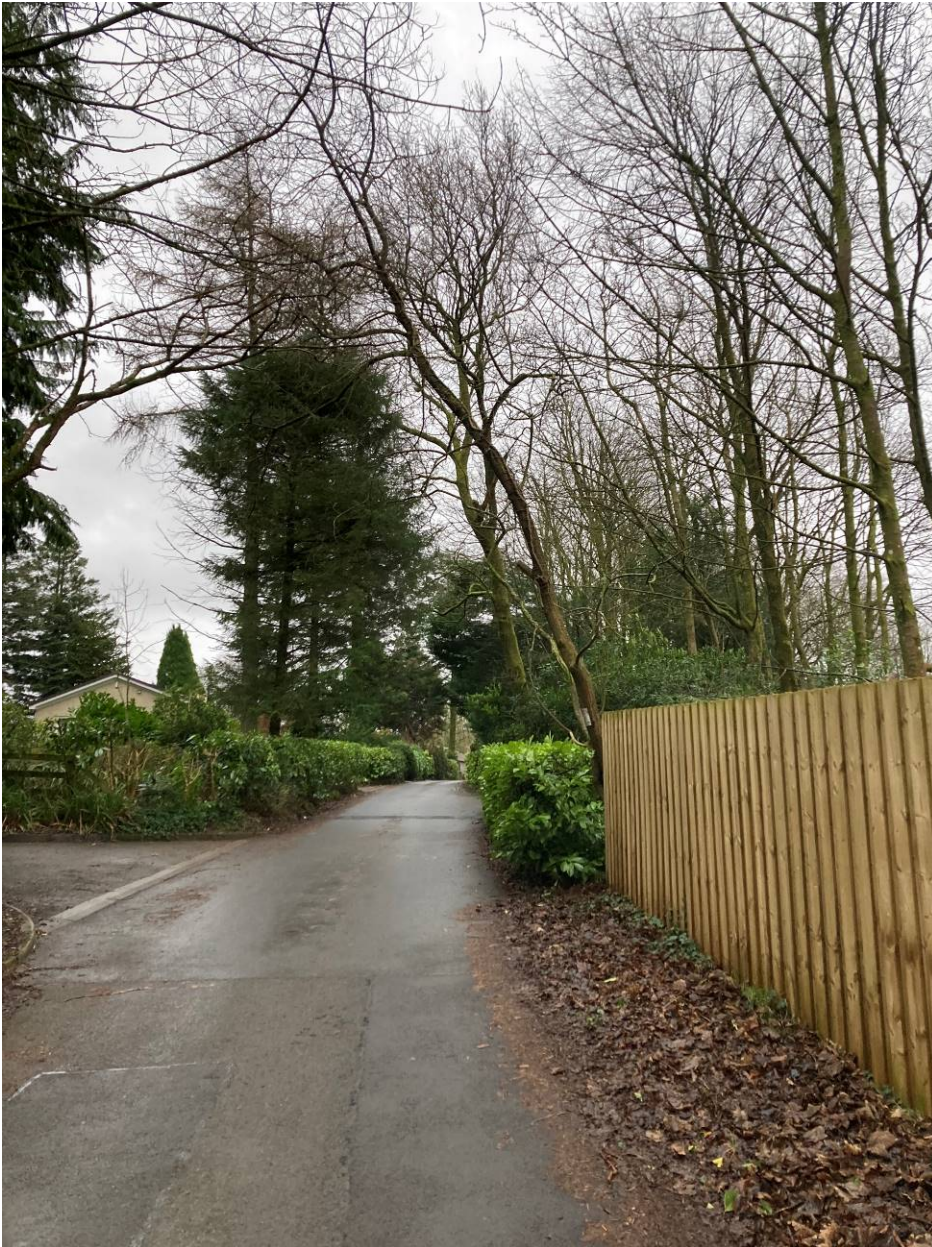
**2. Tree T1 Goat Willow at the boundary.**

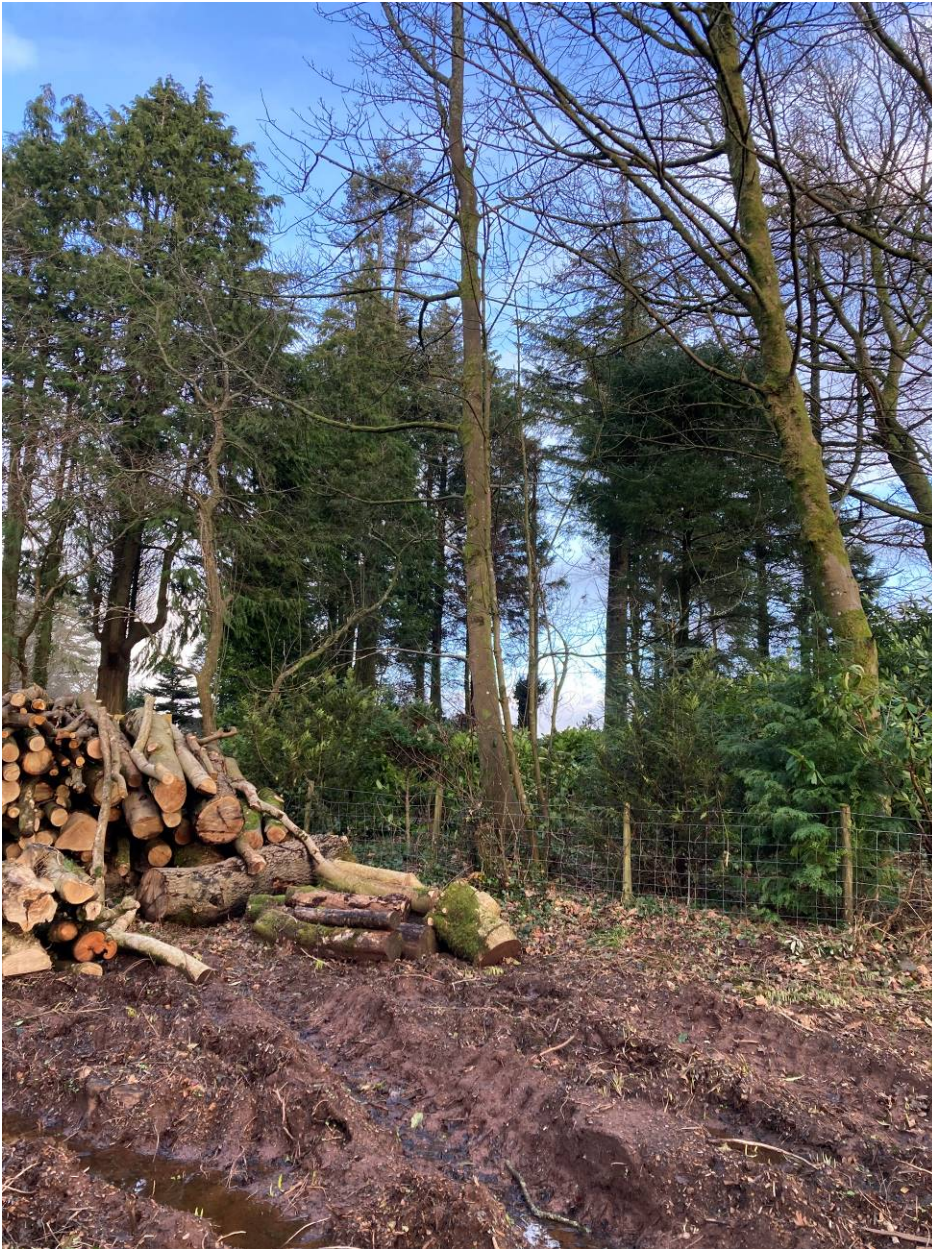
**3. Tree T2 Sycamore**

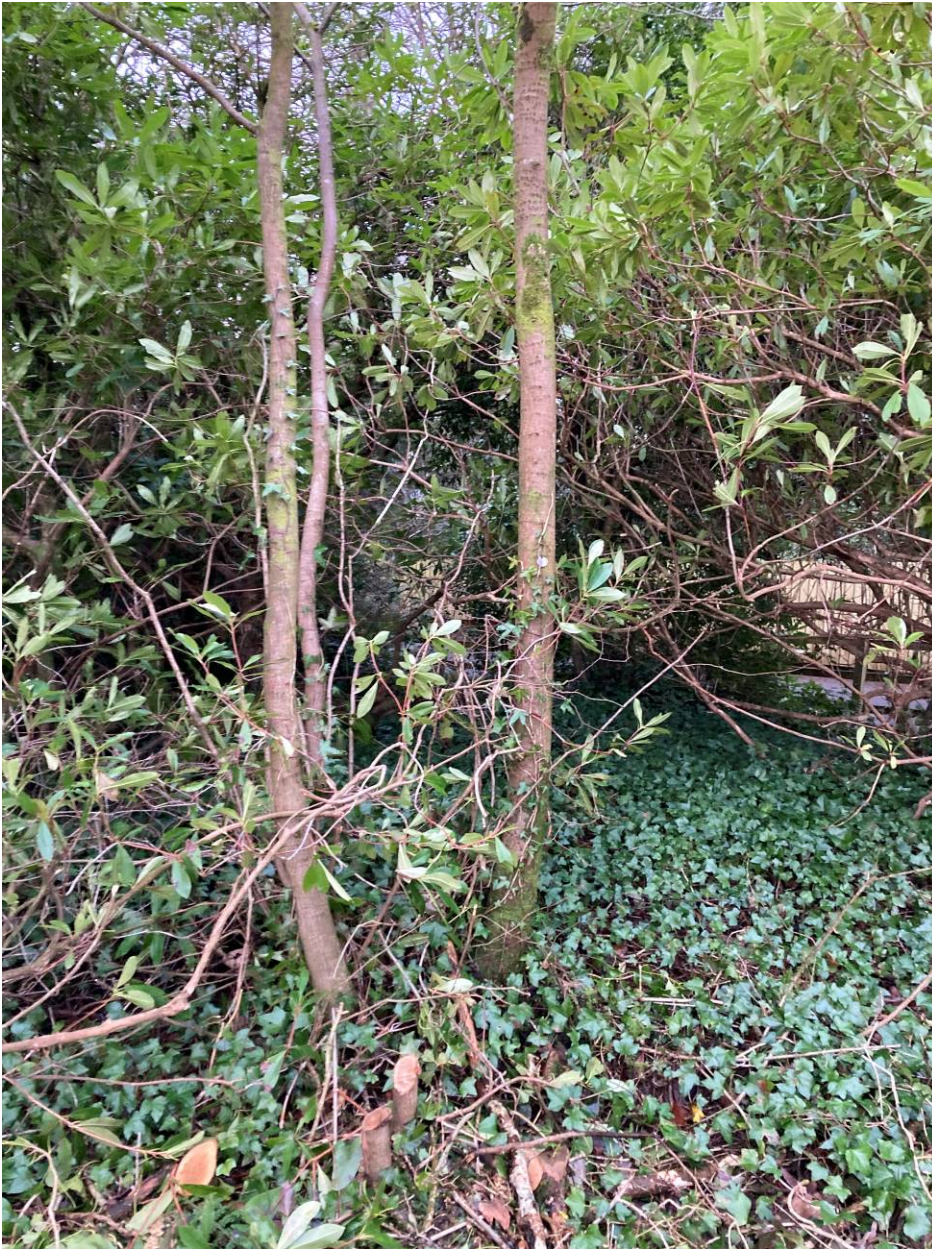
**4. Tree T484 Elm.**

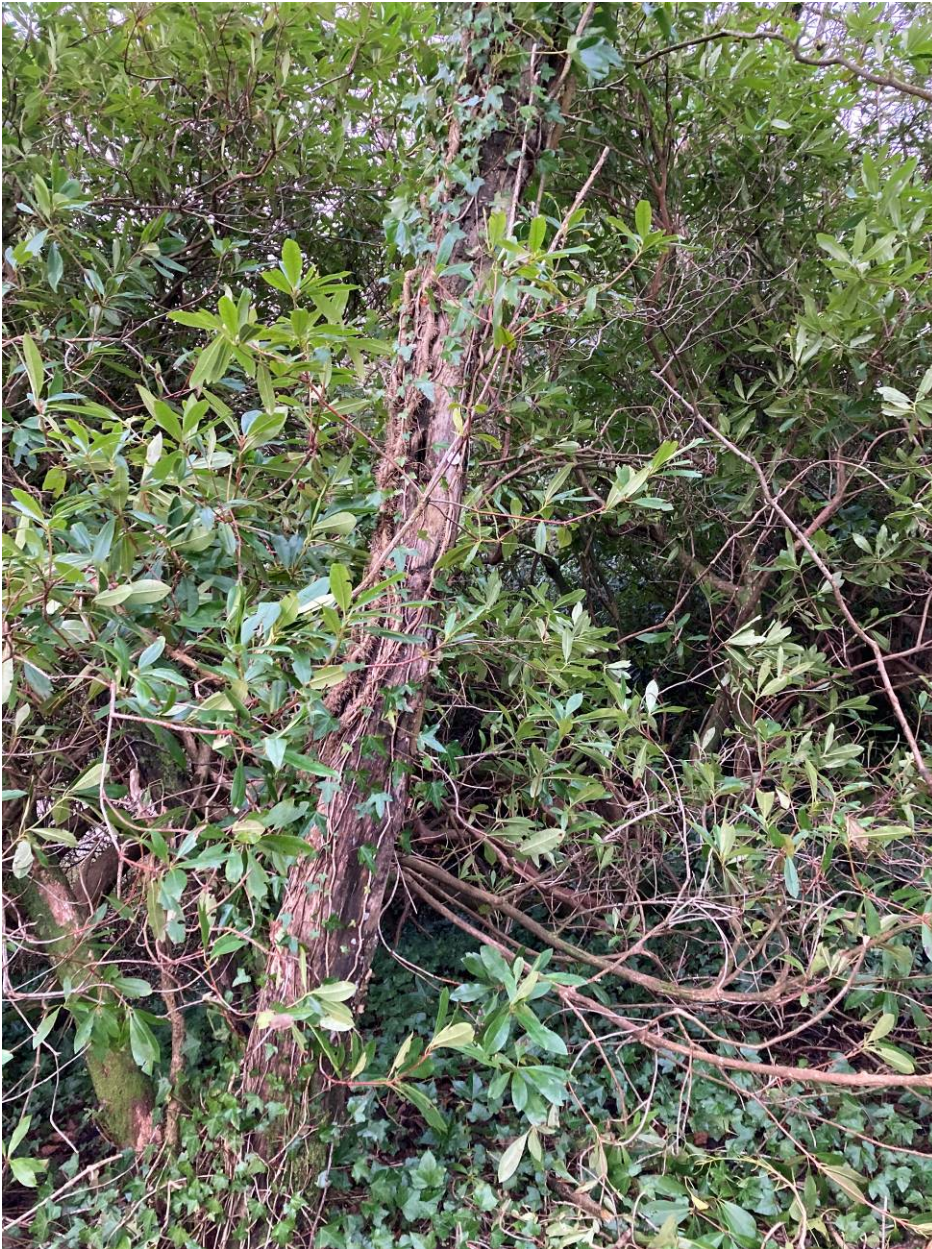
**5. T486 Elm which is dead.**

3.2. We recommend removal of the Category 'U' tree T486 Elm which is dead. Its loss will have a negligible impact on the landscape and amenity value as the wider tree group will remain intact with retained trees. The replacement trees proposed will more than compensate for the loss.

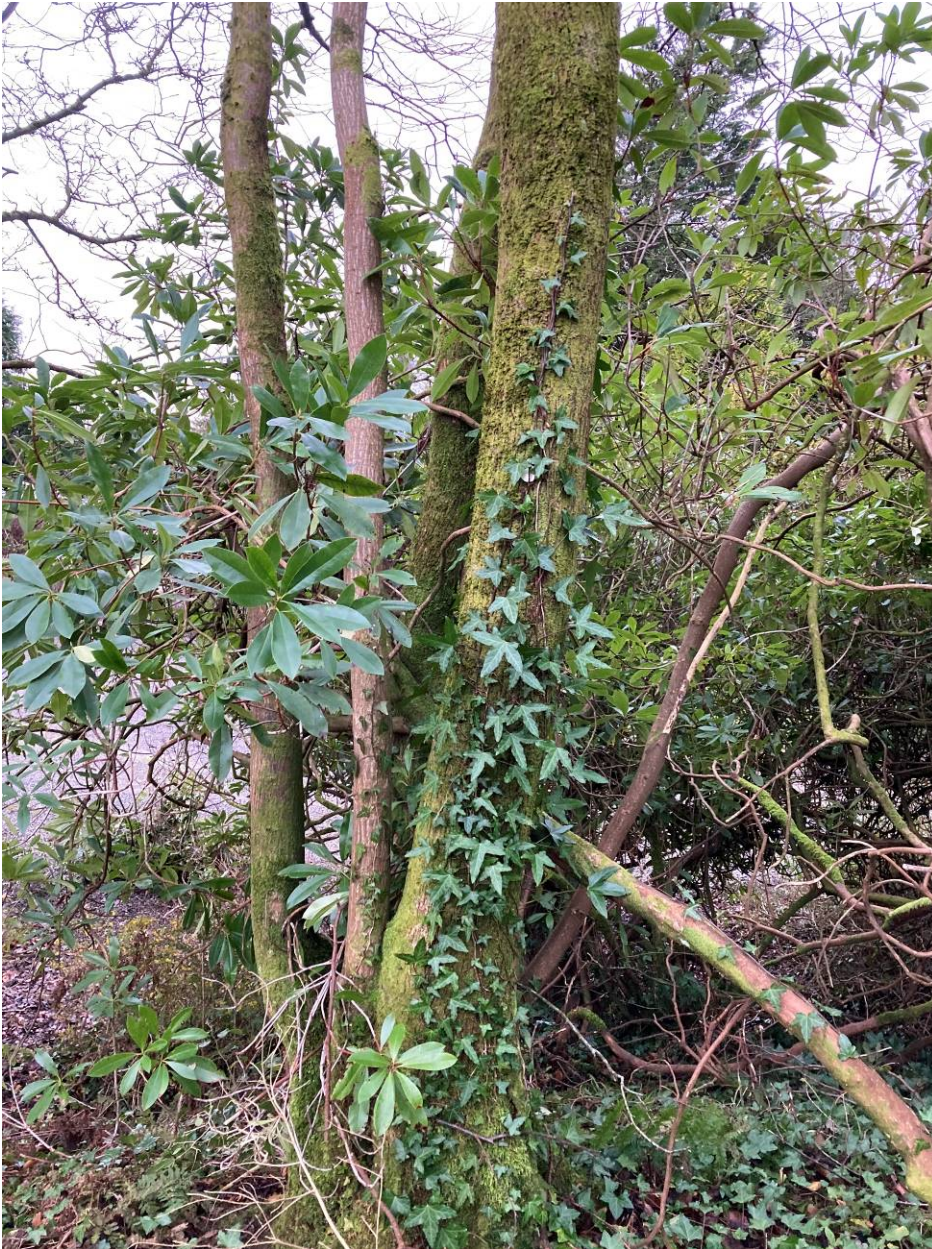
**6. Tree T487 Elm**

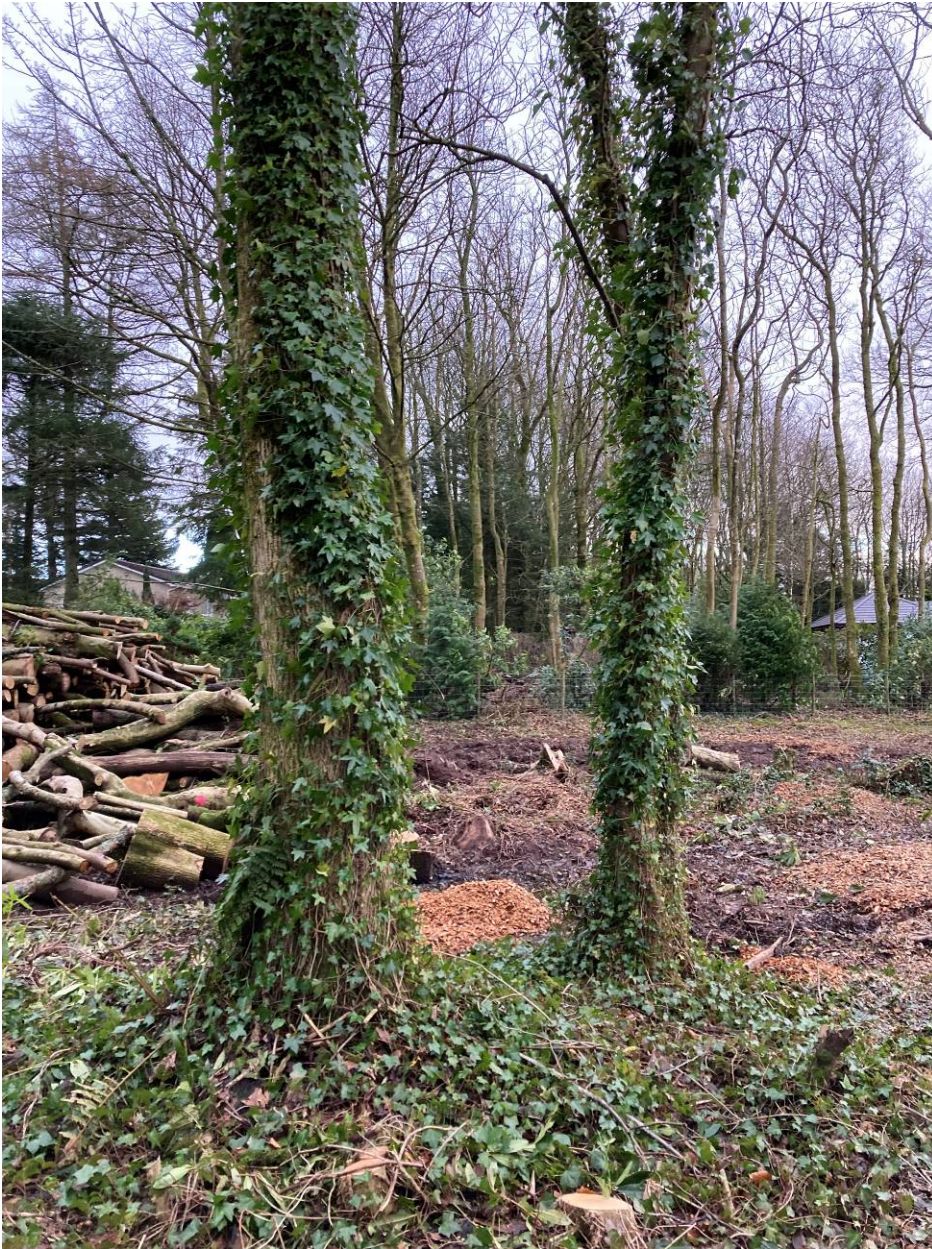
3.3. There is potential for harm to retained trees T488 and T489 as the proposed driveway impedes upon the tree RPA's. The protection of the tree roots will be ensured by the adoption of a minimal excavation permeable surfacing as indicated on the Landscape Plan **WW/L01 Rev D** and detail D/01. The proposed service connections will be routed further to the east to avoid a trench excavation within the RPA's.

**7. Trees 488 Ash and T489 Elm.**

7.2.2. Services: There was no service information available for assessment but the routes should be sensitively design to avoid tree root damage and follow the service corridors associated with the proposed access drive and running to the east of the drive at the northernmost area to avoid the RPA of the retained trees T488 and T489.

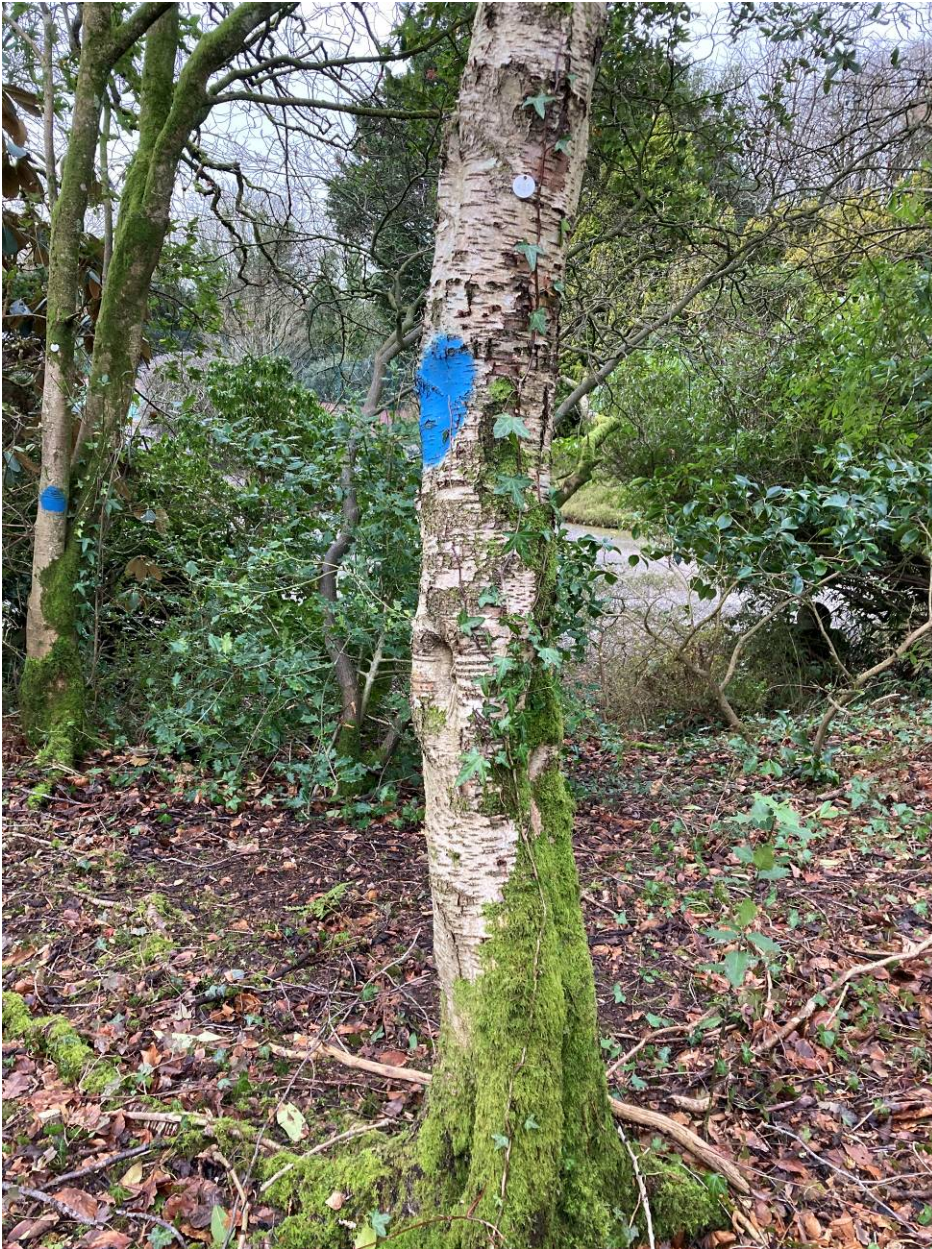
**8. Trees 495 Silver Birch and T496 Holly.**

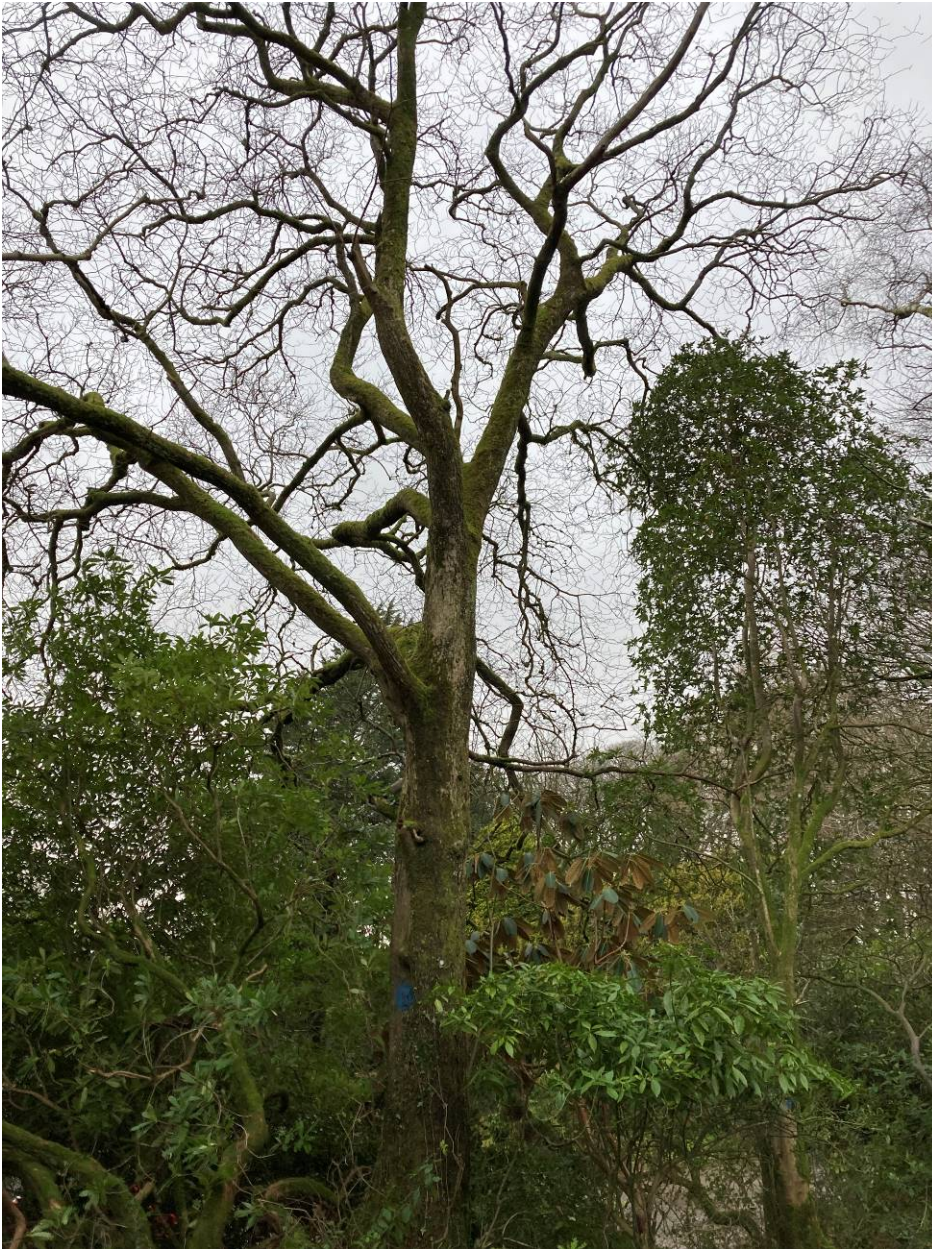
**9. Tree T497 Elm.**

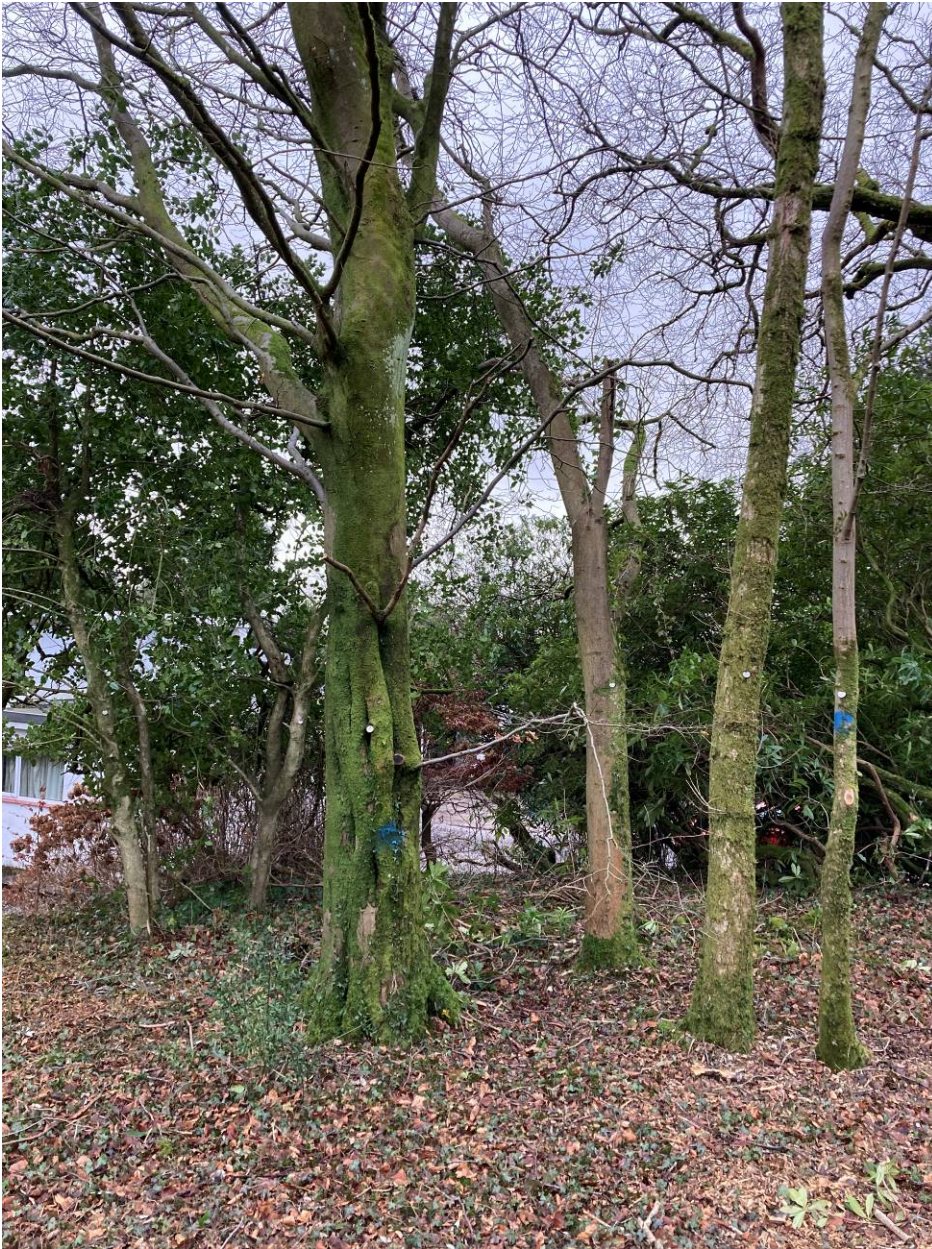
**10. Trees T505, T506, T503, T502, T501 and T500 (left to right)**

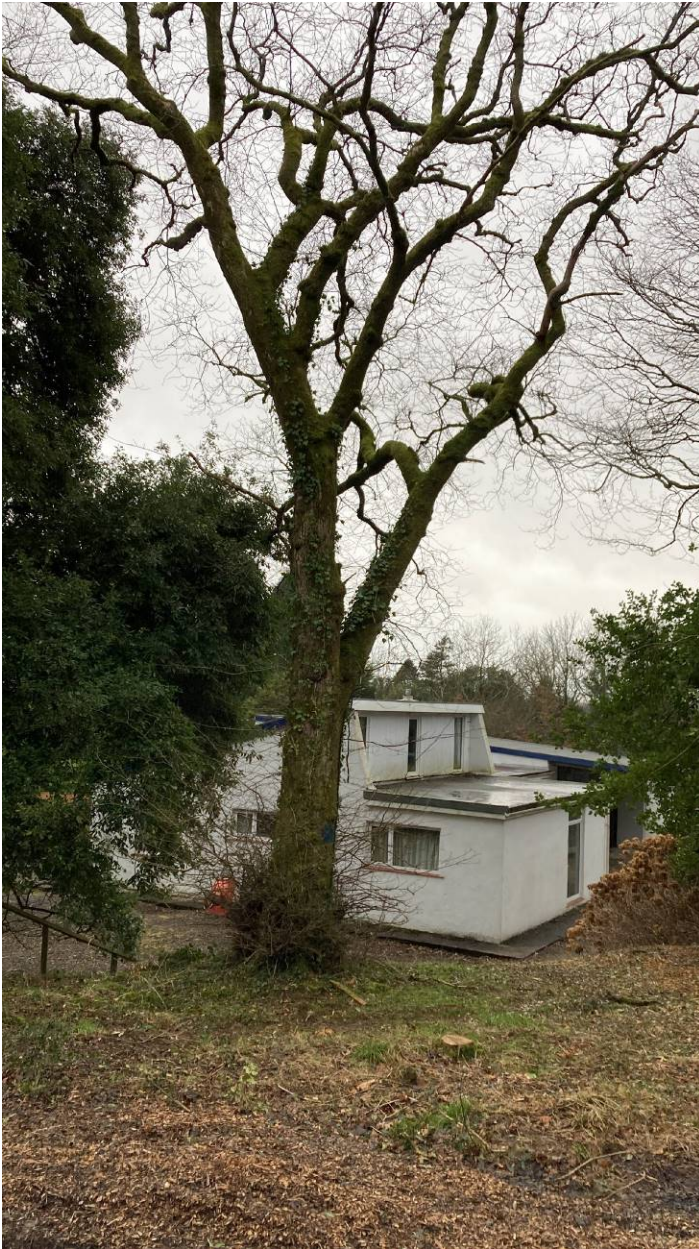
**11. Tree T512 Elm**

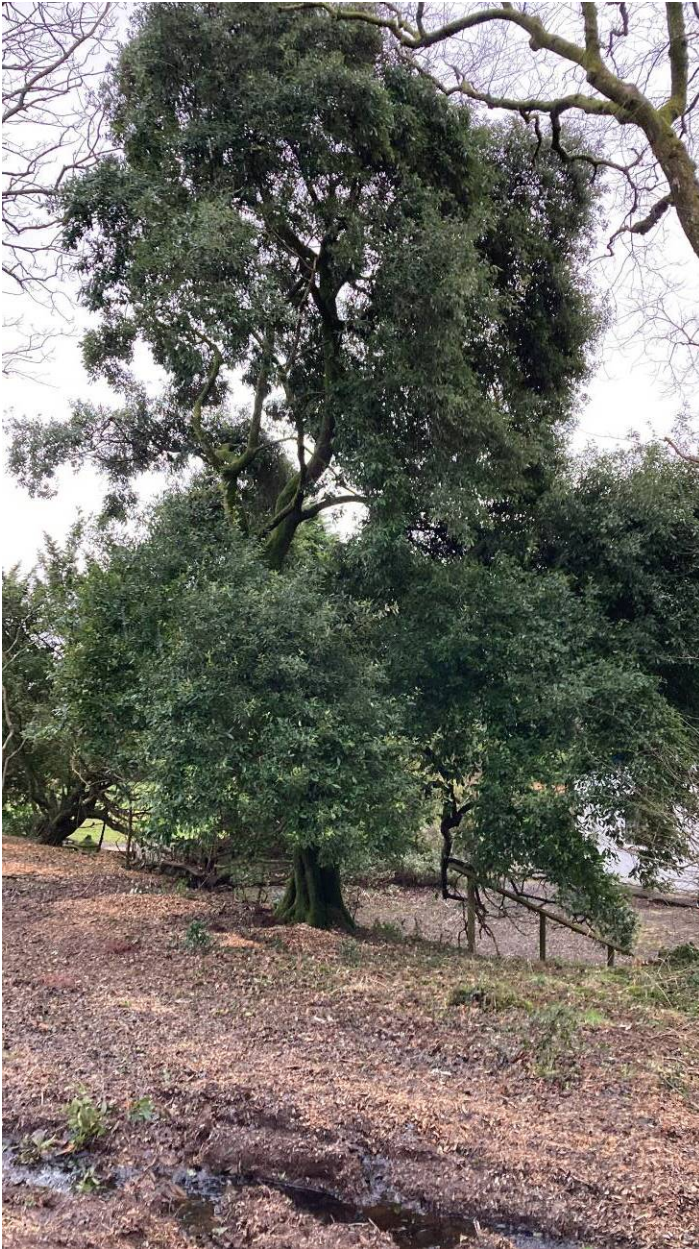
**12. Tree T513 a fine Holme Oak specimen.**

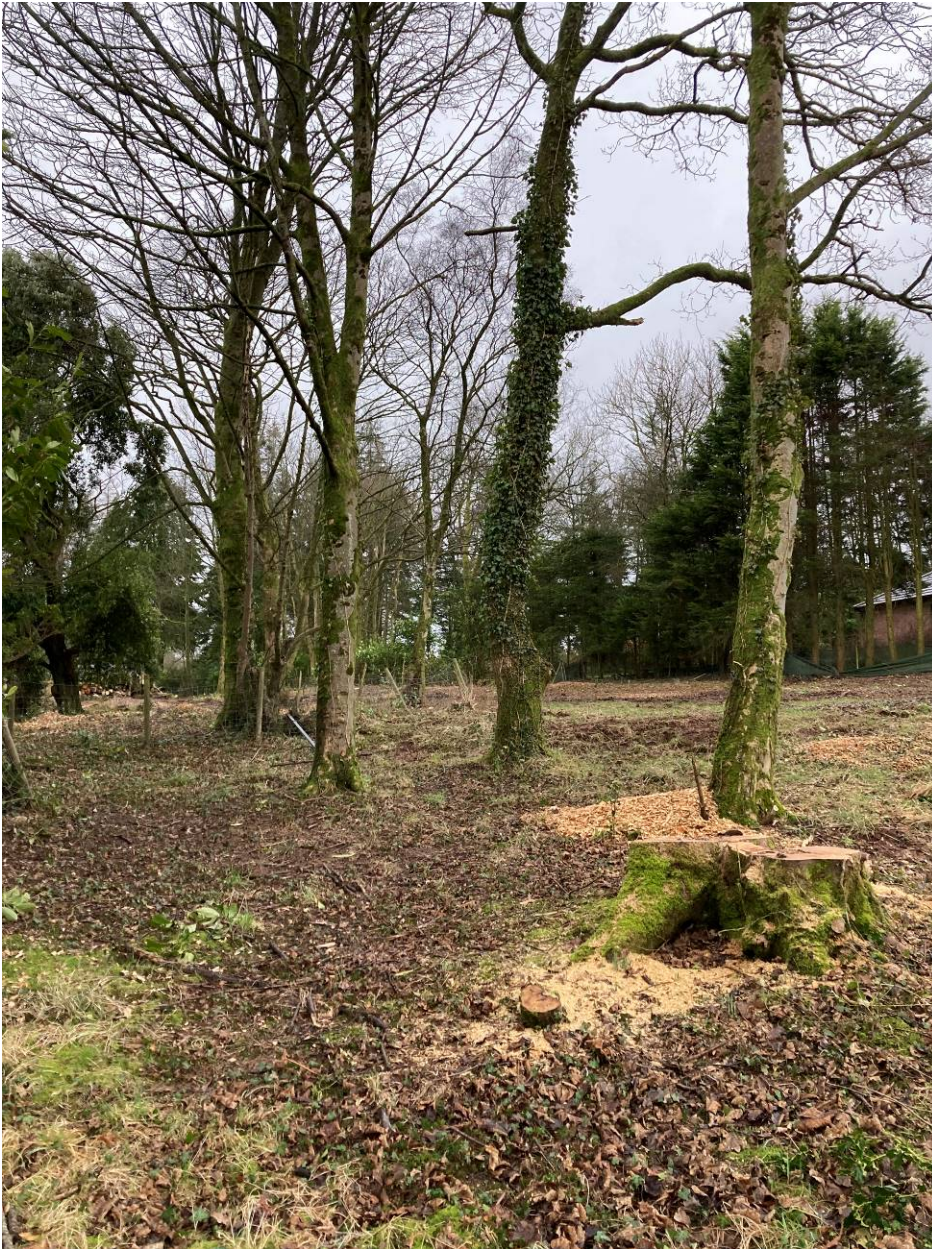
**13. Trees T530 (front), T529 Sycamore (left) and T530 Oak (right).**

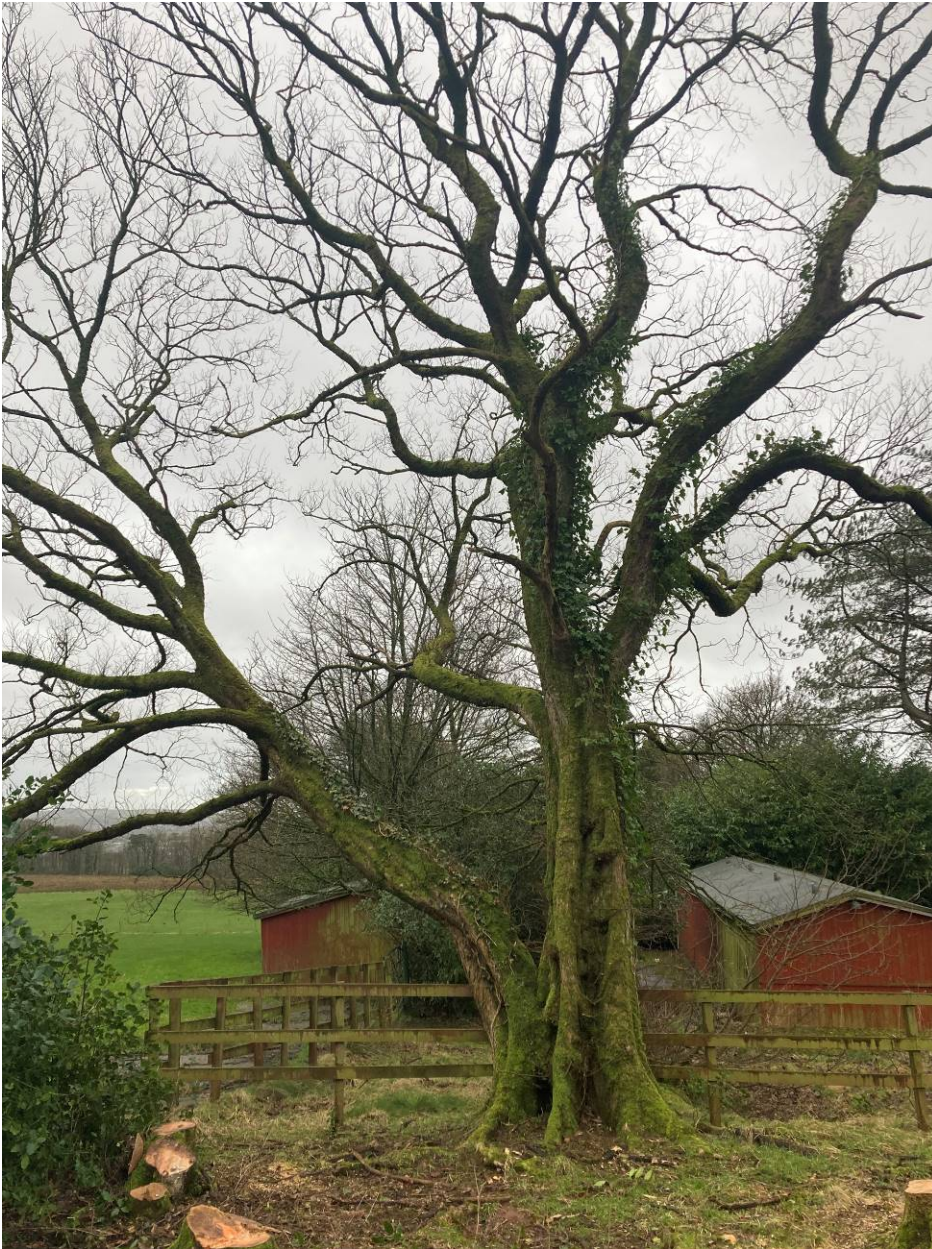
**14. Tree T544 Elm.**

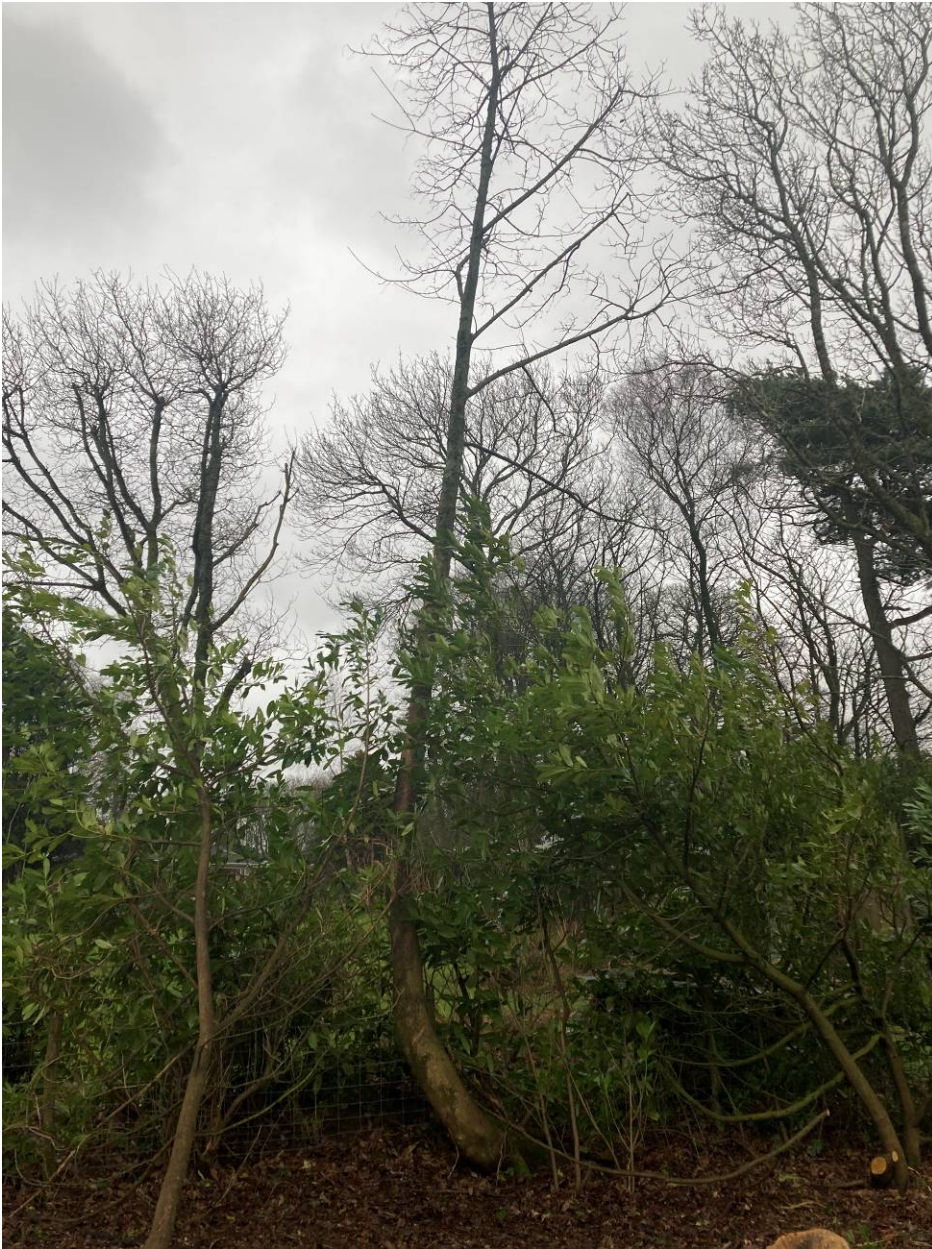
**15. Tree T560 Sycamore**

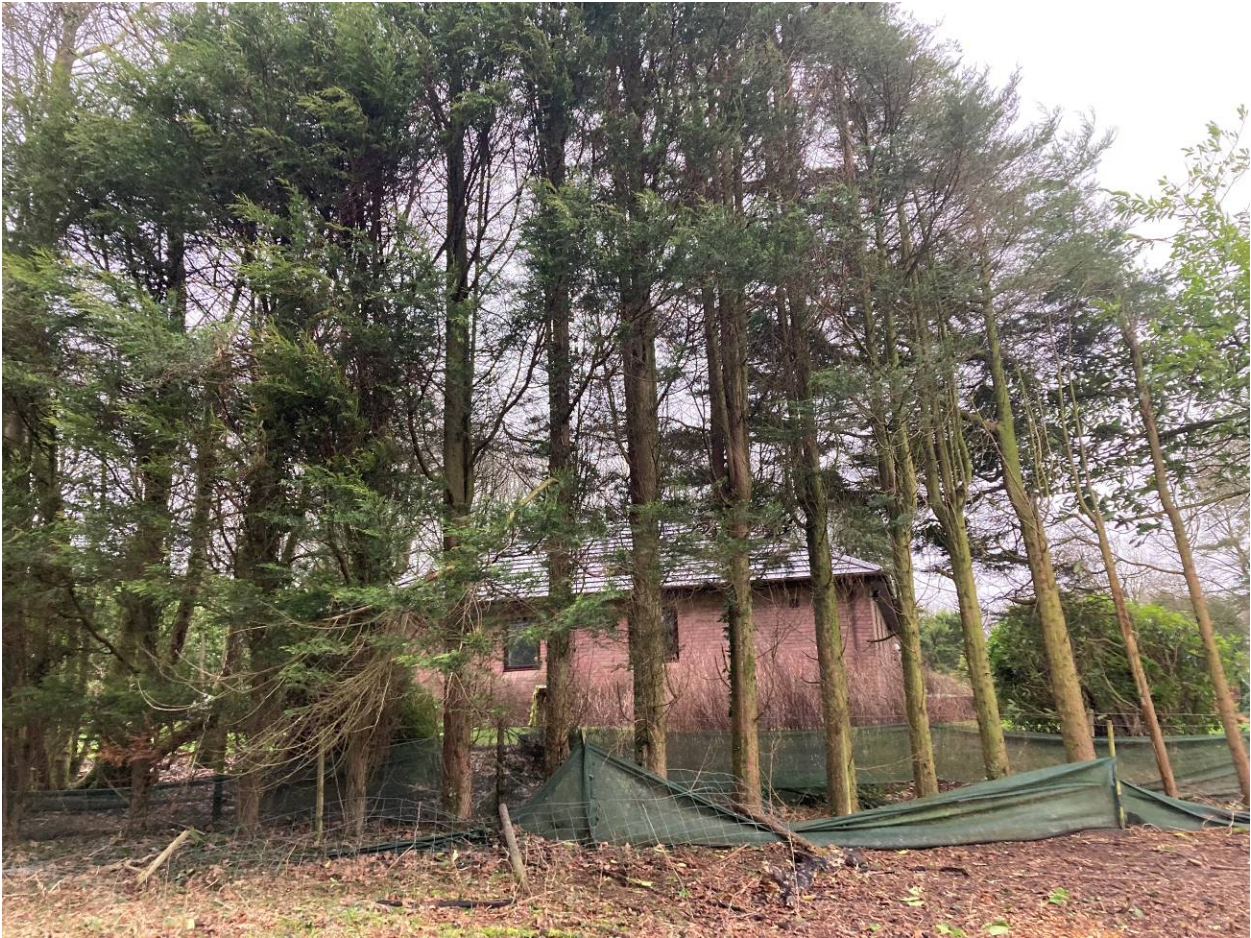
**16. Tree group T577 Leyland Cypress**

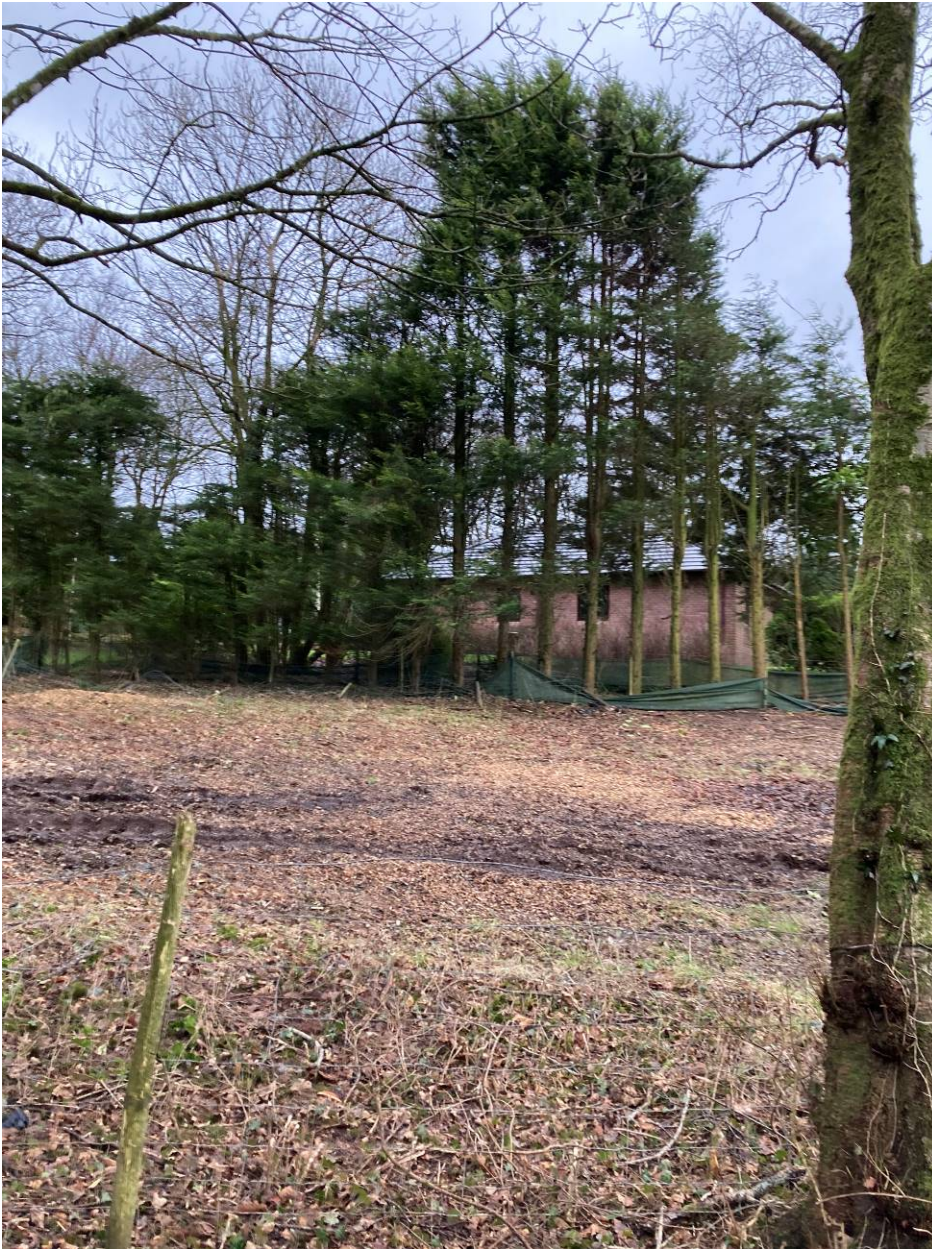
**17. Tree group T577 Leyland Cypress**

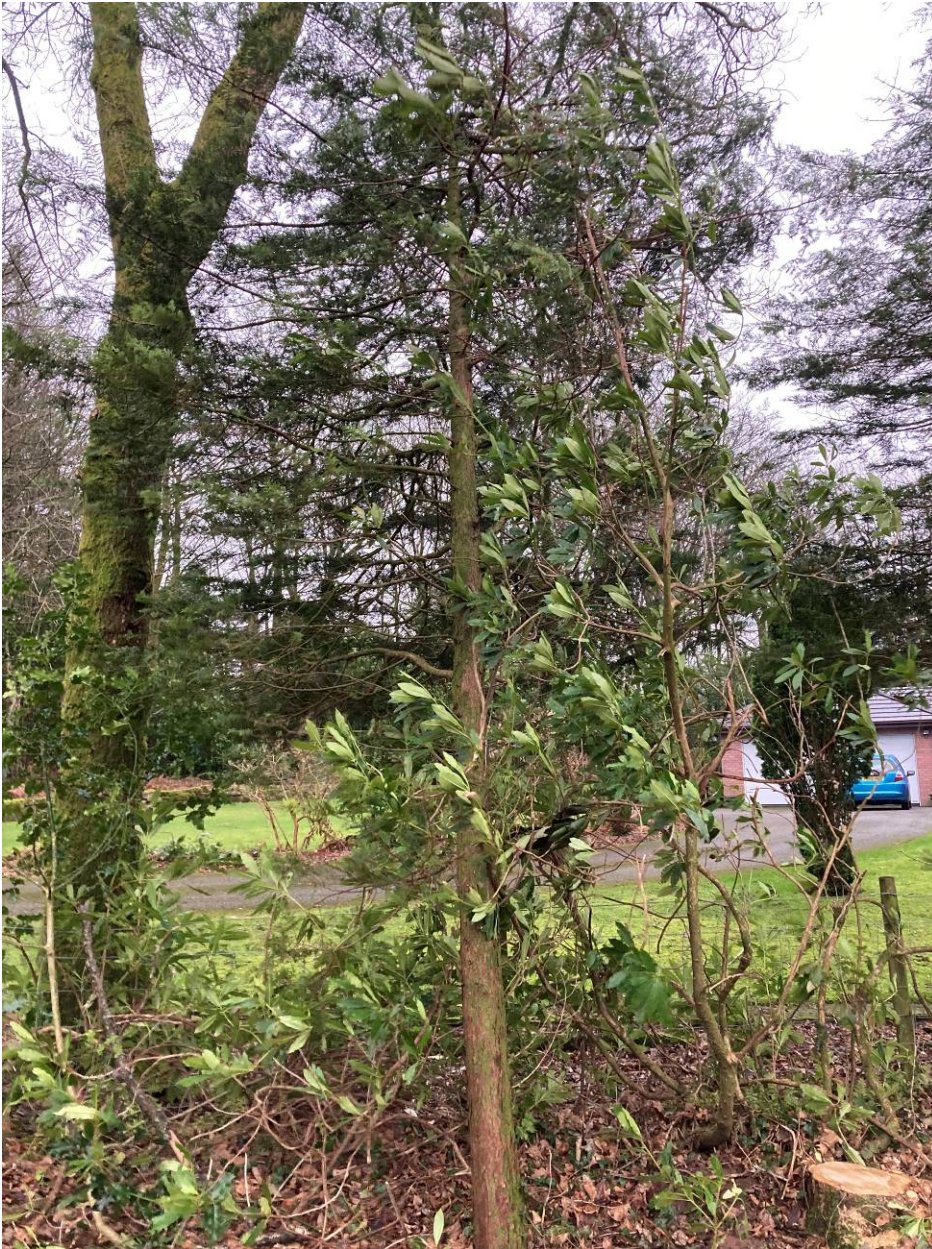
**18. Tree T588 Leyland Cypress**

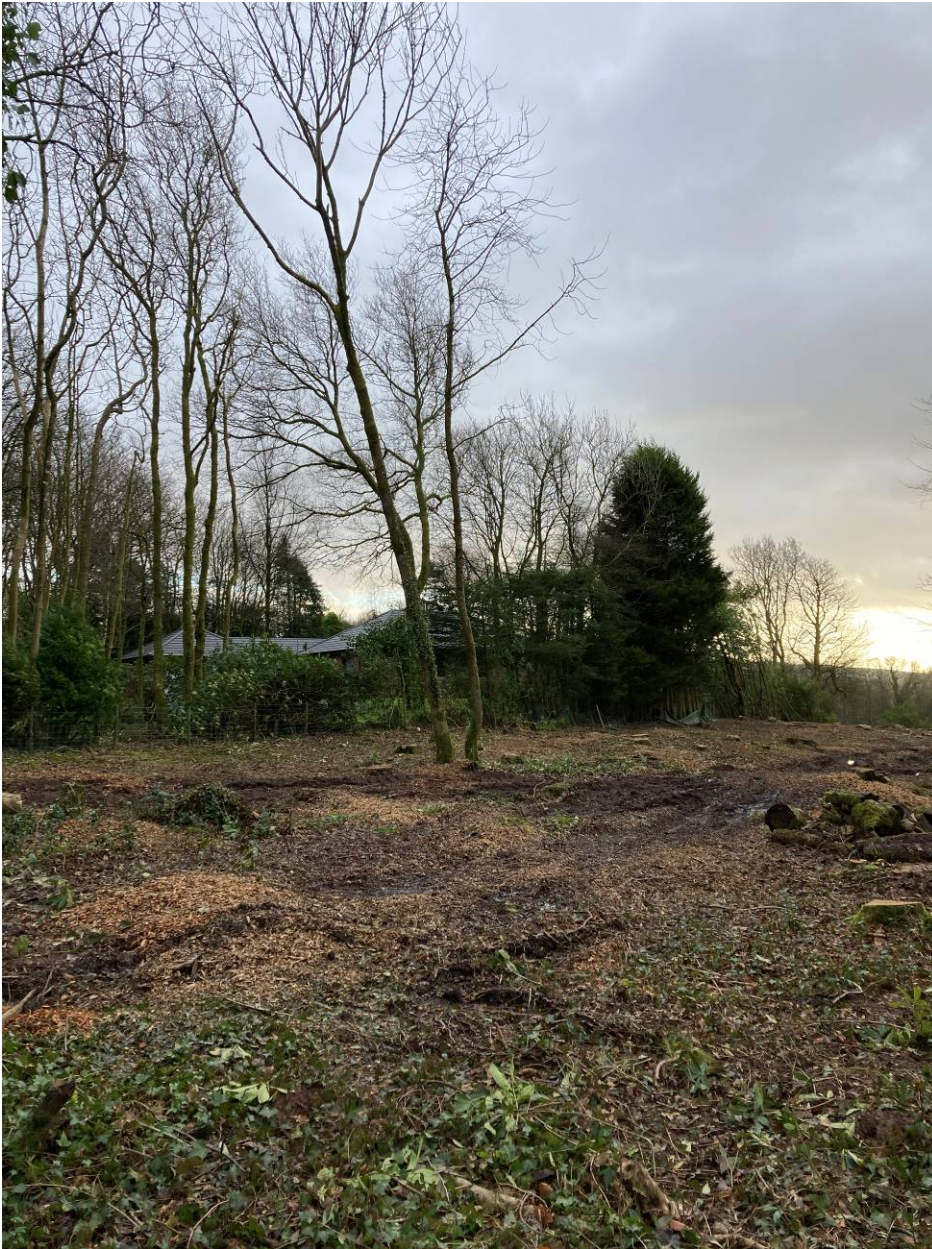
**19. Trees T606 and T605**
