## **TREE SURVEY REPORT**

### **PROPOSED RESIDENTIAL DEVELOPMENT**

**Rheda Cross, Frizington, CA26 3TA**

#### **EAST SITE**

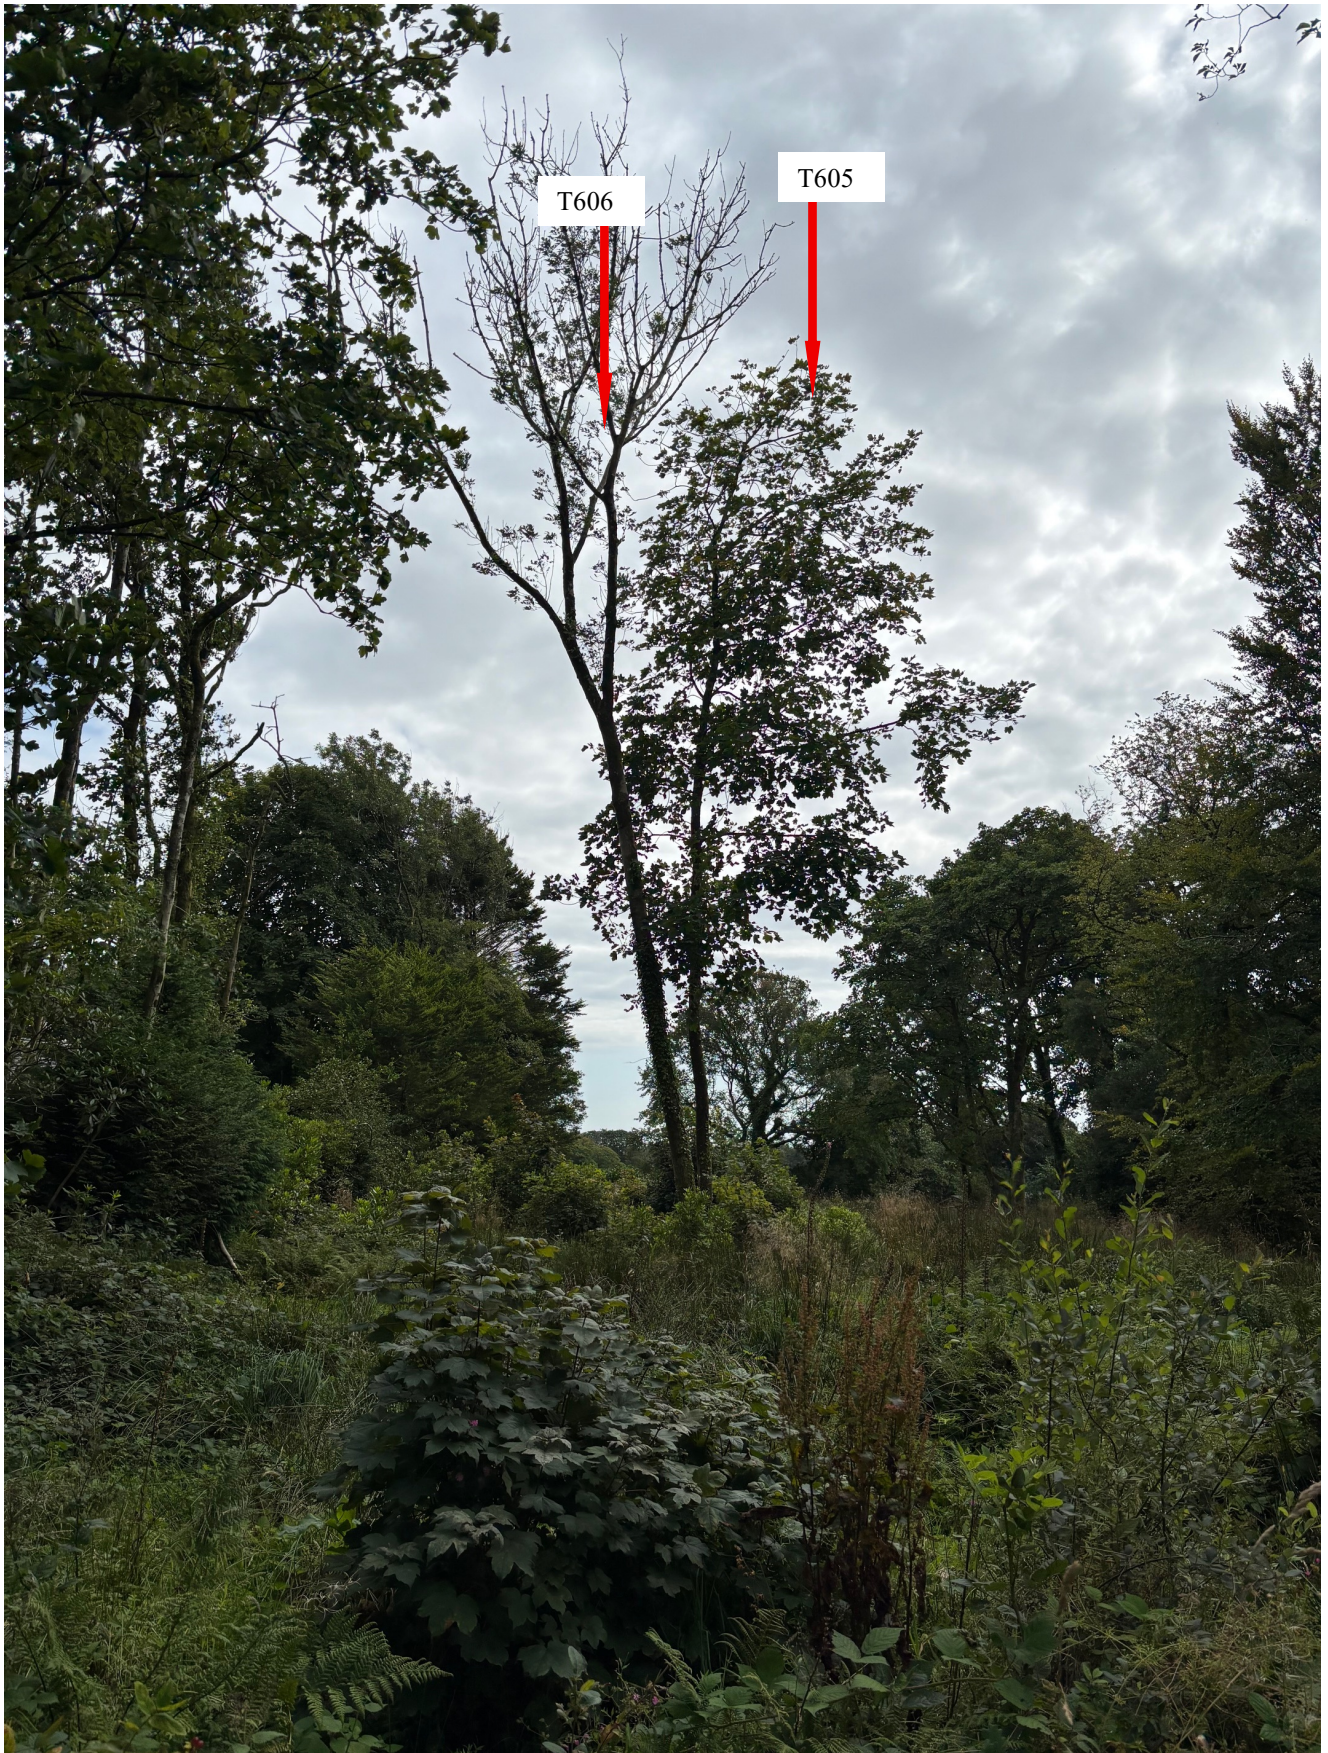
**20. Trees T606 Ash (left) showing signs of severe Ash Dieback and T605 Sycamore which is unsuitable for retention due to its leggy form. Photo from 08.08.25.**

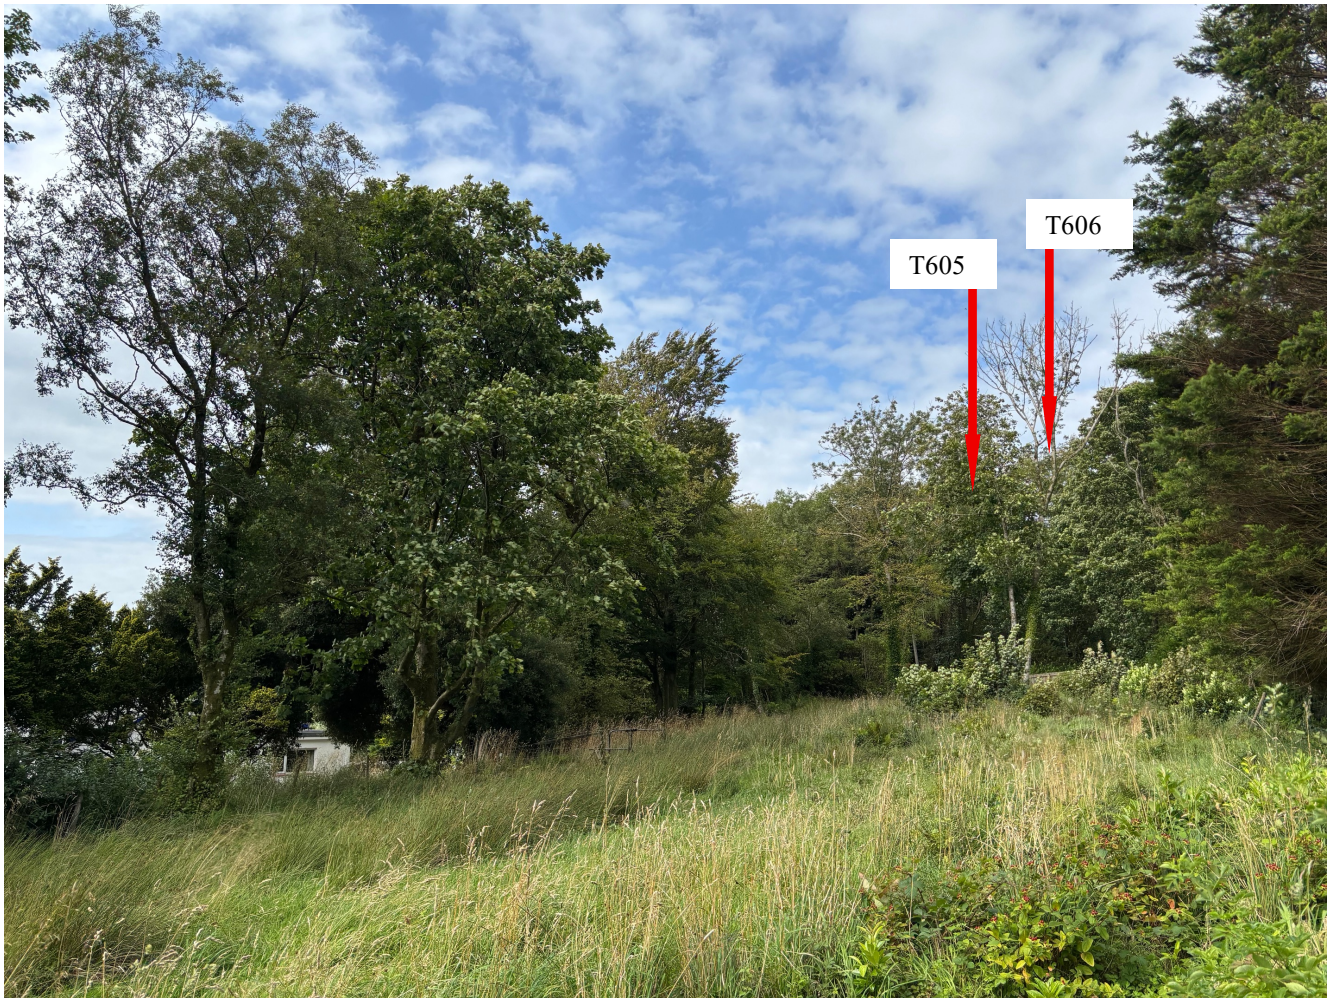
**21. Trees T606 Ash (right) showing signs of severe Ash Dieback and T605 Sycamore which is unsuitable for retention due to its leggy form. Photo from 08.08.25.**

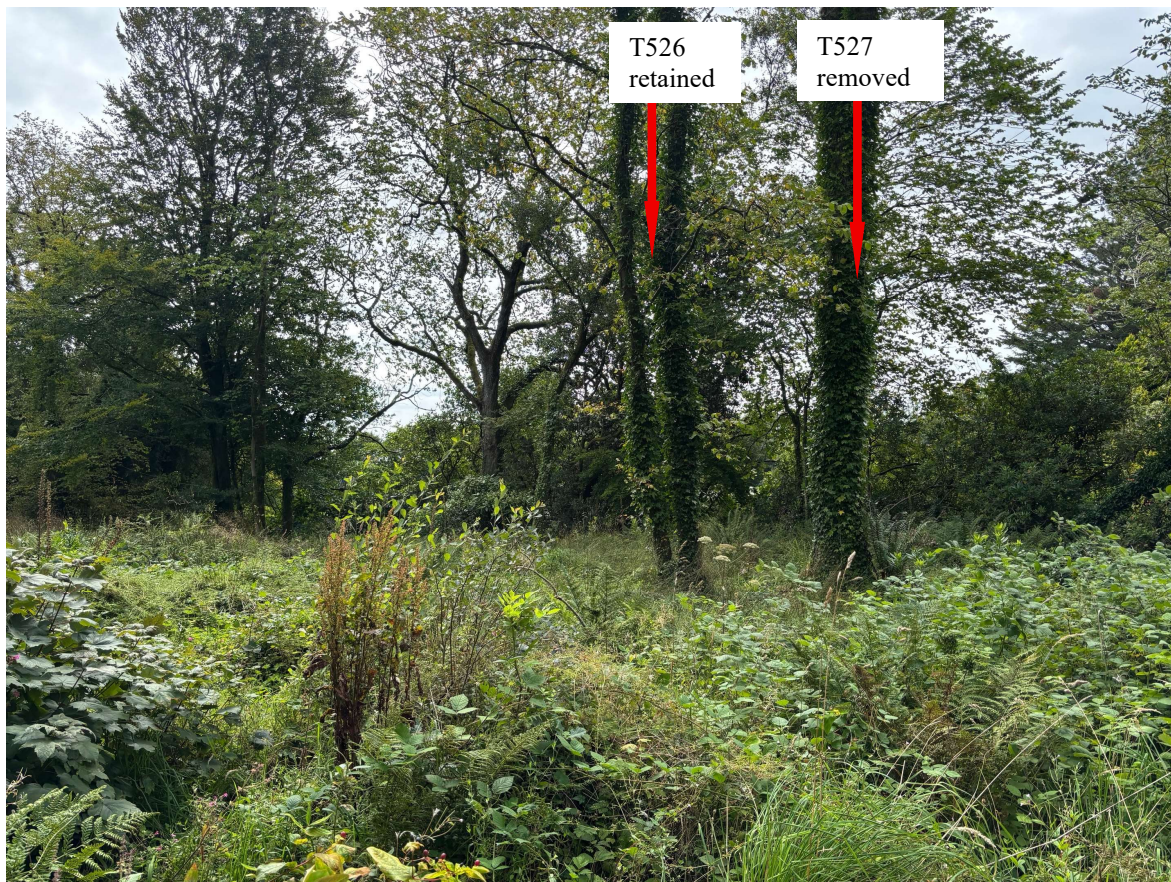
3.4. The proposed house position indicated on the Landscape Plan **WW/L01 Rev D** impedes within the RPA of tree T527, a mature Sycamore. The RPA area is 132sq.m. and 14.8 sq.m. of this area will be covered by wall foundations and perimeter footpath (11% of the total RPA). This extent of intrusion is unlikely to cause significant harm to this tree provided a suitable methodology is adopted for the wall foundations and footpath. **However due to the close proximity to the proposed house we recommend that this tree is removed and replaced with additional mitigation planting. This will give more space for the adjacent Silver Birch tree T526 to grow.**

**22. Tree T527 Sycamore recommended for removal but the adjacent Birch tree T526 will be retained.**

is recommended here rather than a concrete kerb and foundation. Relocation of the drive further eastwards is an alternative solution to avoid the RPA's. If the drive position cannot clear the RPA area then the construction methodology must be adapted to protect the tree roots. This will involve careful excavation by hand or with an air spade to identify and protect any significant roots encountered. Where the house impedes on the RPA of tree T527 the foundation design may have to be adapted to bridge over retained roots. Refer to the Landscape Plan **WW/L01 Revision D** and Detail D01 for the construction methodology. **Following a further site visit on 08.08.25 we advise that this tree is felled and replaced.**
