**PROPOSED DEVELOPMENT: ELIZABETH CRESCENT, WHITEHAVEN  
STAGE 1 ROAD SAFETY AUDIT AND DESIGNER'S RESPONSE**

**PROPOSED DEVELOPMENT: VICTORIA ROAD/BAY VISTA, WHITEHAVEN  
STAGE 1 ROAD SAFETY AUDIT AND DESIGNER'S RESPONSE**

**Land off Elizabeth Crescent, Whitehaven  
Victoria Road/Bay Vista - Proposed Junction Alterations  
Stage 1 Road Safety Audit**

Report No. A102063/RSA1

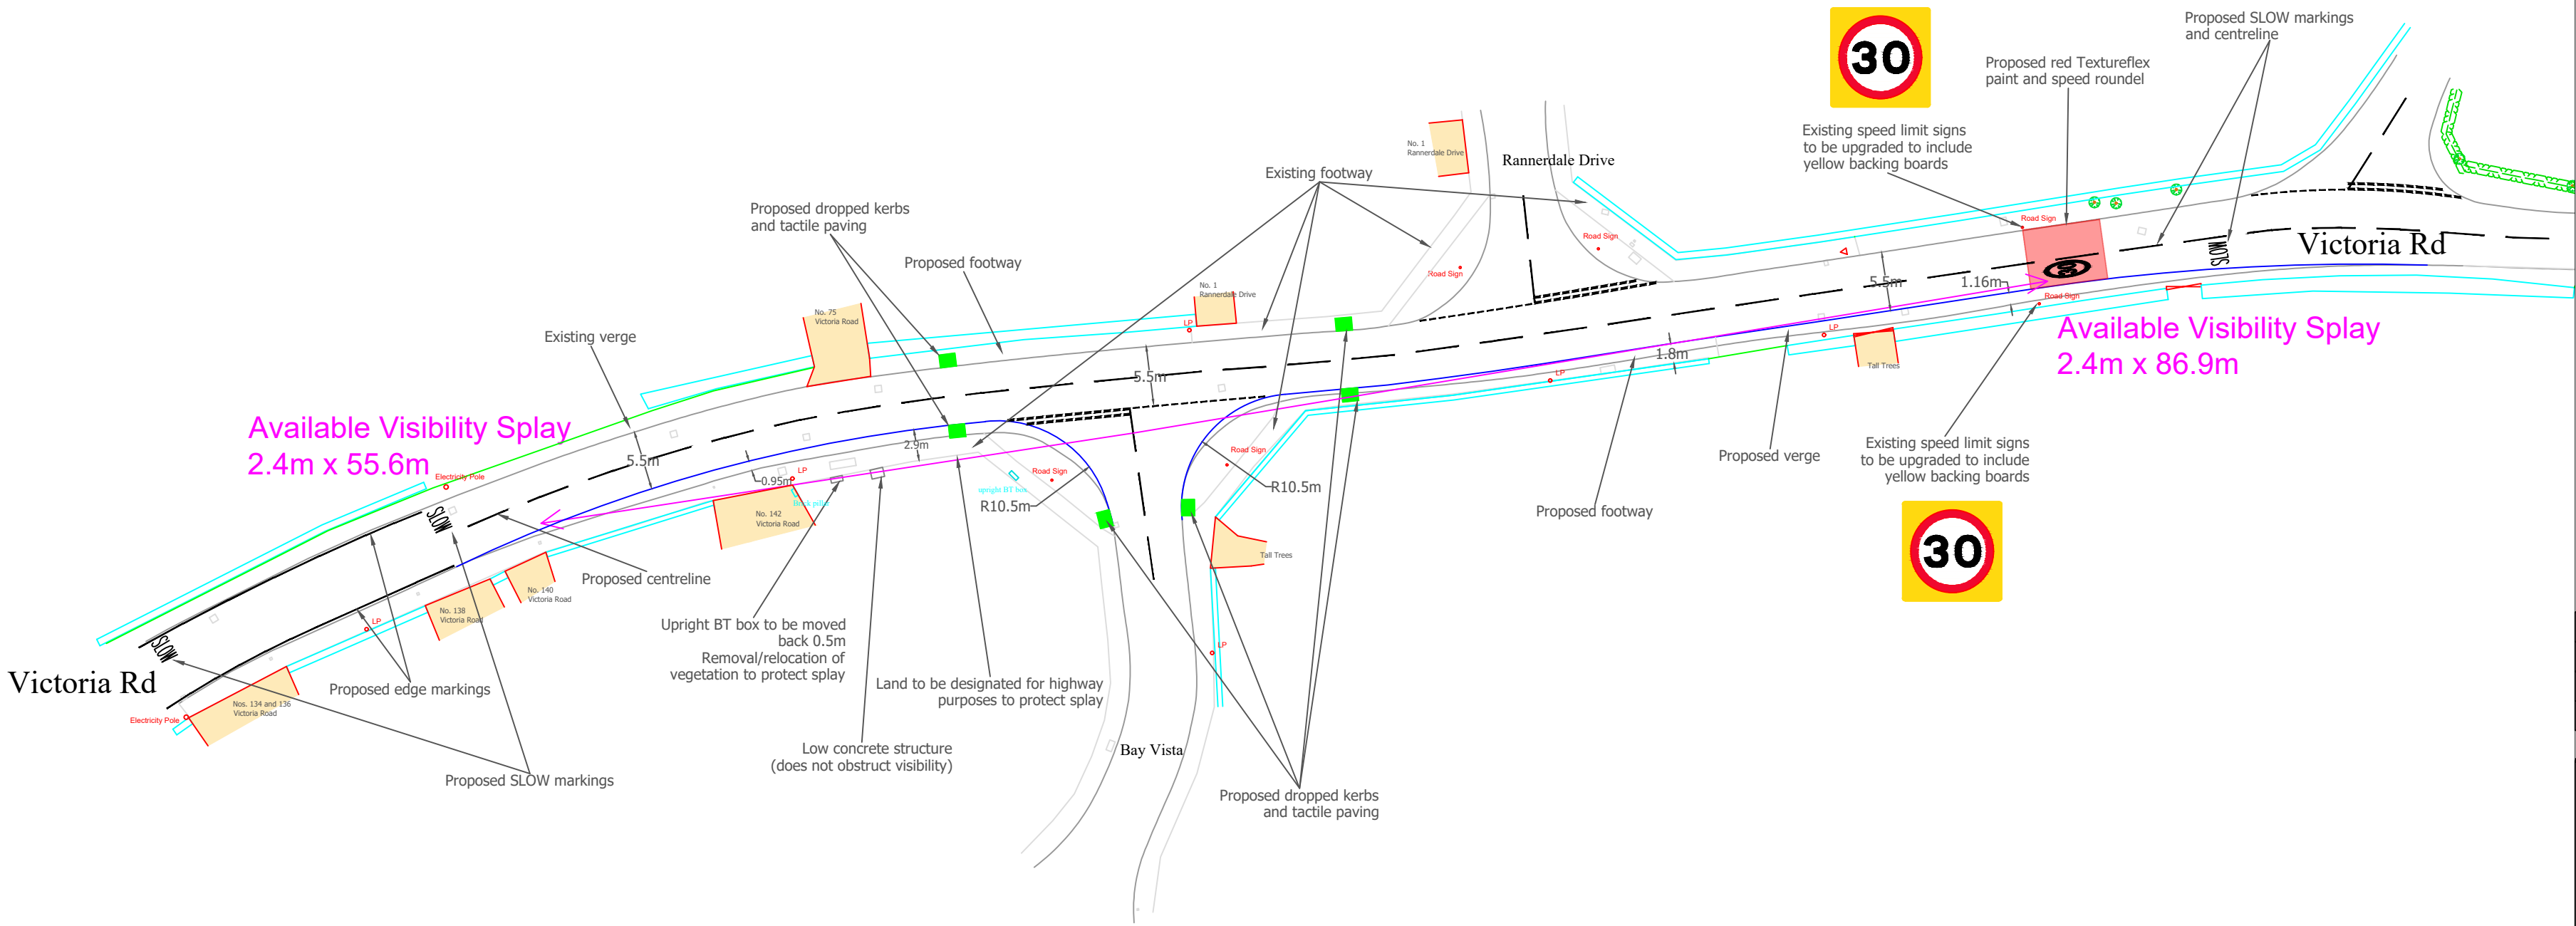
PROPOSED JUNCTION ALTERATIONS  
VICTORIA ROAD/BAY VISTA

| Audit Reference | Problem Summary and Recommendation | Designer's Response |
|---|---|---|
| 3.1 | <p><u>Location:</u><br/>The junction of Victoria Road with Bay Vista.</p> <p><u>Summary:</u><br/>The existing roadside features could compromise mutual visibility at the junction.</p> <p>The land to the west of the junction is to be designated for highway purposes in order to protect the visibility splay and the upright BT box that lies partially within the splay is to be set back. However, there are currently overhanging tree branches and shrubbery close to the splay that could compromise visibility (especially when in full growth), but are not specified for treatment. The absence of mutual visibility at the junction could increase the risk of turning collisions involving both vehicles and pedestrians.</p> <p><u>Recommendation:</u><br/>It is recommended that the detailed design drawings specify the removal or relocation of trees and shrubbery that could compromise visibility, taking into account the potential for re-growth.</p> | <p><u>Response:</u><br/>Recommendation is accepted and has been included on the updated drawing, C001D.</p> |
| 3.2 | <p><u>Location:</u><br/>The pedestrian crossing point on Bay Vista.</p> <p><u>Summary:</u><br/>The location of the crossing could increase the risk of vehicles colliding with pedestrians.</p> <p>The dropped crossing point on the east side of the road is located to coincide with the end of the angled footway, but is within the existing driveway serving Tall Trees. The location of the crossing could increase the risk of collisions between waiting pedestrians and vehicles entering or leaving the driveway. In addition, motorists beginning the turn into the driveway might brake suddenly to allow pedestrians to clear the driveway, with the attendant risk of tail end strikes from following vehicles.</p> <p><u>Recommendation:</u><br/>It is recommended that the crossing is located outside the extents of the driveway. If it is installed to the north, short sections of footway</p> | <p><u>Response:</u><br/>Recommendation is accepted and has been included on the updated drawing, C001D.</p> |

| 3.3 | <p><u>Location:</u><br/>The junction of Victoria Road with Bay Vista.</p> <p><u>Summary:</u><br/>The incorrect pattern of tactile paving could increase the risk of vehicles colliding with pedestrians.</p> <p>Although only schematic at present, the drawing shows shapes for the tactile paving at the pedestrian crossing points that could be construed as two or three rows. If specified and installed as such, they could be interpreted by visually impaired pedestrians as crossings remote from a junction rather than inset from it. This could make them unaware of the possibility of encountering turning vehicles and increase the risk of collisions.</p> <p><u>Recommendation:</u><br/>It is recommended that the tactile paving at each crossing point is specified as a depth of 400-450 mm (a single row of paving) – the pattern for that of an inset crossing – as the detailed design progresses. However, if the recommendation in 3.2 above is accepted and progressed, and the crossing is located to the south of the driveway serving Tall Trees, the pattern for that crossing should be specified as that remote from a junction.</p> | <p><u>Response:</u><br/>Recommendation is accepted.</p> <p>The pattern of tactile paving will be specified to the appropriate crossing types during the detailed design stage.</p> |
| 3.4 | <p><u>Location:</u><br/>Victoria Road.</p> <p><u>Summary:</u><br/>Differential grip could lead to pedestrians slipping and falling.</p> <p>The scheme involves a new section of footway and a footway widening. If a different type of surface finish is used for the new areas of footway compared with the existing, it is possible that, in wet or freezing conditions, the two finishes could look similar but exhibit different degrees of slip resistance, increasing the risk of slips and falls as users move from one surface to another.</p> <p><u>Recommendation:</u><br/>It is recommended that the existing and new surface materials have similar properties in terms of slip resistance in wet or freezing conditions.</p> | <p><u>Response:</u><br/>Recommendation is accepted and surface materials will be specified at the detailed design stage.</p> |

| D | ALTERATIONS FOLLOWING RSA1 | | | EB | NB | NB | 06.01.20 |

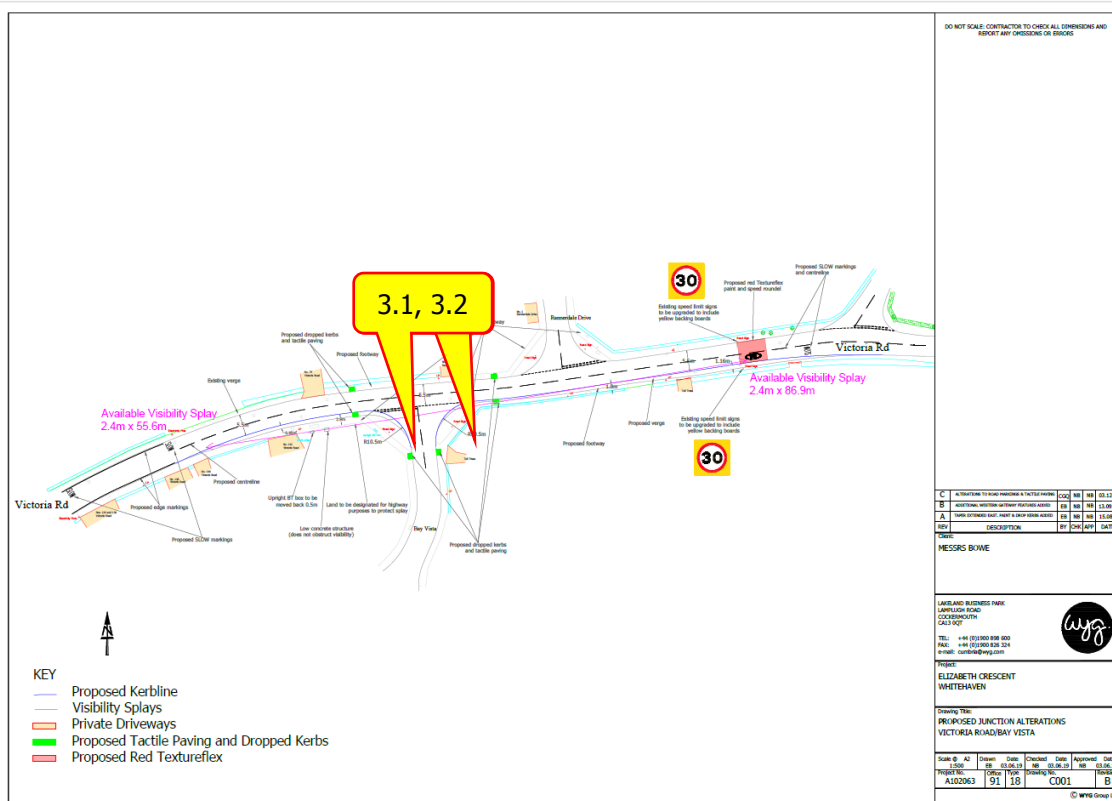
## 6. LOCATION PLAN OF ITEMS RAISED BY THIS AUDIT

Location: The junction of Victoria Road with Bay Vista.

Summary: The existing roadside features could compromise mutual visibility at the junction.

The land to the west of the junction is to be designated for highway purposes in order to protect the visibility splay and the upright BT box that lies partially within the splay is to be set back. However, there are currently overhanging tree branches and shrubbery close to the splay that could compromise visibility (especially when in full growth), but are not specified for treatment. The absence of mutual visibility at the junction could increase the risk of turning collisions involving both vehicles and pedestrians.

Location: The pedestrian crossing point on Bay Vista.

Summary: The location of the crossing could increase the risk of vehicles colliding with pedestrians.

The dropped crossing point on the east side of the road is located to coincide with the end of the angled footway, but is within the existing driveway serving Tall Trees. The location of the crossing could increase the risk of collisions between waiting pedestrians and vehicles entering or leaving the driveway. In addition, motorists beginning the turn into the driveway might brake suddenly to allow pedestrians to clear the driveway, with the attendant risk of tail end strikes from following vehicles.

Summary: The incorrect pattern of tactile paving could increase the risk of vehicles colliding with pedestrians.

Although only schematic at present, the drawing shows shapes for the tactile paving at the pedestrian crossing points that could be construed as two or three rows. If specified and installed as such, they could be interpreted by visually impaired pedestrians as crossings remote from a junction rather than inset from it. This could make them unaware of the possibility of encountering turning vehicles and increase the risk of collisions.

Location: Victoria Road.

Summary: Differential grip could lead to pedestrians slipping and falling.

The scheme involves a new section of footway and a footway widening. If a different type of surface finish is used for the new areas of footway compared with the existing, it is possible that, in wet or freezing conditions, the two finishes could look similar but exhibit different degrees of slip resistance, increasing the risk of slips and falls as users move from one surface to another.

It is recommended that the detailed design drawings specify the removal or relocation of trees and shrubbery that could compromise visibility, taking into account the potential for re-growth.

It is recommended that the crossing is located outside the extents of the driveway. If it is installed to the north, short sections of footway may need to be constructed to connect the existing angled footways to the crossing points.

It is recommended that the tactile paving at each crossing point is specified as a depth of 400-450 mm (a single row of paving) – the pattern for that of an inset crossing – as the detailed design progresses. However, if the recommendation in 3.2 above is accepted and progressed, and the crossing is located to the south of the driveway serving Tall Trees, the pattern for that crossing should be specified as that remote from a junction.

It is recommended that the existing and new surface materials have similar properties in terms of slip resistance in wet or freezing conditions.
