# Draft Phase 2: Site Investigation

**Site A, Leconfield Industrial Estate, Cleator Moor  
Copeland Borough Council**

**S220141**

**Solmek Ltd**

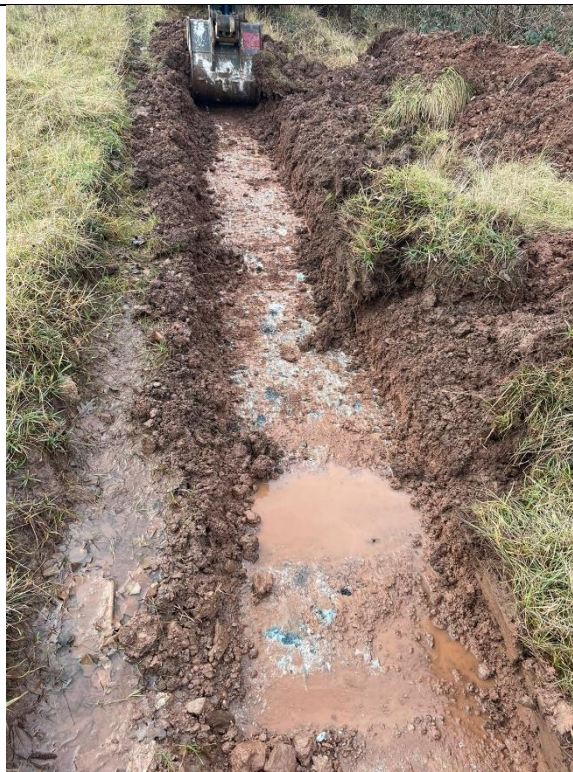
Figure 10: Area of slit trenching around Shaft 006.

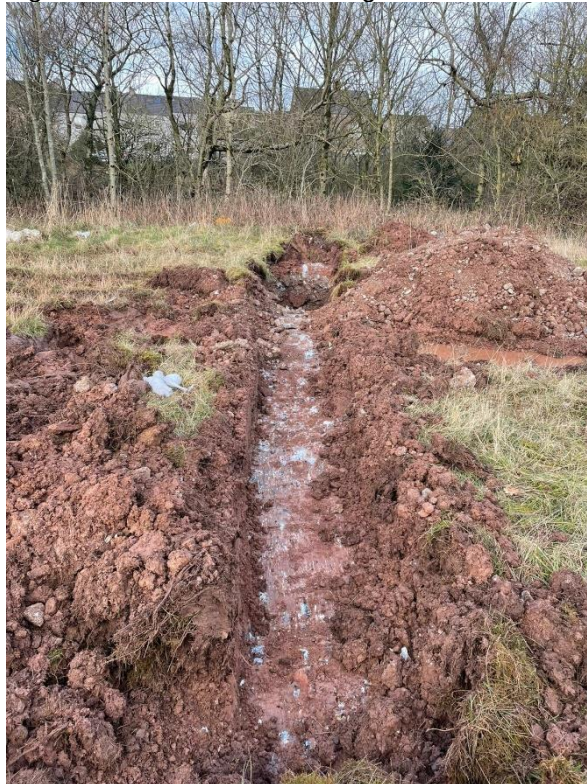
Figure 11: Area of slit trenching around Shaft 006.

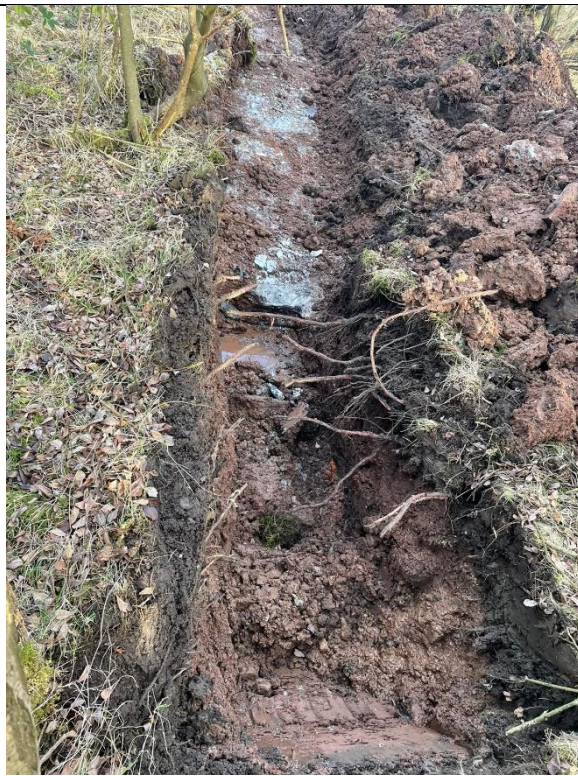
Figure 12: Area of slit trenching around Shaft 008.

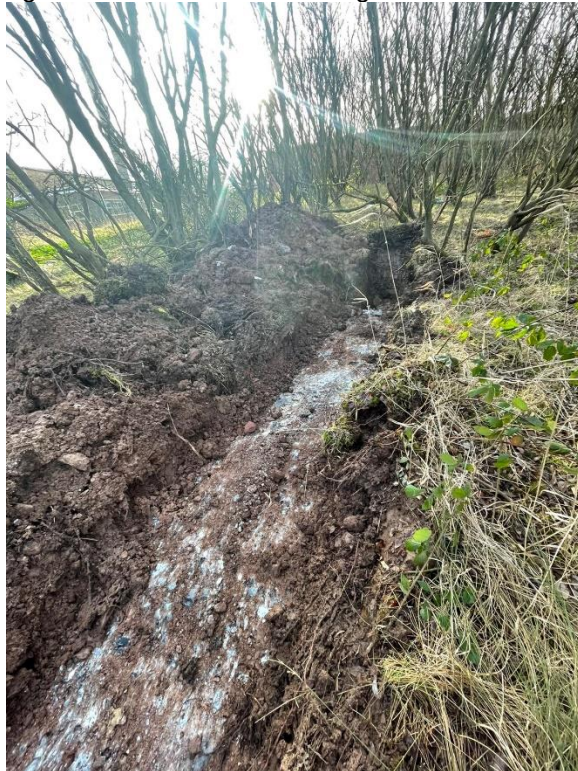
Figure 13: Area of slit trenching around Shaft 008.

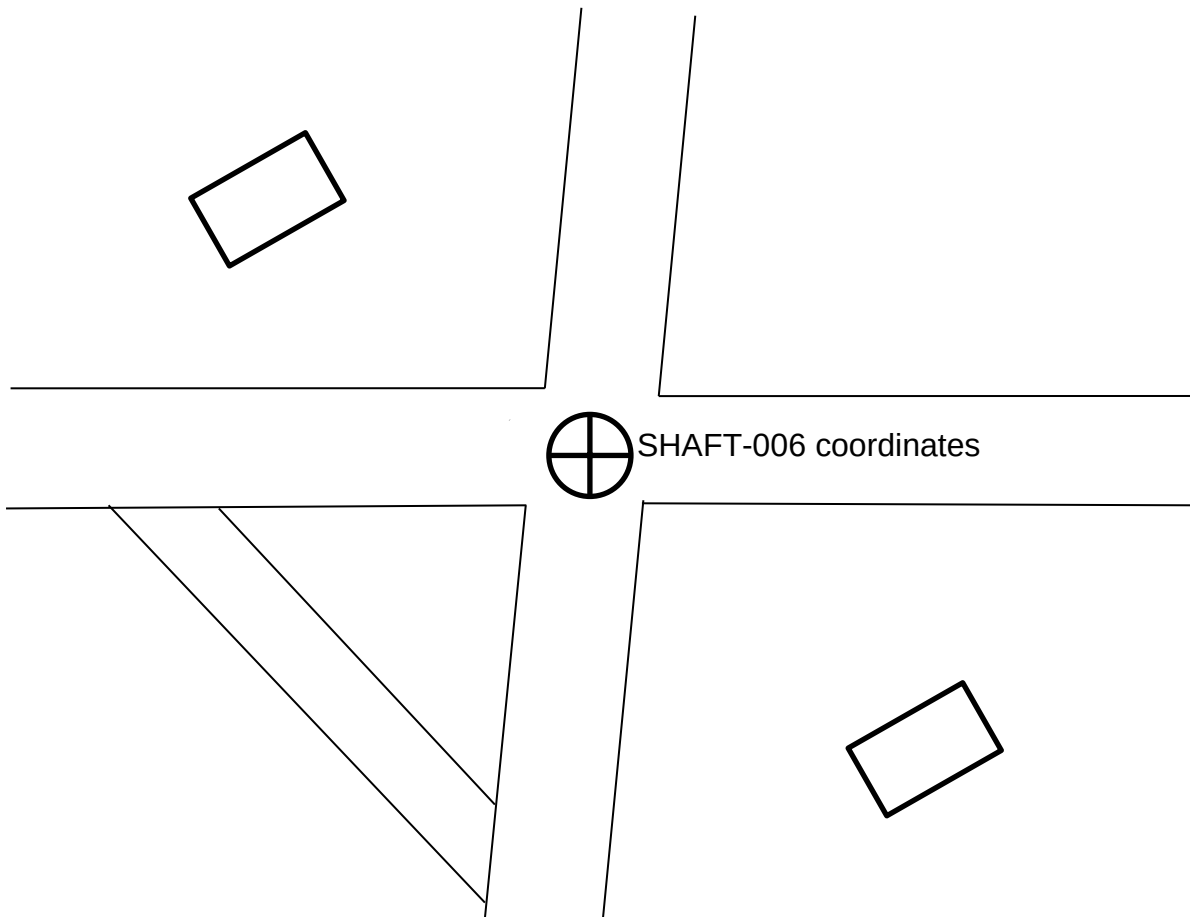
SHAFT-006

Pecked into slag from 0.30m-0.60m at  
centre of shaft marked ⊕

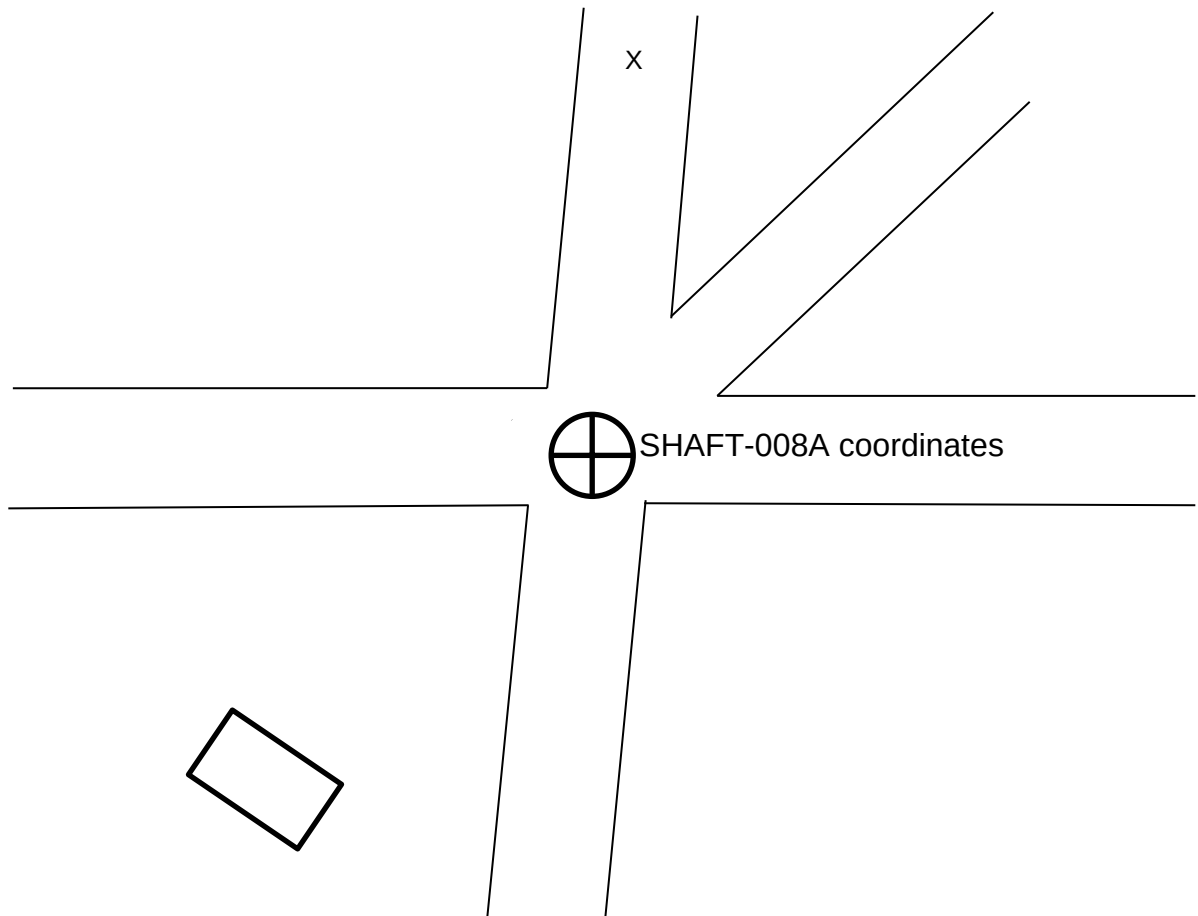
SHAFT-008A AND SHAFT-008B

X denotes area with slag absent until  
0.50mbgl
