# The Stirling Memorial Fountain, Cleaton Moor

Proposals for Fountain Restoration.

***Edited Version - Associated with Level 2 Historic Buildings Record Report***

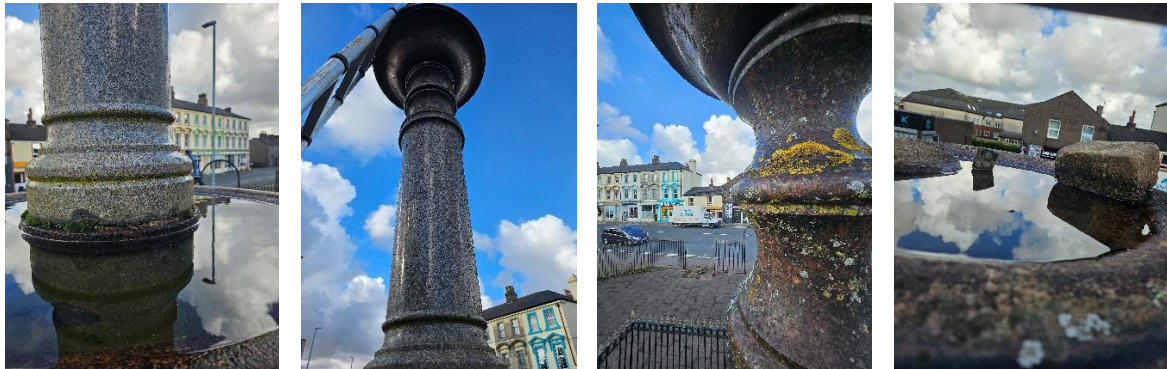
The upper bowl is approximately 0.8m diameter. From information provided by others there was originally a bronze stork set within the upper bowl from which the water for the fountain display emitted, fixing points for the stork remain within the bowl.

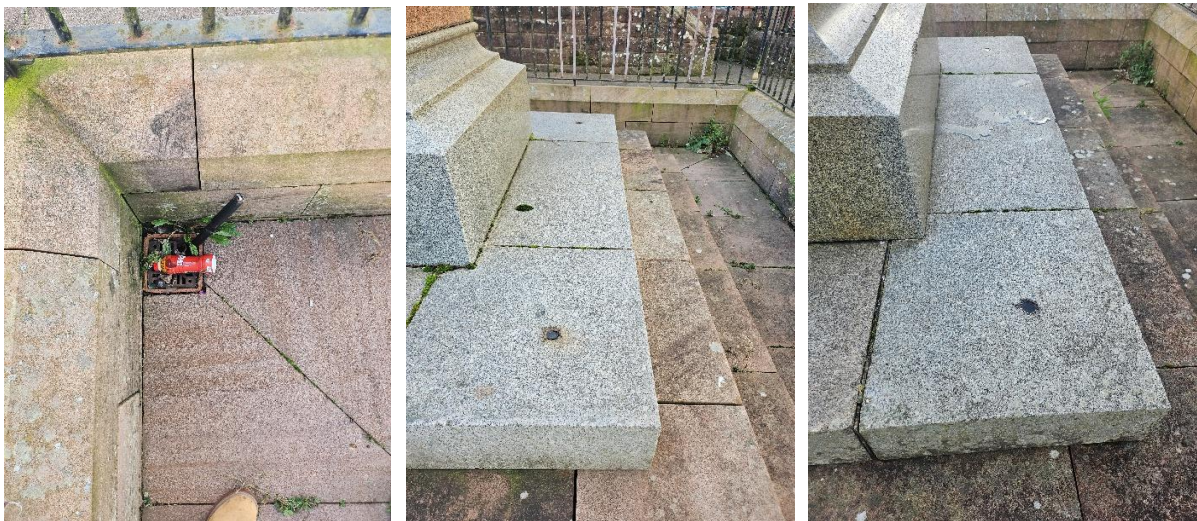
The lower pool area incorporates a floor drain however this is likely to only serve as a drain for rainfall etc. The square step of grey Rubislaw granite incorporates remains of dowels in each corner which from historical information located four red granite vases set on circular plinths.

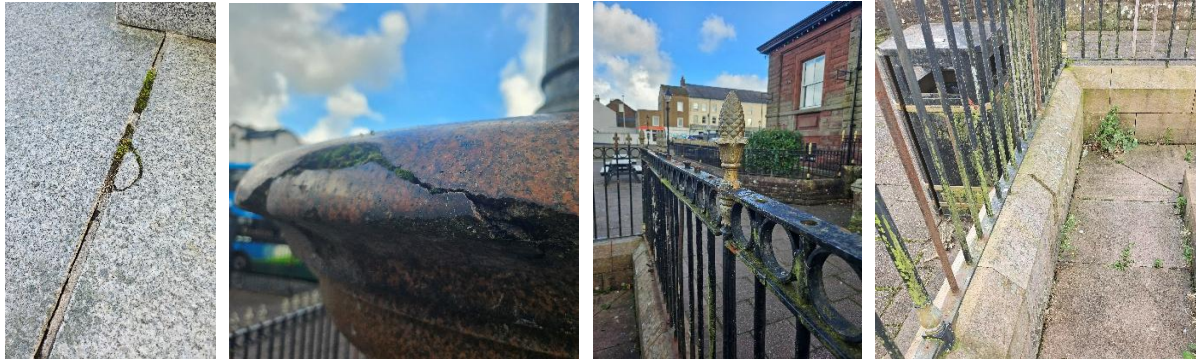
Iron railings surmount the outer wall which match the railings set around the adjacent buildings, although these have suffered some damaged to the tops.

The overall condition of the structure appears satisfactory, but some of the pointing at the joint lines of each granite section has deteriorated, and some of the sandstone wall sections have been pushed out of line. There is also slight frost damage to the main bowl.
