**NADIR RASHID**  
**PROPERTY INTELLECTS LTD**  
Job Ref. **SK-S 068-2026 37 HIGH ST**  
22/06/2026  
MSCC5 Drain and Sewer Codes (SRM5 Scoring)

## Report Overview

| Notes/Purpose of Survey |
|---|
| SURVEY OF THE EXISTING DRAINAGE |

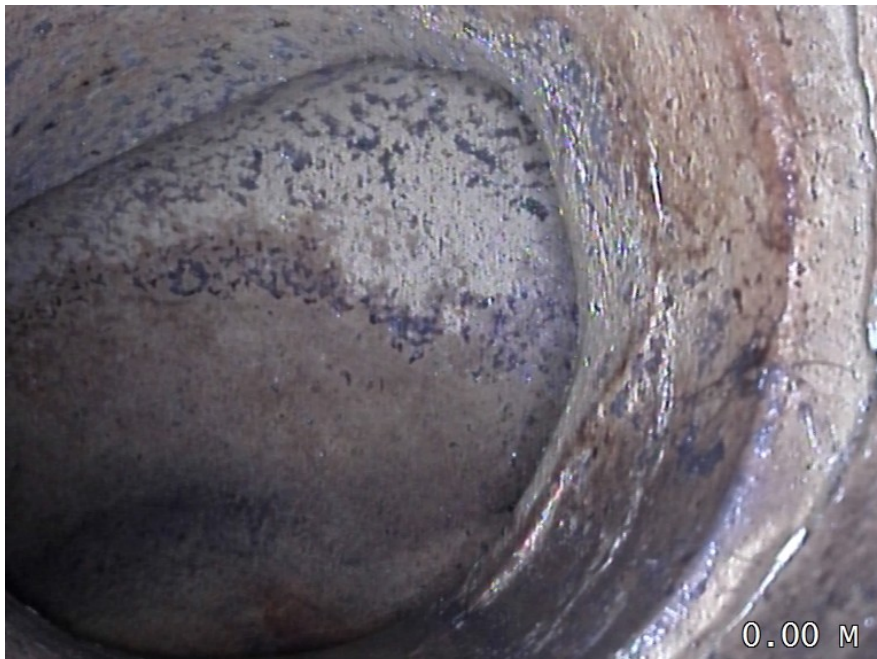
**S1C2**

00:00:00 - 0.00 m  
Water level 0% height/diameter

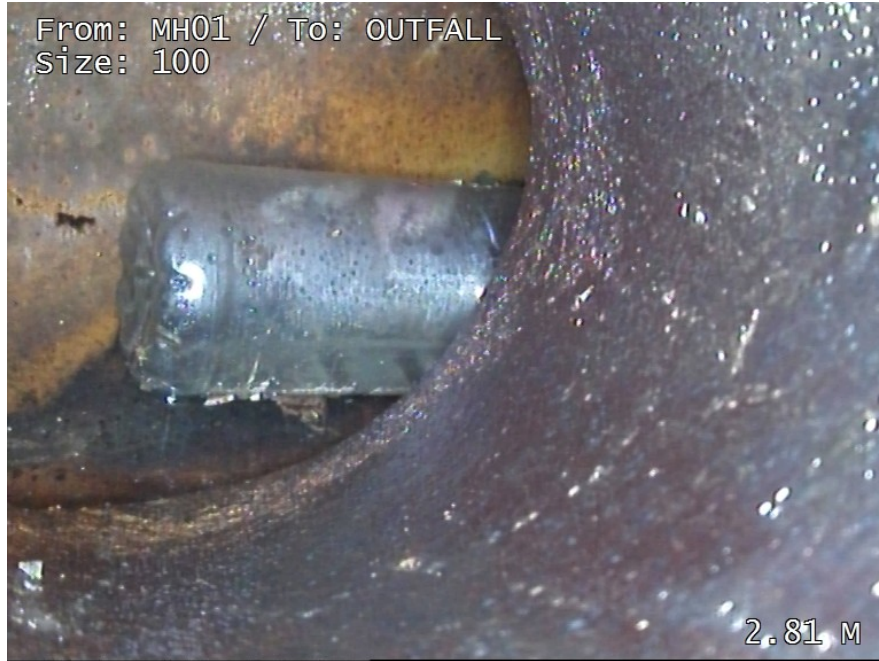
S1C4

Finish node type, major connection without manhole, reference OUTFALL MAINS CONNECTION

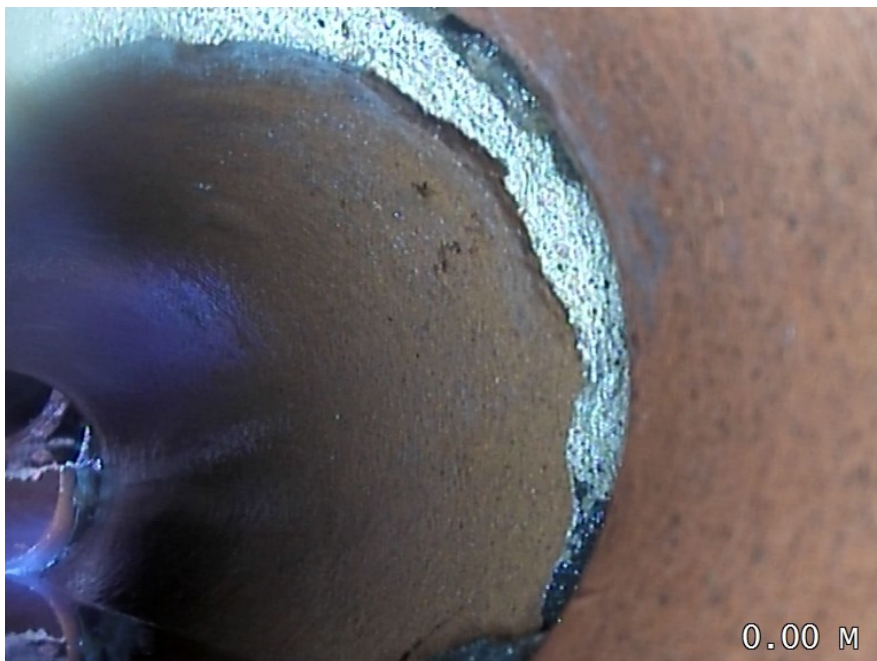
**S2C2**

00:00:00 - 0.00 m  
Water level 0% height/diameter

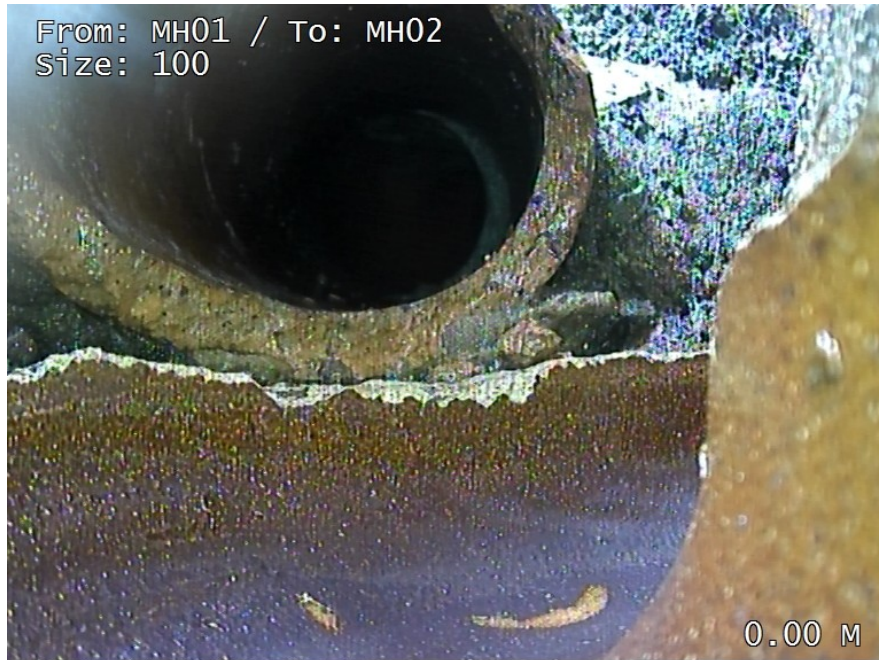
S2C3

Finish node type, manhole, reference MH02

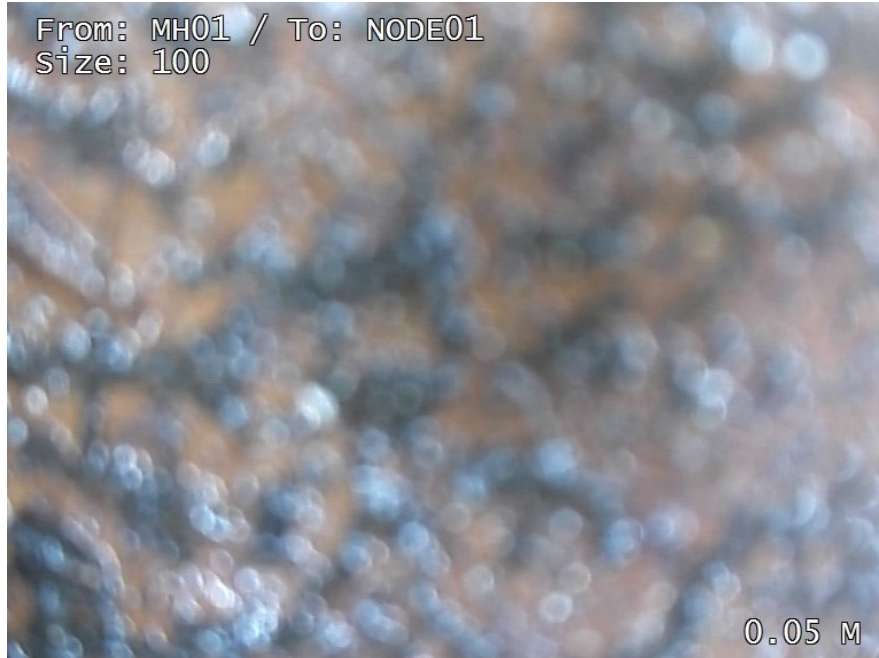
**S3C3**

Finish node type, gully, reference NODE01

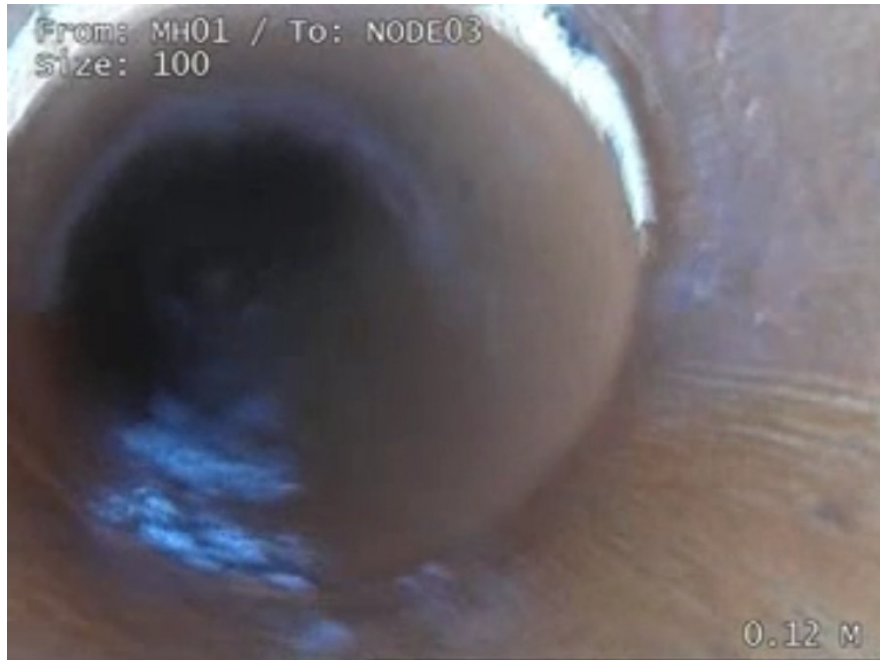
**S5C3**

00:00:01 - 0.12 m  
Joint displaced 20mm

| Structural Defect | Quantity |
|---|---|
| Displaced joints | 1 |

| Survey 5 - MH01 to NODE03 (22/06/2026) | |
|---|---|
| Pipe Length: <b>0.93m</b><br>Inspection Length: <b>0.93m</b><br>Structural Grade: <b>4</b><br>Service Grade: <b>0</b><br>Material: <b>Vitrified clay</b><br>Pipe Size: <b>100mm</b><br>Use: <b>Combined</b> | PIPE FRACTURED AT 0.69M, JOINT DISPLACED AT 0.12M |

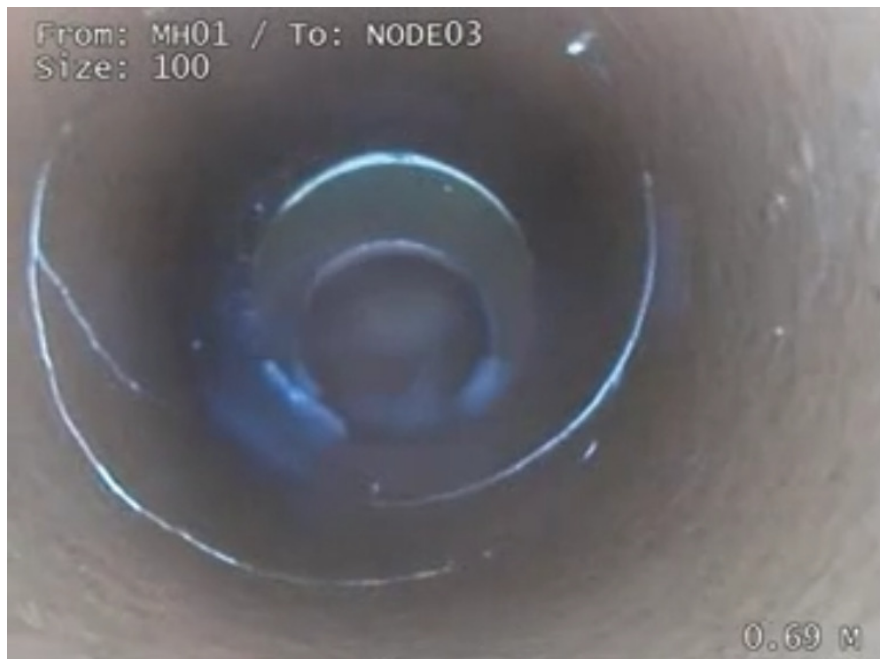
**S5C4**

| Section | PLR | Grade | Fault Description |
|---|---|---|---|
| 5 | NODE03 X | 4 | Multiple defects, made up of displaced joints & fractures |

00:00:04 - 0.69 m  
Fracture circumferential from 3 to 10 o'clock

| Pipeline Length Ref.<br><b>NODE03 X</b> | Direction<br><b>Upstream</b> | Upstream Node<br><b>MH01</b> | Downstream Node<br><b>NODE03</b> | Pipe Material<br><b>Vitrified clay</b> | Dia/Height<br><b>100 mm</b> |
|---|---|---|---|---|---|
| 0.69 | FC | Fracture circumferential from 3 to 10 o'clock | | | |

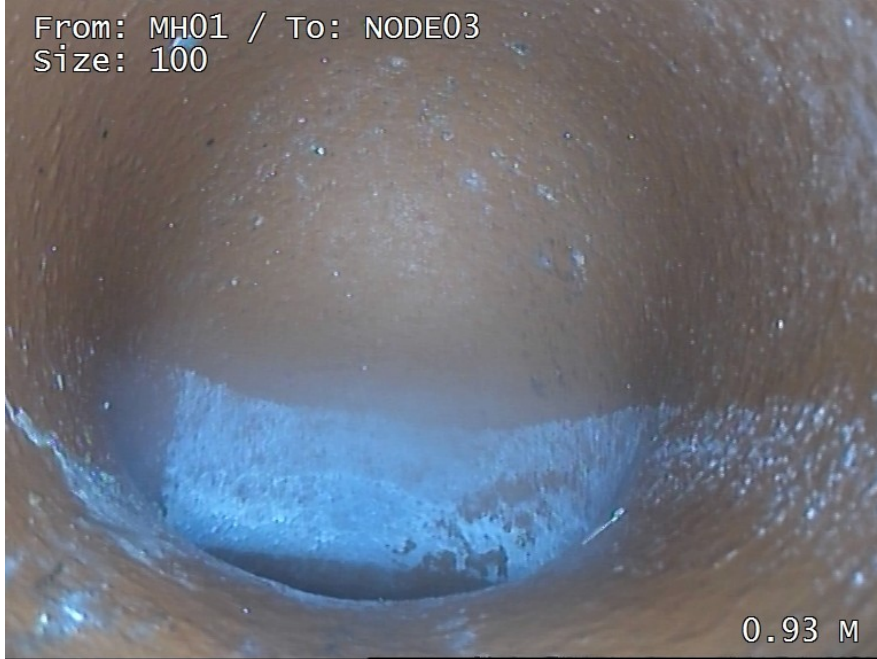
S5C5

Finish node type, gully, reference NODE03 INT GULLY

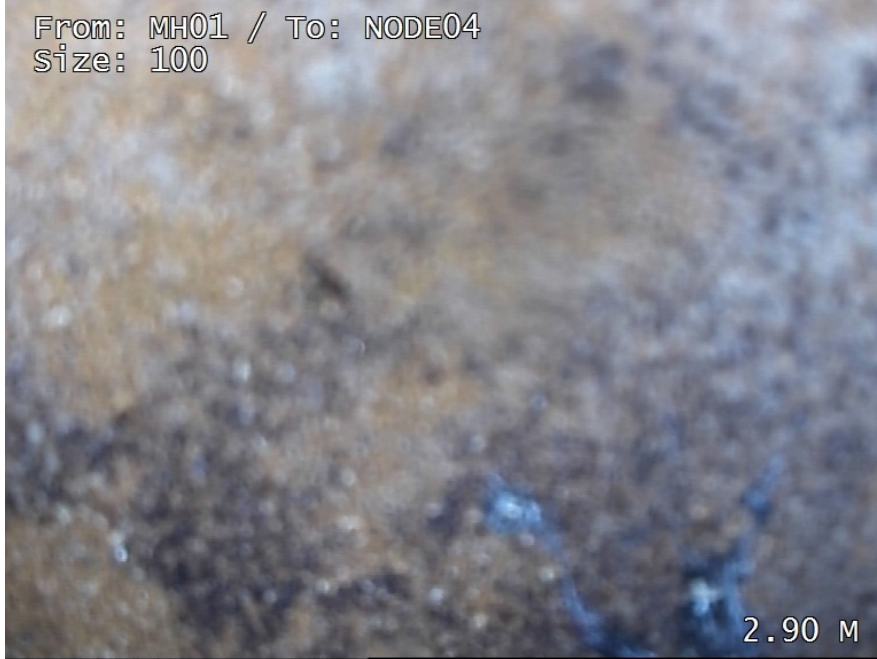
**S6C3**

Finish node type, gully, reference NODE04 INT GULLY

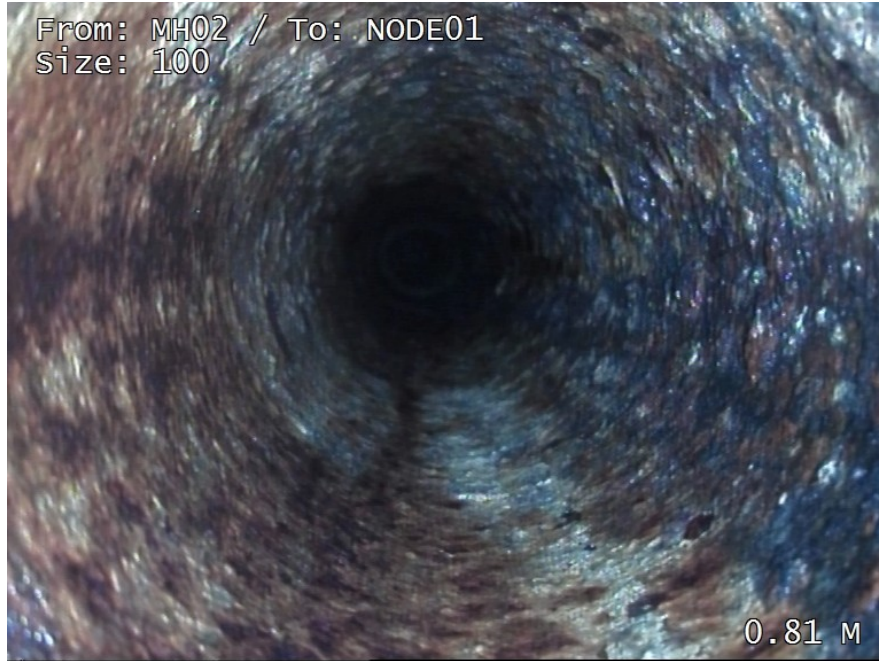
S7C3

Finish node type, major connection without manhole, reference NODE01 SVP

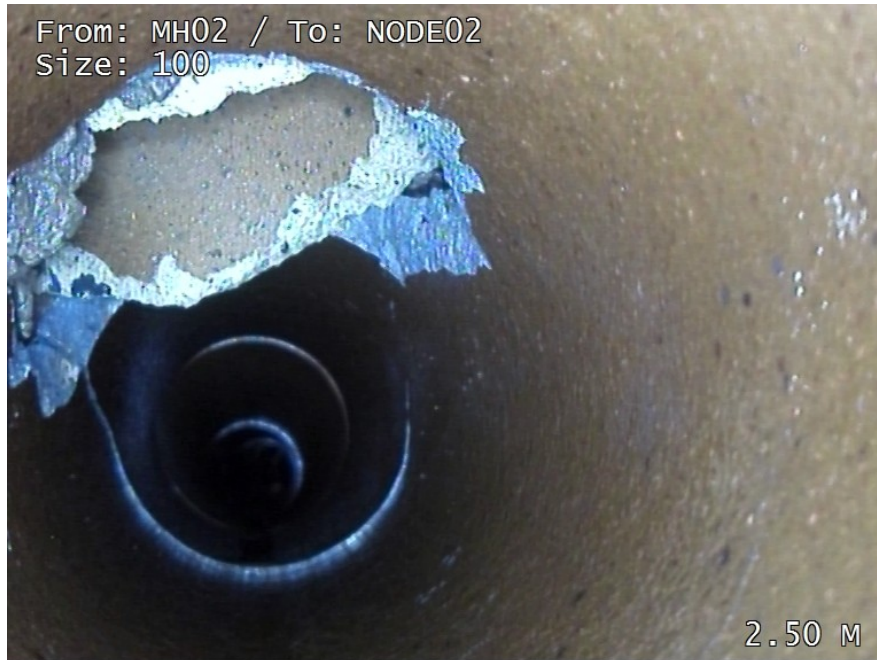
**S8C3**

| Section | PLR | Grade | Fault Description |
|---|---|---|---|
| 8 | NODE02 X | 4 | Defective connections |

Connection defective, connecting pipe is damaged at 11 o'clock, diameter 100mm, intrusion 10%

| Pipeline Length Ref.<br><b>NODE02 X</b> | Direction<br><b>Upstream</b> | Upstream Node<br><b>MH02</b> | Downstream Node<br><b>NODE02</b> | Pipe Material<br><b>Vitrified clay</b> | Dia/Height<br><b>100 mm</b> |
|---|---|---|---|---|---|
| 2.5 | CXDI | Connection defective, connecting pipe is damaged at 11 o'clock, diameter 100mm, intrusion 10% | | | |

Pipe Length: **7.31m** POORLY INSTALLED CONNECTION NOTED AT 2.5M  
Inspection Length: **7.31m**  
Structural Grade: **4**  
Service Grade: **0**  
Material: **Vitrified clay**  
Pipe Size: **100mm**  
Use: **Combined**

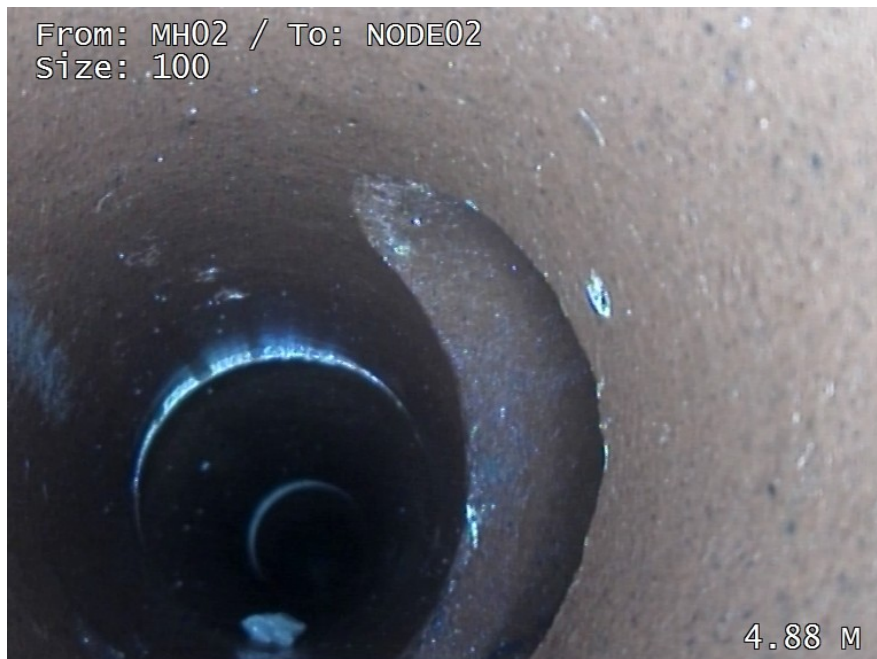
**S8C4**

Junction at 3 o'clock, diameter 100mm

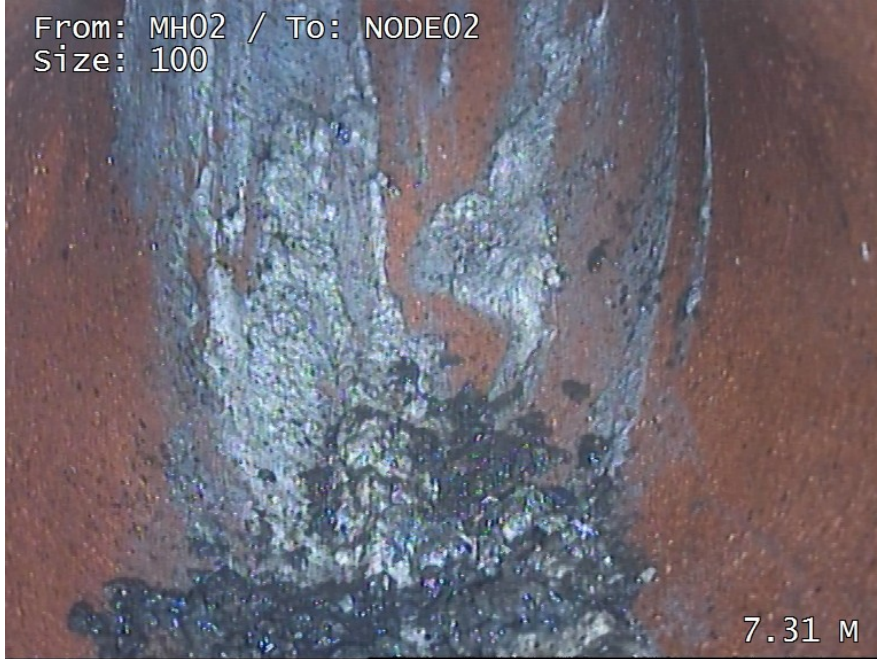
S8C5

Finish node type, major connection without manhole, reference NODE02
