## **VISUAL STRUCTURAL INSPECTION**

**BARNS ADJACENT TO  
MOWBRAY FARM  
FRIZINGTON  
CUMBRIA**

**Reference - WDS/05/9202/REP01**

**Date - 25/04/2025**

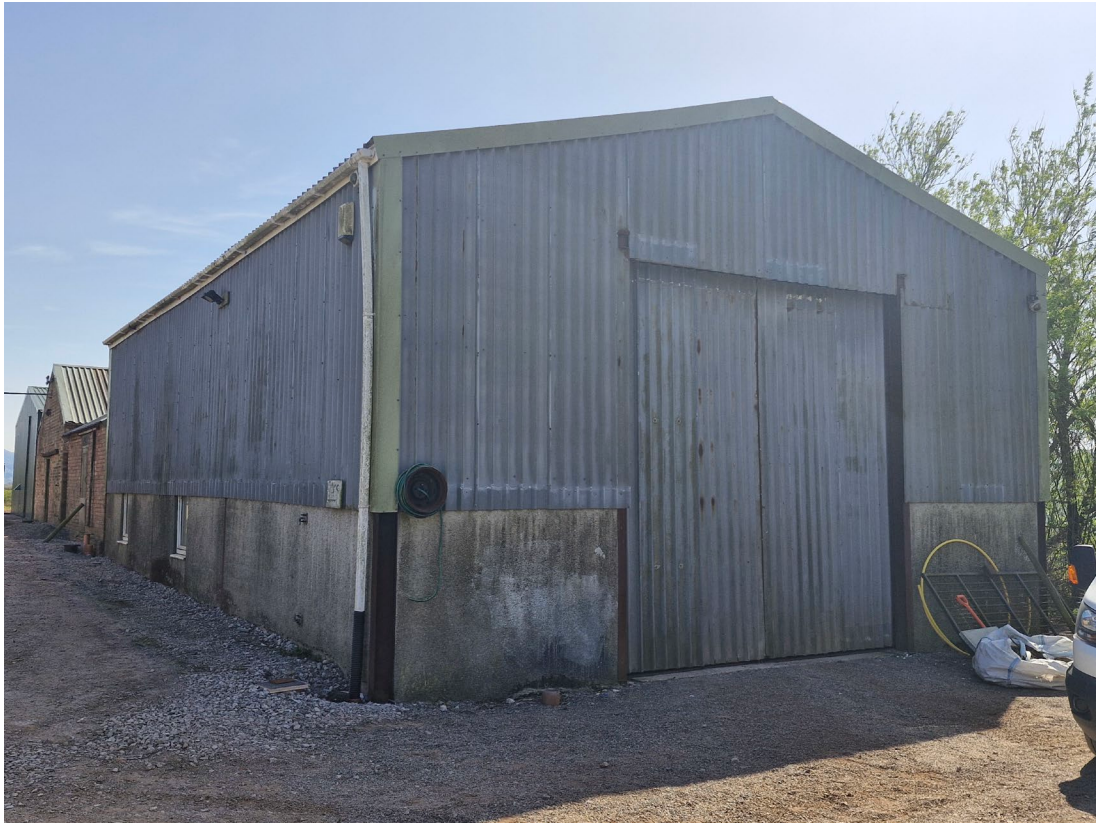
PHOTO 01 VIEW ON BARN 1 FRONT ELEVATION

- 2.1** Barn 1 and 5 steel frames have some surface rust throughout however this has not compromised the structural integrity of the buildings. The frames appear structurally suitable and do not show any signs of distress or excessive deflection that would affect its conversion. The proposed conversion works will be sympathetic to the existing structure and will not apply any additional loading to the existing frames.

- 3.1** Barn 1 and 5 are structurally adequate in their current form and it is proposed to convert the buildings sympathetically to the existing structures. We propose a new masonry and timber framed structure is built internally around the frame to allow the frame to be retained whilst relieving loading off the steel frame and thus not compromising the existing barn structure. The steel frame will need cleaned down and painted with a rust inhibiting paint.

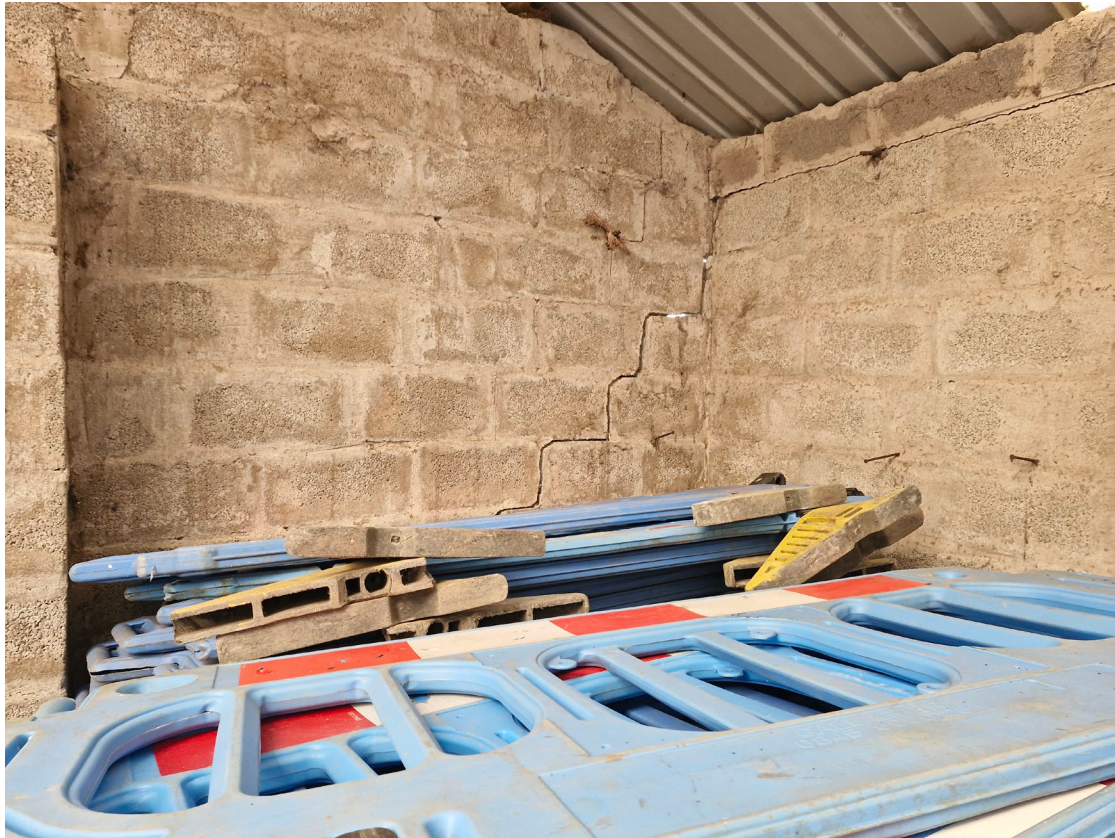
- 2.2** Barn 4 rear wall is cracked (see photograph 09 attached). The cracking is consistent with structural movement of the foundations. It appears that the building has been built on raised ground, the ground may have settled towards the rear extent. The steel roof trusses are excessively rusted and the purlins are structurally inadequate when considering a insulated boarded roof structure; the roof will need replaced as part of any conversion scheme.

PHOTO 09 CRACKING TO REAR WALL BARN 4

- 3.2** Barn 4 needs the rear wall underpinned and the cracking to the rear gable masonry wall tied. Depending on the foundation extent it may be more cost effective to rebuild the rear wall off a new foundation. The roof structure will need replaced as part of any conversion scheme. With the works noted completed the building will be suitable to be retained as part of a conversion scheme.

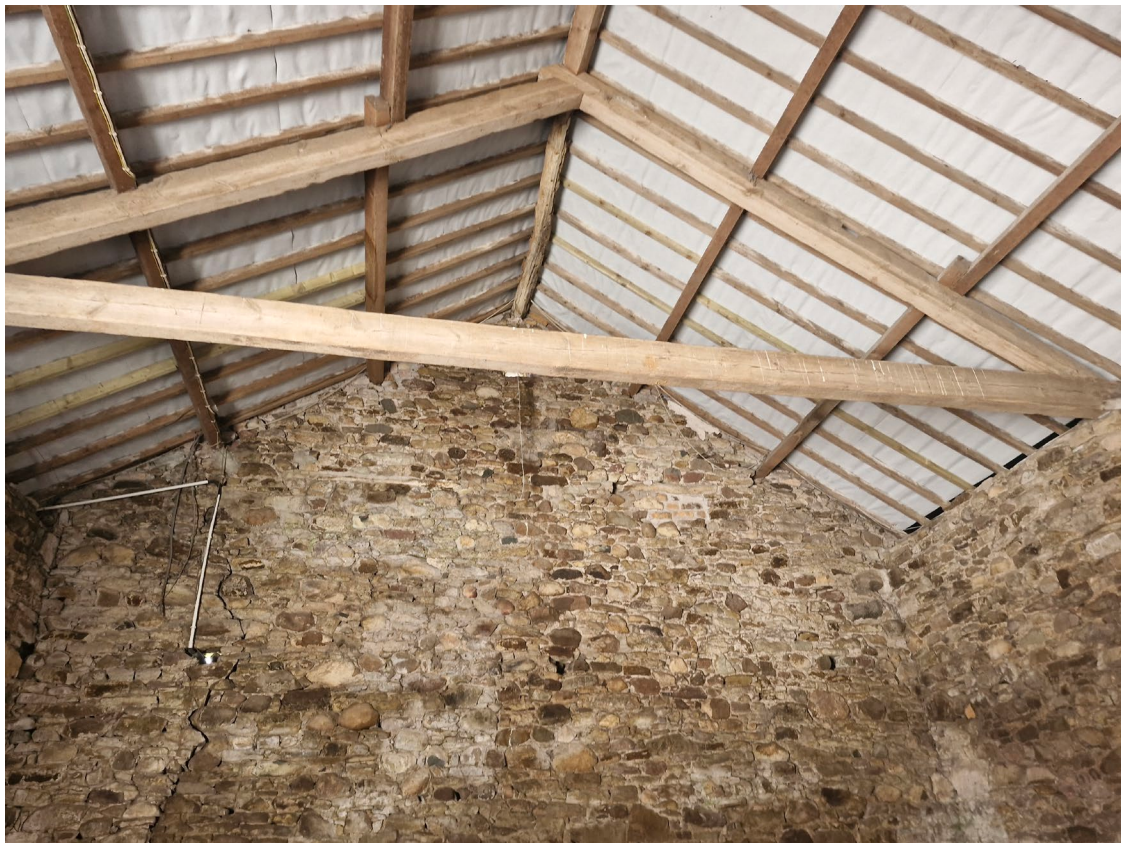
PHOTO 10 BARN 6 INTENRAL VIEW TWO STOREY EXTENT

- 2.3** Barn 6 is generally in poor condition due to a lack of maintenance. The walls have numerous cracks and there a numerous rotten/woodworm infested inset timber lintels. The walls to the single storey extent are out of plumb especially to the front and left hand flank walls. There is evidence of separation cracking to the two storey extent gable wall although this appears due to historic movement. The roof structure to the single storey extent is in a poor condition and needs removed; the roof to the two storey extent is in a better condition and could be retained with some strengthening works. See photographs 10-11 attached.

- The roof structures, if to be retained, will need inspected by a timber specialist to check for infestation and rot and treated accordingly. It is likely that only the main trusses will be structurally suitable to be retained as the rafters and purlins are not in accordance with current standards. Depending on the findings of the timber specialist the purlins may be strengthened, this will need checked by a structural Engineer as part of the building design phase

- The masonry corners to the rear two storey extent need retied as part of any conversion scheme. There are numerous areas of loose masonry which will need rebuilt/pointed. In addition, there are numerous masonry cracks which will need re-tied as part of the general building refurbishment works. The bowed walls may need some rebuild however we see this as less than 20 percent of the overall building wall extent.

- The timber lintels and inserts throughout the building will need replaced with precast concrete or steel sections to suit spans and loadings.
- We recommend that a trial hole is excavated at each corner of the barns to expose the base level of the wall such that the ground floor slab and insulation detail can be specified to ensure that undermining of the wall does not occur during construction.
