## FLOOD RISK ASSESSMENT

### **Cleator Mill, Proposed Commercial Development, Flood Risk Assessment.**

| Reference | RO/FRA/NEWCOM/13000.1 |

### **Asset Condition survey: River Ehen (right bank) Flood Defence at Cleator Mills**

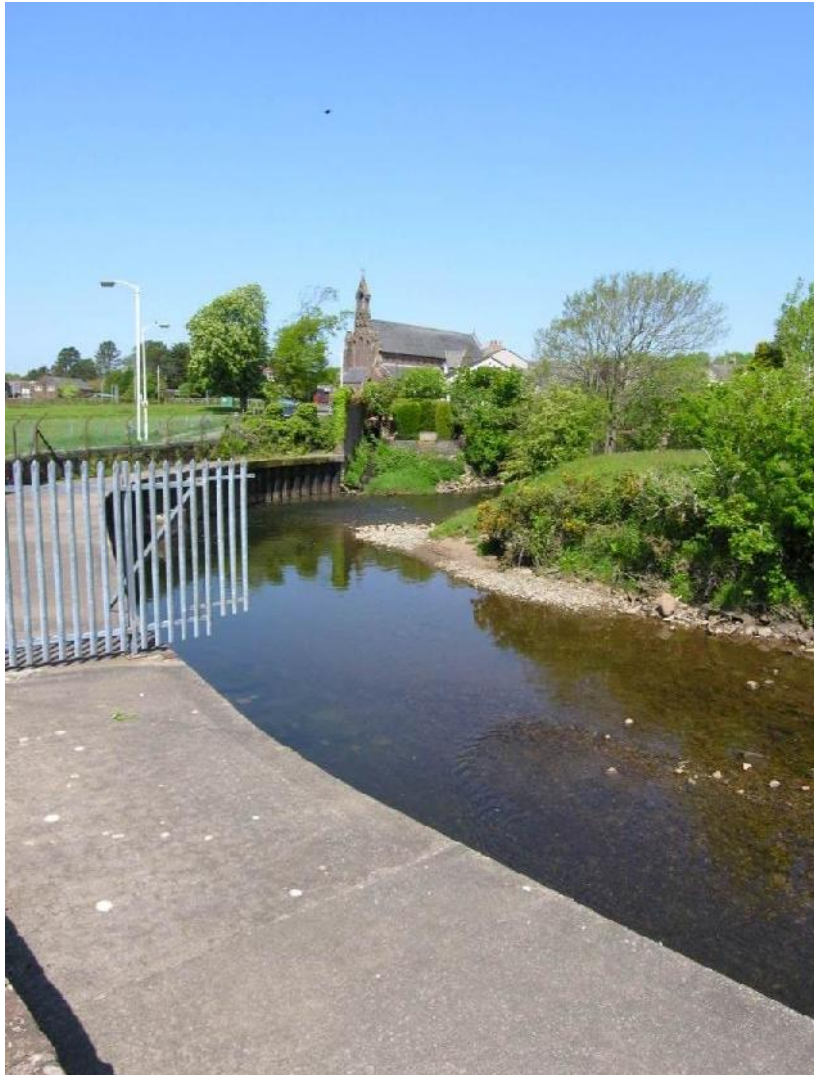
**Photo 1 – Hard flood defences between 1896 & 1726**

A site walkover has been undertaken to review the flood defences and gain an understanding of the locations and risks associated with the defences. Flood protection is provided along the river reaches adjacent to the development site. At the most vulnerable point, on the northern boundary with the River Ehen hard defences are located on the right boundary located between modelled node points 1896 and 1726, as can be seen in Figure 3. The Environment Agency data shows these hard defences are at a 1:100 year standard. Photo 1 below of existing hard defences between 1896 and 1726 modelled nodes;

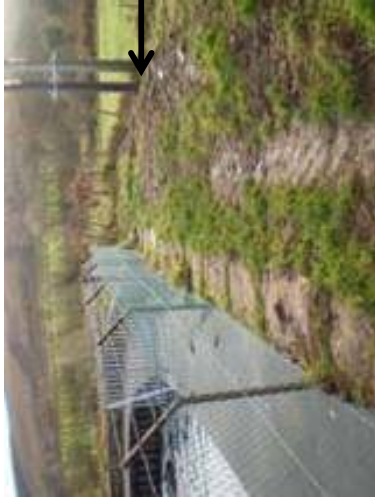
*Flood crest Upstream (rutting)*

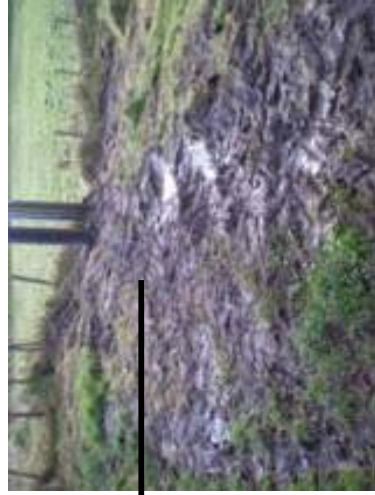
*Outward face and Flood crest (heavy poaching)*

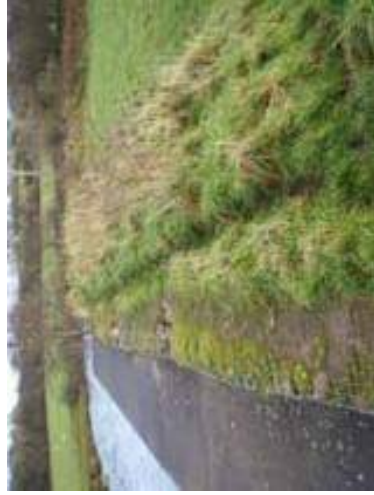
*Heavily overgrown flood crest*

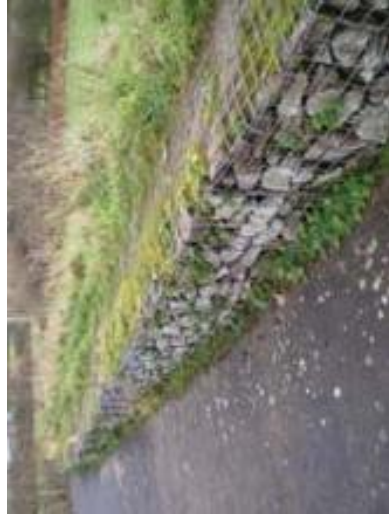
*Gabions in Good condition (Grade 2)*

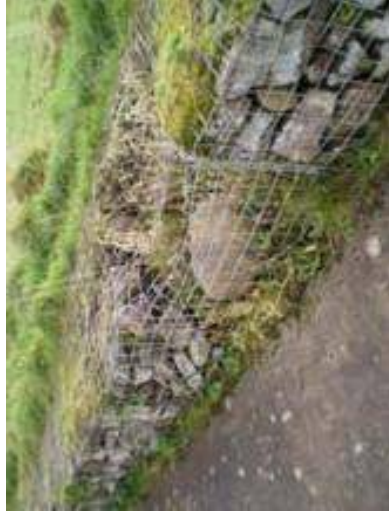
The CAM system works on the weakest link philosophy; in the gabion basket section of the defence, even though most of the baskets are in fair to good condition, the face inward can be assumed to have failed completely and it is likely that within a year the crest (and therefore the integrity of the whole defence) will erode away as the baskets further decay. The present target 3 has just failed. Failure of the defence is self evident and remedial work is very necessary. Along with the vegetation management and treatment of bare patches, at least 7 baskets need replacement (maybe more as the theft continues).

*Gabions in Very Poor condition (Grade 5)*

- Vegetation management and re-profiling of Outward face  
£3,000
- Replacement of 7 gabion baskets  
£10,000

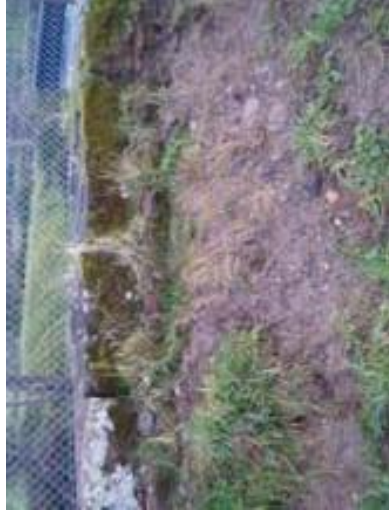
*Heavily eroded outward face*

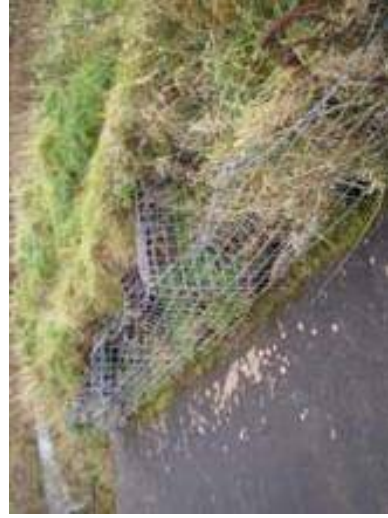
*D/S gabion baskets in failed condition*

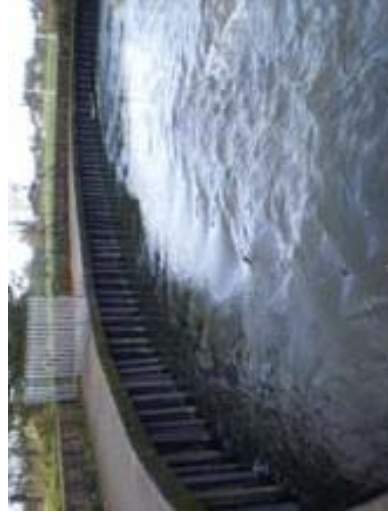
*Sheet pile FI showing minor distortion  
 But flood wall well protected by concrete berm*

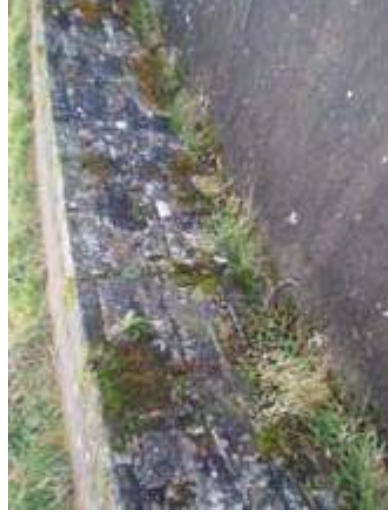
*Minor grass growth in masonry wall joints*

Vegetation management of Face Outward and Flood Crest, some pointing to masonry wall; reseeding bare patches and fencing with an approximate cost of circ £3,000. Maintenance to retain target condition requires superficial vegetation management and regular inspection to monitor any deterioration.

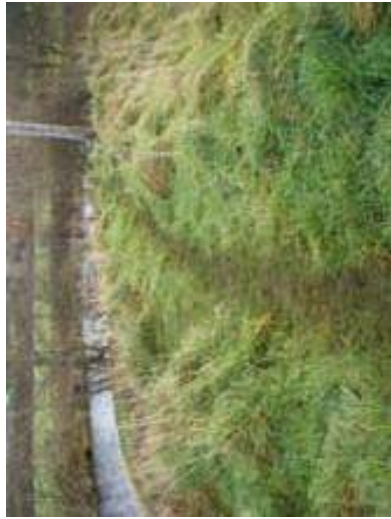
*Crest heavily vegetated with rutting*

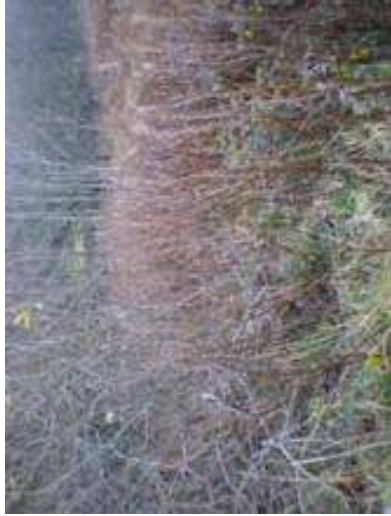
The defence fails to meet target 3 as currently set and wholesale vegetation clearance is required along the whole length of defence, with selective vegetation management in co-operation with EA's Fisheries, Recreation and Biodiversity team on the berm and channel side. The rock revetment at the toe of the channel side is helping to prevent undercutting of the berm and strategic repair might be appropriate.

*Invasive vegetation on whole bank*

Once vegetation has been cleared the entire bank requires re-shaping to reduce its current fragility.

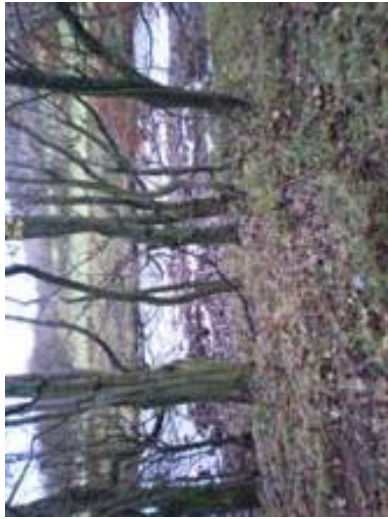
*Mature Trees on Inward face*

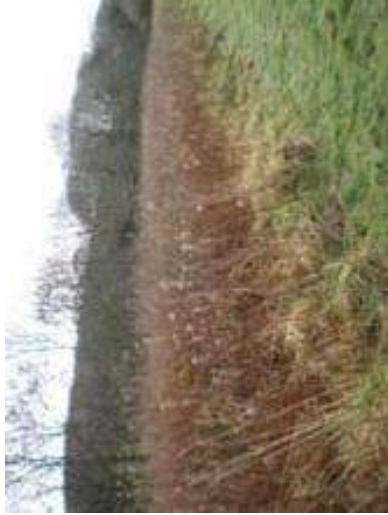
*Invasive vegetation on outward face*

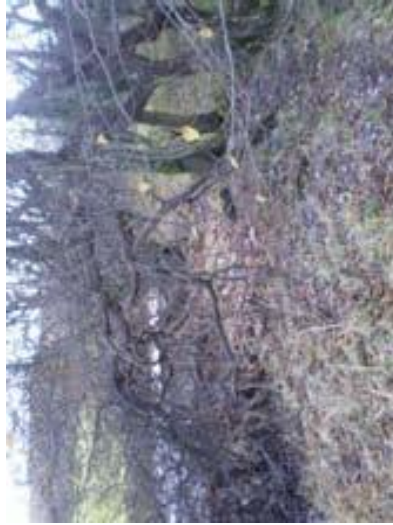
*Trees on „crest“ of defence*

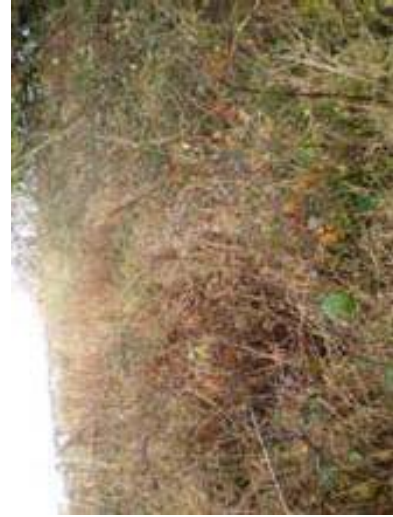
*Invasive vegetation on whole embankment*

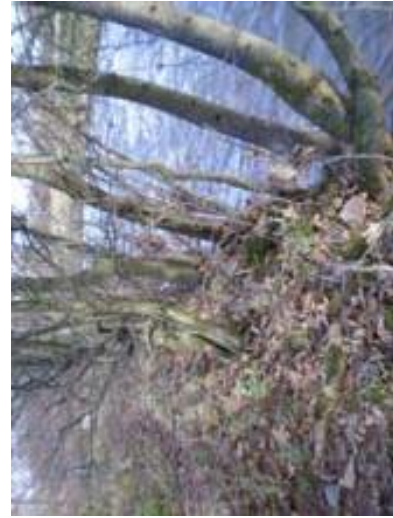
*Trees on Channel Side*

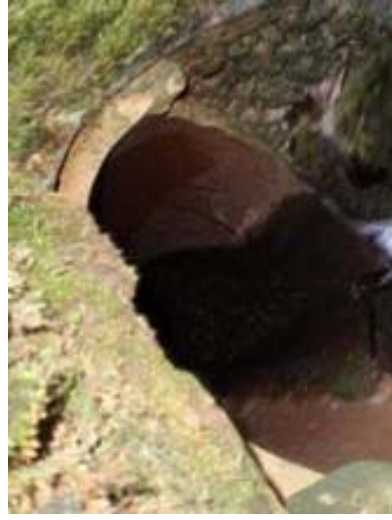
*U/S broken 18" clay pipe*

- Following construction of the development the clay pipes or their replacements should be fitted with flaps to prevent ingress of flood water.

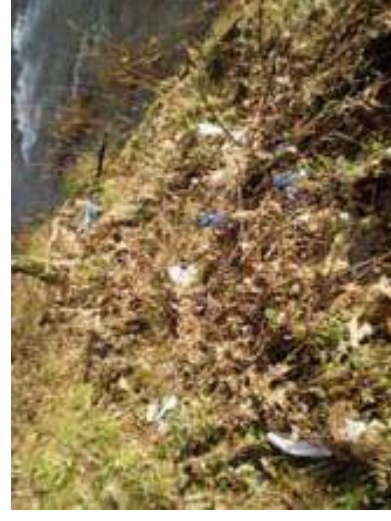
*Channel side showing wrack from flooding*
