# Stubsgill Farm, Wind Turbine Repowering

## Construction Traffic Management Plan

November 2025  
3369-01-CTMP01

Stubsgill Farm - Pre-Construction Highway Condition Survey

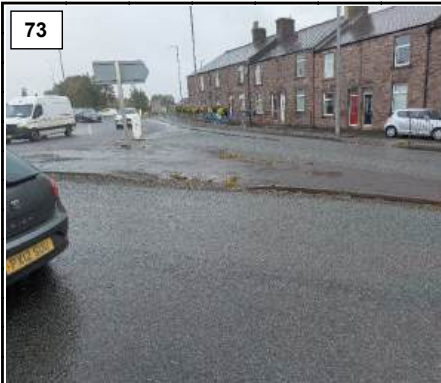
- i) The B5306 / the A595 roundabout itself was observed to be in generally good condition.
- ii) Serious road marking wear and tear present across the southern arm (**Images 64-74**)
- iii) There are some potholes on the southern entry arm. (**Image 74**)
- iv) A strip of reinstated surfacing on the dropped kerb on the central refuge side of the southern arm. (**Images 72-73**)
- v) Road chippings seem to be scattered across the central refuge and around it. (**Images 69-71**)
- vi) Minor wear and tear present on the centre of the carriageway on the bend before the southern arm of the Distington Roundabout. (**Images 64-66**)
