**Project No:** GEO2025-7009

**Project Title:** Coal Mining Risk Assessment (CMRA) for Coach Road, Whitehaven

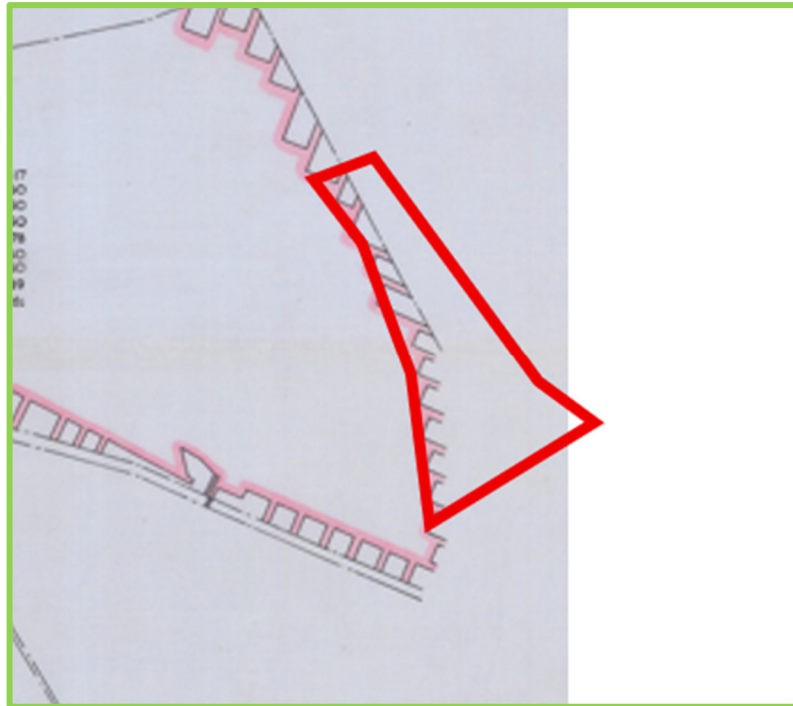
Figure 1 – Extract of Bannock / Brick Mine Abandonment Plan with site boundary (approx.)

Based on the plan provided, GEO has approximately overlaid the site boundary based on the geographical features included on the plan. An extract of the plan can be found on the following page (Figure 1), and this suggests that potential workings exist along and below the western boundary of the site. This appears to be contrary to the indicative information provided by the MRA. The plan would also suggest that the subcrop position of the Bannock / Brick is located further to the east than indicated on geological maps. In addition, it is possible that the depth of the recorded workings within the Bannock / Brick coal seam exist at a greater depth than indicated by the MRA.

When considering Figure 1 and the proposed development layout, properties located nearest to the western boundary may be at risk from land instability should void migration reach the surface.

As a result of the conflicting information and resulting uncertainty, it is recommended that targeted intrusive investigation works are undertaken prior to the development commencing, in the form of rotary boreholes (at least 5 no.), should be undertaken targeting the northwestern portion of the site and western site boundary to determine the ground conditions with greater certainty and the level of risk posed to the site from known subjacent coal workings. These rotary boreholes are necessary to determine if the site requires remedial measures to stabilise the ground prior to development commencing (e.g., pressure grouting).
