**Copeland Borough Council**

**Leconfield Industrial Estate,  
Cleator Moor**

**Geo-Environmental Desk Top Study**

**December 2019**

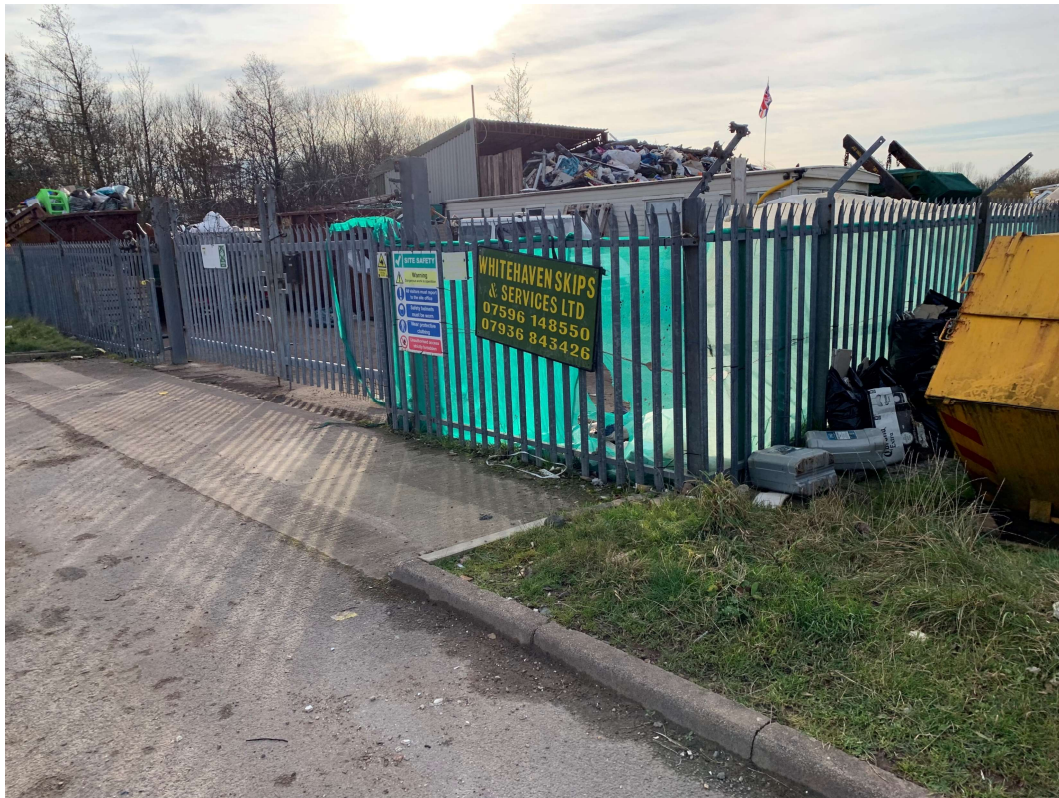
Photo Plate No. 01: Skip hire company in east of site.

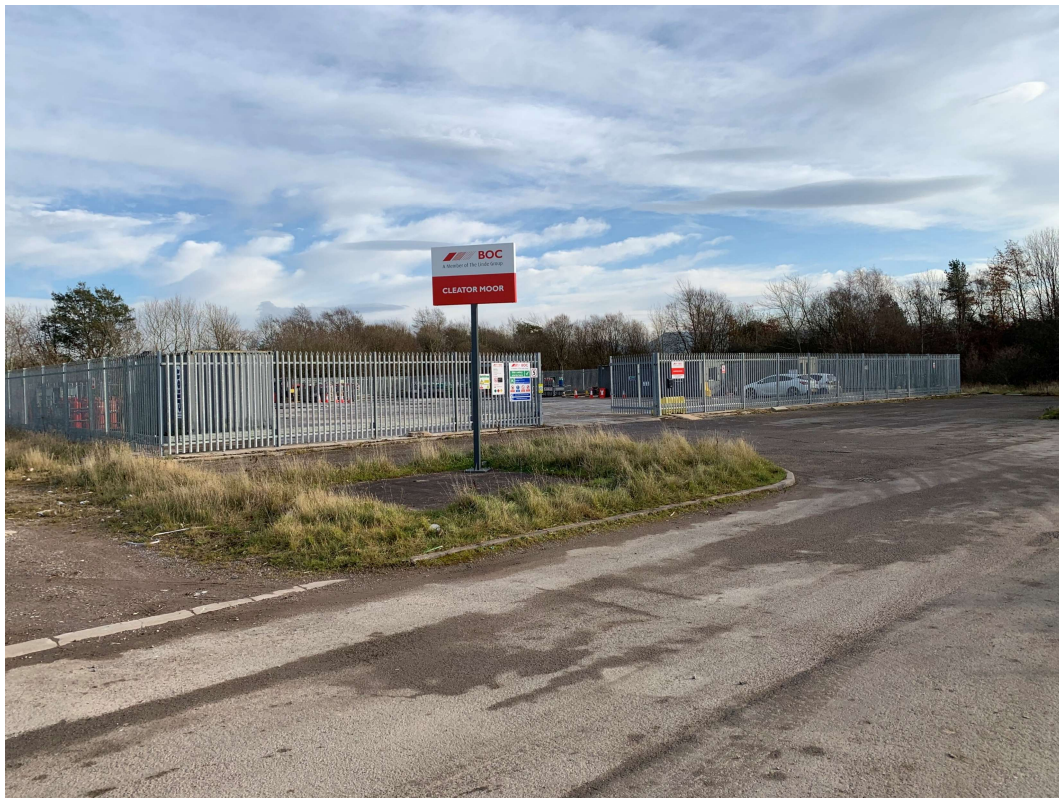
Photo Plate No. 02: BOC gas supplies in east.

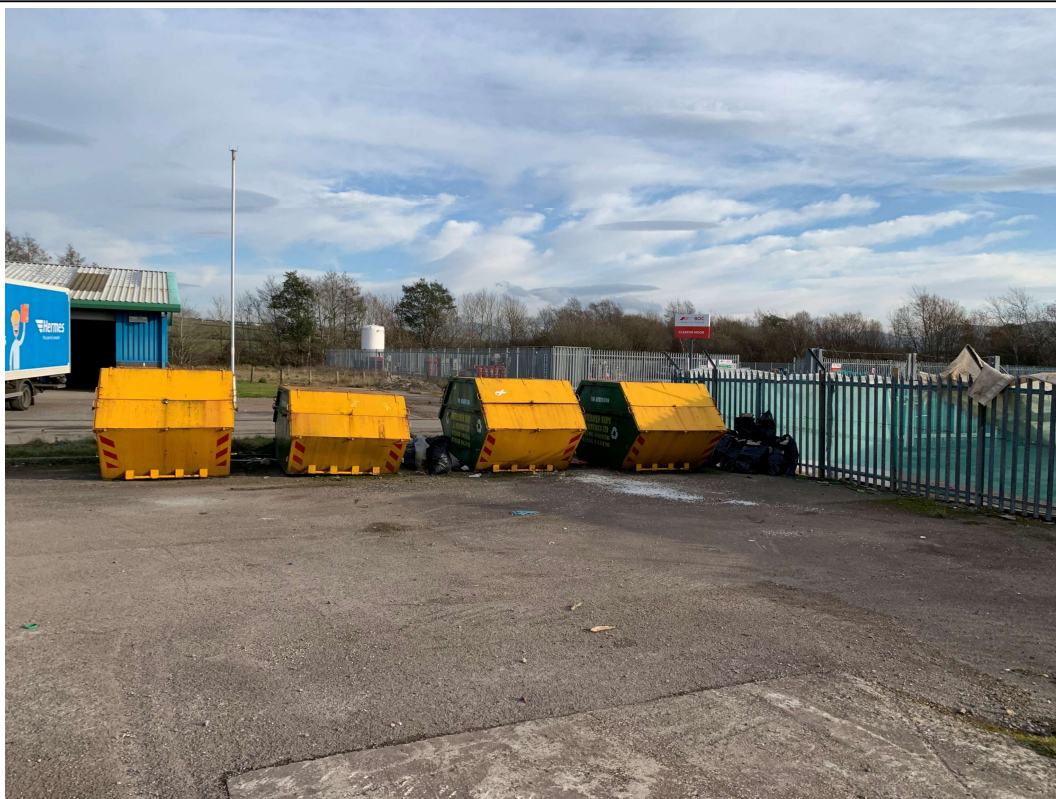
Photo Plate No. 03: Public skips for waste/recycling in east adjacent to skip hire company (looking southwards).

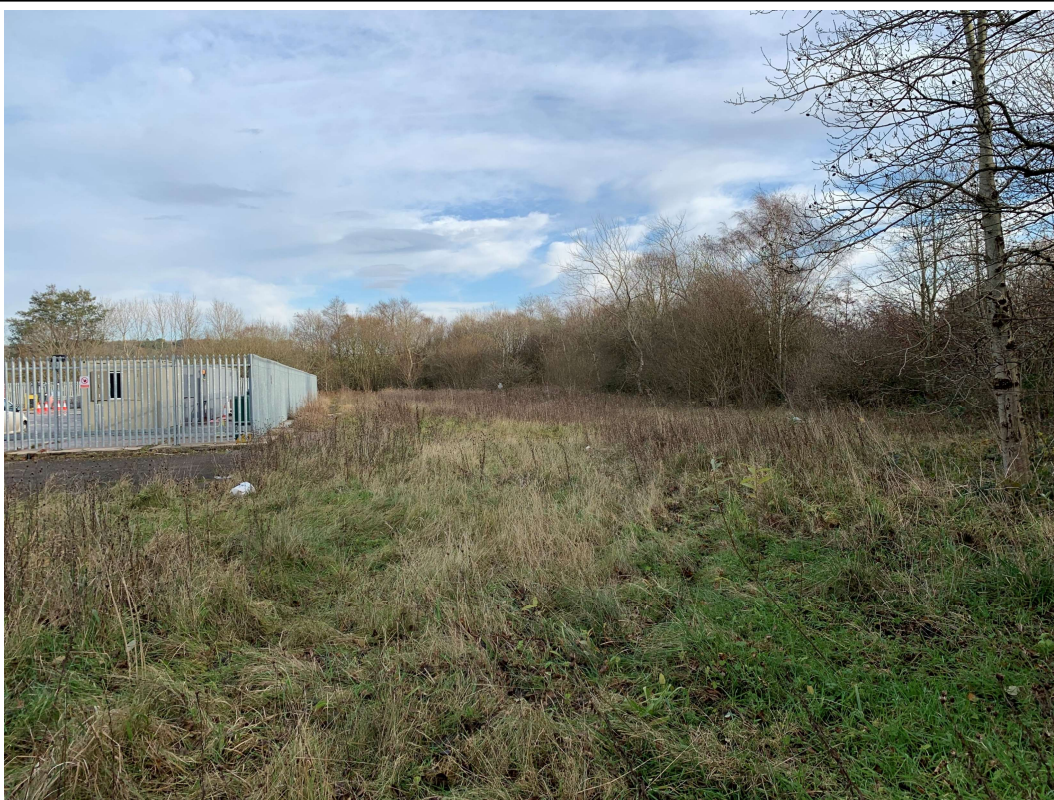
Photo Plate No. 04: Grassland in north-east of site adjacent to BOC Ltd.

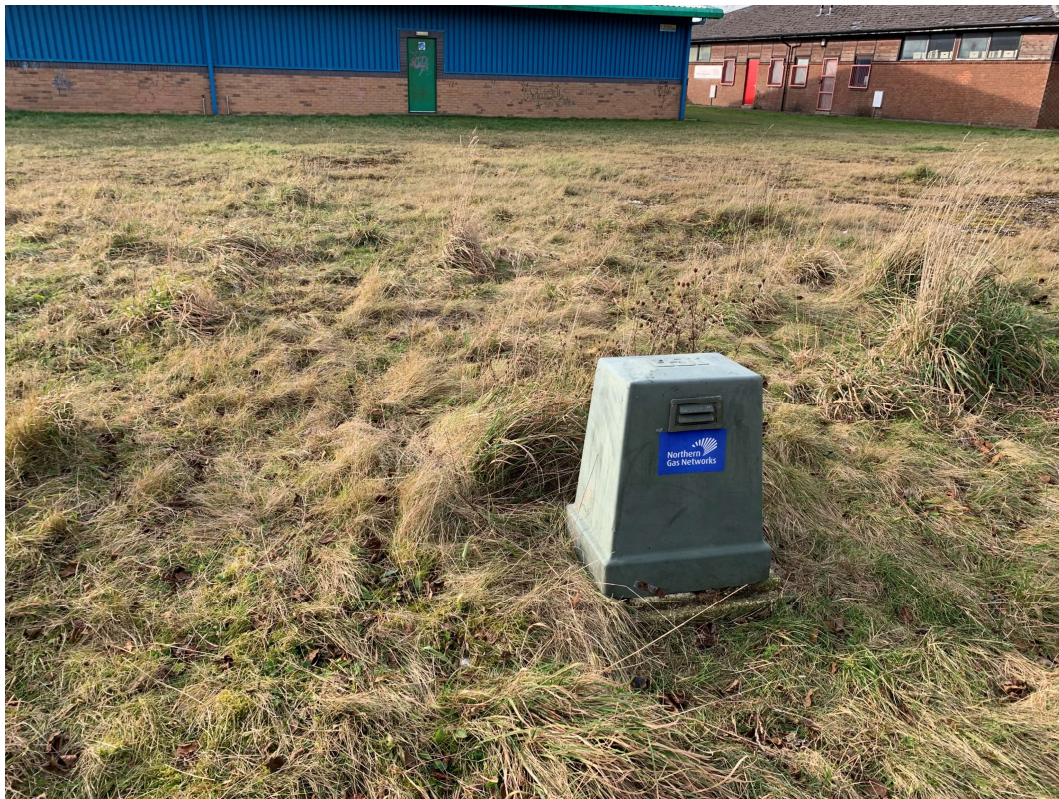
Photo Plate No. 05: Gas service marker in east behind parcel depot.

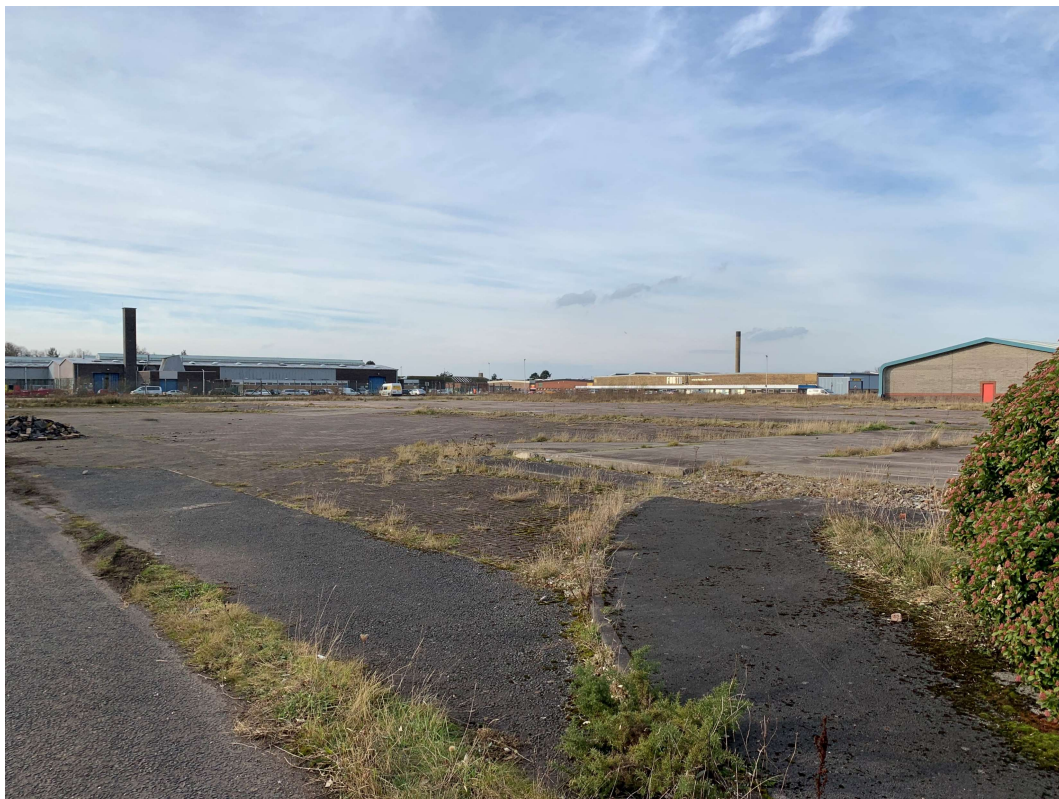
To the west of the parcel depot is an active children's nursery with adjacent unoccupied units. To the south of the nursery, immediately adjacent to the east of Leconfield Street / Little Croft is Forth UK, an engineering manufacturer with two large concrete slabs occupying the footprint of historically demolished buildings beyond. Several small areas of fly tipped material were noted on the concrete slabs mainly consisting of bricks.

Photo Plate No. 06: Large concrete footing of demolished building behind Forth UK in east.
