# HERITAGE STATEMENT

## FULL RENOVATION OF EXISTING No 11 TERRACE HOUSES

St Bees, 1-11 Lonsdale Terrace, Parish Council, Cumbria

M.A.C Architects, Project Number: 2019:303

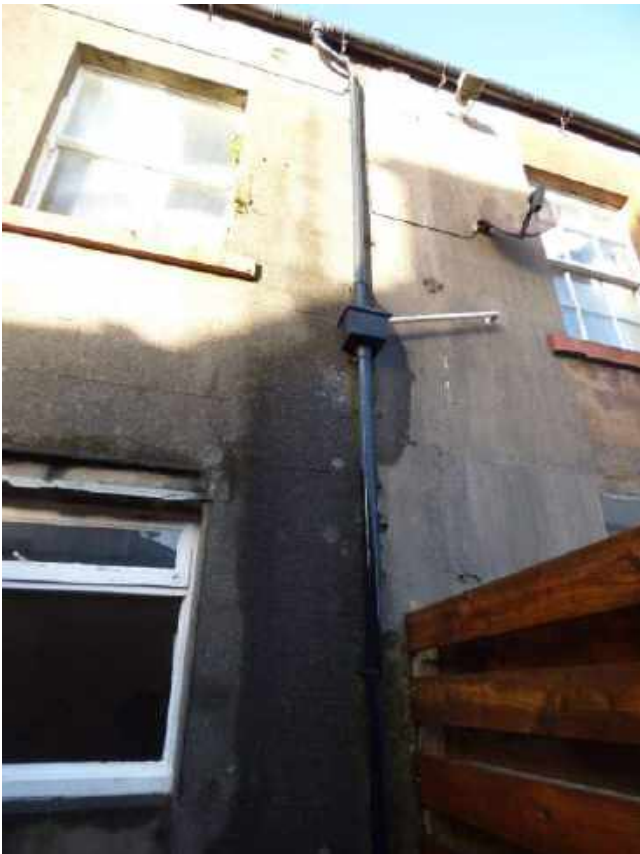
Left: The ground floor window to the kitchen is not original and requires replacement. The proposed replacement will reinstate the original Georgian style of window, in the original opening (which has been walled up), with a double-glazed slimline heritage painted timber window that would have been originally installed.

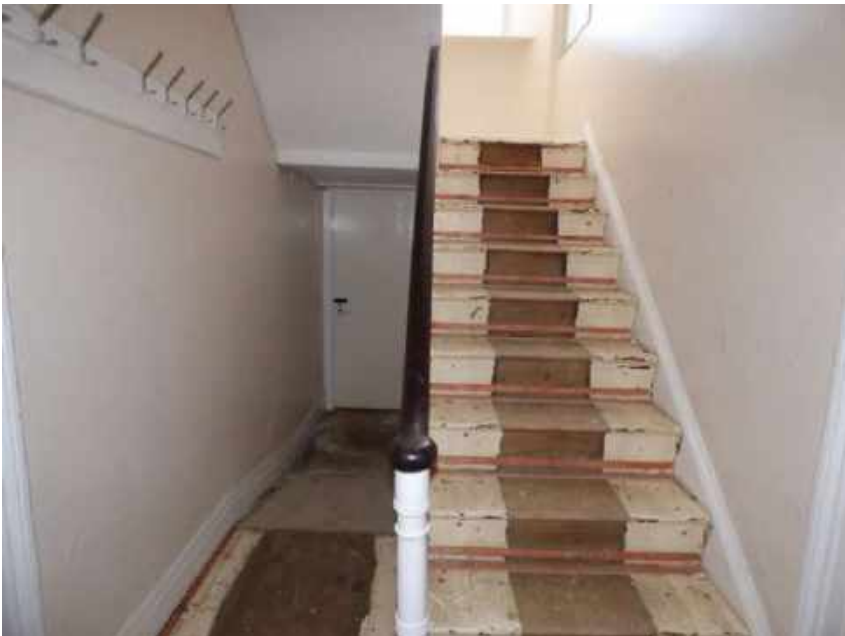
Left: period features to be retained, including archway and architraves. (Modern lighting to all be stripped out and make good surfaces). All architraves and plaster features to be retained.

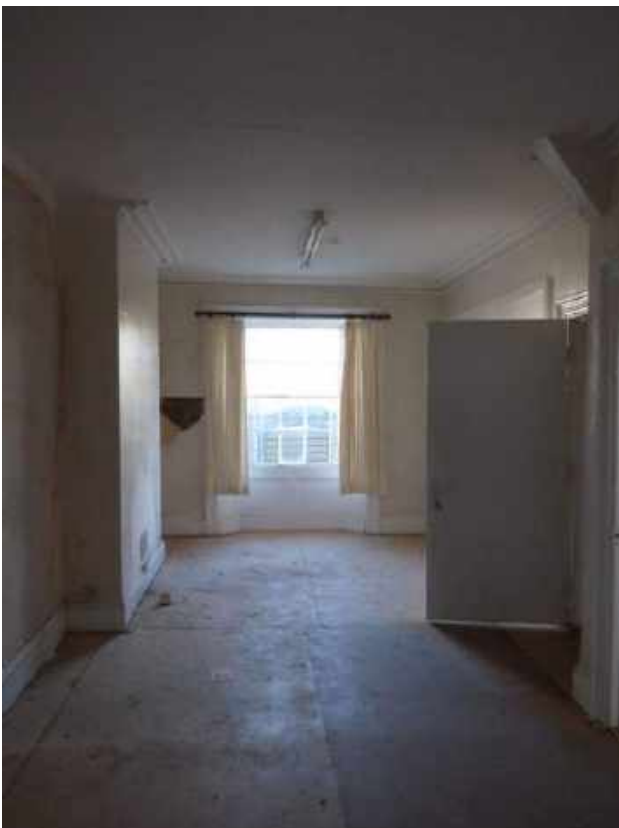
Left: In the existing lounge, the period features below and to the sides of the existing windows both front and back are in good condition, it is proposed to carefully refurbish the existing timber shutters.

Existing cornice to be made good in locations where redundant services are to be removed and where hairline cracks have appeared.

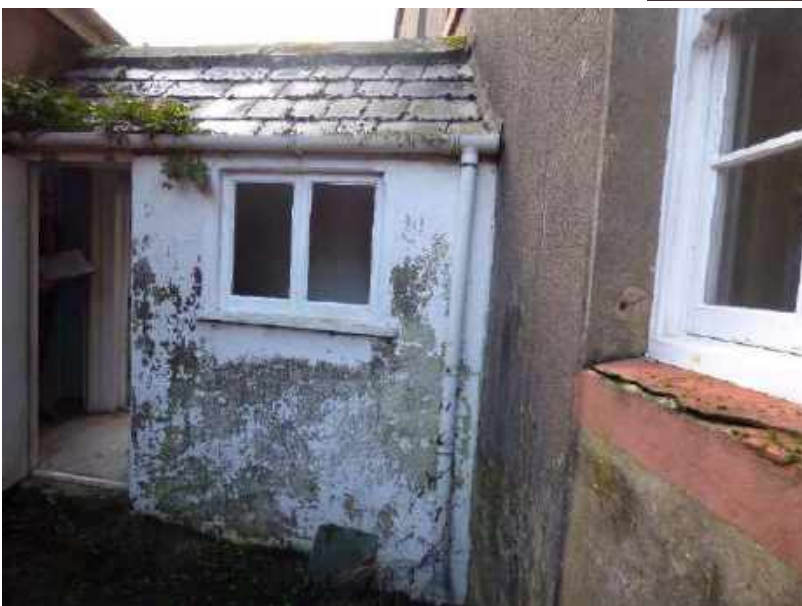
Rear of property – render to be repaired by specialist and decorated with off white render.

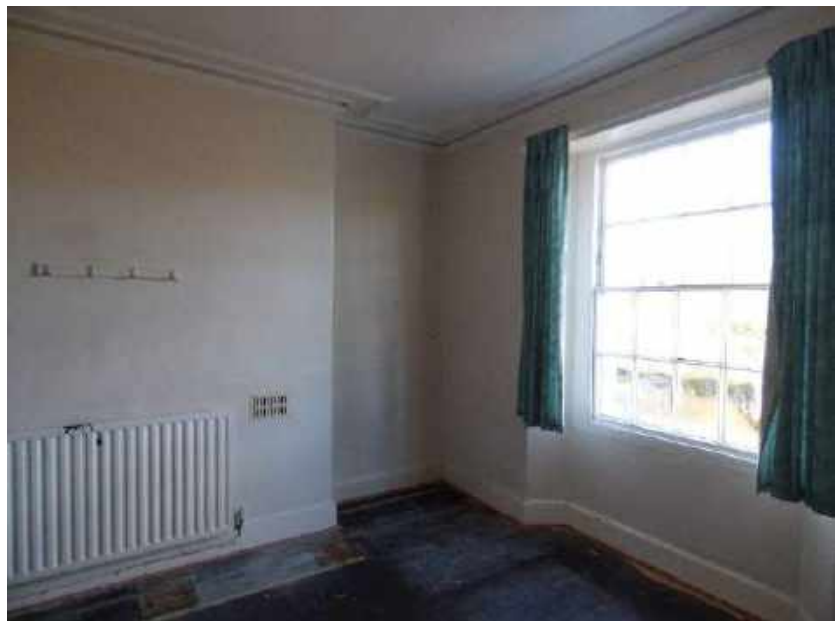
Front bedroom (First floor RHS), cornice, skirtings and architraves to be retained. Existing flush panelled door to be replaced with new Georgian heritage style 4 panel door to be provided and installed by specialist joinery company such as Batty Joinery Ltd.

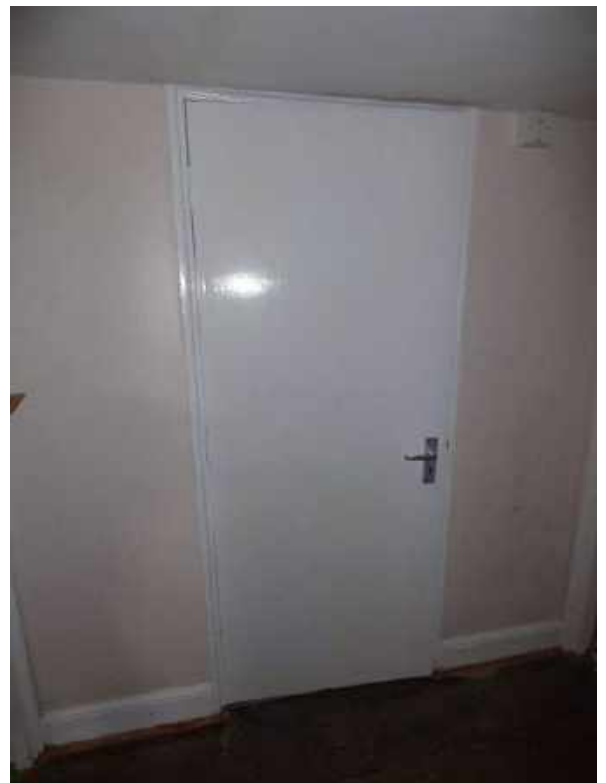
Left: Attic Store is proposed to be converted into a bathroom to be shared by the attic bedrooms by increasing the size of the room to each side to allow for the new bathroom.

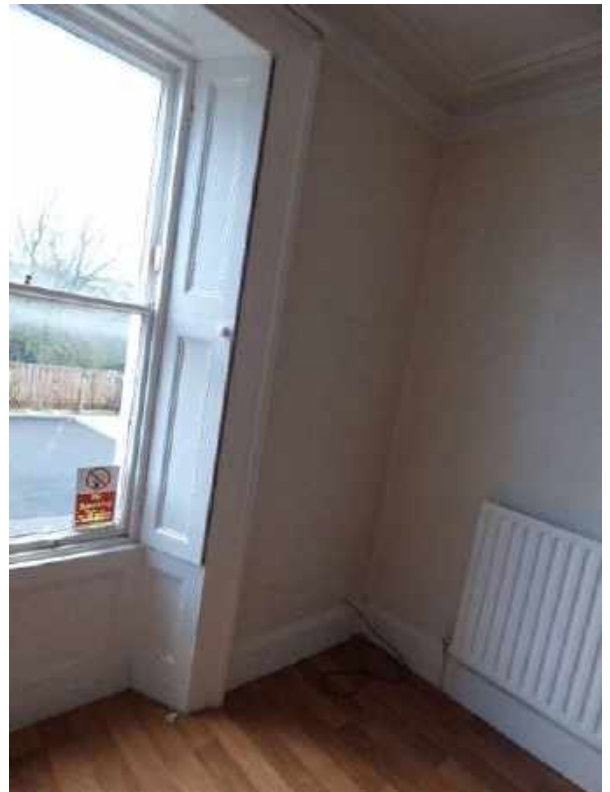
Below: In the existing lounge, the period features below and to the sides of the existing windows both front and back are in good condition, it is proposed to carefully refurbish the existing timber shutters

Existing cornice to be made good in locations where redundant services are to be removed and where hairline cracks have appeared.

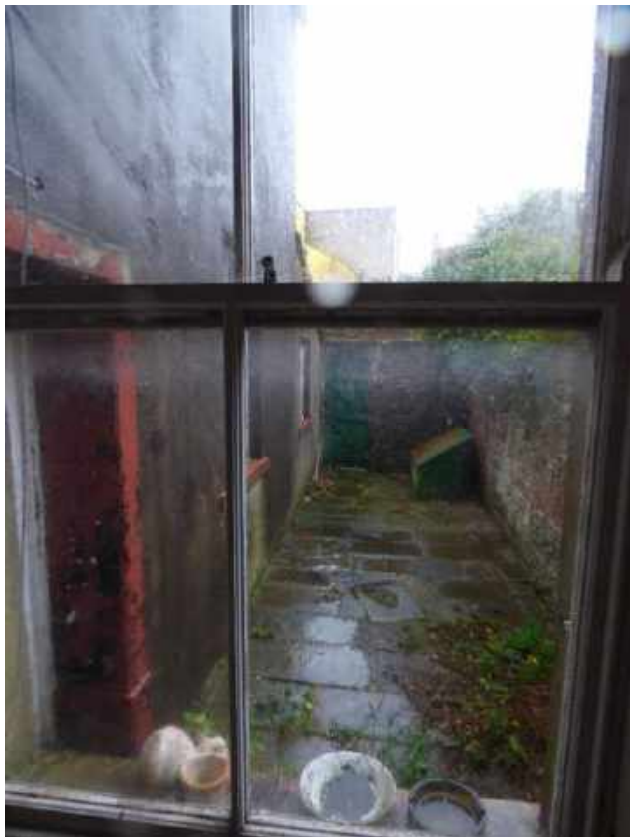
Left: View of rear of property – render to be repaired by specialist and decorated with off white render.

Cills to be repaired, as necessary.

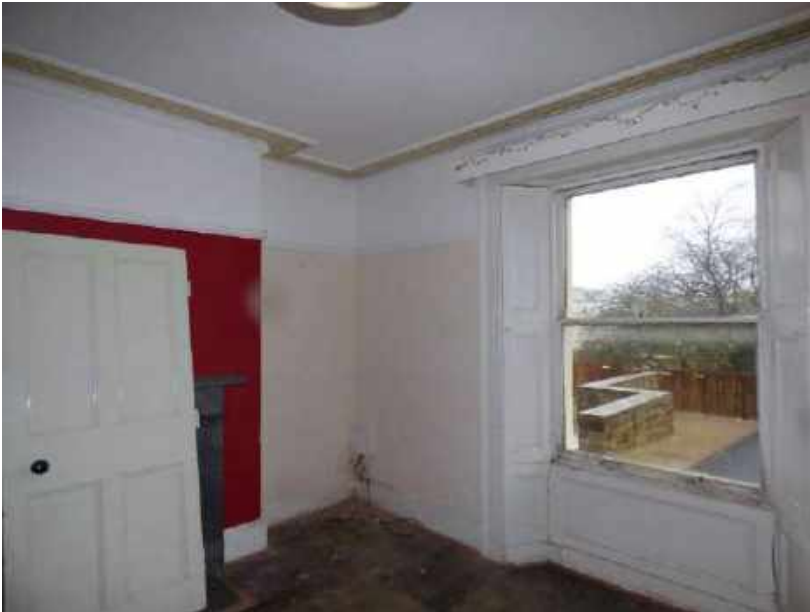
Left: Existing lounge architraves, cornices, and skirtings to be retained and repaired where hairline cracks have appeared.

It is proposed to form a new opening between the lounge and dining area to create more open plan living as already undertaken in properties 1-5. The fireplace is not original, and it is proposed to replace with a more in keeping fireplace.

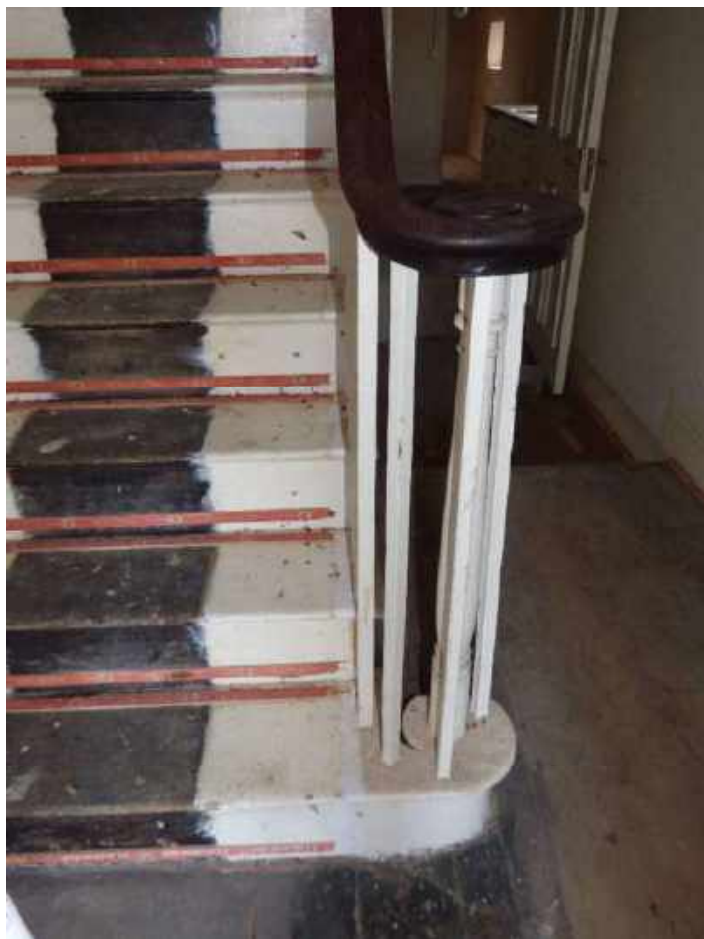
Left: Existing ramp to be removed and original step to be reinstated.

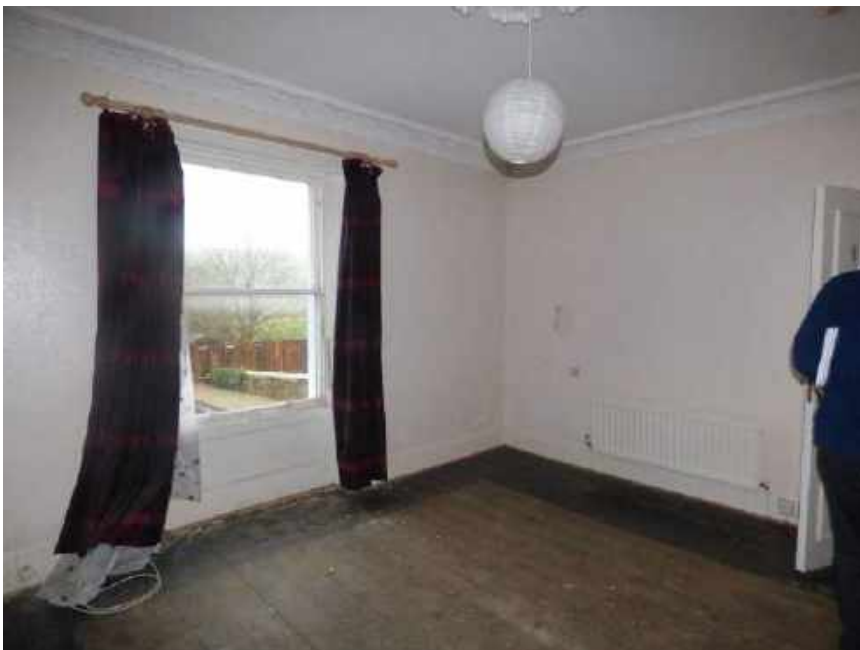
Left: Existing cornice to be made good in locations where redundant services are to be removed and where hairline cracks have appeared.

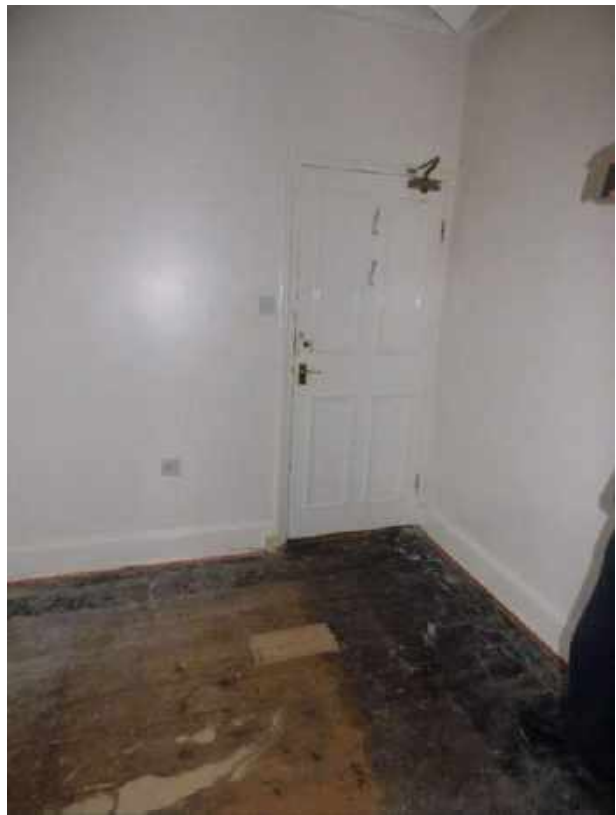
Below Left: Existing cornice damaged due to water ingress from attic room above. Cornice to be repaired.

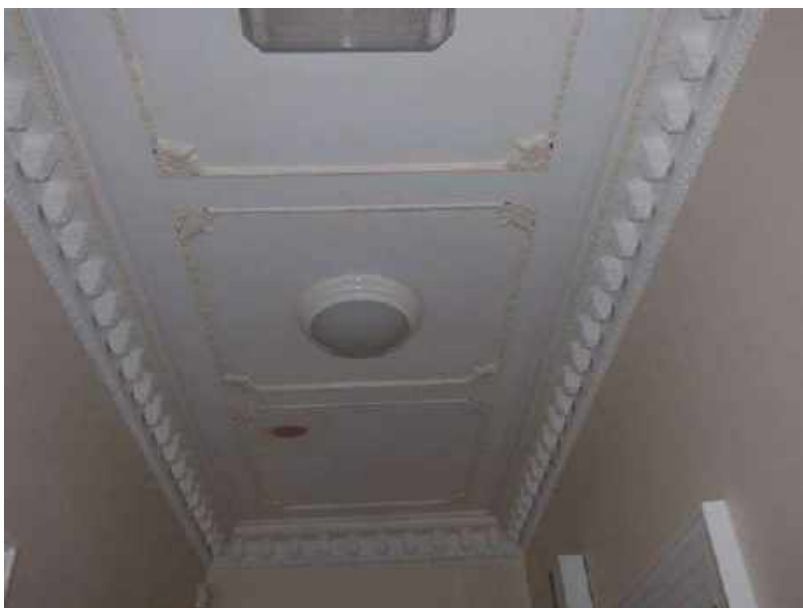
Minor damp patch repair required to ceiling.
