# HERITAGE STATEMENT

## FULL RENOVATION OF EXISTING No 11 TERRACE HOUSES

St Bees, 1-11 Lonsdale Terrace, Parish Council, Cumbria

M.A.C Architects, Project Number: 2019:303

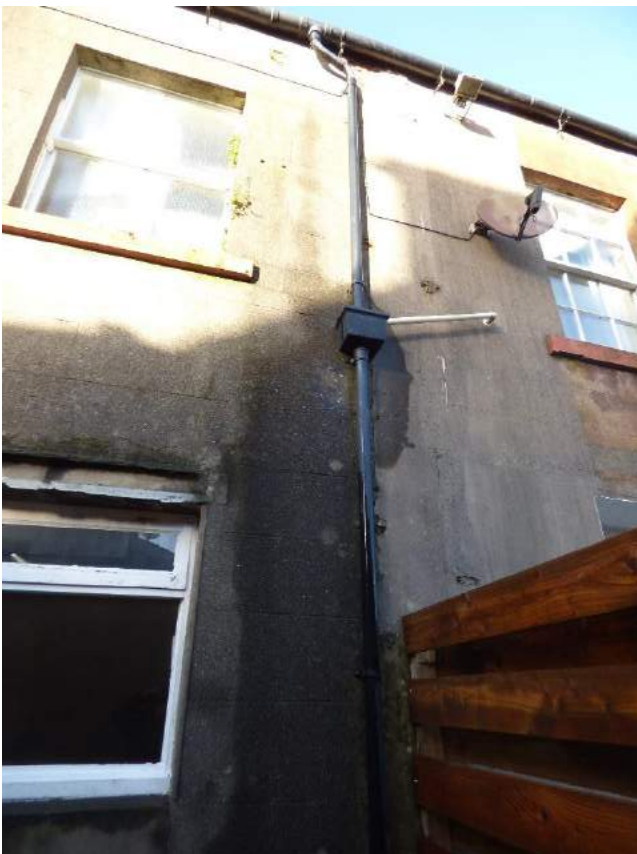
Left: The ground floor window to the kitchen is not original and requires replacement. The proposed replacement will reinstate the original Georgian style of window, in the original opening (which has been walled up), with a double-glazed slimline heritage painted timber window that would have been originally installed.

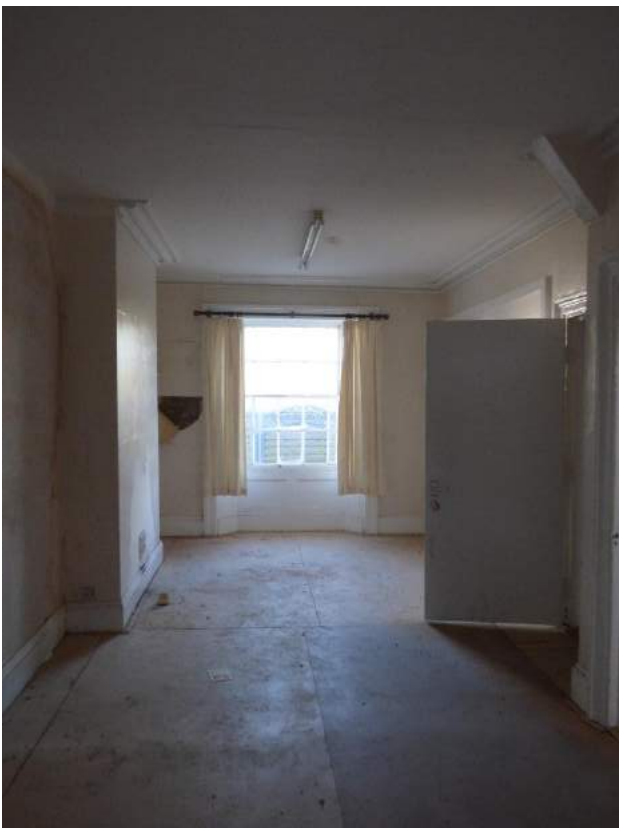
Left: In the existing lounge, the period features below and to the sides of the existing windows both front and back are in good condition, it is proposed to carefully refurbish the existing timber shutters.

Existing cornice to be made good in locations where redundant services are to be removed and where hairline cracks have appeared.

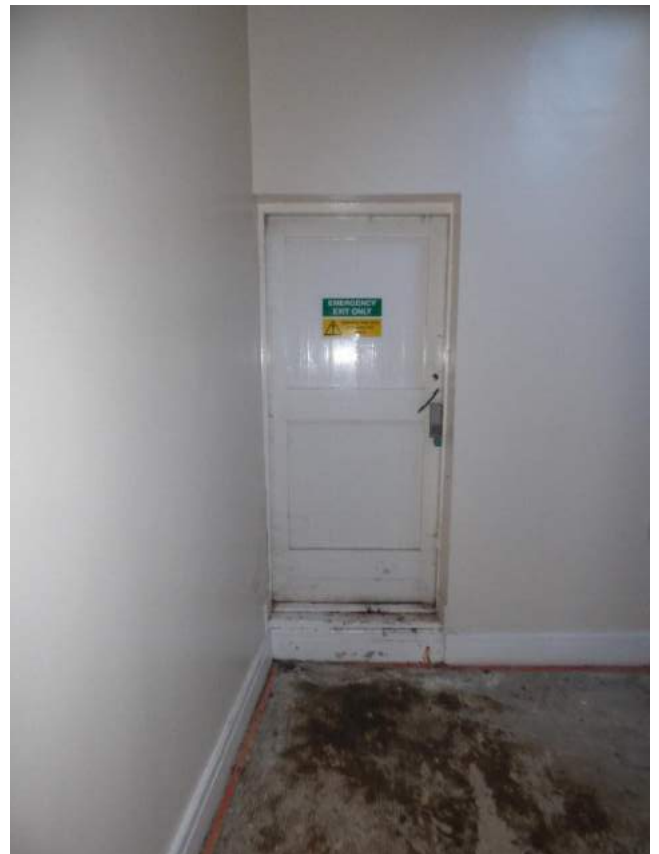
Left: Retain original staircase, which is in good condition. One missing baluster between first and second floor staircase to be provided with new baluster to match existing.

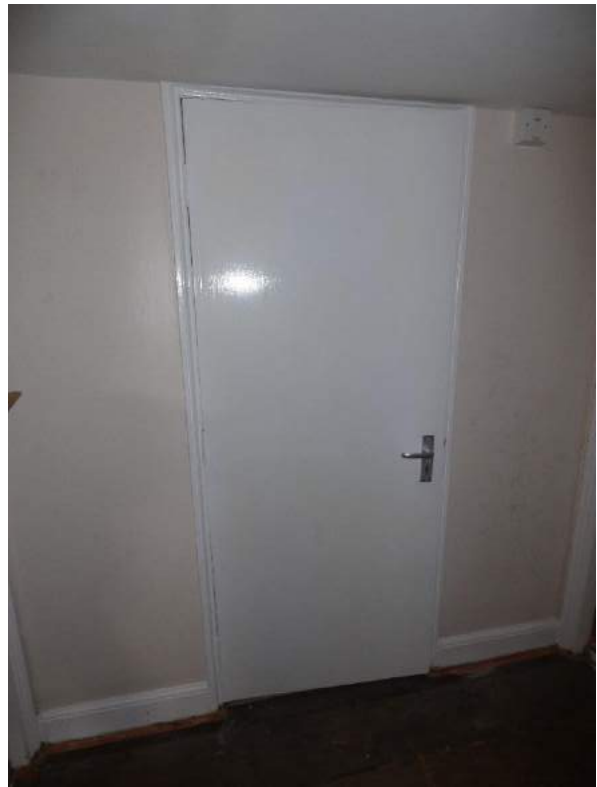
Left: Attic Store is proposed to be converted into a bathroom to be shared by the attic bedrooms by increasing the size of the room to each side to allow for the new bathroom.

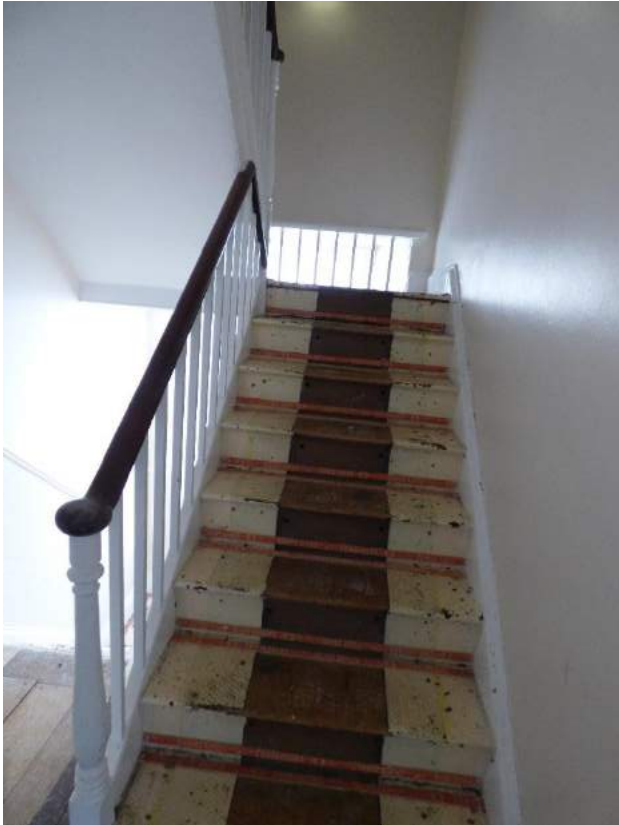
Left and below: Handrail, balusters and rails are original and are to be retained. Missing baluster to be replaced with matching baluster and decorated to match existing.

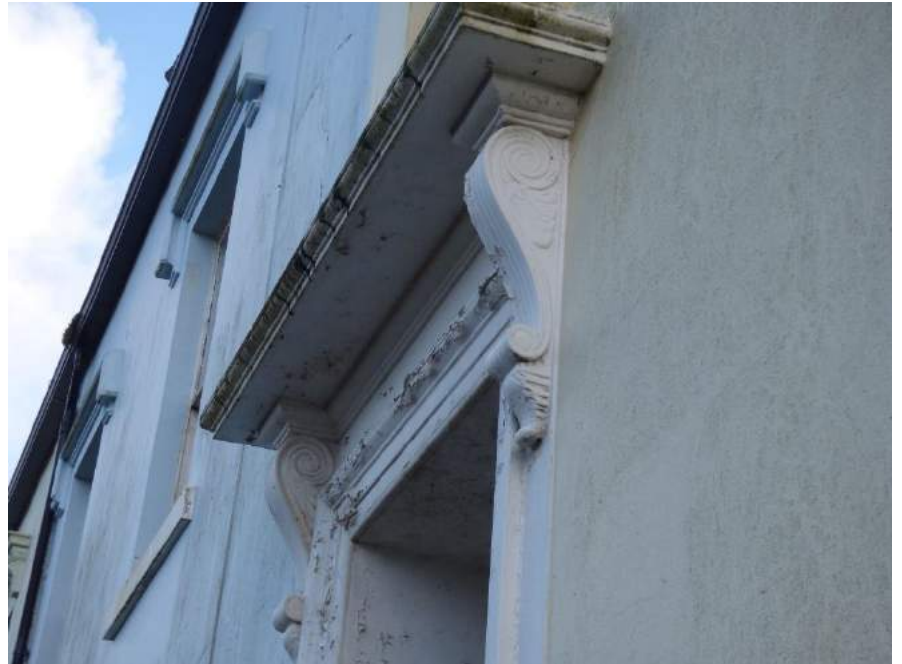
Left: View of rear of property – render to be repaired by specialist and decorated with off white render.

Cills to be repaired, as necessary.

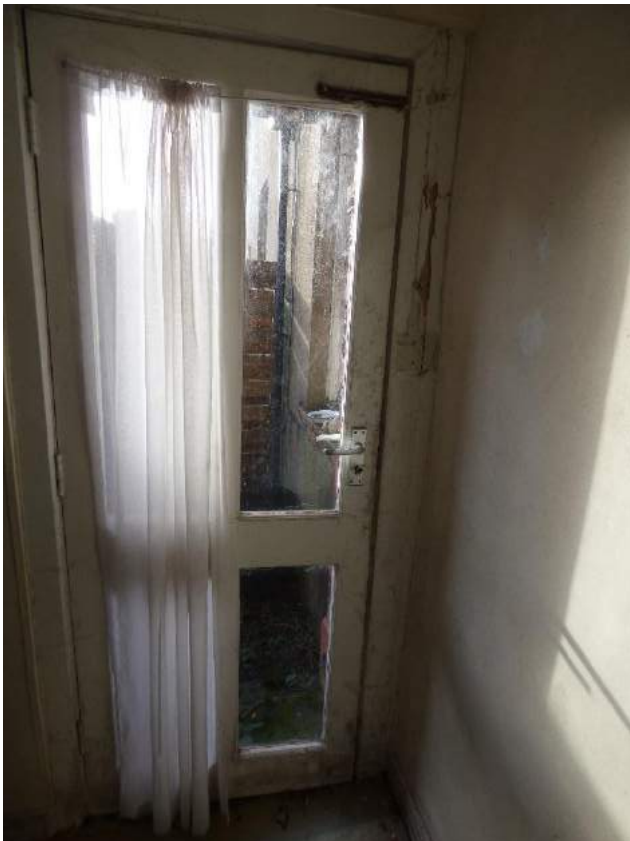
Left: rear door to be replaced with a Georgian style as front door.

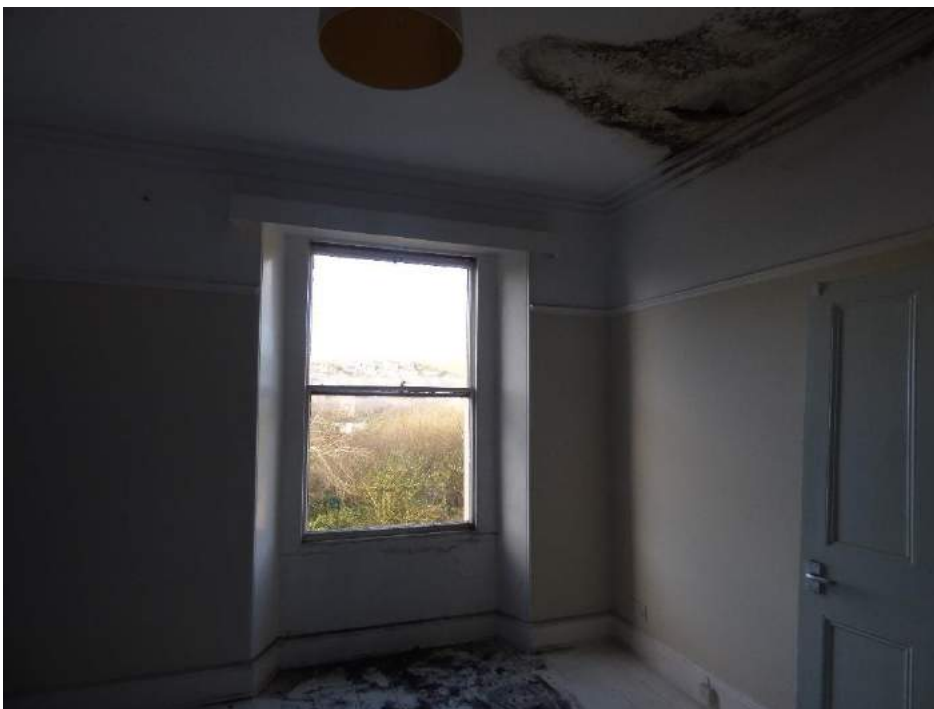
Damp damage to plaster ceiling to be removed and reinstated. Any damage to lath and plaster to be repaired by specialist.

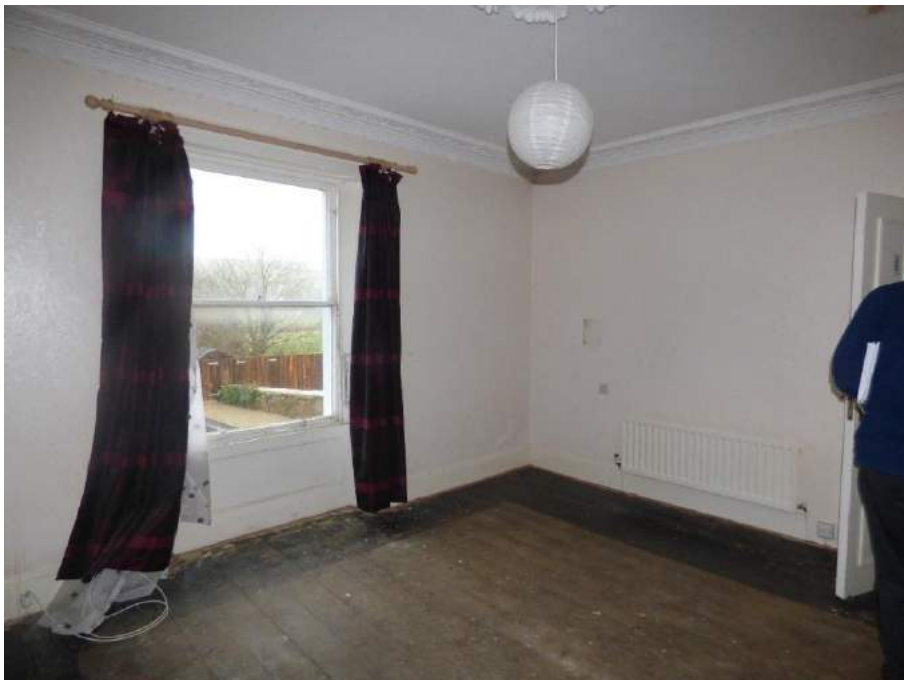
Left: Existing cornice to be made good in locations where redundant services are to be removed and where hairline cracks have appeared.

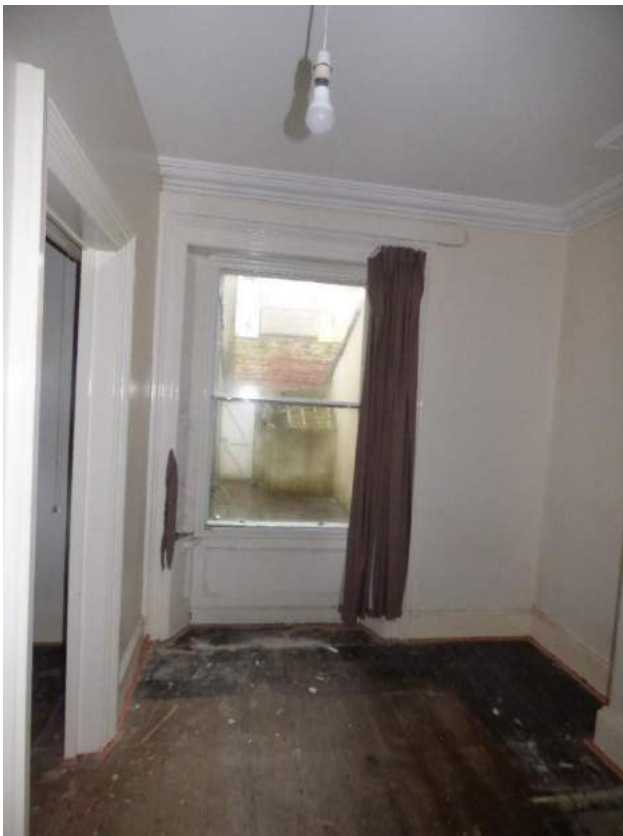
Left: The existing room I partitioned with a stud partition to provide a downstairs bathroom. It is proposed to remove this bathroom and all the associated fixtures and fittings. None are original.

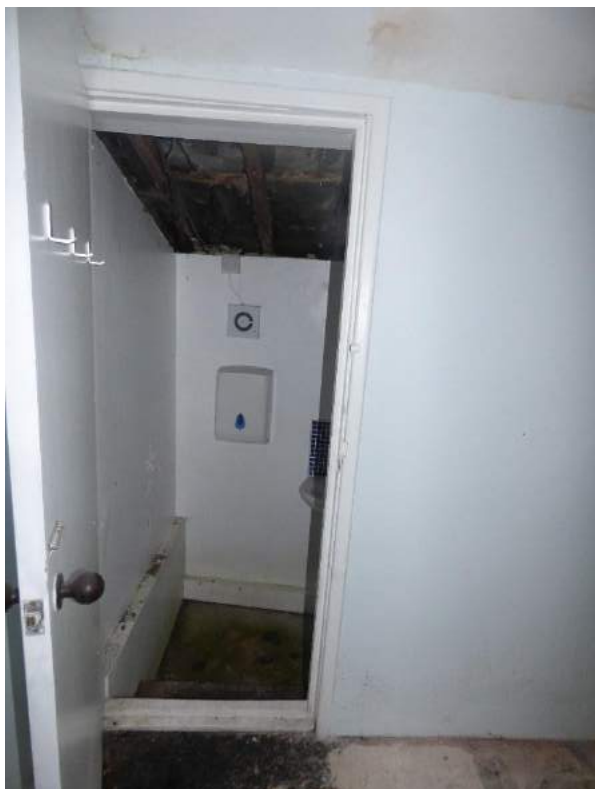
Left: Existing w.c. (not original) to be stripped out and space reconfigured. All skirtings and cornices to be reinstated to match existing.

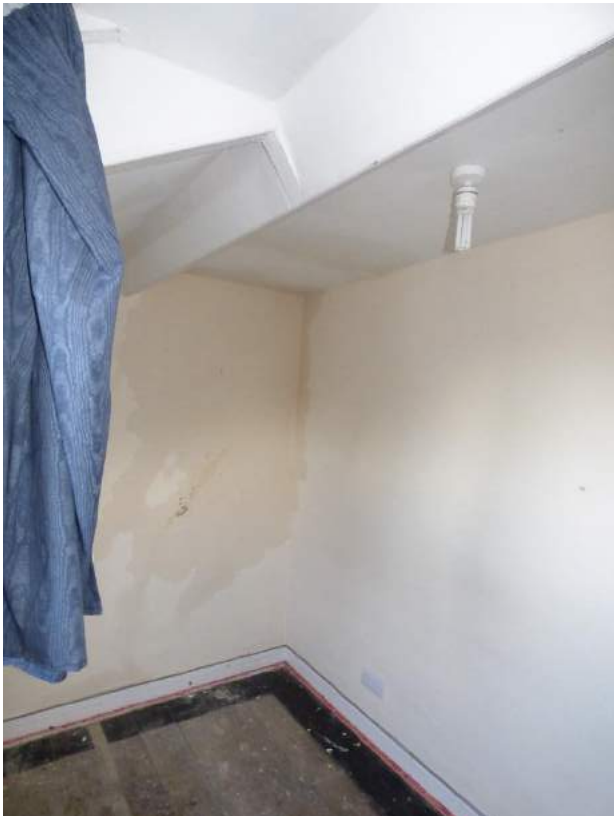
The dormer window has degraded to an extent that it requires complete replacement. The dormer window is between two existing rooms, which are to be reconfigured to make the

It is proposed to completely reconstruct the dormer windows in a style to match dormer windows on other properties, so there is consistency with the design approach.

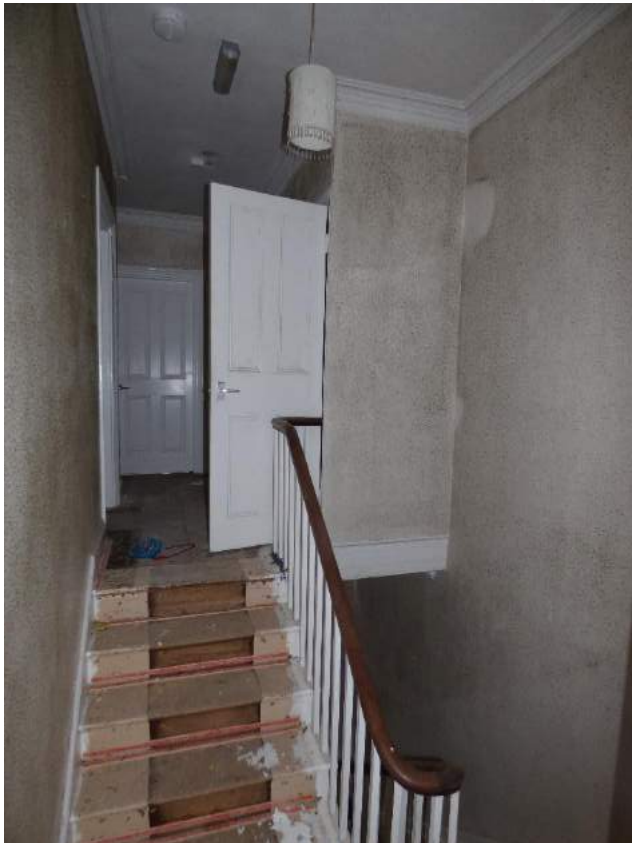
Left: Handrail, balusters and rails are original and are to be retained.

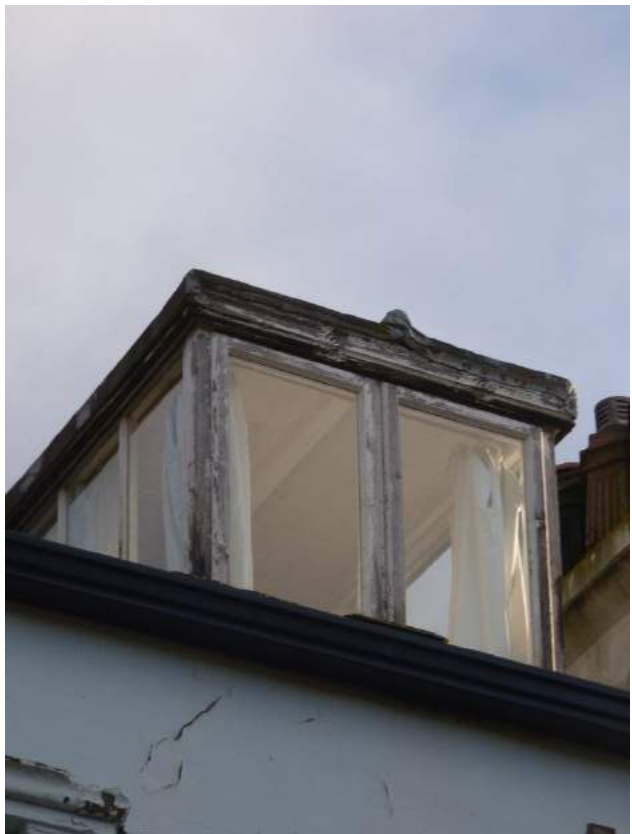
Existing dormer window is in extremely poor condition and it is proposed to completely reconstruct the dormer, in a style to match the other dormer windows on the adjacent buildings.

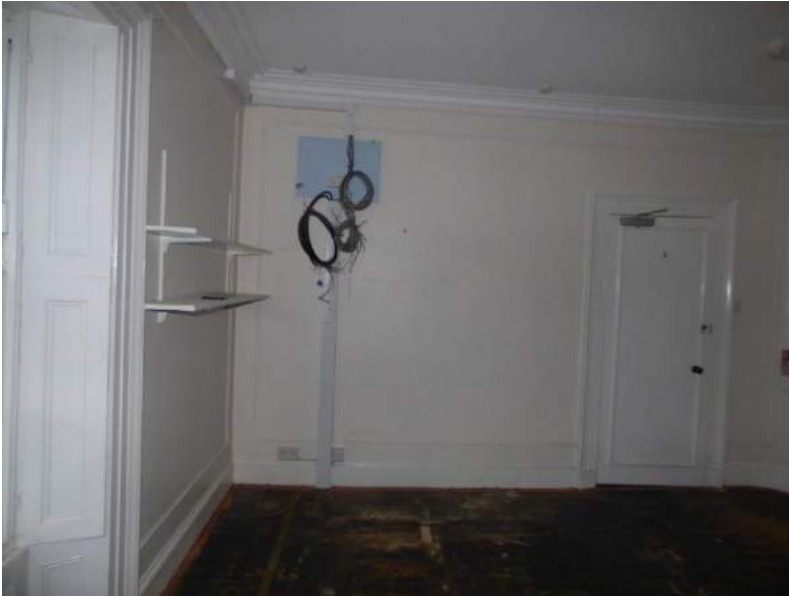
Left: Existing services to be stripped out and walls made good.

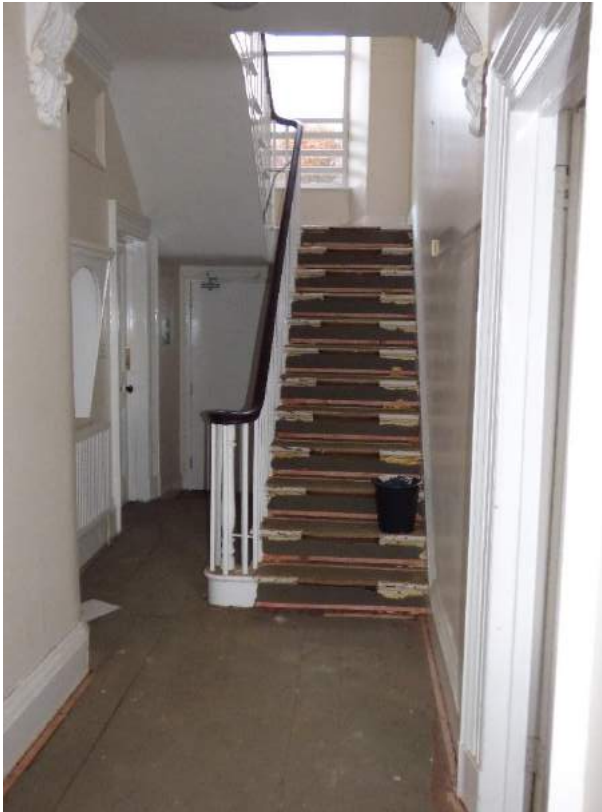
Left: The existing walls and floor are generally in good condition.

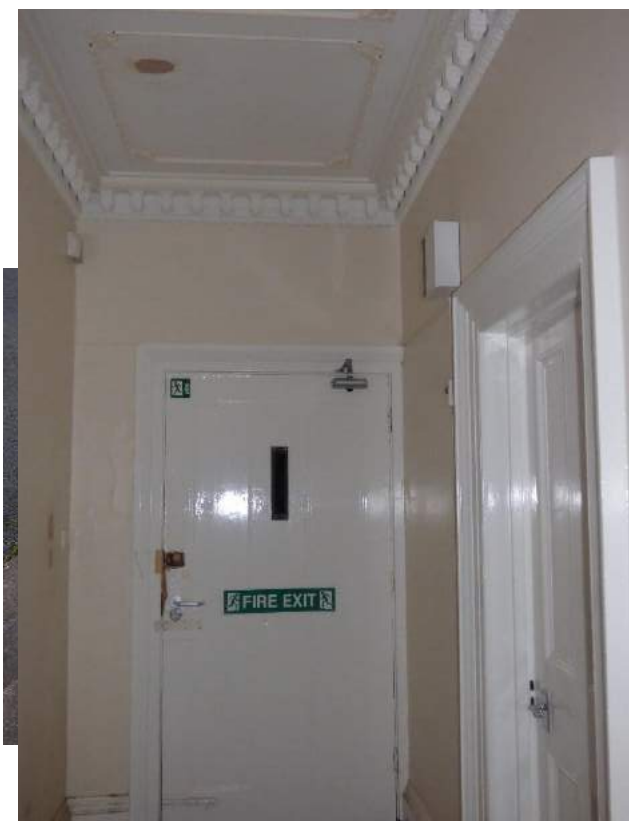
Left: Period features to be retained, including archway and architraves. (Modern lighting to all be stripped out and make good services./ All architraves and plaster features to be retained.

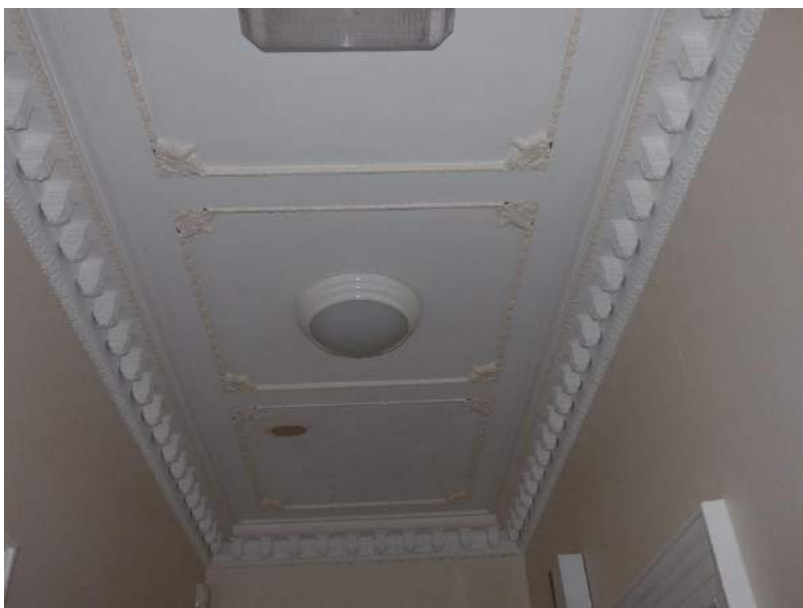
Minor damp patch repair required to ceiling.

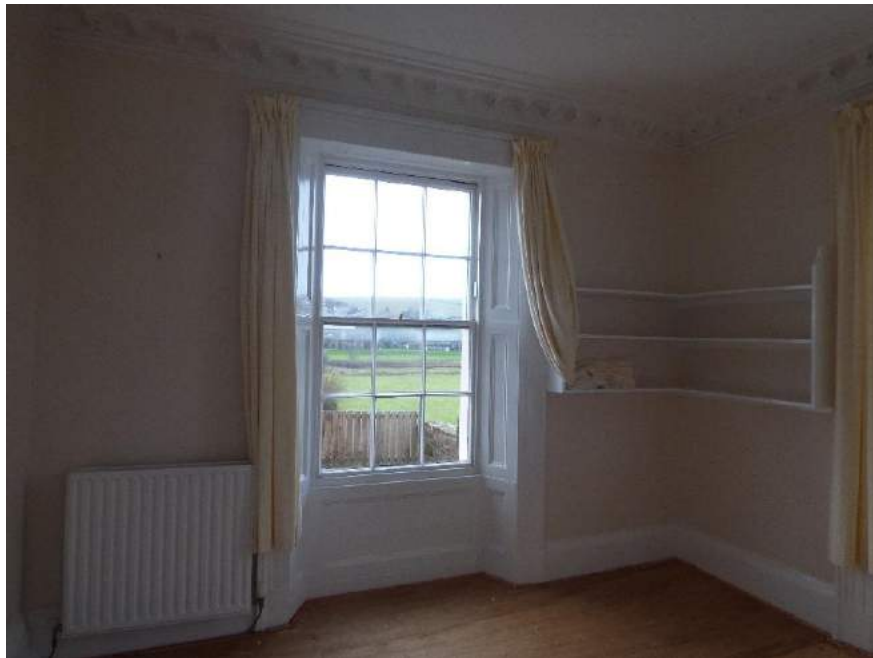
The period features below and to the sides of the existing window are in good condition, it is proposed to carefully refurbish the existing timber shutters.

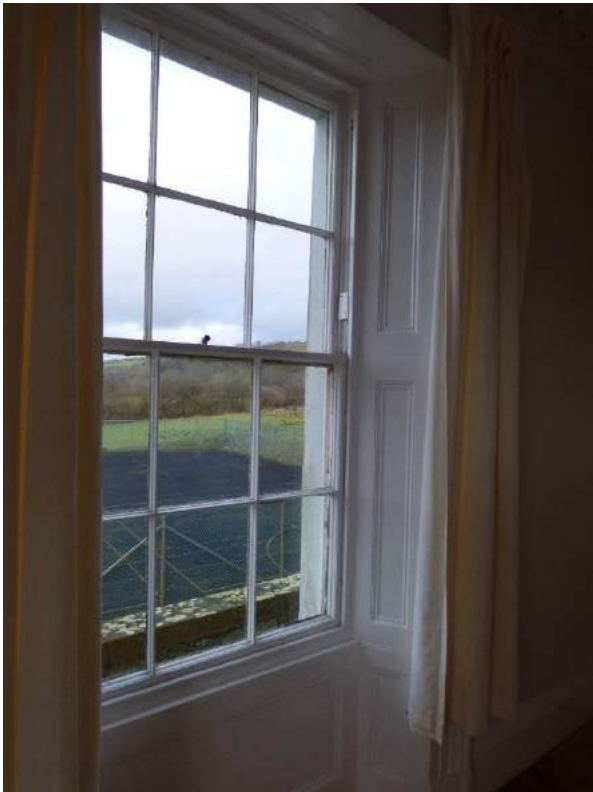
In the existing dining room at the rear of the property the period features below and to the sides of the existing window are in good condition, it is proposed to carefully refurbish the existing timber shutters.
