# HERITAGE STATEMENT

## FULL RENOVATION OF EXISTING No 11 TERRACE HOUSES

St Bees, 1-11 Lonsdale Terrace, Parish Council, Cumbria

M.A.C Architects, Project Number: 2019:303

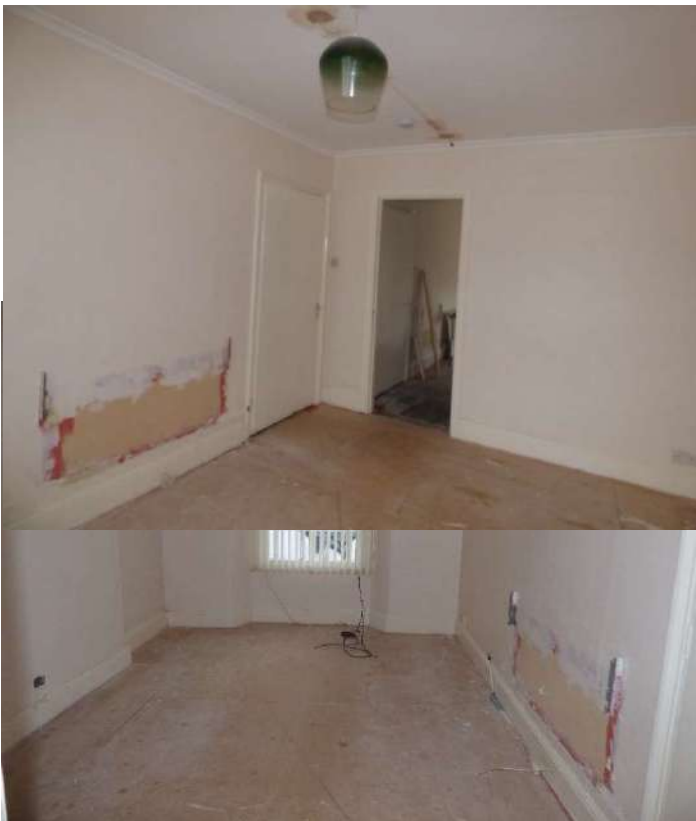
Existing living area at first floor is proposed to remain as existing subject to minor decorative repairs. Flush panel doors to be replaced with heritage style four panel painted timber fire doors to enhance the heritage asset.

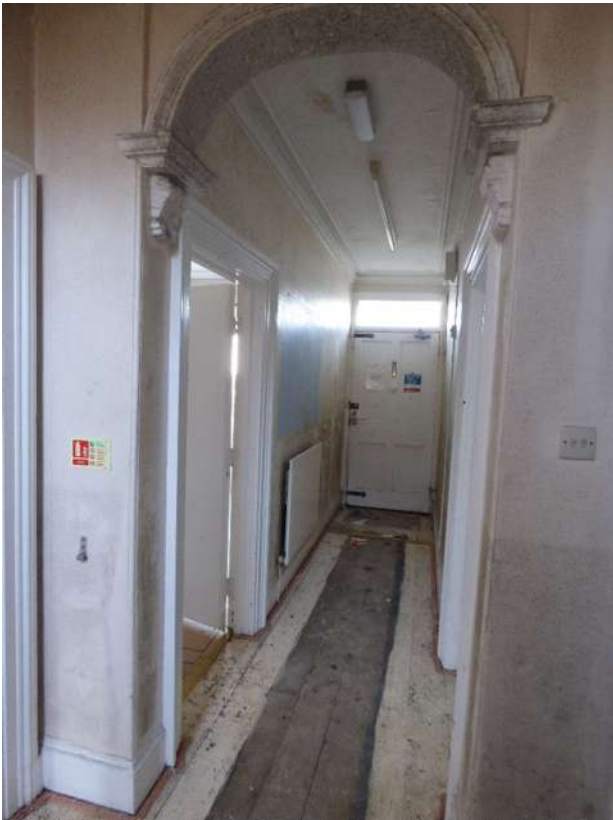
Left: The existing walls and floor are generally in good condition.

Redundant M&E to be removed and wall / ceiling finishes made good, and primed, prepared, and fully decorated.

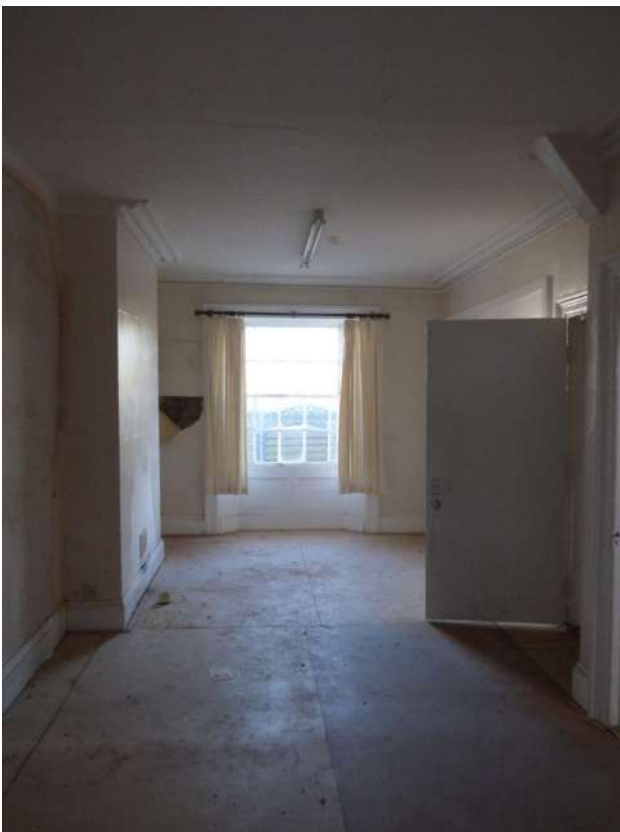
Left: In the existing lounge, the period features below and to the sides of the existing windows both front and back are in good condition, it is proposed to carefully refurbish the existing timber shutters.

Existing cornice to be made good in locations where redundant services are to be removed and where hairline cracks have appeared.

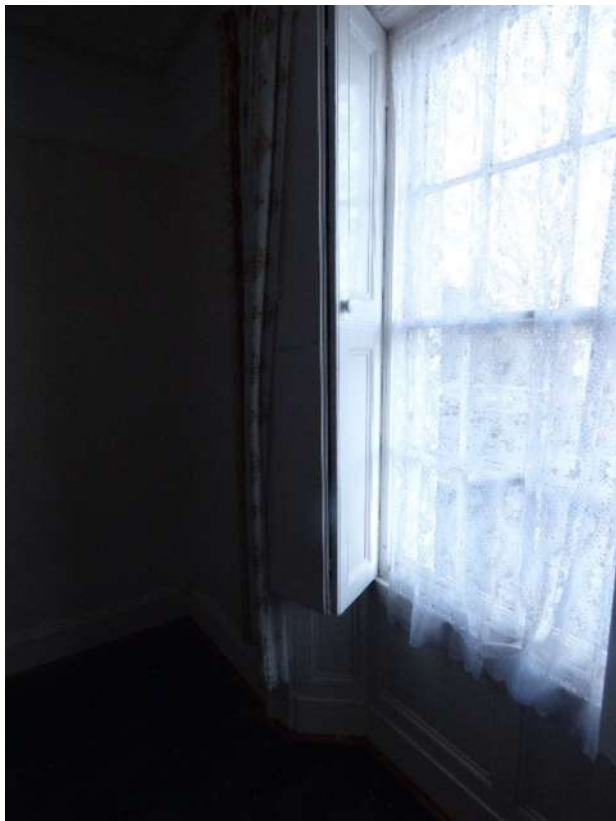
Above and Left: In the existing study, the period features below and to the sides of the existing windows both front and back are in good condition, it is proposed to carefully refurbish the existing timber shutters.

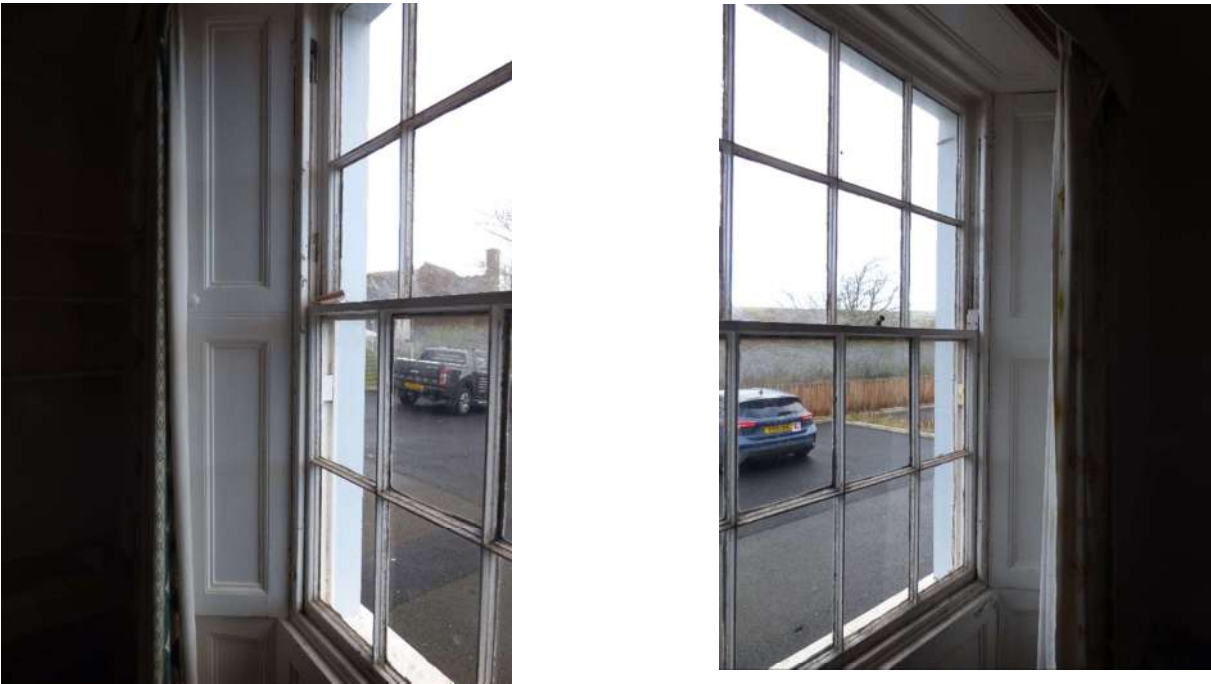
Above: In the existing lounge, the period features below and to the sides of the existing windows both front and back are in good condition, it is proposed to carefully refurbish the existing timber shutters.

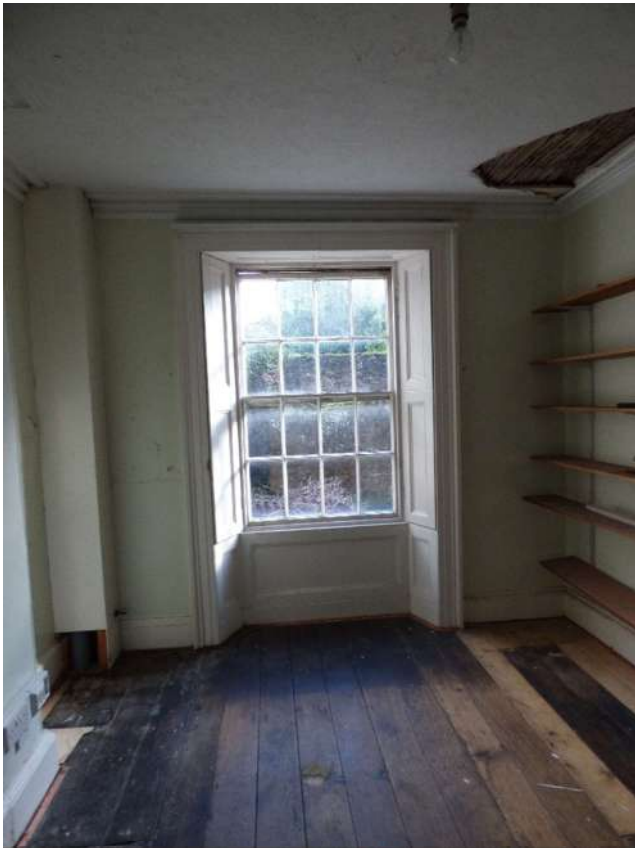
Left and below: The period features below and to the sides of the existing window are in good conditions, it is proposed to carefully refurbish the existing timber shutters.

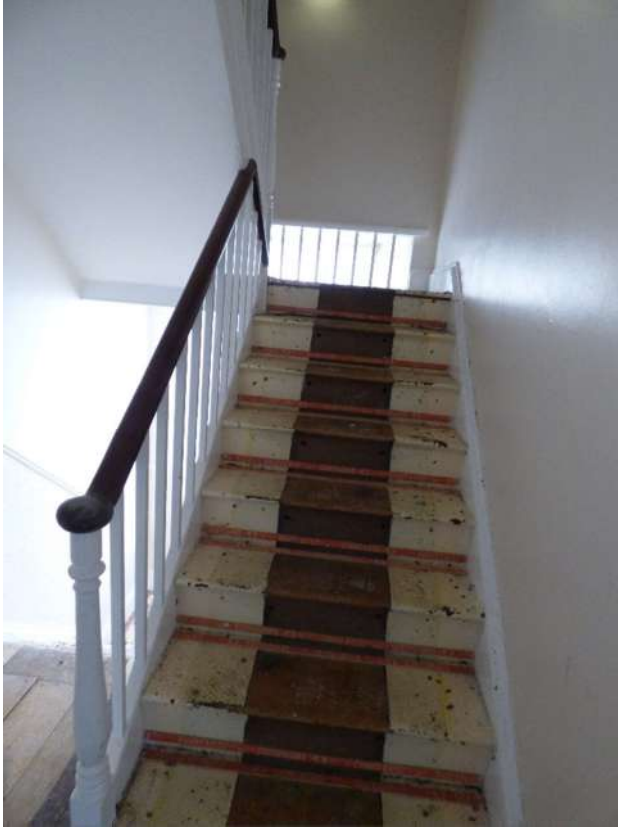
Left and below: Handrail, balusters and rails are original and are to be retained. Missing baluster to be replaced with matching baluster and decorated to match existing.

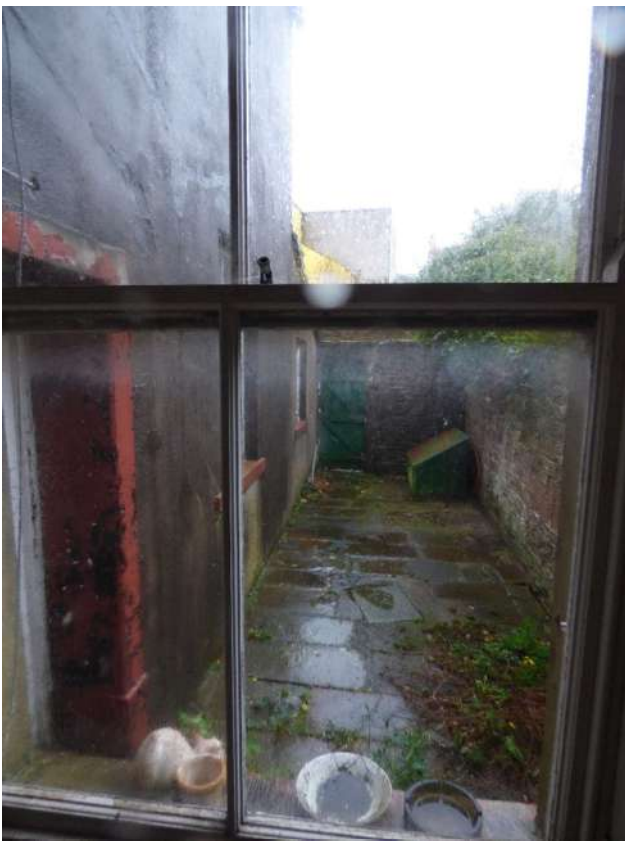
Left: View of rear of property – render to be repaired by specialist and decorated with off white render.

Cills to be repaired, as necessary.

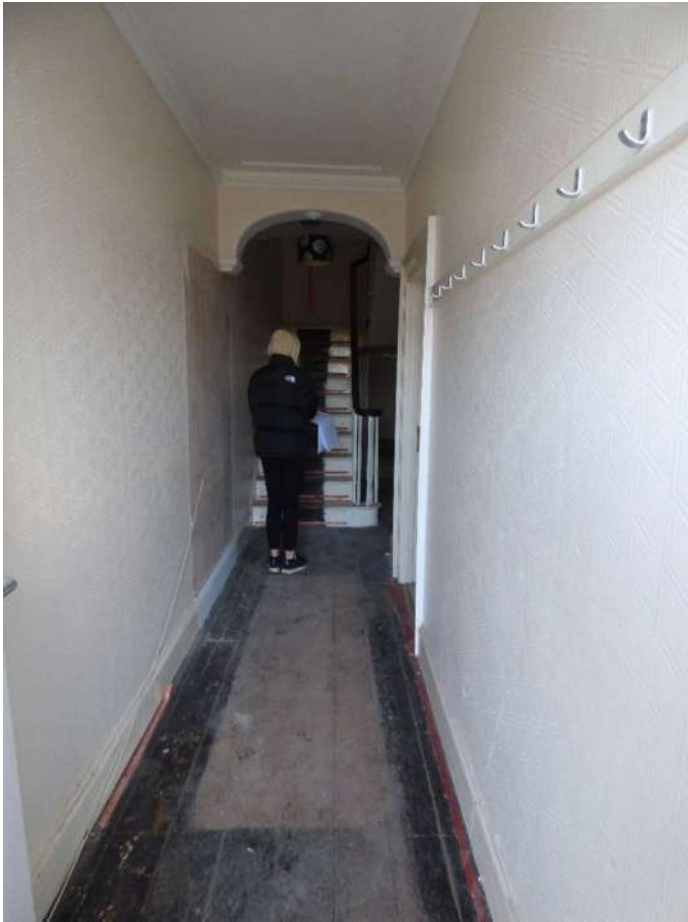
Entrance and hallway Left: The existing walls and floor are generally in good condition.

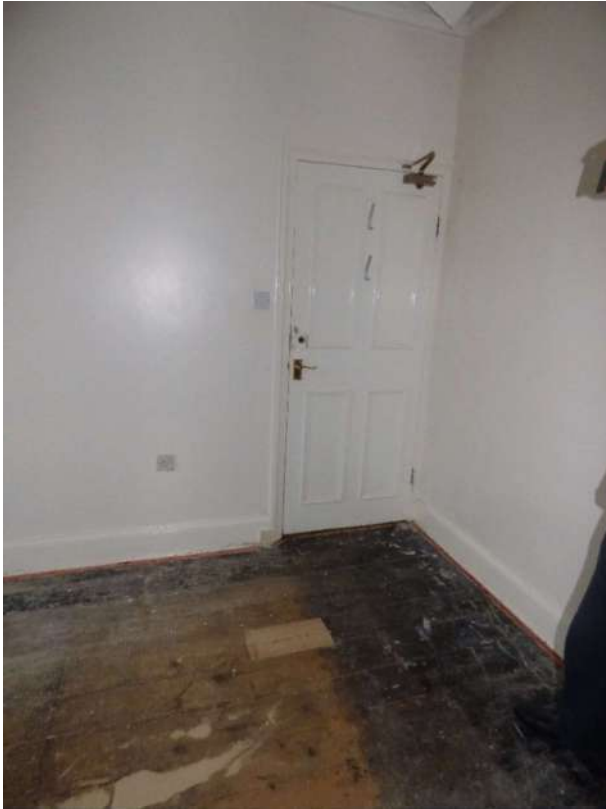
Left: Front Bedroom (small) skirtings and architraves to be retained, existing door to be replaced with new Georgian heritage style 4 panel door to be provided and installed by specialist joinery company such as Batty Joinery Ltd. Where possible it is proposed to refurbish any original doors with door closers and intumescent paint subject to building control approval.

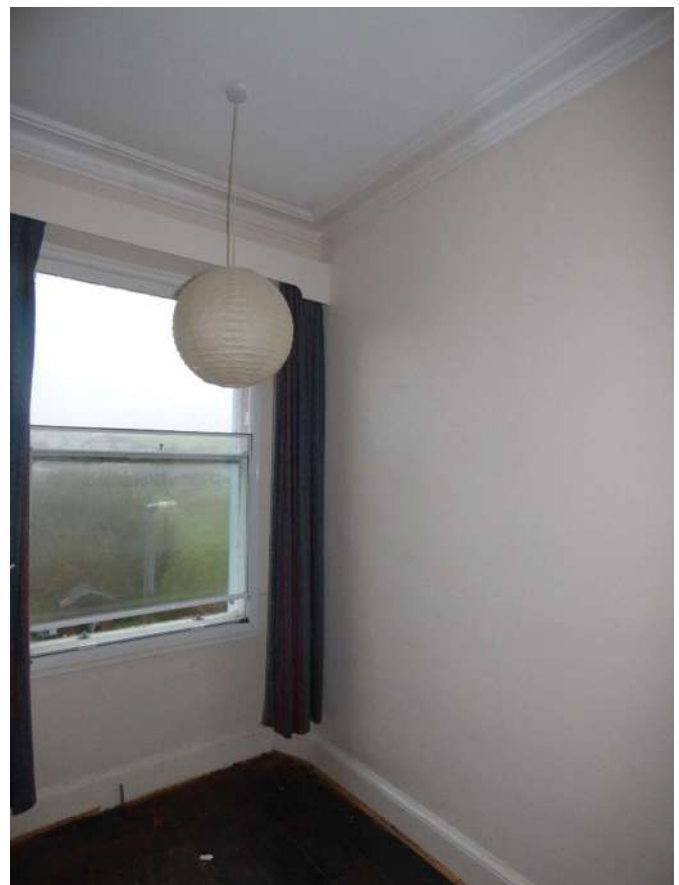
Below Left: Existing cornice damaged due to water ingress from attic room above. Cornice to be repaired.

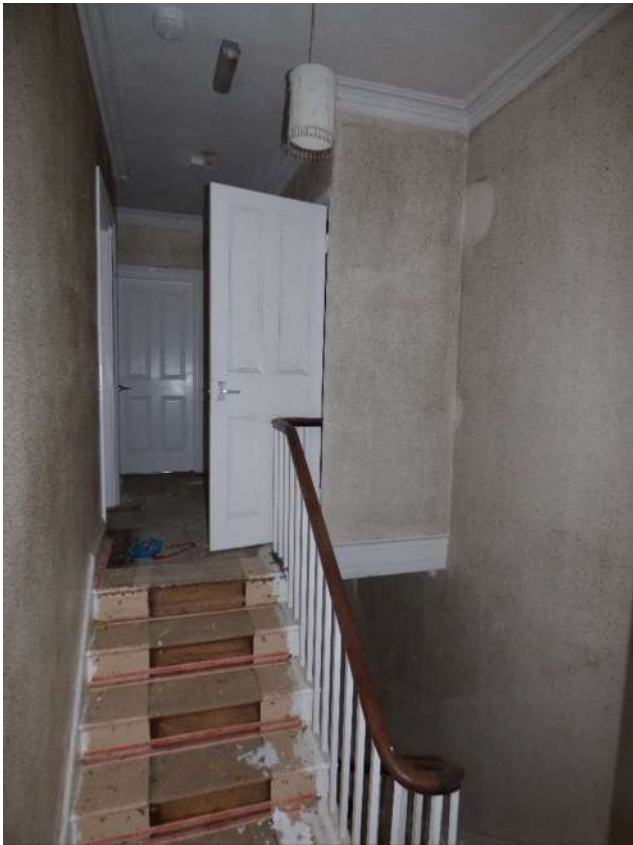
Left: Handrail, balusters and rails are original and are to be retained.

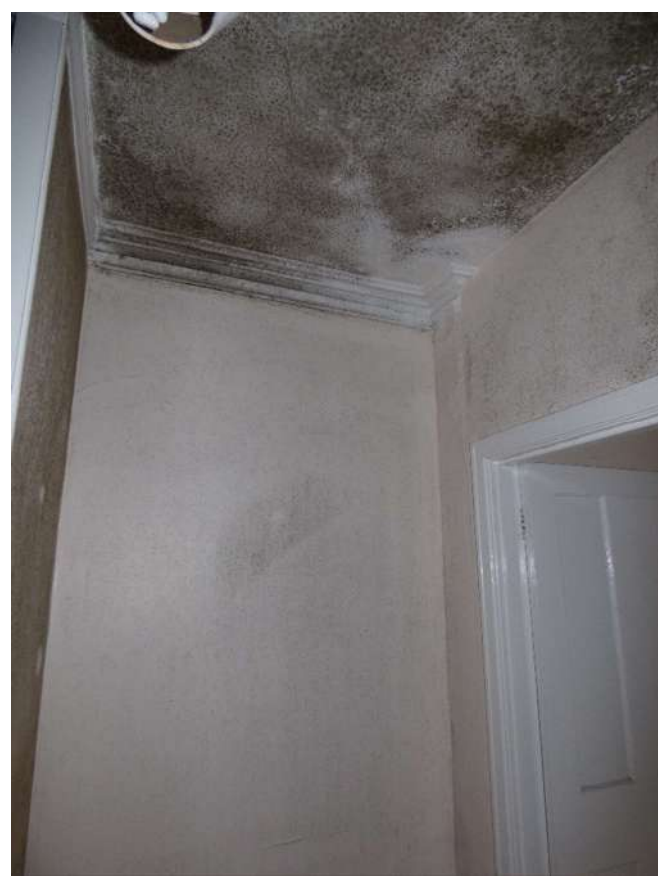
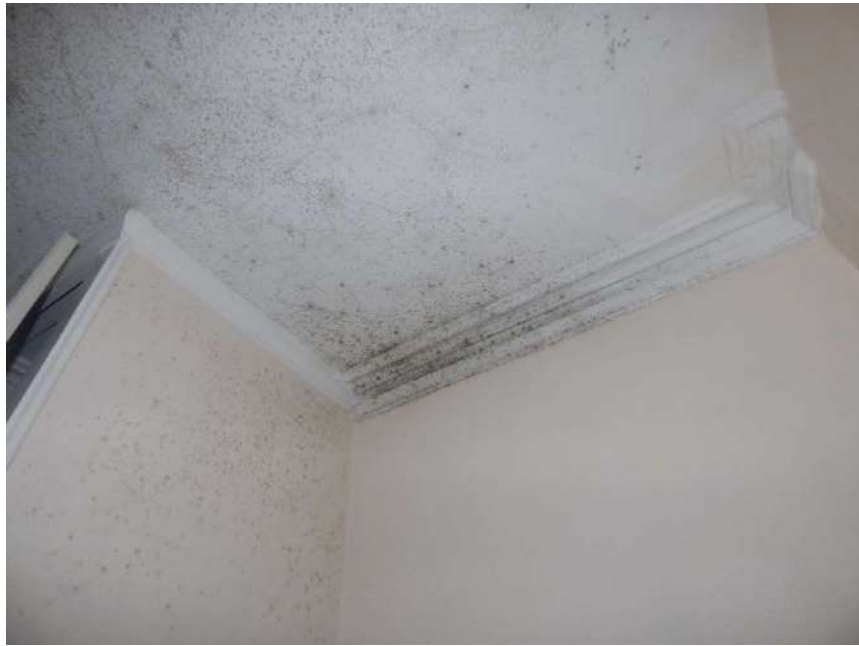
Left and above: Existing ceiling to be made good by removing mould and replacing blown plaster with lime plaster as required.

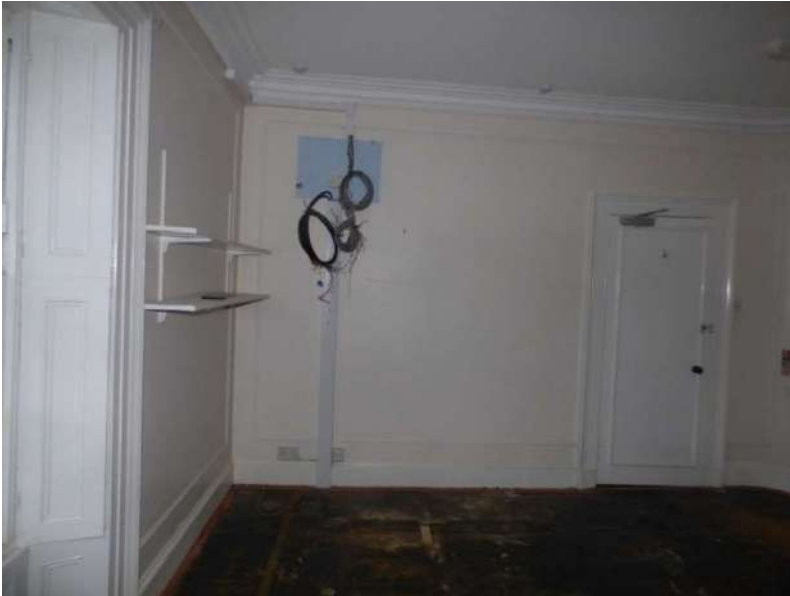
Left: Existing services to be stripped out and walls made good.

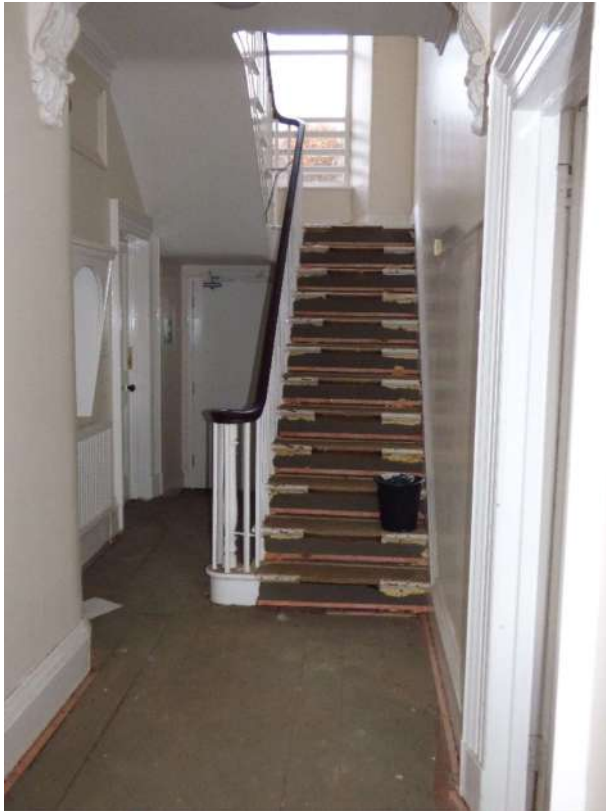
Left: The existing walls and floor are generally in good condition.

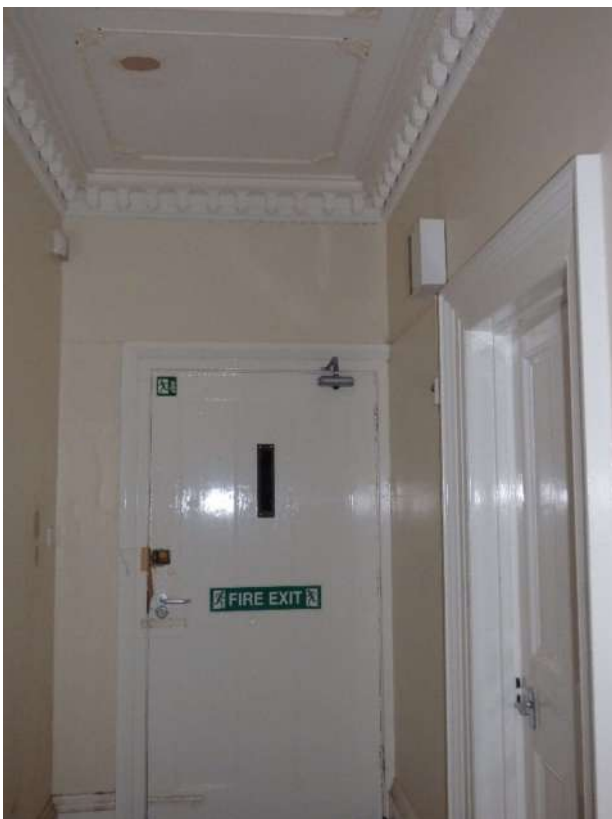
Left: Period features to be retained, including archway and architraves. (Modern lighting to all be stripped out and make good services./ All architraves and plaster features to be retained.

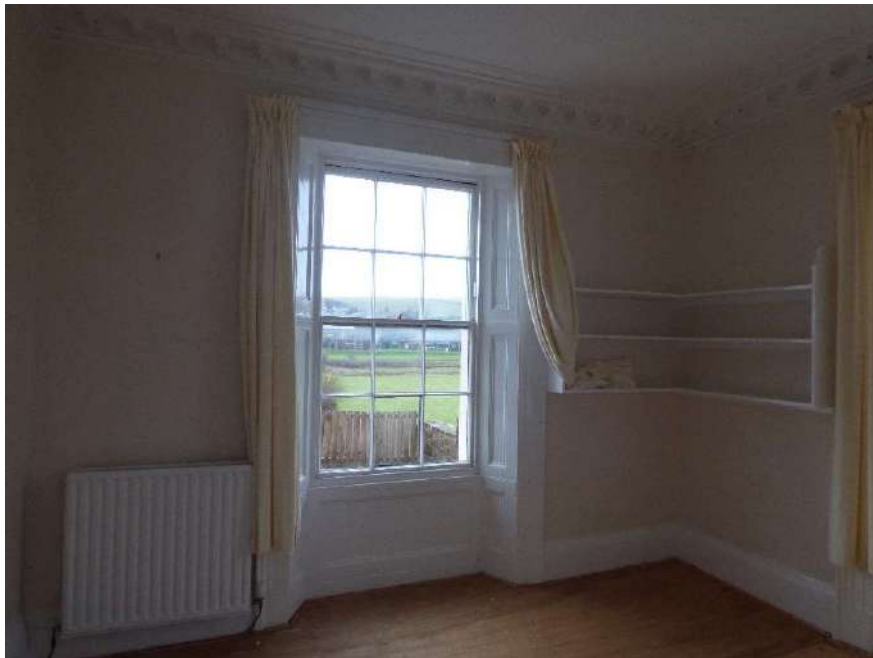
The period features below and to the sides of the existing window are in good condition, it is proposed to carefully refurbish the existing timber shutters.

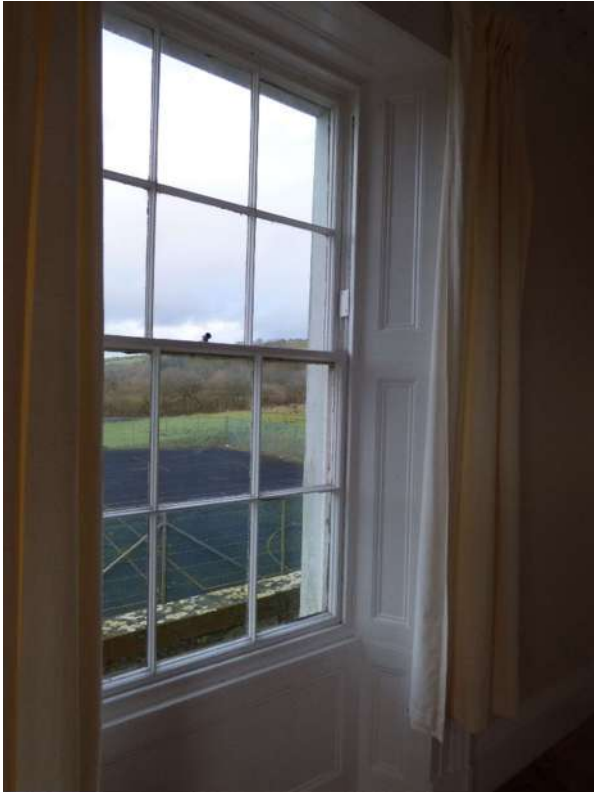
In the existing dining room at the rear of the property the period features below and to the sides of the existing window are in good condition, it is proposed to carefully refurbish the existing timber shutters.
