# HERITAGE STATEMENT

## FULL RENOVATION OF EXISTING No 11 TERRACE HOUSES

St Bees, 1-11 Lonsdale Terrace, Parish Council, Cumbria

M.A.C Architects, Project Number: 2019:303

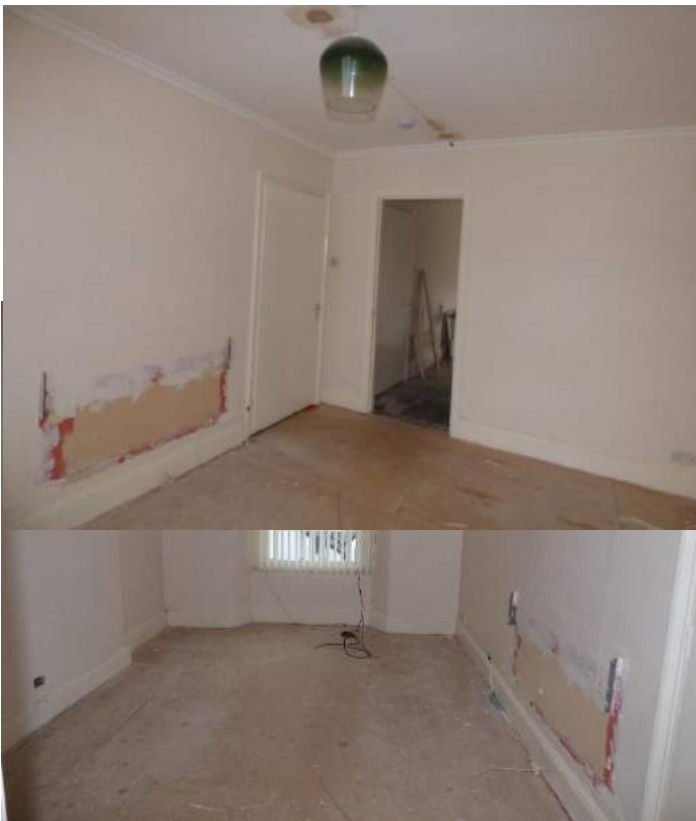
Existing living area at first floor is proposed to remain as existing subject to minor decorative repairs. Flush panel doors to be replaced with heritage style four panel painted timber fire doors to enhance the heritage asset.

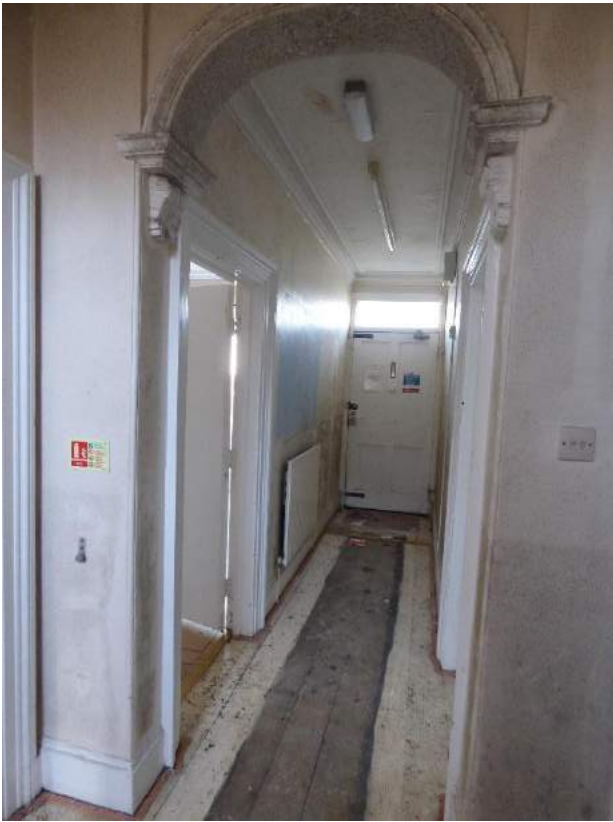
Left: The existing walls and floor are generally in good condition.

Redundant M&E to be removed and wall / ceiling finishes made good, and primed, prepared, and fully decorated.

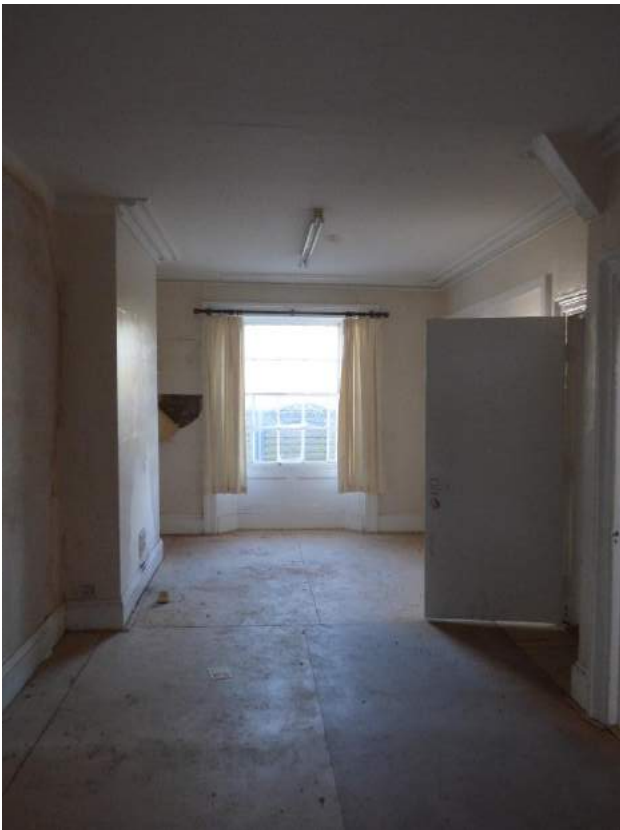
Left: In the existing lounge, the period features below and to the sides of the existing windows both front and back are in good condition, it is proposed to carefully refurbish the existing timber shutters.

Existing cornice to be made good in locations where redundant services are to be removed and where hairline cracks have appeared.

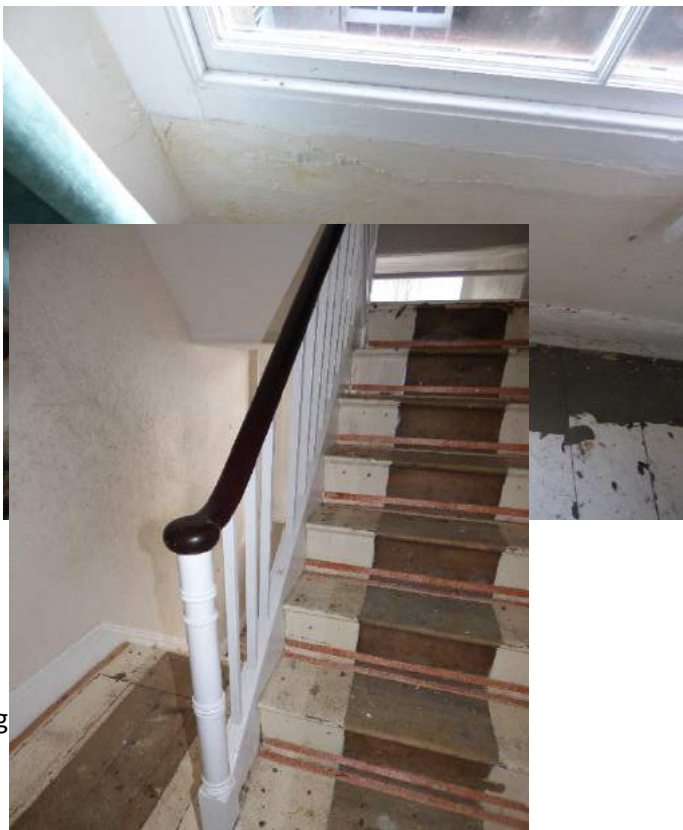
Handrail, balusters, and rails are original and are to be retained. Missing baluster to be replaced with matching baluster and decorated to match existing.

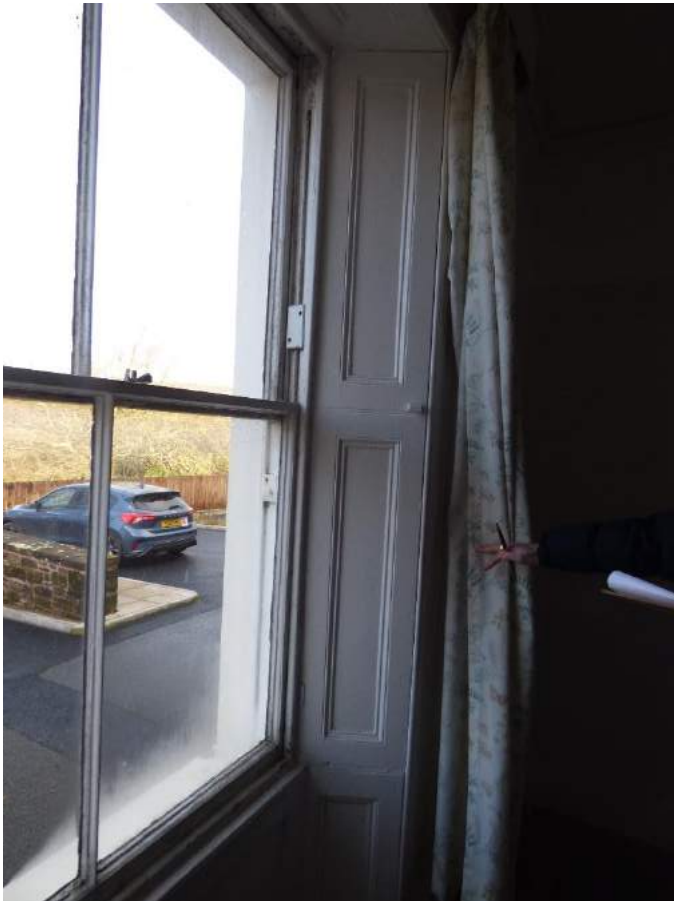
Above: In the existing lounge at the front of the property and

Right and below: The existing dining area to the rear of the property, the period features below and to the sides of the existing window are in good condition, it is proposed to carefully refurbish the existing timber shutters.

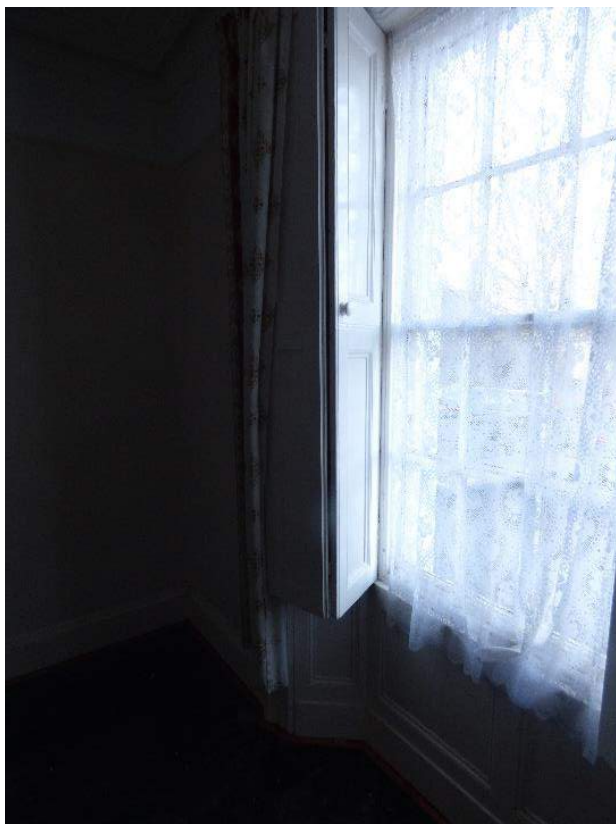
Above and Left: In the existing study, the period features below and to the sides of the existing windows both front and back are in good condition, it is proposed to carefully refurbish the existing timber shutters.

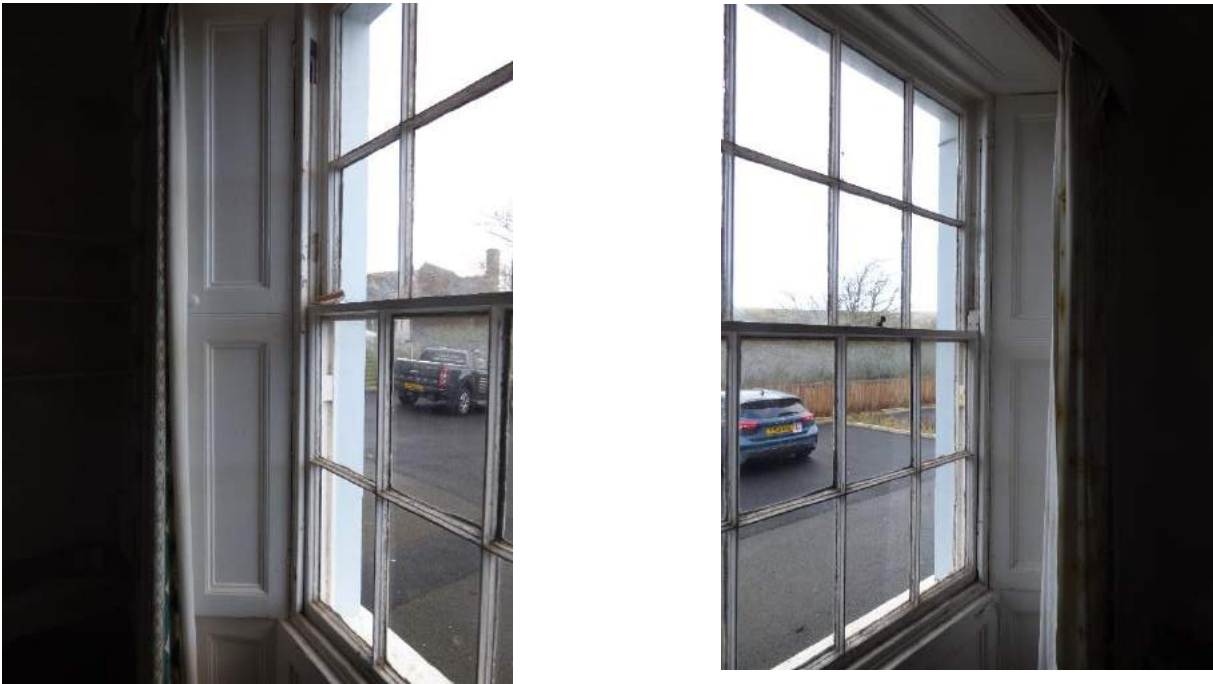
Above: In the existing lounge, the period features below and to the sides of the existing windows both front and back are in good condition, it is proposed to carefully refurbish the existing timber shutters.

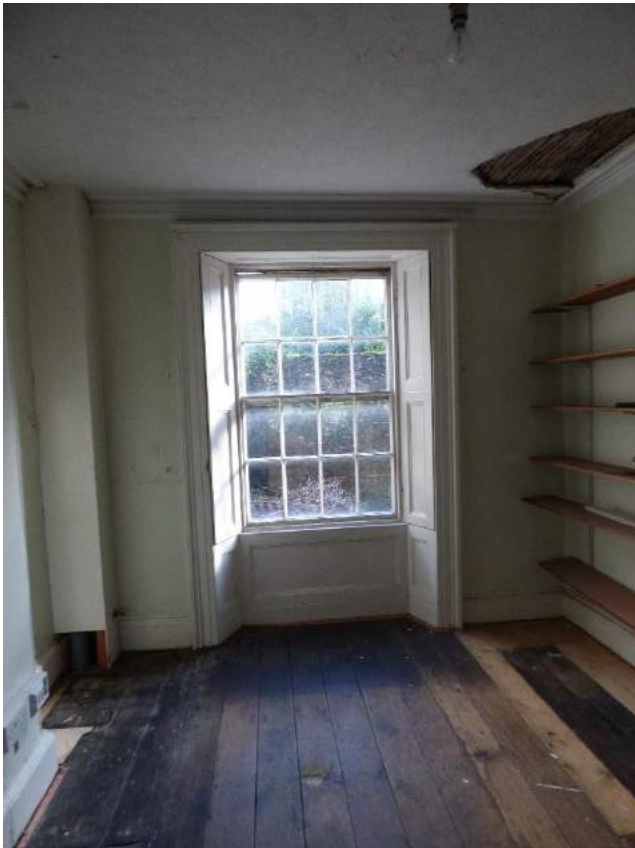
Left and below: The period features below and to the sides of the existing window are in good conditions, it is proposed to carefully refurbish the existing timber shutters.

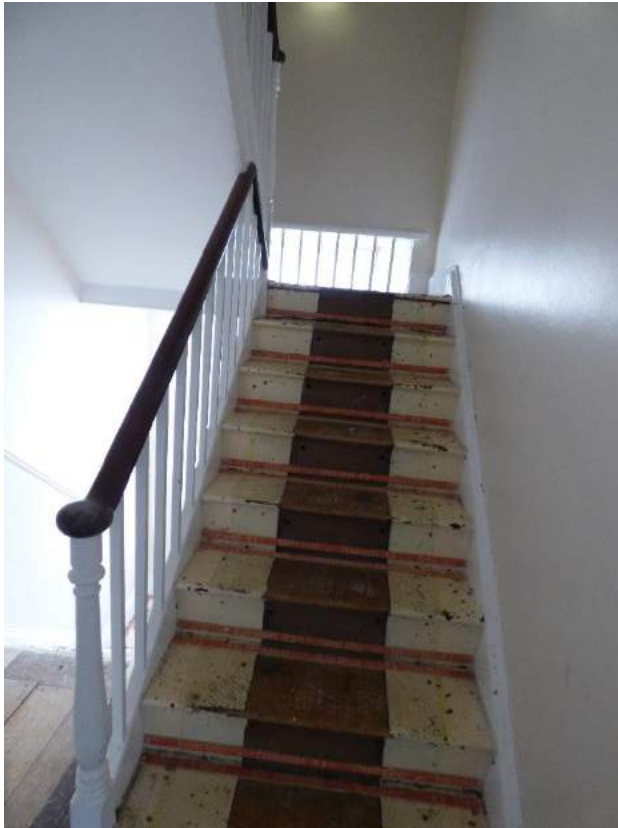
Left and below: Handrail, balusters and rails are original and are to be retained. Missing baluster to be replaced with matching baluster and decorated to match existing.

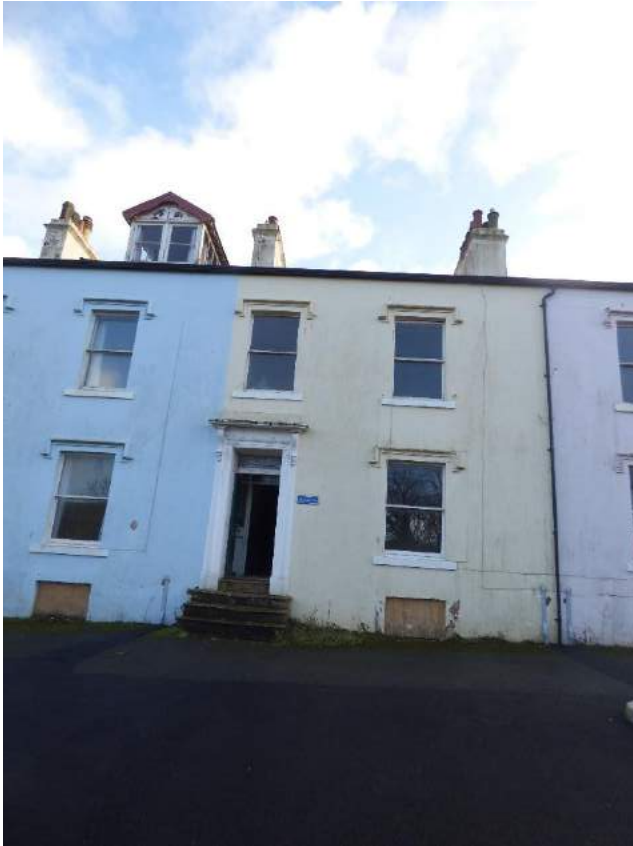
Left: The main entrance is mentioned in the listing text and is to be entirely retained.

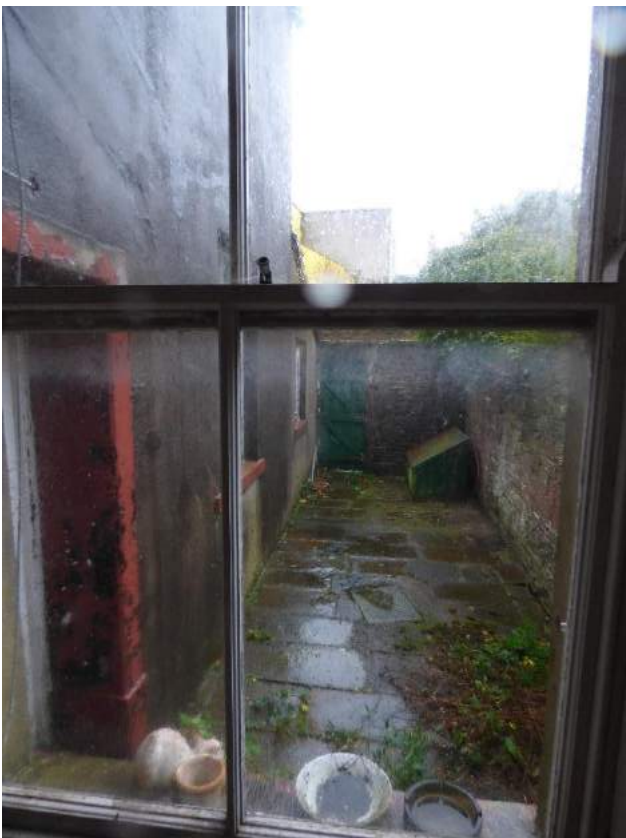
Left: View of rear of property – render to be repaired by specialist and decorated with off white render.

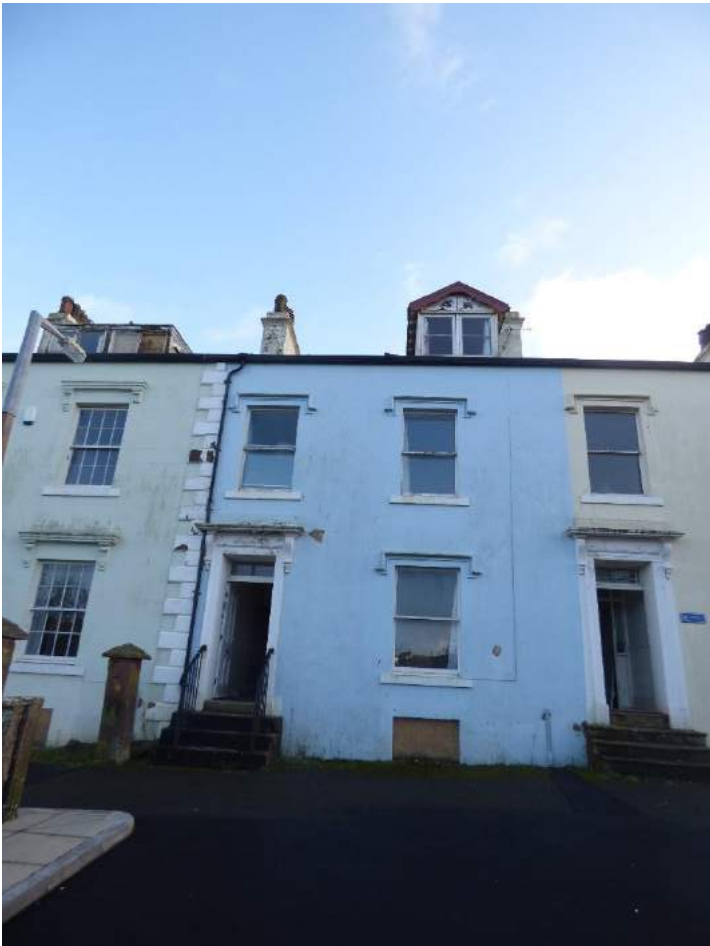
Left: The main entrance is mentioned in the listing text and is to be entirely retained.

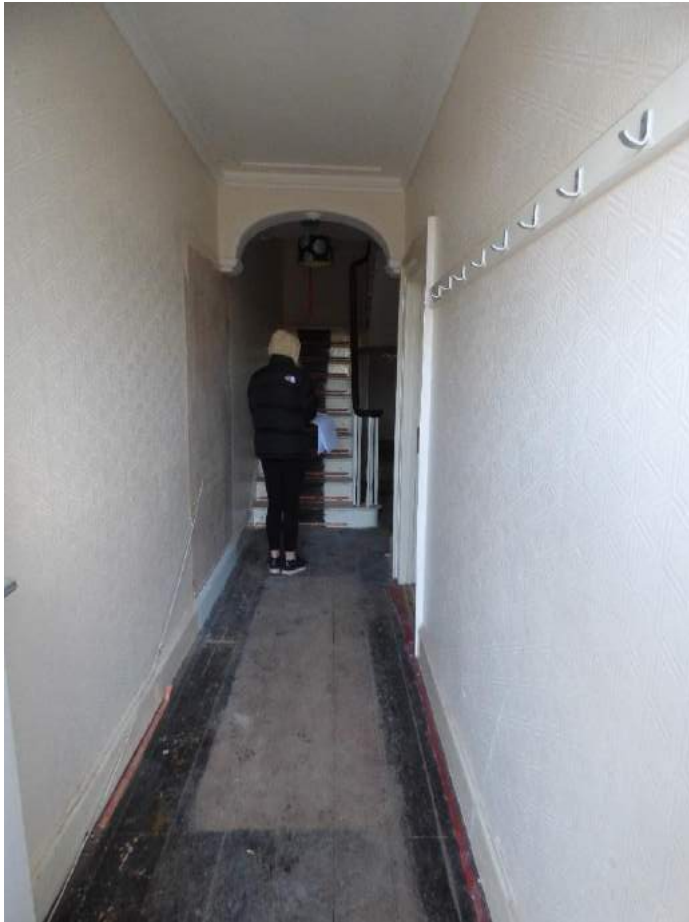
Entrance and hallway Left: The existing walls and floor are generally in good condition.

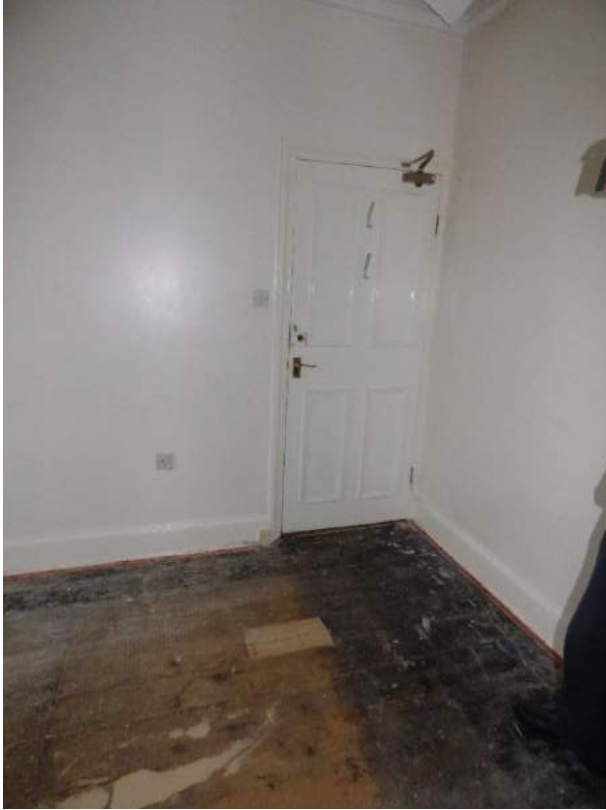
Left: Front Bedroom (small) skirtings and architraves to be retained, existing door to be replaced with new Georgian heritage style 4 panel door to be provided and installed by specialist joinery company such as Batty Joinery Ltd. Where possible it is proposed to refurbish any original doors with door closers and intumescent paint subject to building control approval.

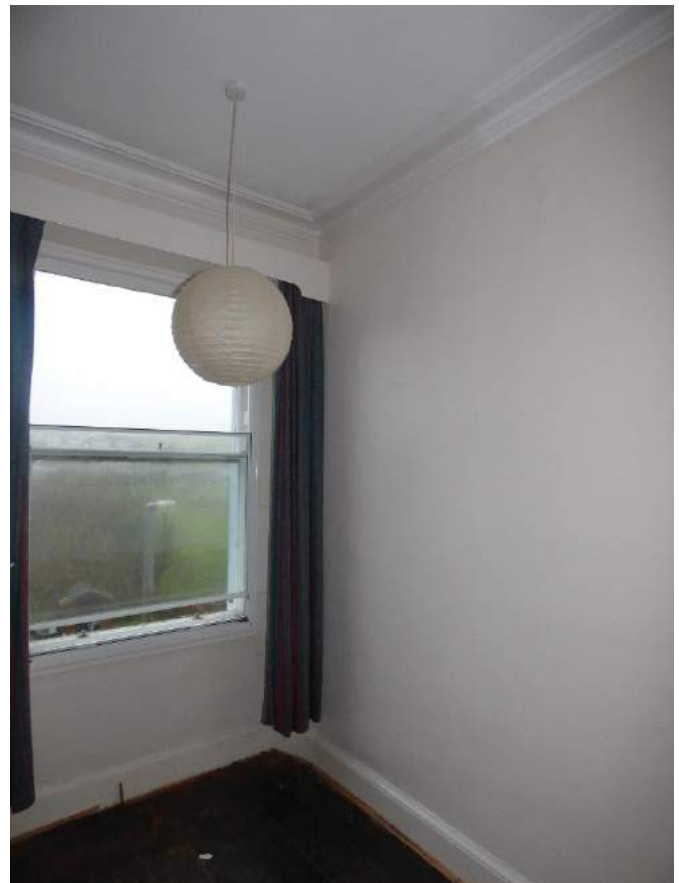
Below Left: Existing cornice damaged due to water ingress from attic room above. Cornice to be repaired.

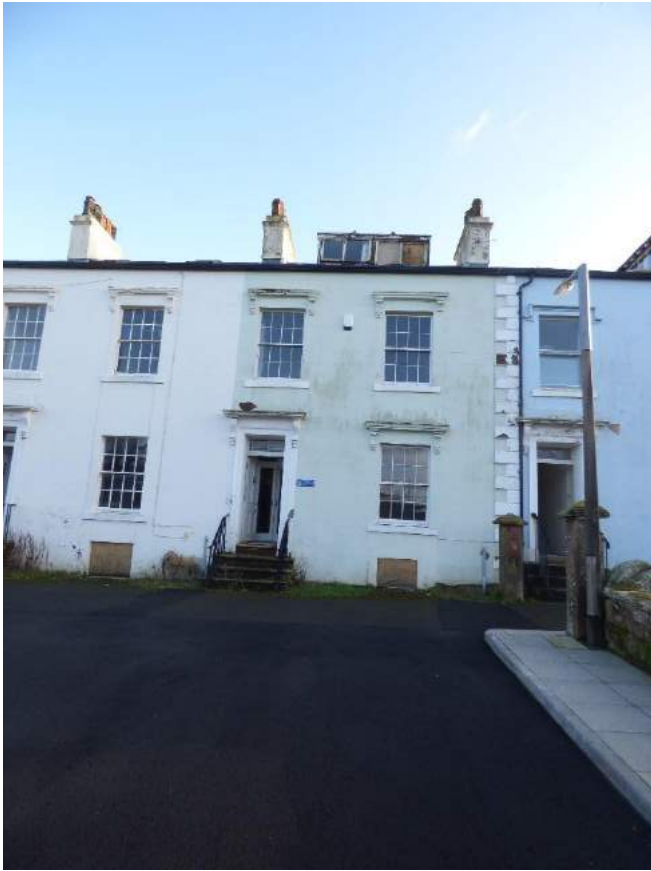
Left: The main entrance is mentioned in the listing text and is to be entirely retained.

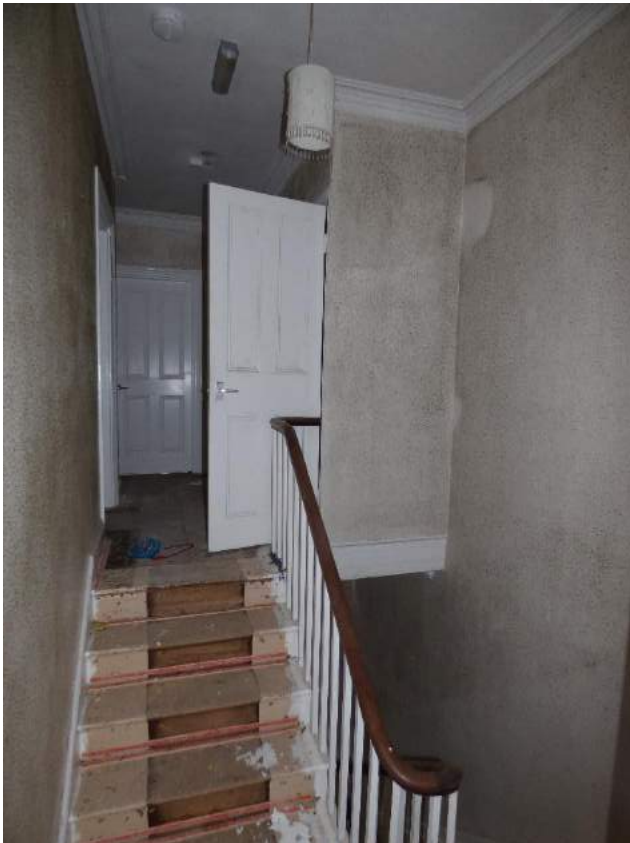
Left: Handrail, balusters and rails are original and are to be retained.

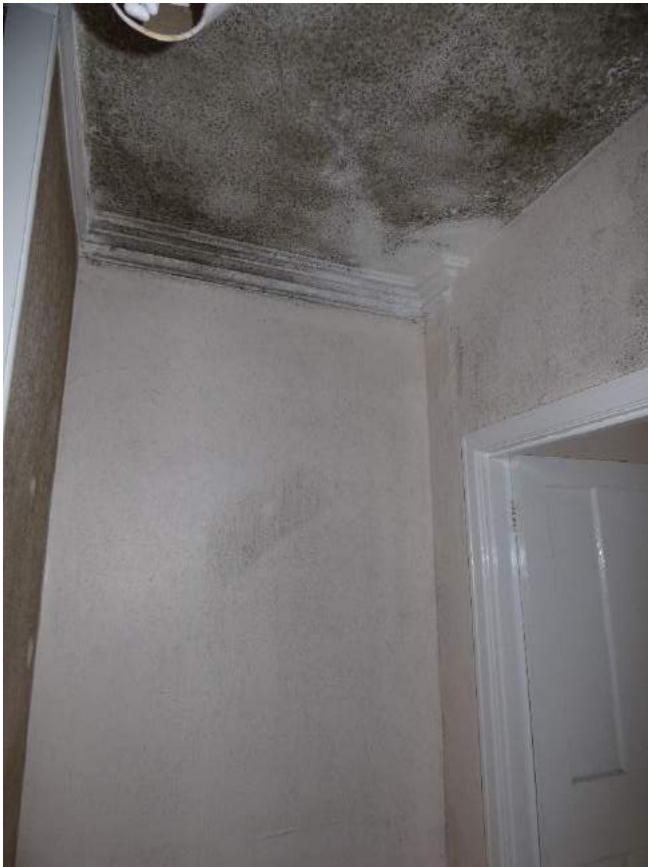
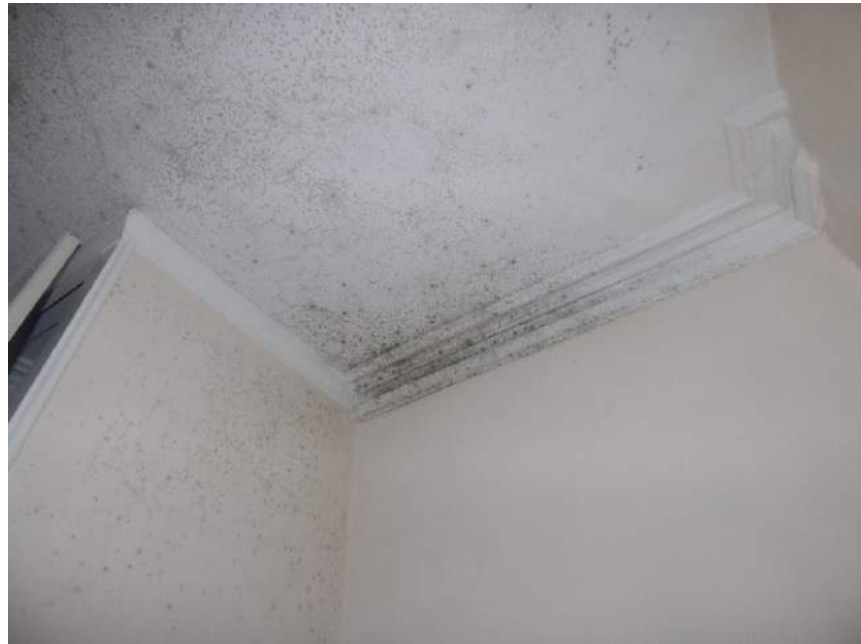
Left and above: Existing ceiling to be made good by removing mould and replacing blown plaster with lime plaster as required.

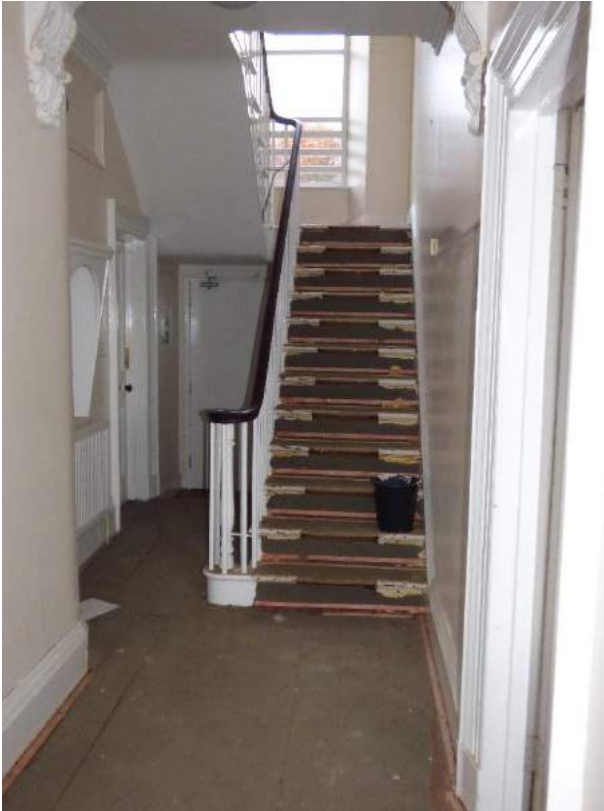
Left: The existing walls and floor are generally in good condition.

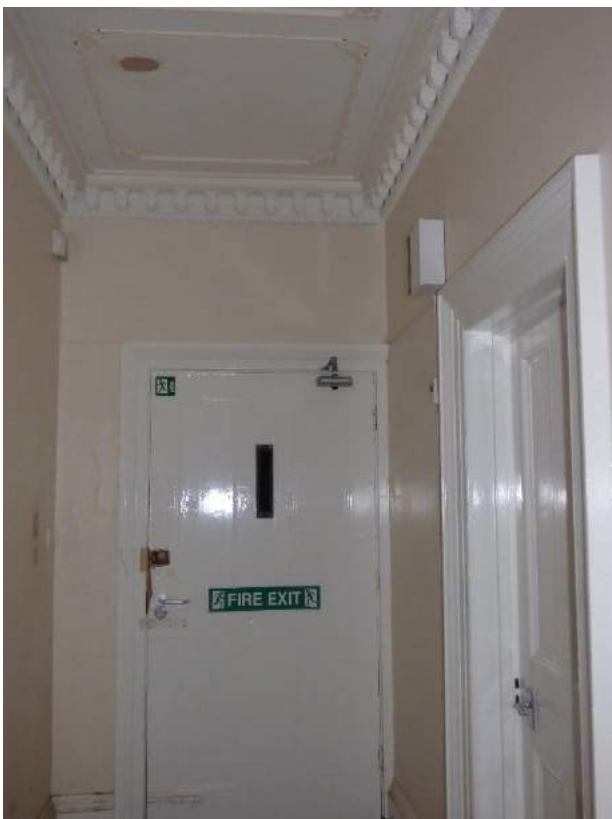
Left: Period features to be retained, including archway and architraves. (Modern lighting to all be stripped out and make good services./ All architraves and plaster features to be retained.
