DEMOLITION OF SIDE ADDITION TO  
UNION HALL, SCOTCH STREET,  
WHITEHAVEN, CUMBRIA, CA28 7BJ

## HERITAGE STATEMENT

Project Reference: 5416  
Date Prepared: May 2020  
Prepared By: Andrew West BSc(Hons) MRICS MCABE MFPWS

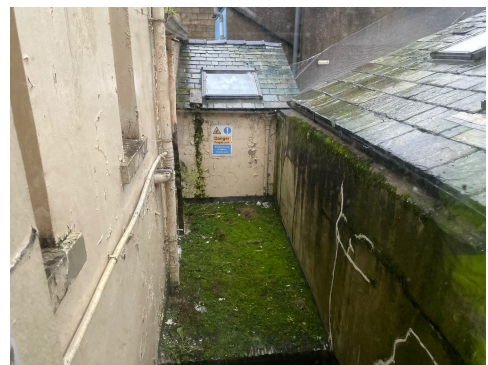
Image of the remaining open area to the rear of Union Hall at 1<sup>st</sup> floor level. Note the moss-covered corrugated roof encloses the 'yard' area at ground floor level.

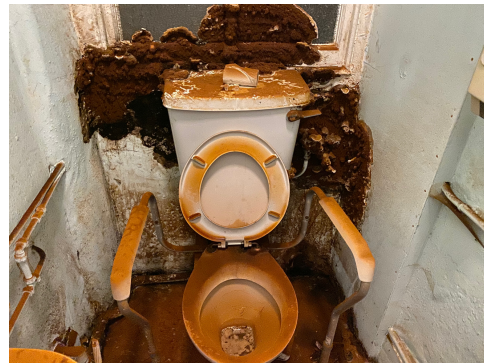
In consultation with the LPA Conservation officer, the extension has undergone a programme of initial stripping out works, which revealed an extensive infestation of dry rot to both timber and masonry elements of the extension – which includes the timber suspended floor structure, timber joinery, timber lintels, the timber staircase progressing into the masonry elements of the structure.

Image of the W.c within the two storey extension and the extent of the dry rot found therein.

Although, it may be considered drastic the proposed demolition of the Twentieth Century addition with its rife and extensive dry rot problems would prevent the dry rot from spreading further into the original Union Hall structure and causing irreparable damage to the interiors and the main structure.

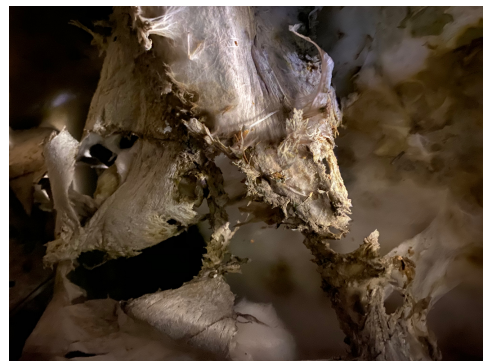
Image of dry rot below the ground floor level, within the sub-floor void.
