**TREE SURVEY REPORT**  
**PROPOSED RESIDENTIAL DEVELOPMENT**  
**ULDALE VIEW, EGREMONT**

**GLEESON HOMES**

**Revision B 01 04 24**

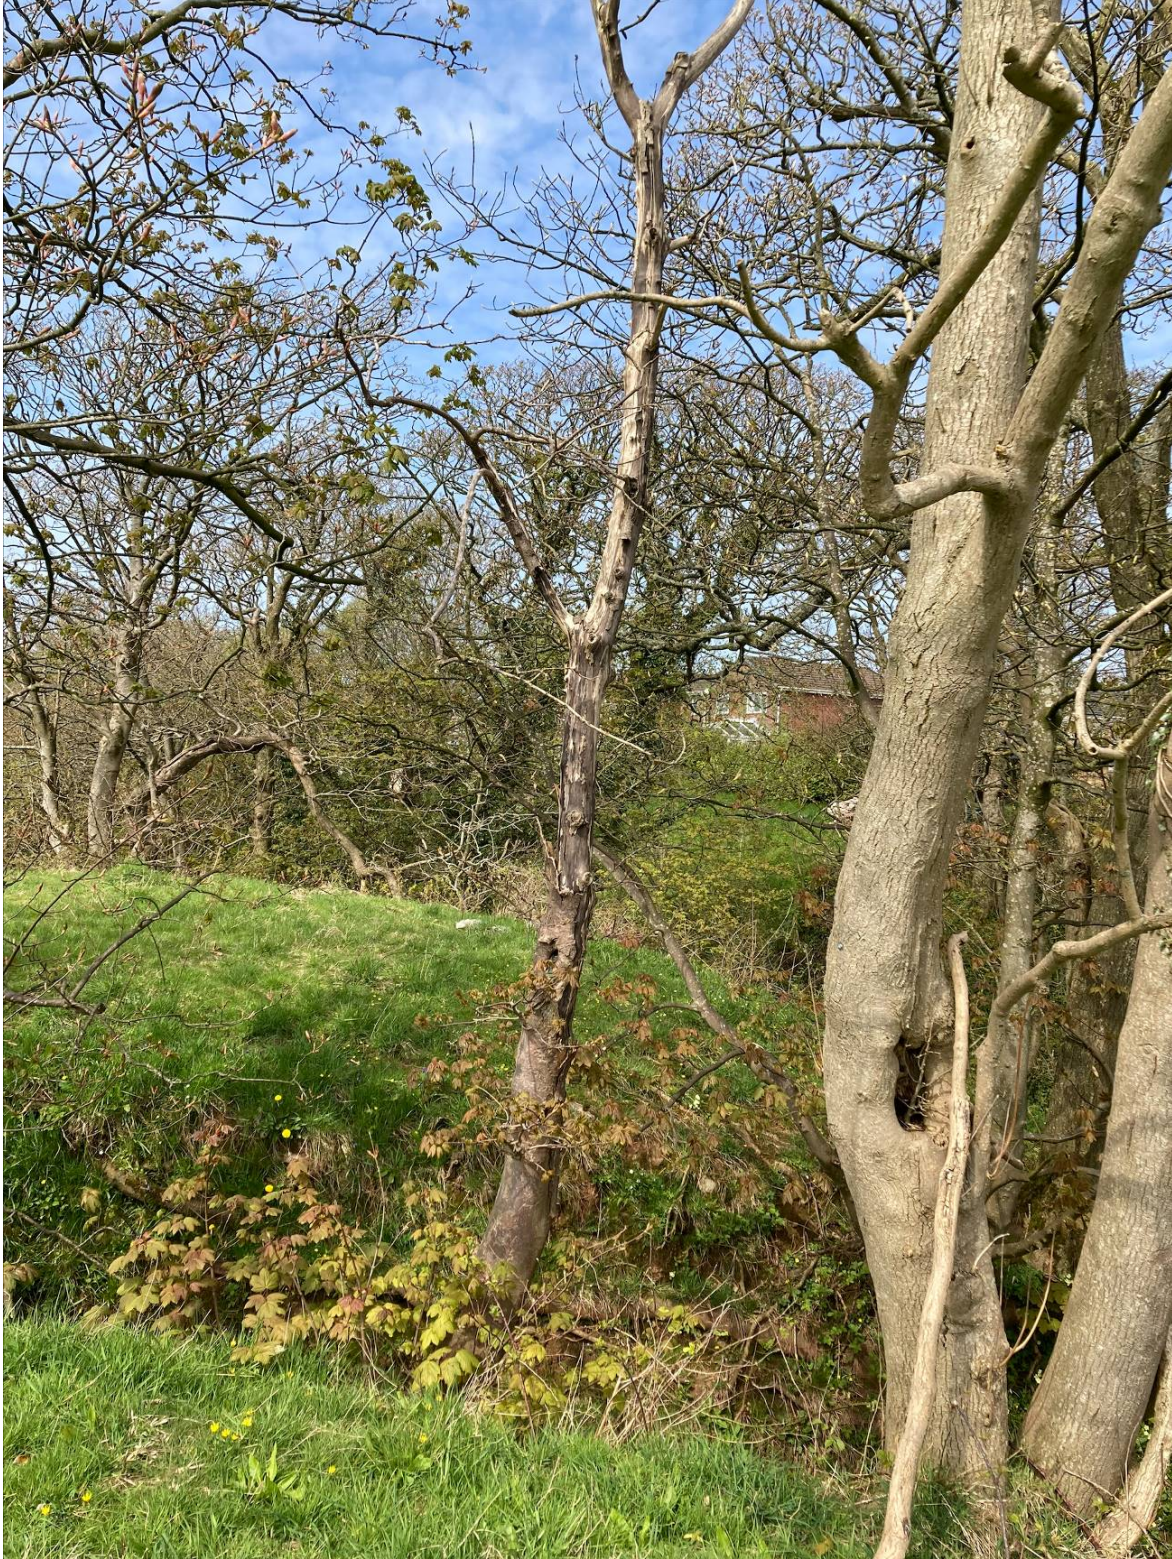
3.1 The trees surveyed are mostly of low-moderate value category 'C' trees. There are three Category 'U' trees which are diseased, decaying and poorly formed trees which

2 Tree T2 dead Sycamore and T3 Ash- both to remove.

- 2.3.1. The removal of approximately 45m of hedge is required to facilitate access for the development. This includes a 30m section of the roadside hedge H1 to accommodate the proposed access and associated sightlines and 15m of hedge H2 for the internal access roads.
- 2.3.1. The Category 'U' trees within group G2: T2 Willow, T3 Sycamore and T4 Ash should be removed for arboriculture reasons.

3.2. We recommend removal of all of the Category 'U' trees. Their loss will have a low impact on the landscape and amenity value as they are part of a wider tree group on the woodland edge which will remain intact with retained trees. The replacement trees proposed will more than compensate for the loss.

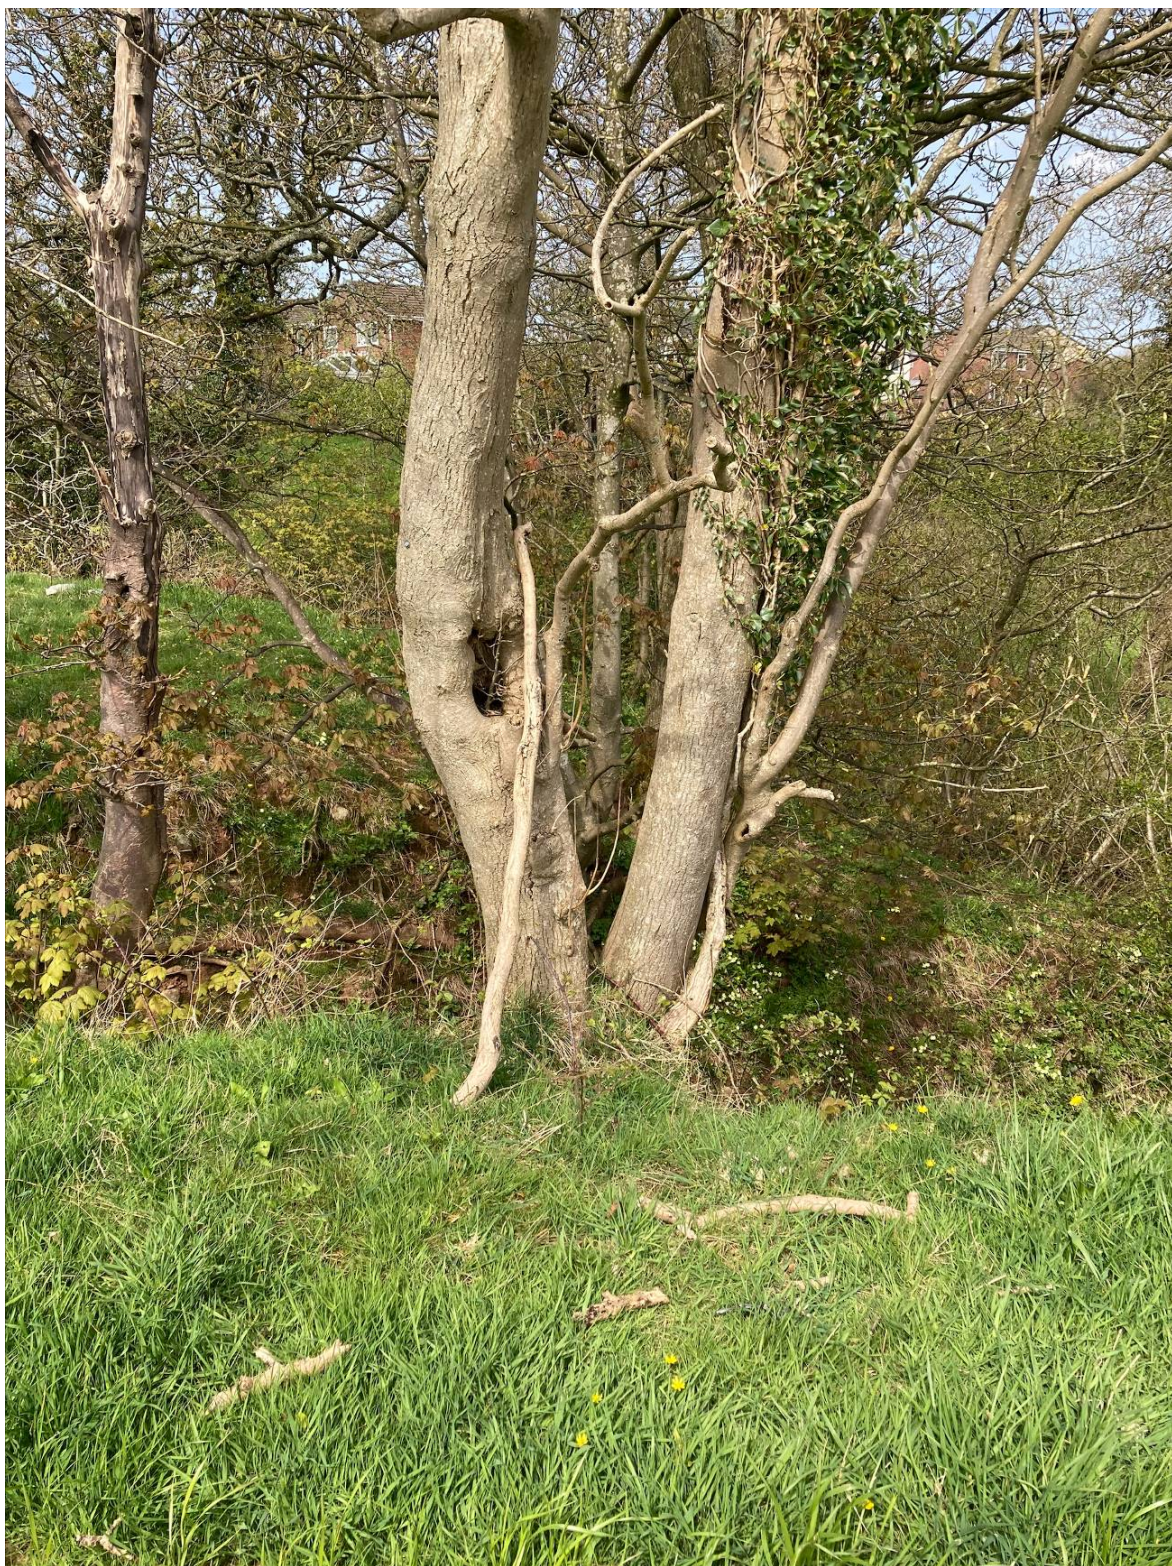
3 T3 Twin stemmed Ash to remove

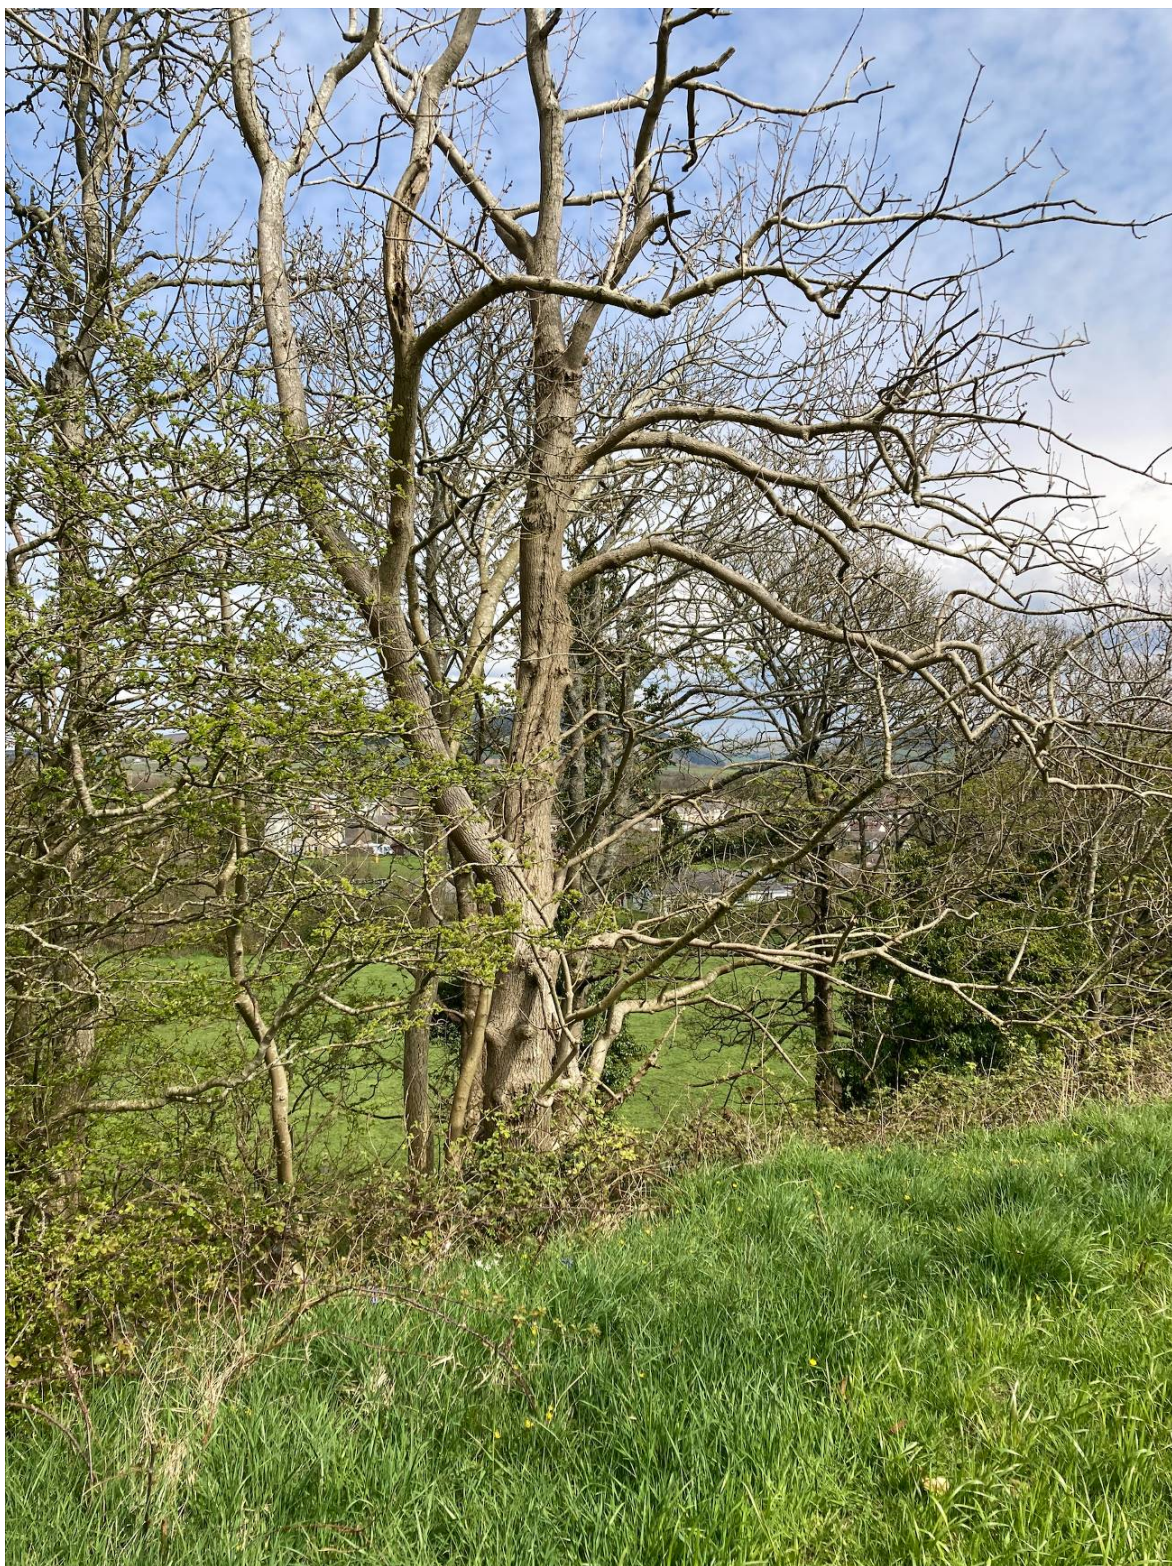
4. T4 Ash to remove

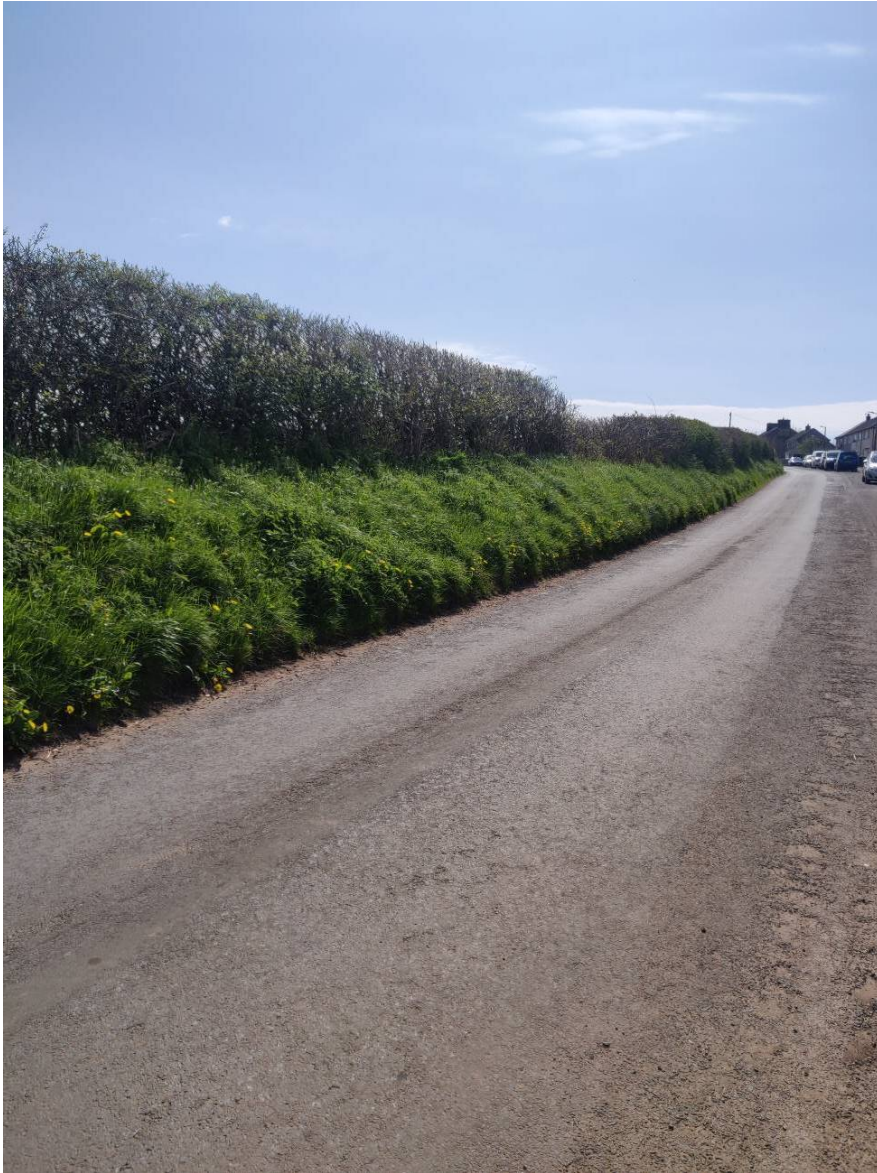
3.3. The roadside hedge H1 has a moderate landscape and amenity value as it contributes to the rural road character and provides good low-level screening. It should be retained and improved with regular maintenance maintain its height. The removal of one section of hedge will impact on the landscape value but can be compensated for by additional native hedge planting. Hedge H2 has been reasonably well maintained and is of low- moderate landscape and amenity value. It should be retained and enhanced with infill planting to the gaps, although the development will cause the loss of approximately 15m. The other hedges area also of low-moderate landscape and amenity value and maintenance has been lacking for some with some recent laying work carried out.

11. Hedge H1 on Uldale View.

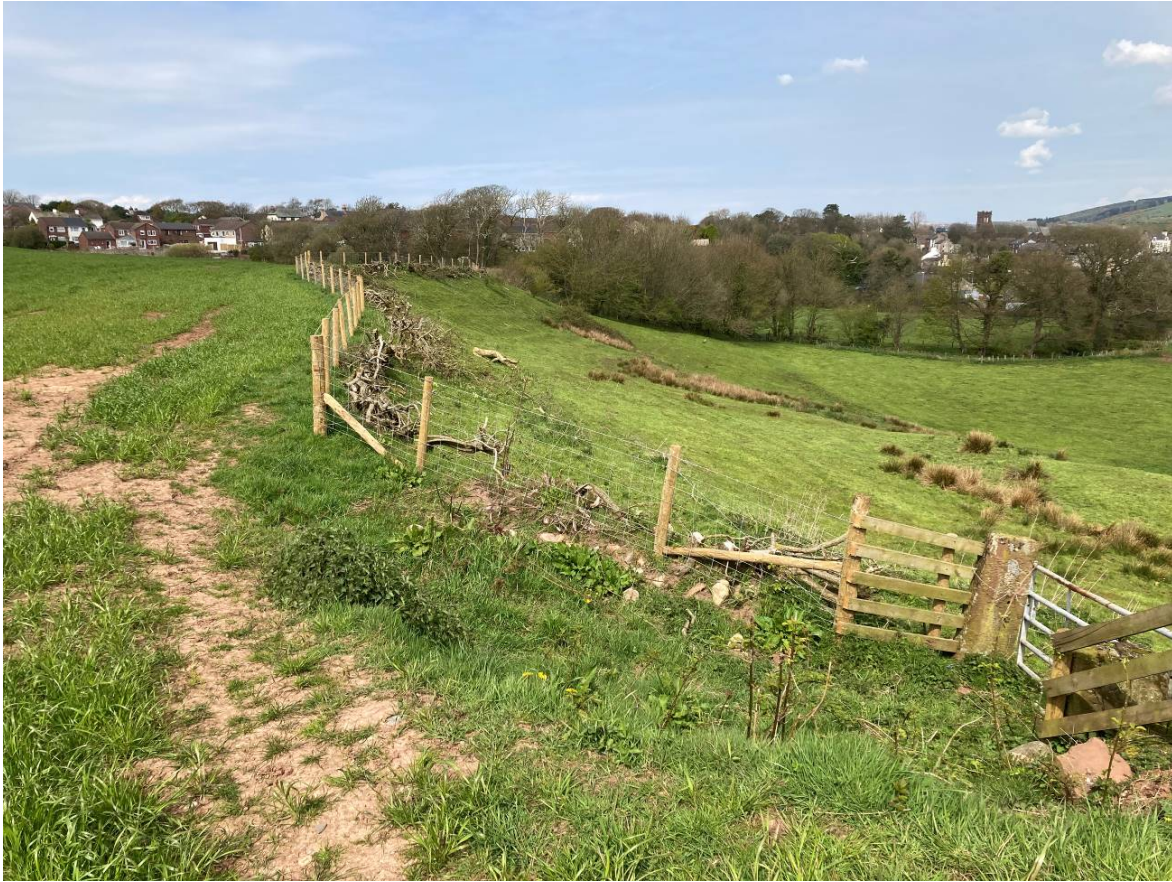
16. Hedge H6 recently laid.
