DEMOLITION OF SIDE ADDITION TO  
UNION HALL, SCOTCH STREET,  
WHITEHAVEN, CUMBRIA, CA28 7BJ

## **DESIGN & ACCESS / HERITAGE STATEMENT**

Project Reference: 5416  
Date Prepared: May 2020  
Prepared By: Andrew West BSc(Hons) MRICS MCABE MFPWS

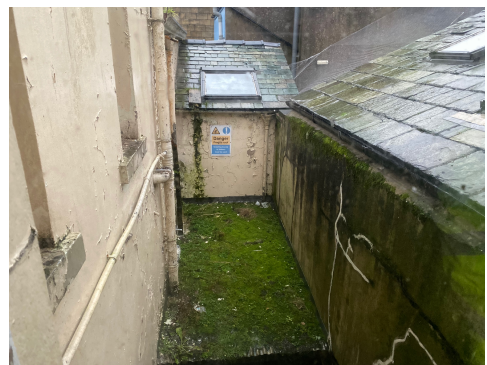
Image of the remaining open area to the rear of Union Hall at 1<sup>st</sup> floor level. Note the moss-covered corrugated roof encloses the 'yard' area at ground floor level.

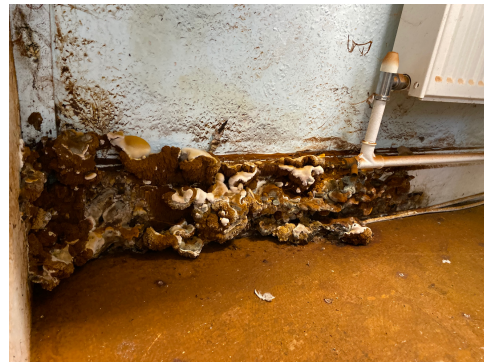
Image of dry rot at low level, above the suspended timber floor structure.

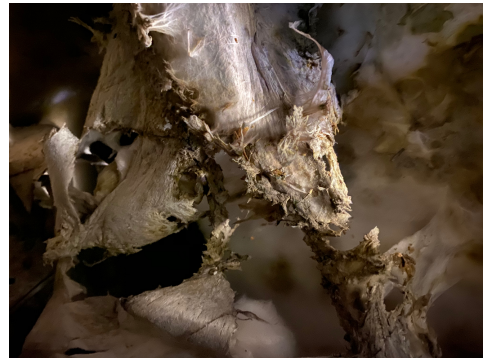
Image of dry rot below the ground floor level, within the sub-floor void.

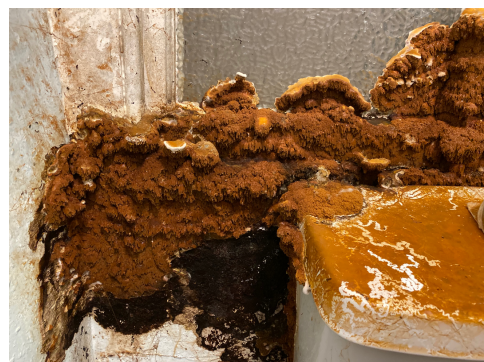
Enlarged image of dry rot.
