## Wilson Pit Road, Whitehaven, Cumbria: Phase 5

Archaeological Evaluation  
Report No. Y505/21

**Archaeological Evaluation**

**Report No. Y505/21**

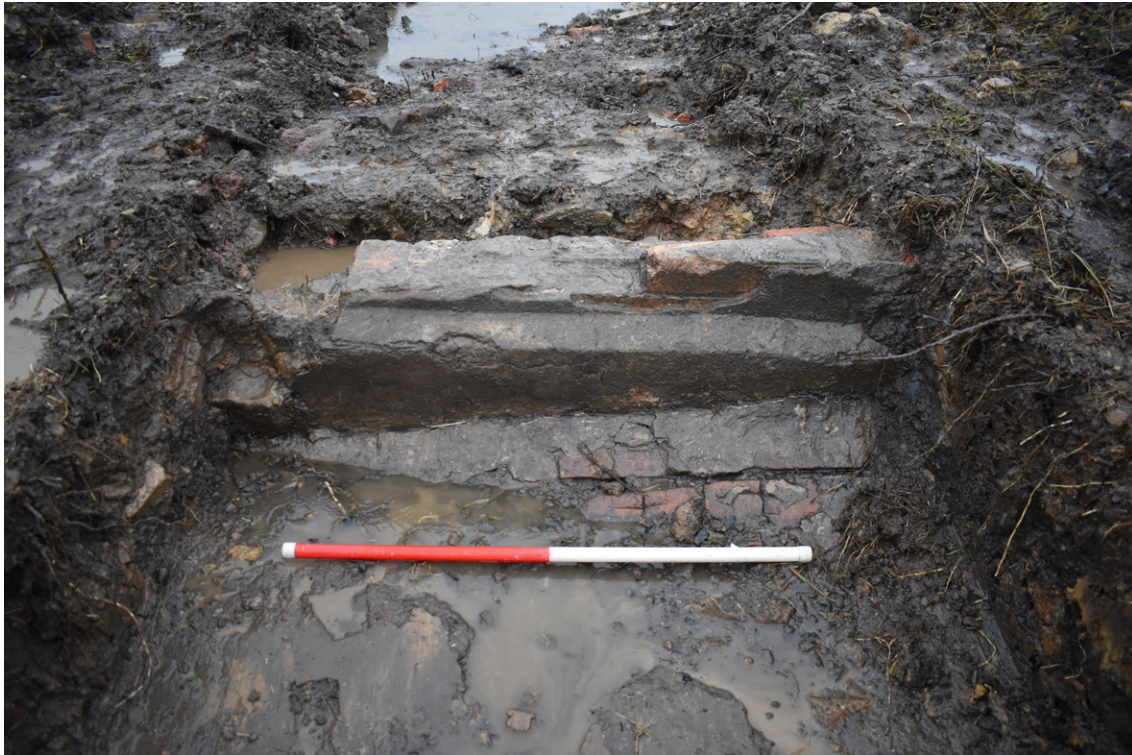
Fig.6 - Photograph of E-W Orientated Wall (602)

The remains of a brick structure were identified. It consisted of a cement-mortared brick wall sitting on a concrete base (**602**) (Fig. 6), rendered on the south face, measured two courses high and one brick wide, on an E-W alignment. This was parallel to, and 5m away from, a second cement-mortared brick wall (**603**), constructed of different brick types. No floor surfaces were identified.

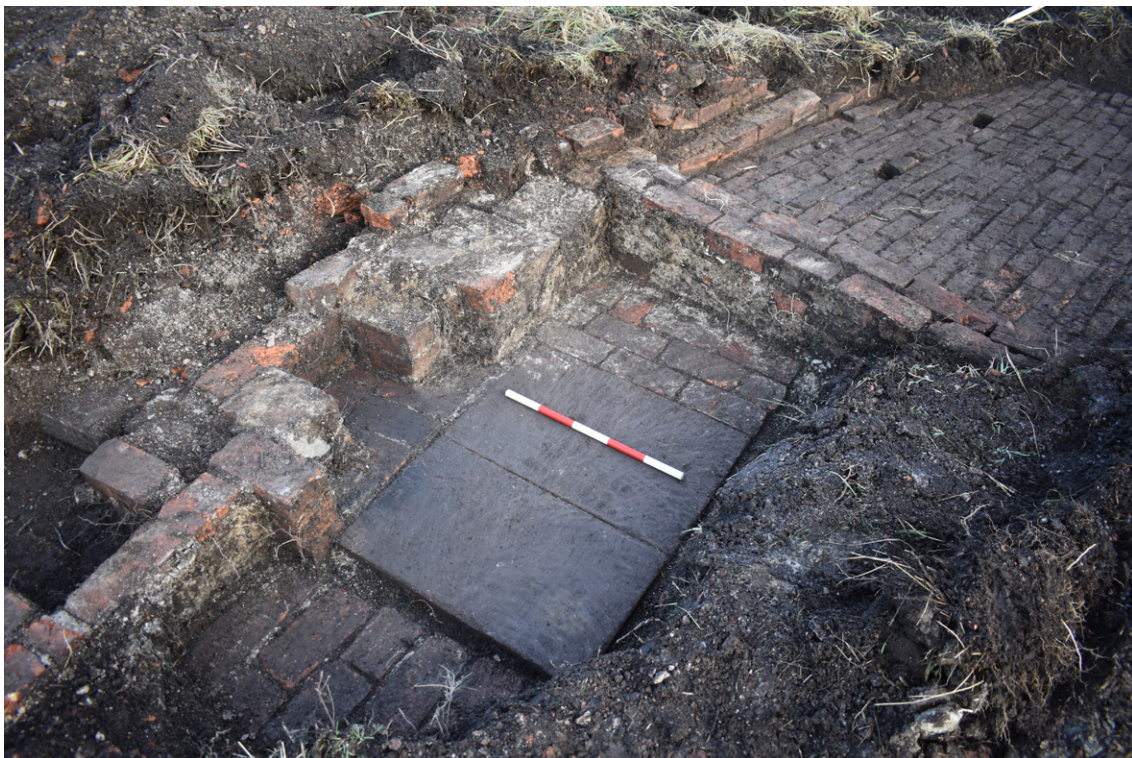
Fig.7 - Photograph of Trench 12, showing Surface (1205) and Surface (1206)

Trench 12 was targeted on the possible remains of a structure noted on the first edition Ordnance Survey map. In Trench 12 the remains of a structure were identified (Fig. 2iv, 7). A brick wall, one brick wide and running NW-SE (**1201**), was abutted at its NW end by another brick wall to its west (**1202**), running at a right angle. Wall **1202** had a plaster finish on its NW face. These two walls formed two edges of a brick floor (**1203**), measuring 3m by 1.85m and consisting of unfrogged bricks laid on edge, in which some of the bricks were burnt a dark grey colour, and bedded on a cinder/clinker deposit (**1213**).

Fragments of brick floor (**1205**, **1207**) survived in the corner formed by walls **1204** and **1202**, laid perpendicular to wall **1204**; some of it had whitewash on its surface. Floor **1205** was flush to an area of adjoining sandstone flagstones (**1206**) and is possibly a brick repair to an earlier flagstone surface; floor **1207** was laid at a slightly lower level.
