## **PHASE 2: GROUND INVESTIGATION REPORT**

**PROPOSED RESIDENTIAL DEVELOPMENT OF**

**LAND OFF ULDALE VIEW, EGREMONT**

**Report Ref:** 2022-5346

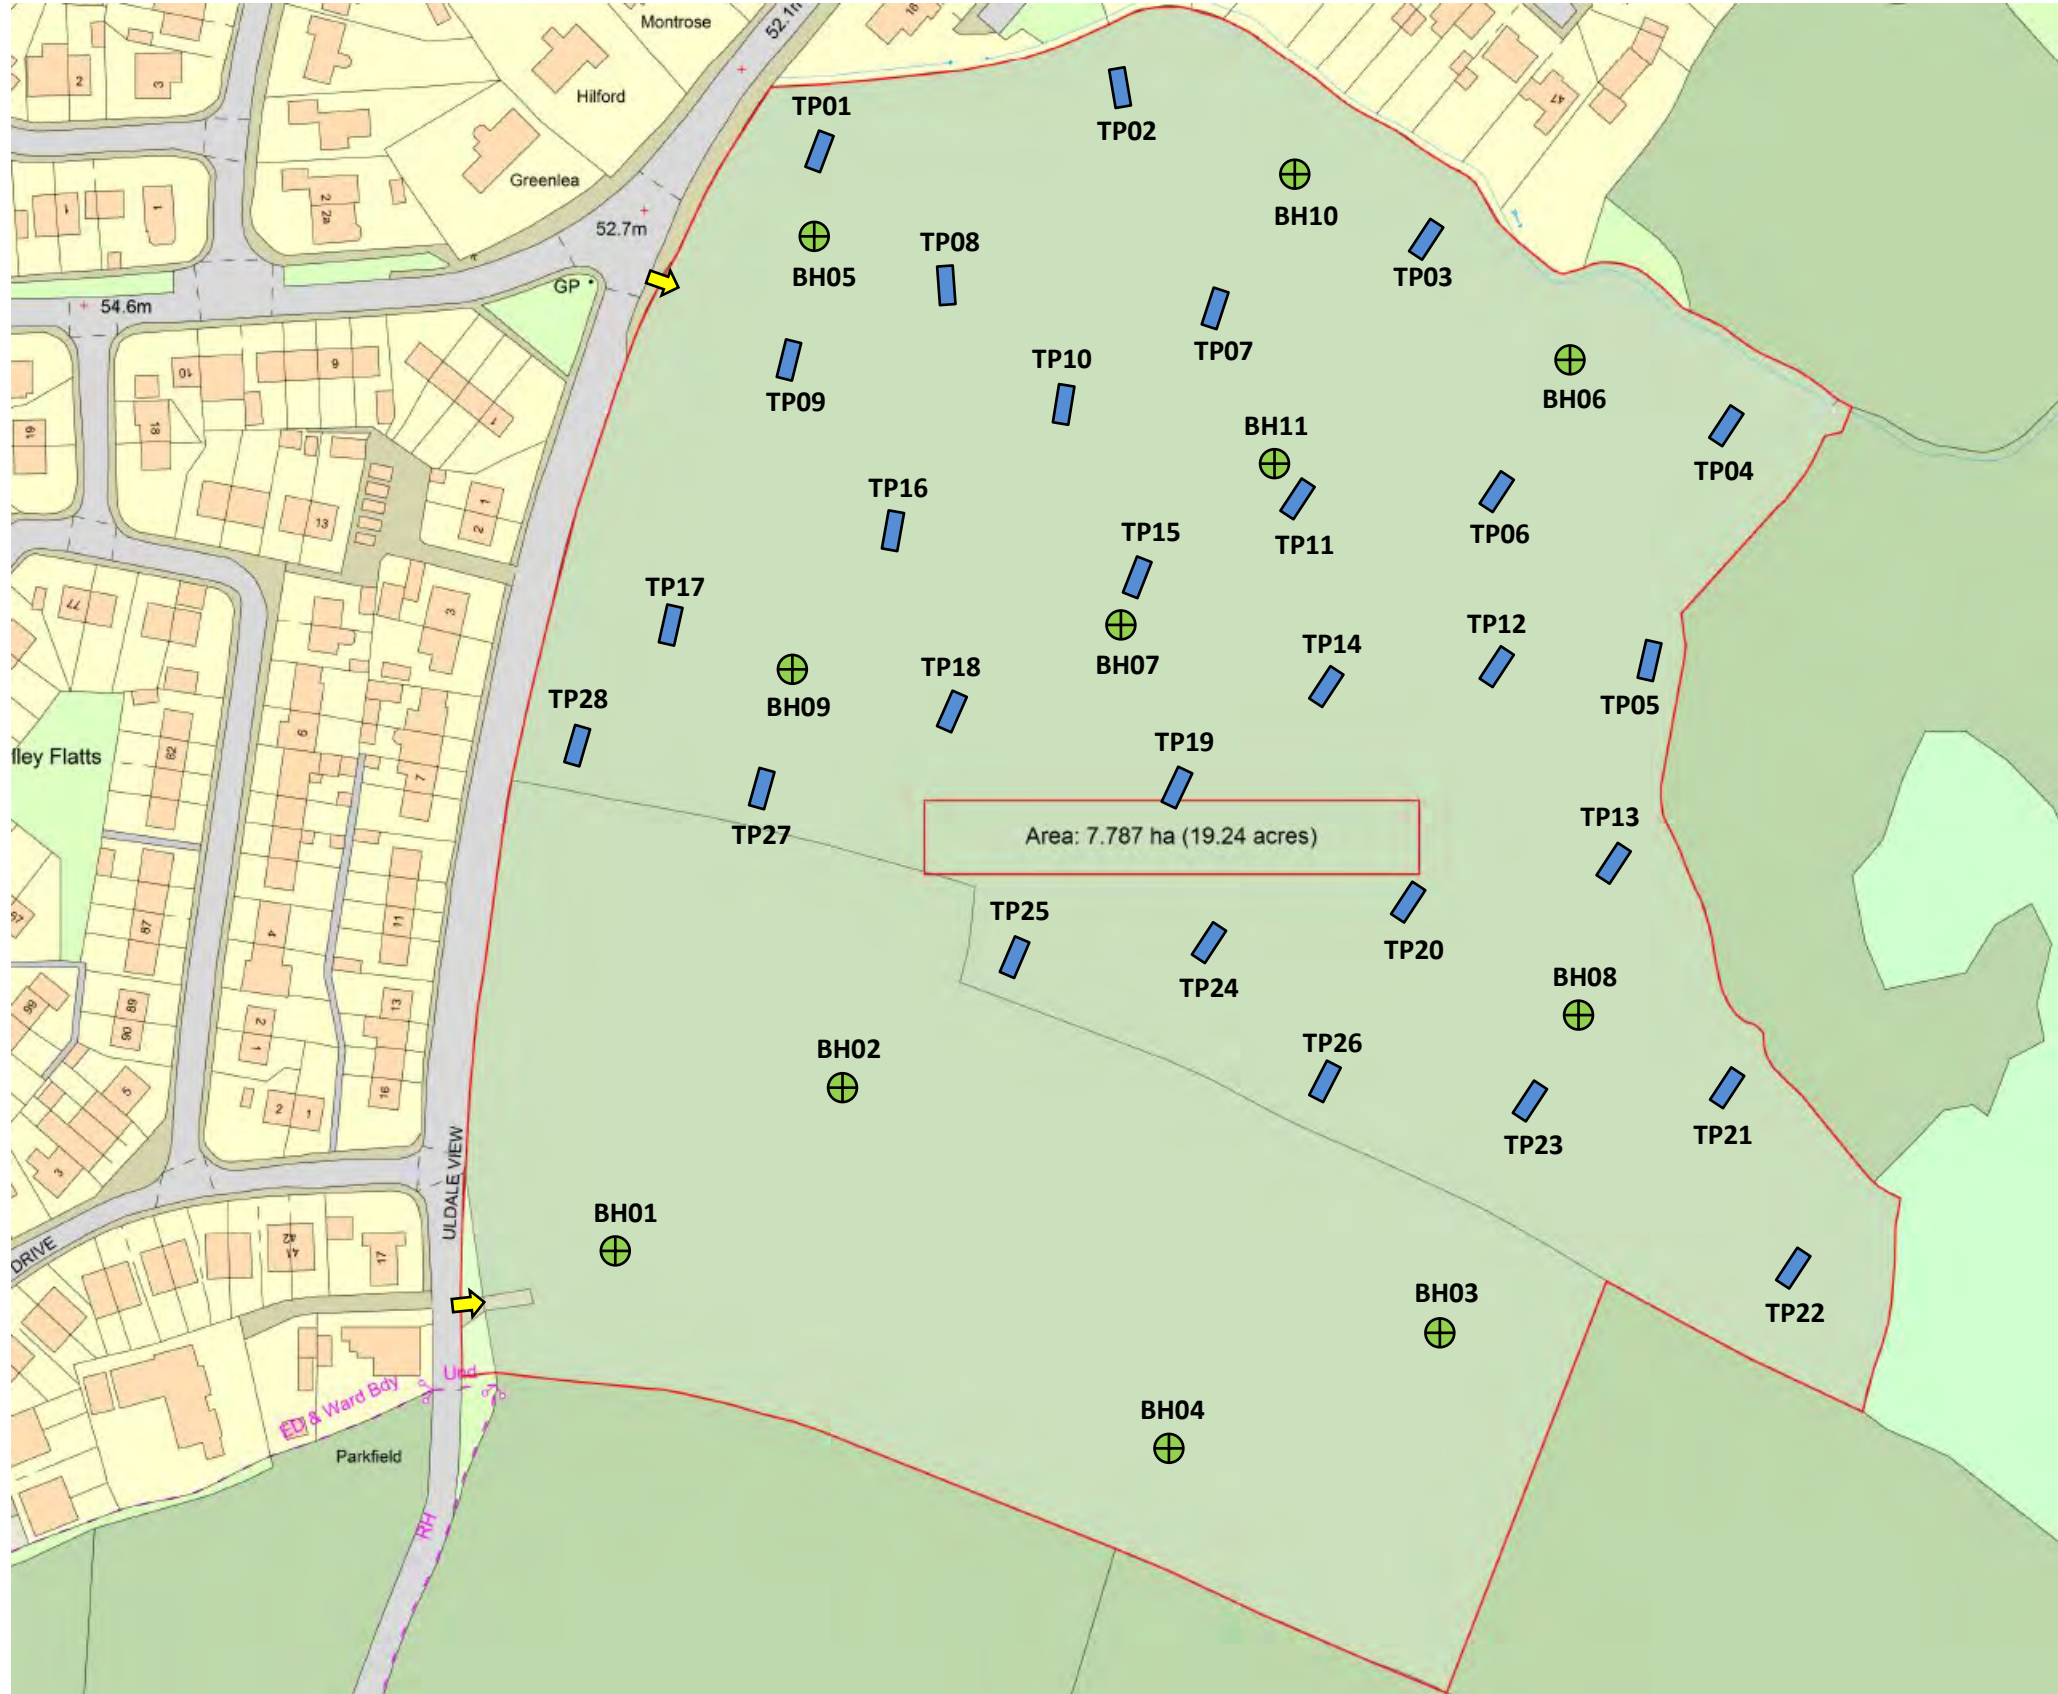
**GEO2022-5346: Uldale View, Egremont, Cumbria – Exploratory Hole Location Plan**

NB: Access to southern field not permitted with excavator due to crop.

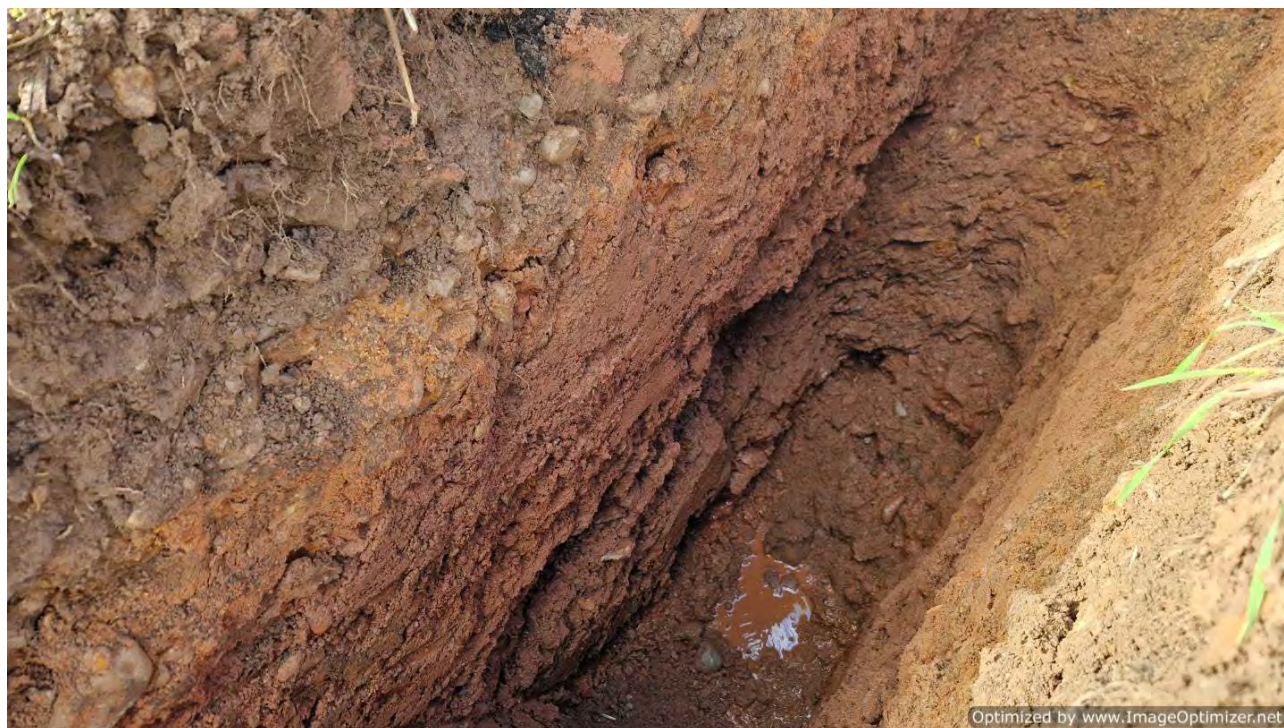
**GEO2022-5346: Uldale View, Egremont, Cumbria – TP02**

| Depth From (m) | Depth To (m) | Strata Description | Legend | Testing / Samples |
|---|---|---|---|---|
| | | End of trial hole at 1.90m.<br>Trial hole remained dry and stable on completion.<br>Trial hole backfilled with arisings on completion. | | |

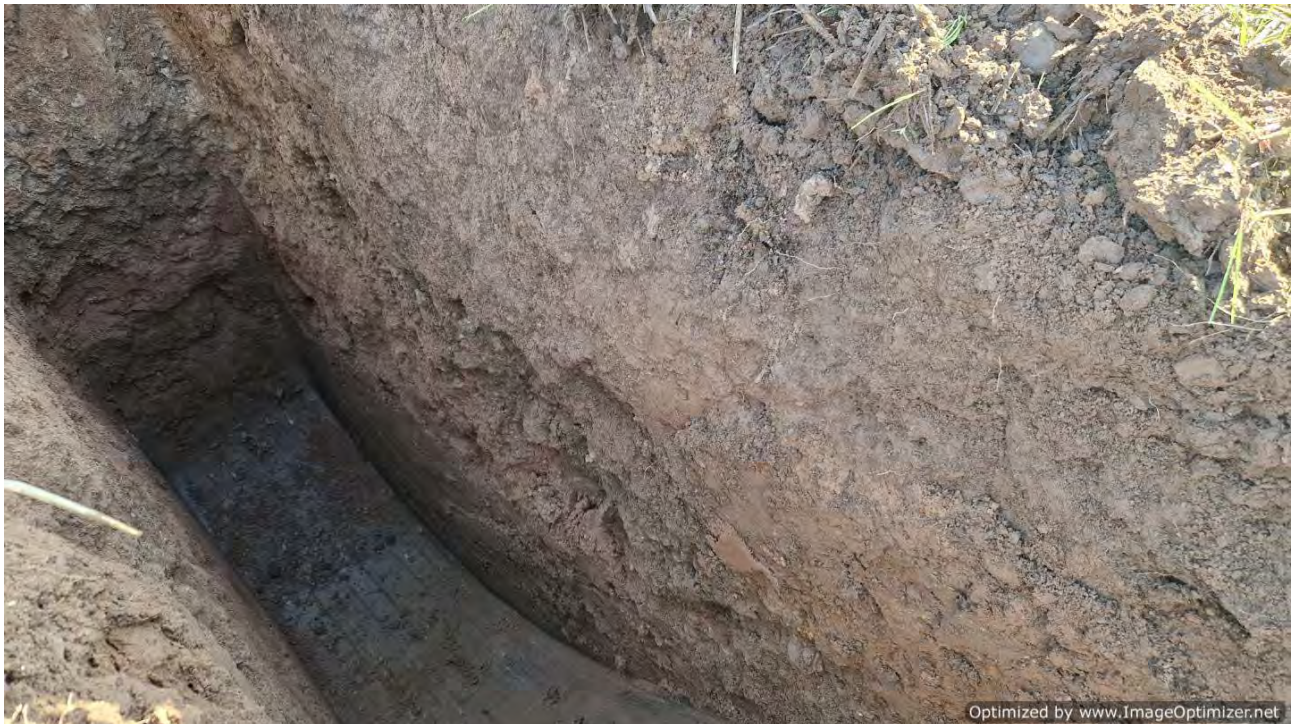
**GEO2022-5346: Uldale View, Egremont, Cumbria – TP04**

| Depth From (m) | Depth To (m) | Strata Description | Legend | Testing / Samples |
|---|---|---|---|---|
| | | End of trial hole at 1.60m – refusal on boulders.<br>Trial hole remained dry and stable on completion.<br>Trial hole backfilled with arisings on completion. | | |

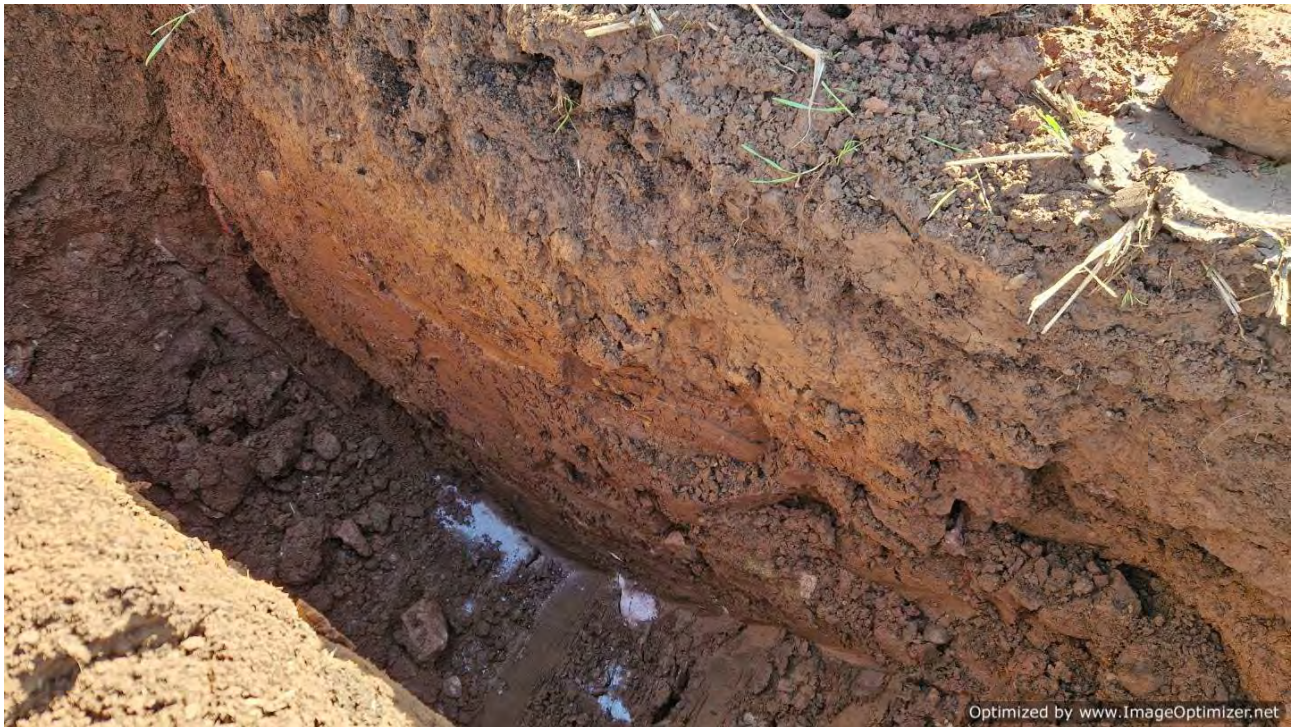
**GEO2022-5346: Uldale View, Egremont, Cumbria – TP05**

| Depth From (m) | Depth To (m) | Strata Description | Legend | Testing / Samples |
|---|---|---|---|---|
| | | End of trial hole at 2.00m – refusal on boulders.<br>Trial hole remained dry and stable on completion.<br>Trial hole backfilled with arisings on completion. | | Too gravelly for HSV. |

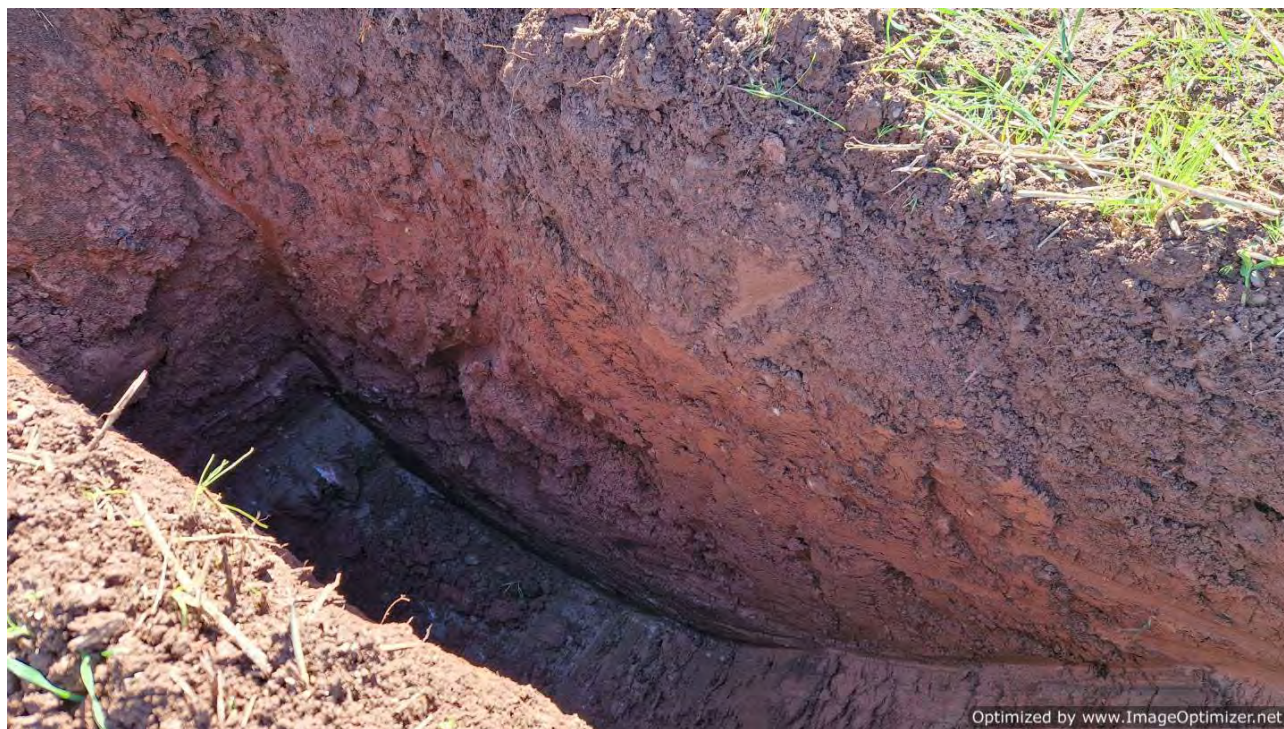
**GEO2022-5346: Uldale View, Egremont, Cumbria – TP06**

| Depth From (m) | Depth To (m) | Strata Description | Legend | Testing / Samples |
|---|---|---|---|---|
| | | End of trial hole at 2.00m.<br>Trial hole remained dry and stable on completion.<br>Trial hole backfilled with arisings on completion. | | |

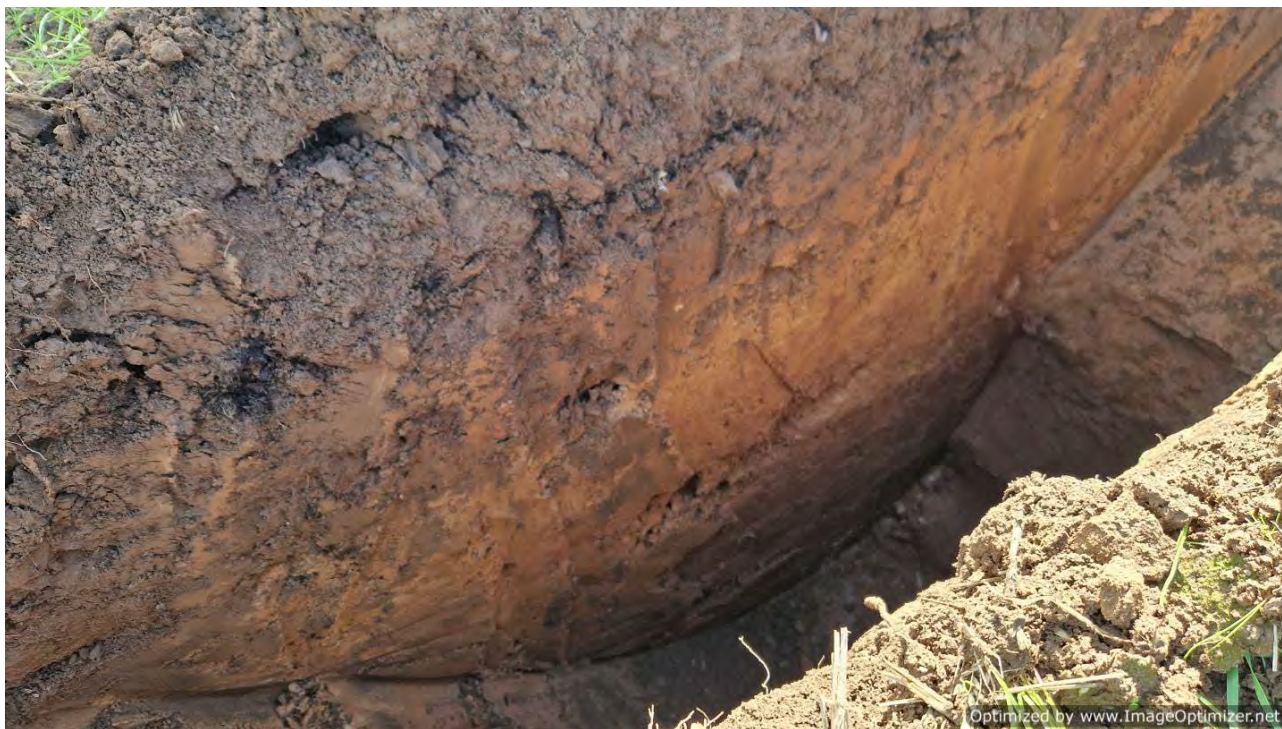
**GEO2022-5346: Uldale View, Egremont, Cumbria – TP07**

| Depth From (m) | Depth To (m) | Strata Description | Legend | Testing / Samples |
|---|---|---|---|---|
| | | End of trial hole at 1.90m.<br>Groundwater ingress (slight) at c.1.60m bgl.<br>Trial hole remained stable on completion.<br>Trial hole backfilled with arisings on completion. | | |

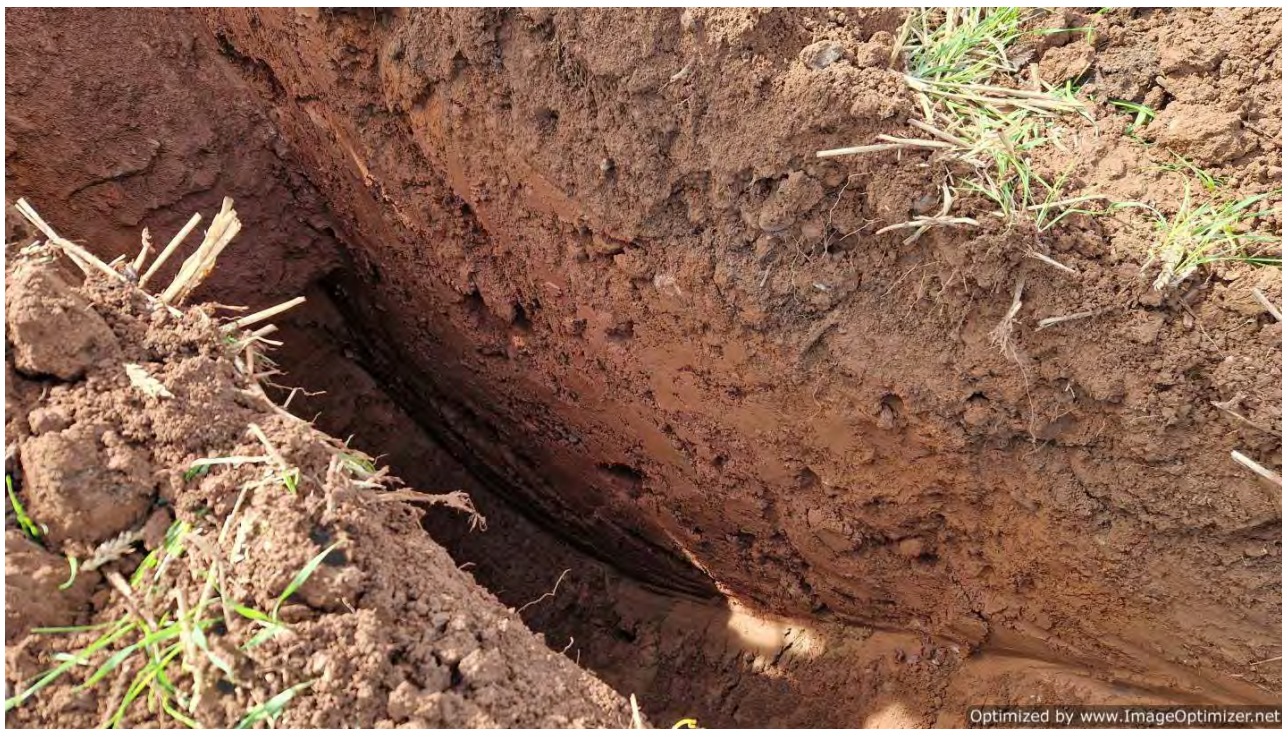
**GEO2022-5346: Uldale View, Egremont, Cumbria – TP08**

Groundwater ingress was noted in trial pits TP01 and 08 in the north western part as a slight seepage at depths of between c.1.60m and c.1.80m bgl, and in trial pits TP27 and 28 in the western part within the granular deposits at depths of between c.0.60m and 1.60m bgl. All of the boreholes remained dry during the intrusive ground investigation works.

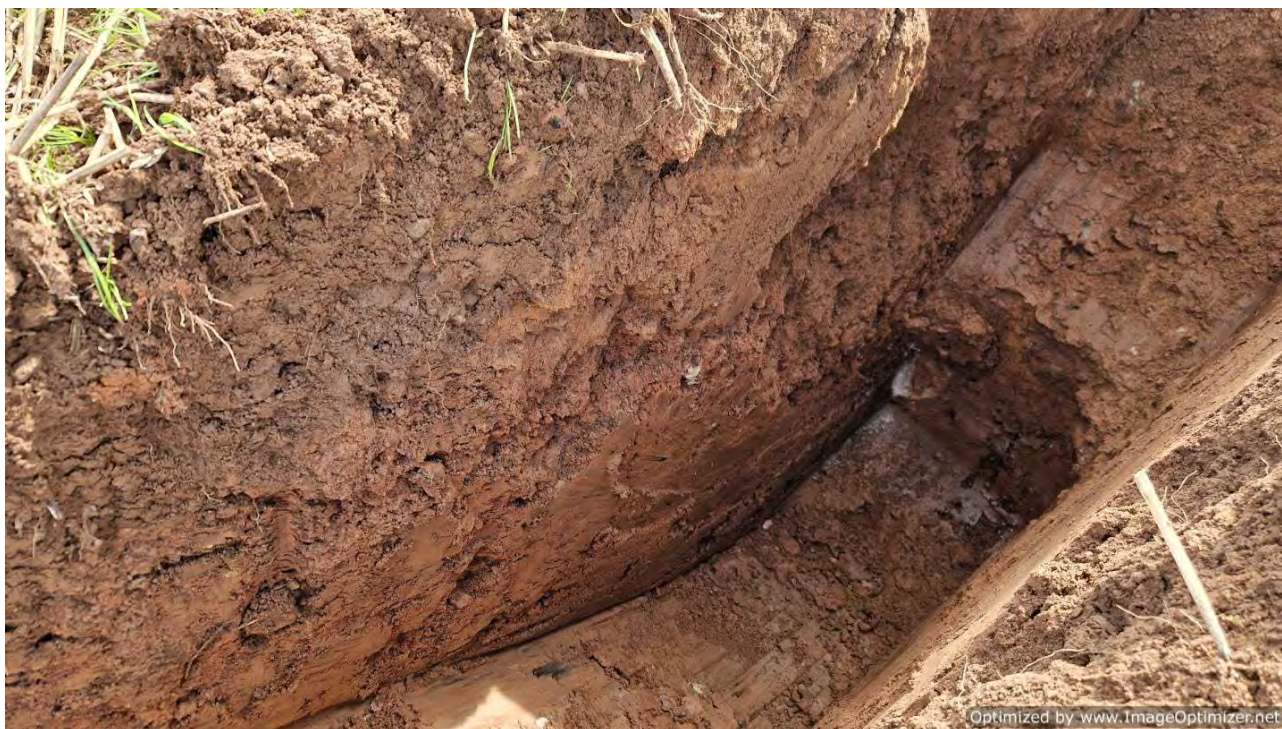
**GEO2022-5346: Uldale View, Egremont, Cumbria – TP09**

| Depth From (m) | Depth To (m) | Strata Description | Legend | Testing / Samples |
|---|---|---|---|---|
| | | End at 2.40m due to sand collapsing during excavation.<br>DCP test completed adjacent to trial pit.<br>GW and running sand (minor) noted at base.<br>Trial hole backfilled with arisings on completion. | | |

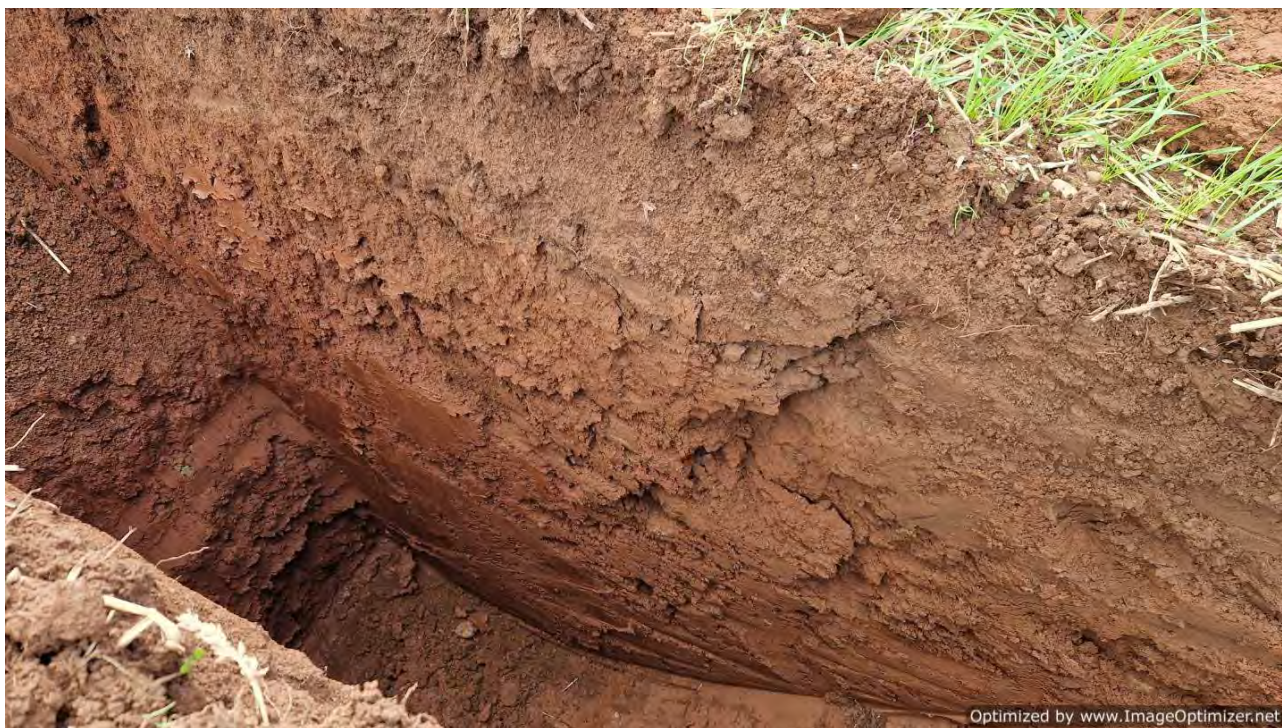
**GEO2022-5346: Uldale View, Egremont, Cumbria – TP10**

The topsoil in the north western part of the site was occasionally underlain by a firm brown sandy gravelly silt which was encountered to depths of between c.0.50m and c.1.20m bgl. This was noted in trial pits TP02, 03 and 10 only.

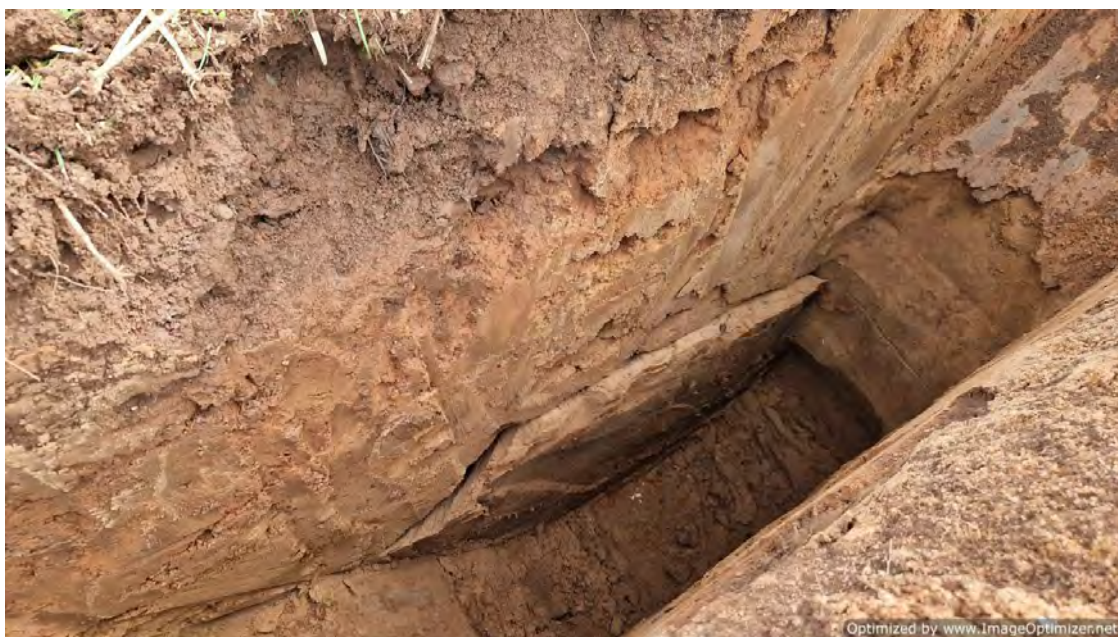
**GEO2022-5346: Uldale View, Egremont, Cumbria – TP11**

| Depth From (m) | Depth To (m) | Strata Description | Legend | Testing / Samples |
|---|---|---|---|---|
| | | End of trial pit at 2.20m.<br>Trial pit dry and stable on completion.<br>Trial hole backfilled with arisings on completion. | | |

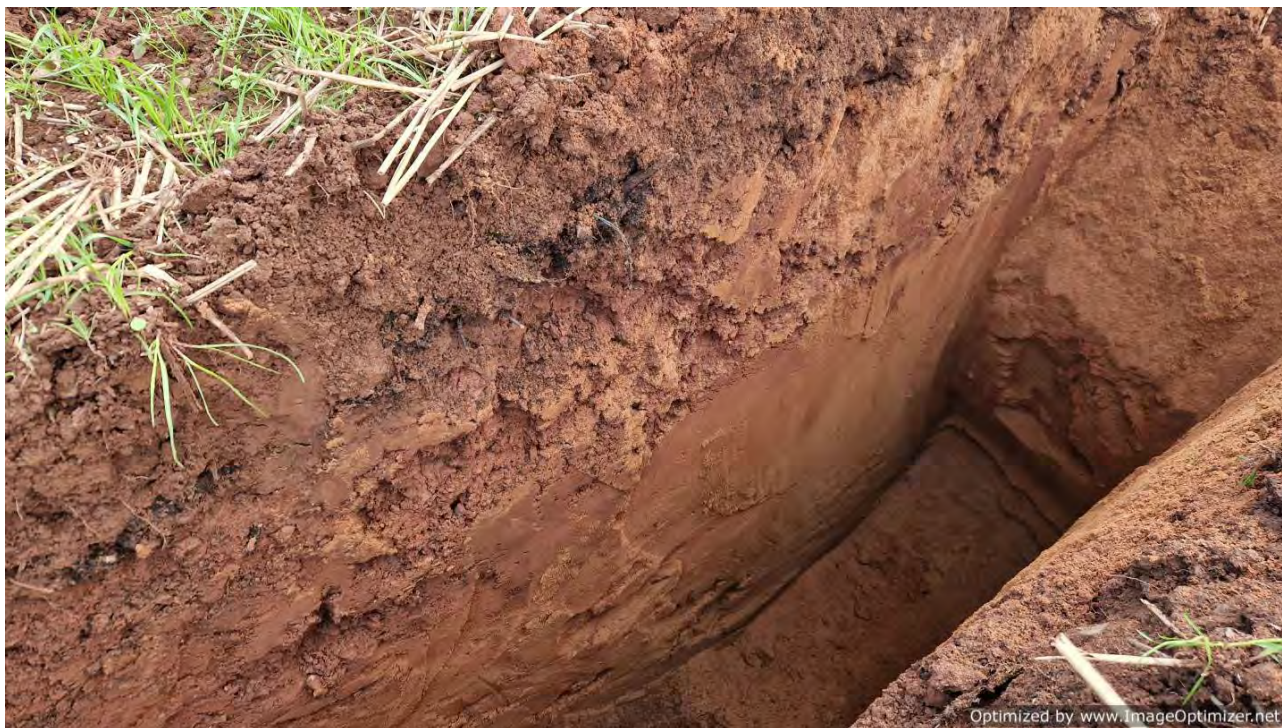
**GEO2022-5346: Uldale View, Egremont, Cumbria – TP12**

| Depth From (m) | Depth To (m) | Strata Description | Legend | Testing / Samples |
|---|---|---|---|---|
| | | End of trial pit at 2.20m.<br>DCP test completed adjacent to trial pit.<br>Trial pit dry and stable on completion.<br>Trial hole backfilled with arisings on completion. | | |

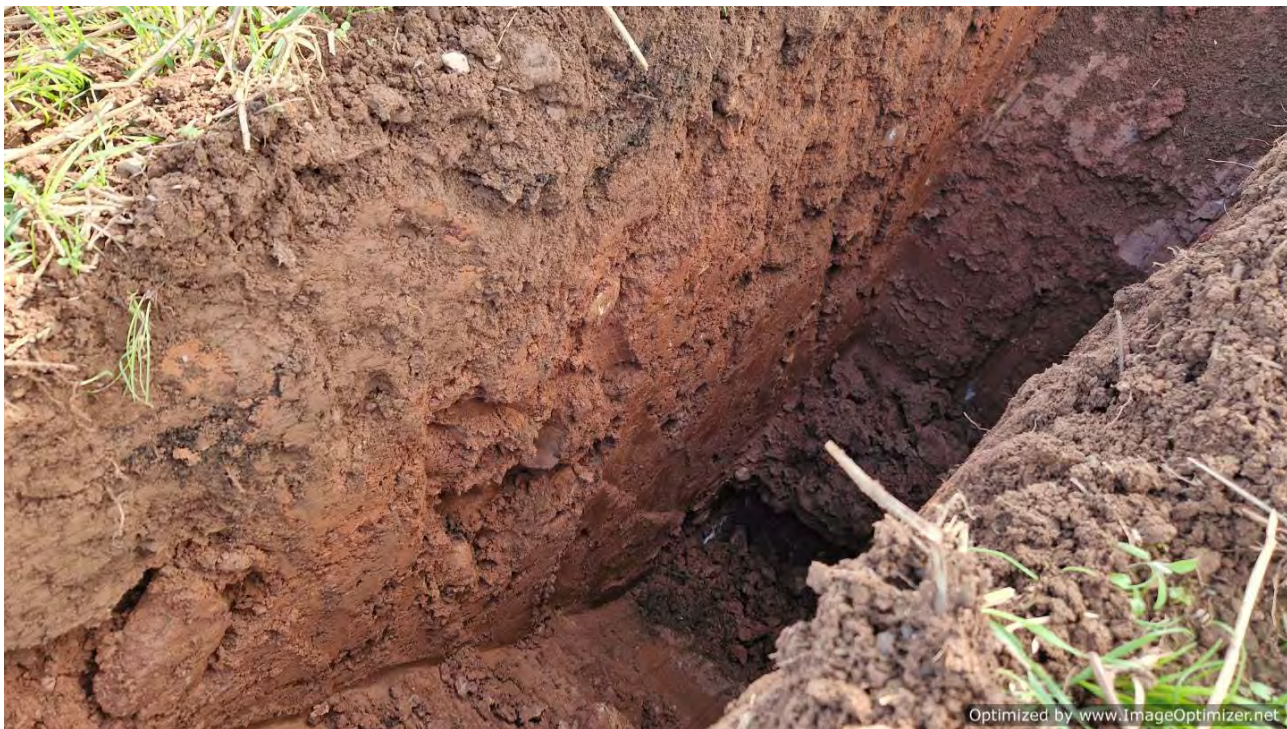
**GEO2022-5346: Uldale View, Egremont, Cumbria – TP13**

| Depth From (m) | Depth To (m) | Strata Description | Legend | Testing / Samples |
|---|---|---|---|---|
| | | End of trial pit at 2.10m.<br>Trial pit dry and stable on completion.<br>Trial hole backfilled with arisings on completion. | | |

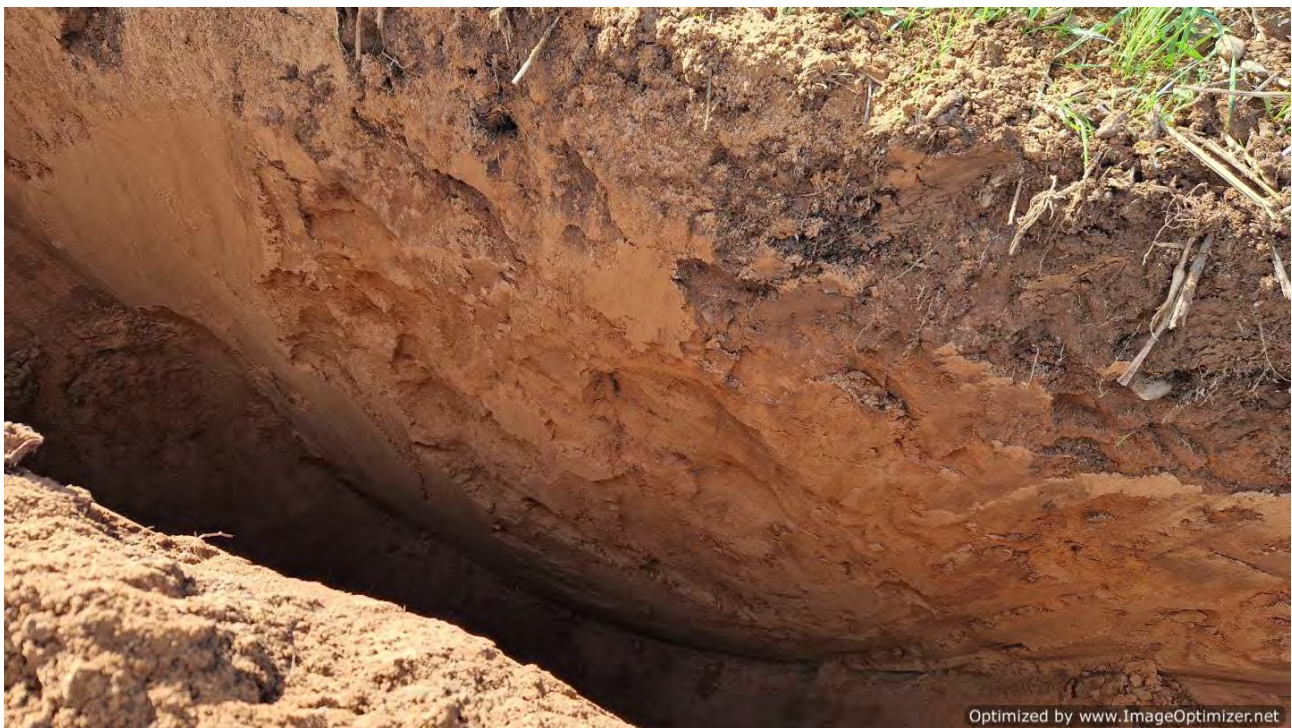
**GEO2022-5346: Uldale View, Egremont, Cumbria – TP15**

The boundary between the sand and the clay deposits was encountered in trial pit TP15 in the centre of the northern field and this is highlighted on the log. The boundary is noted to be sub-vertical close to the surface, becoming less steep with depth.

| Depth From (m) | Depth To (m) | Strata Description | Legend | Testing / Samples |
|---|---|---|---|---|
| | | End of trial pit at 2.10m.<br>Trial pit dry and stable on completion.<br>Trial hole backfilled with arisings on completion. | | |

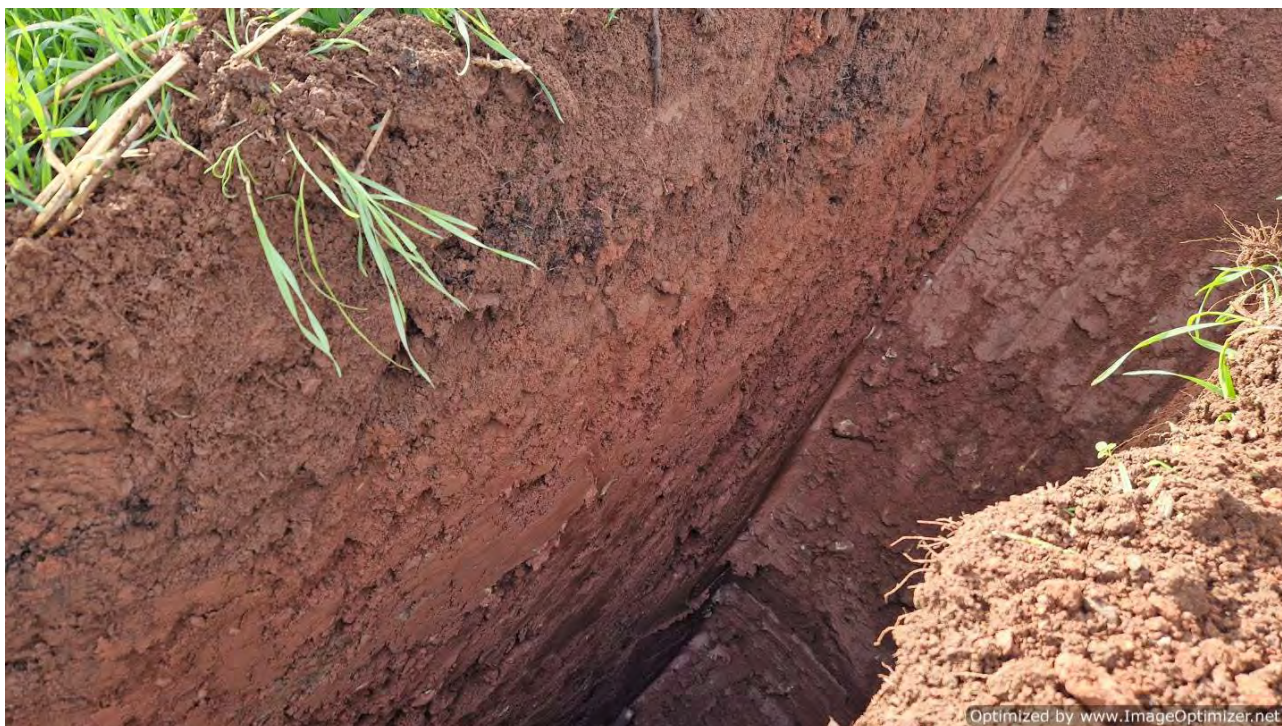
**GEO2022-5346: Uldale View, Egremont, Cumbria – TP17**

| Depth From (m) | Depth To (m) | Strata Description | Legend | Testing / Samples |
|---|---|---|---|---|
| | | End of trial pit at 2.20m.<br>Trial pit dry and stable on completion.<br>Trial hole backfilled with arisings on completion. | | |

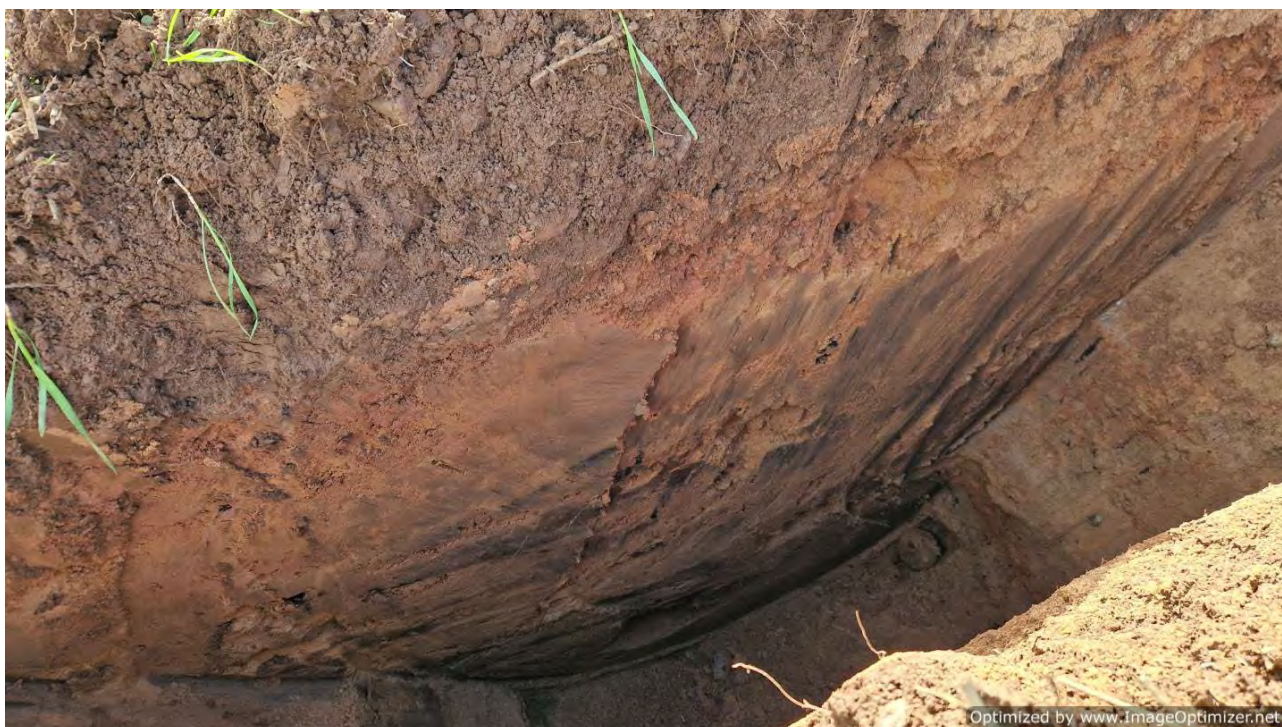
**GEO2022-5346: Uldale View, Egremont, Cumbria – TP18**

| Depth From (m) | Depth To (m) | Strata Description | Legend | Testing / Samples |
|---|---|---|---|---|
| | | End of trial pit at 2.30m.<br>DCP test completed adjacent to trial pit.<br>Trial pit dry and stable on completion.<br>Trial hole backfilled with arisings on completion. | | |

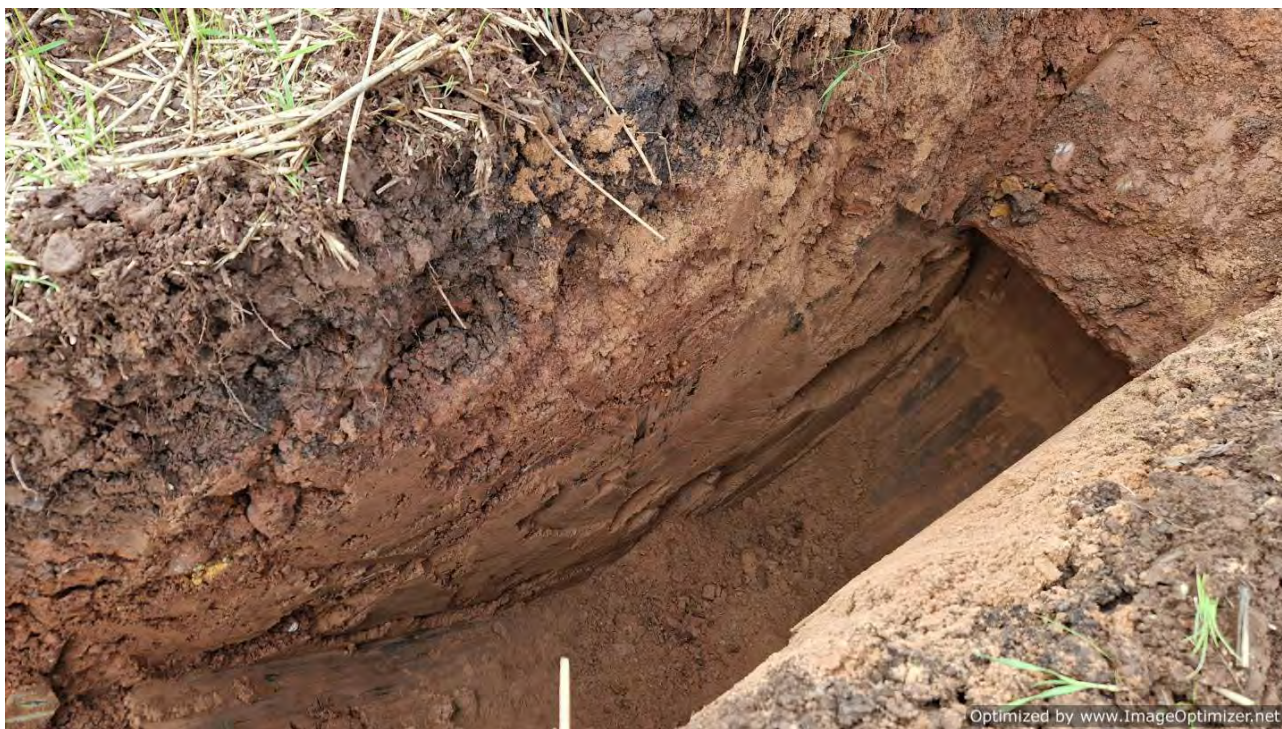
**GEO2022-5346: Uldale View, Egremont, Cumbria – TP22**

| Depth From (m) | Depth To (m) | Strata Description | Legend | Testing / Samples |
|---|---|---|---|---|
| | | End of trial pit at 2.30m.<br>Trial pit dry and stable on completion.<br>Trial hole backfilled with arisings on completion. | | |

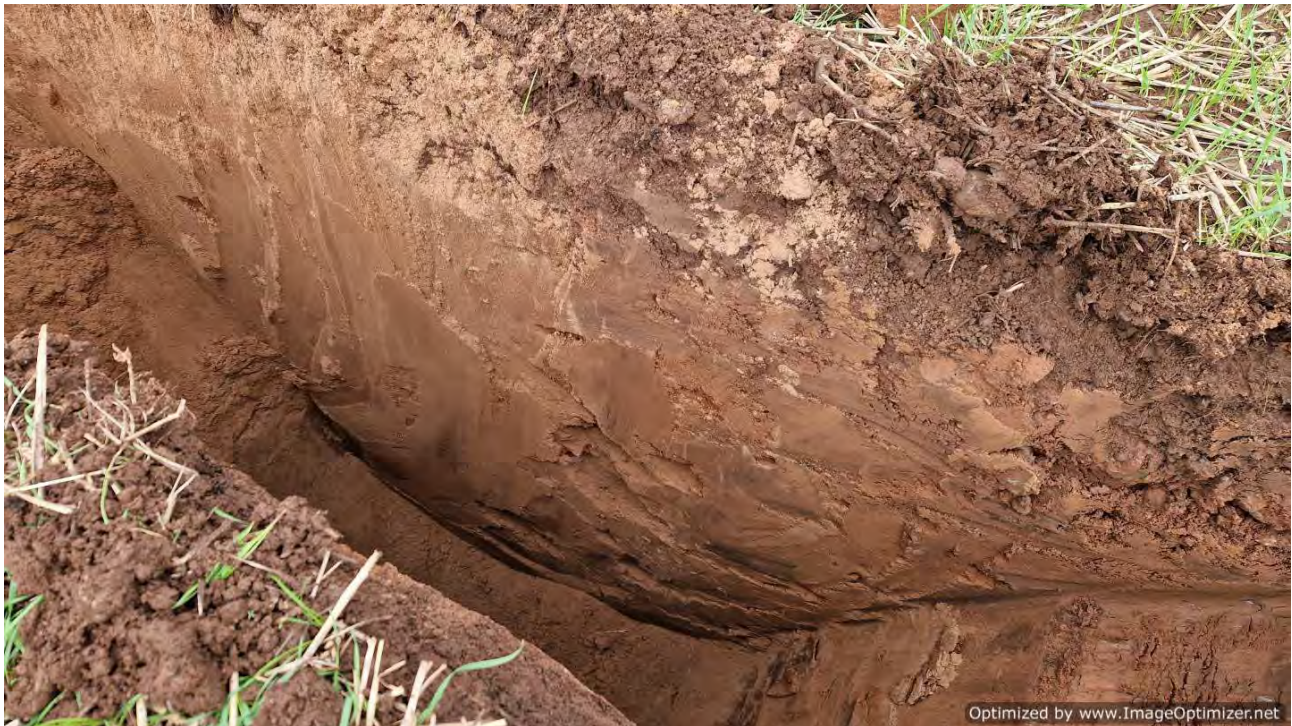
**GEO2022-5346: Uldale View, Egremont, Cumbria – TP23**

| Depth From (m) | Depth To (m) | Strata Description | Legend | Testing / Samples |
|---|---|---|---|---|
| | | End of trial pit at 2.00m.<br>Trial pit dry and stable on completion.<br>Trial hole backfilled with arisings on completion. | | |

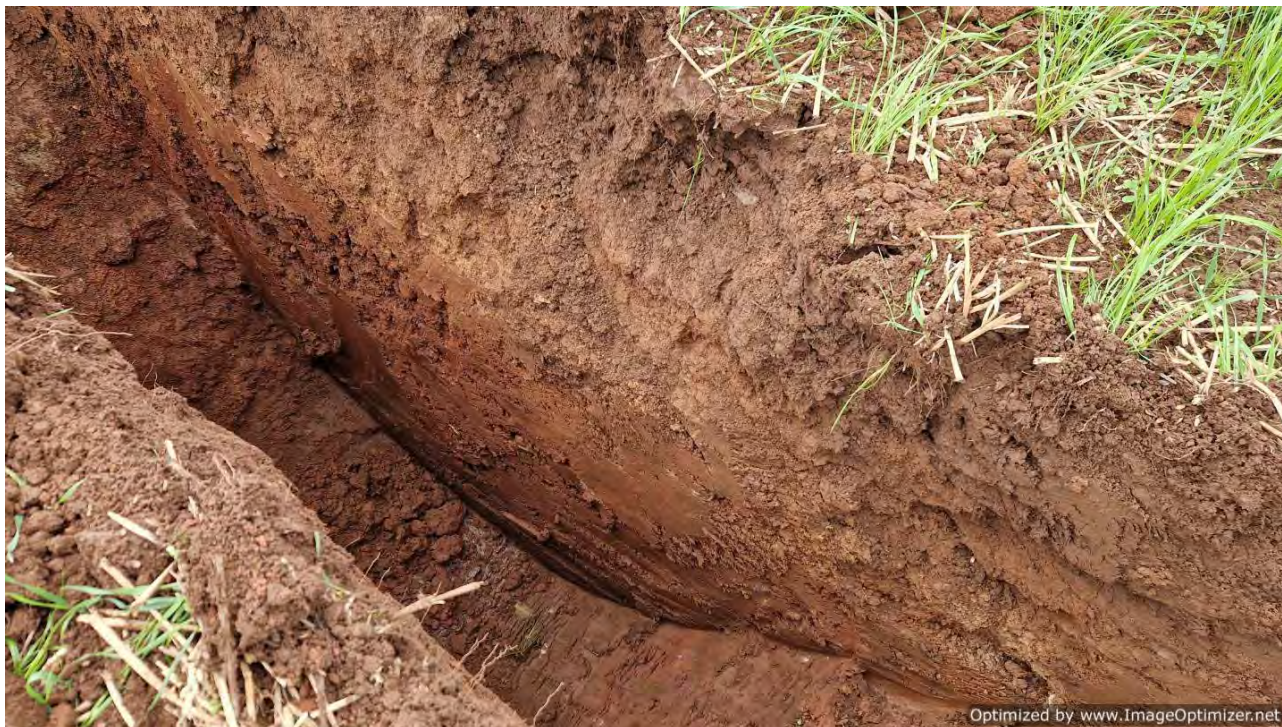
**GEO2022-5346: Uldale View, Egremont, Cumbria – TP24**

| Depth From (m) | Depth To (m) | Strata Description | Legend | Testing / Samples |
|---|---|---|---|---|
| | | End of trial pit at 2.20m.<br>DCP test completed adjacent to trial pit.<br>Trial pit dry and stable on completion.<br>Trial hole backfilled with arisings on completion. | | |

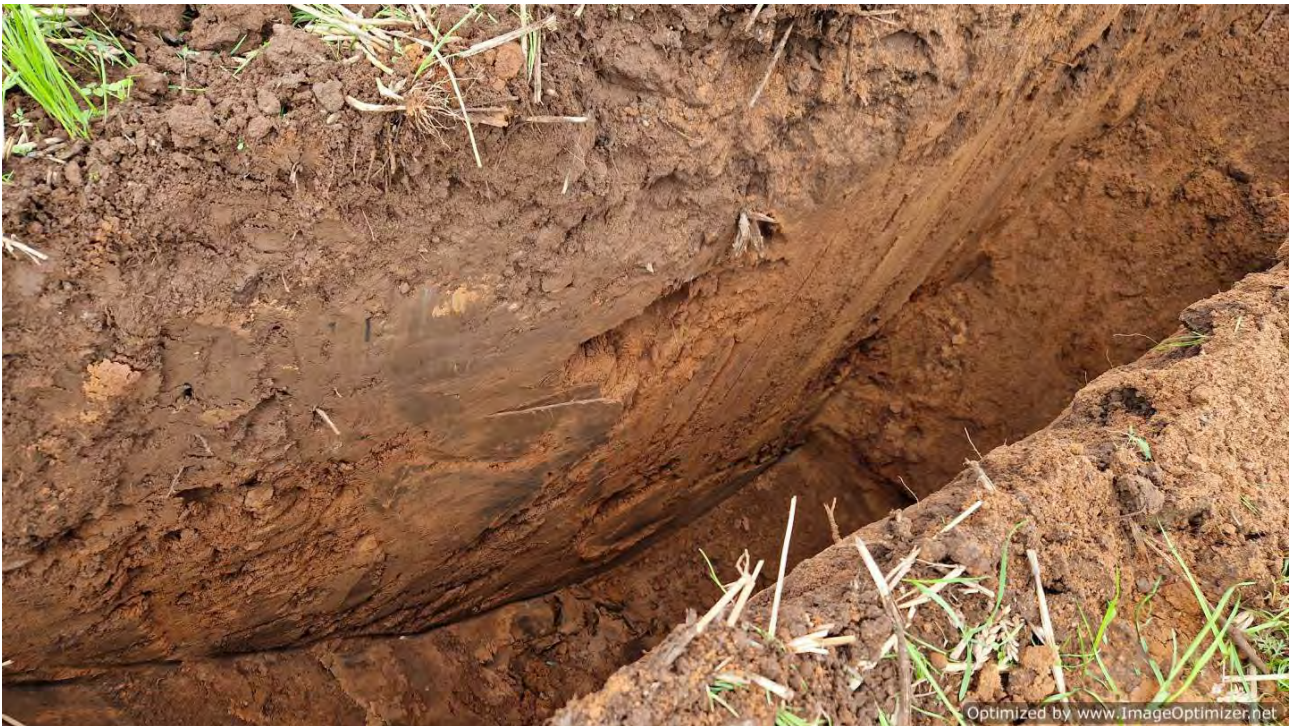
**GEO2022-5346: Uldale View, Egremont, Cumbria – TP26**

| Depth From (m) | Depth To (m) | Strata Description | Legend | Testing / Samples |
|---|---|---|---|---|
| | | End of trial pit at 2.00m.<br>Trial pit dry and stable on completion.<br>Trial hole backfilled with arisings on completion. | | |

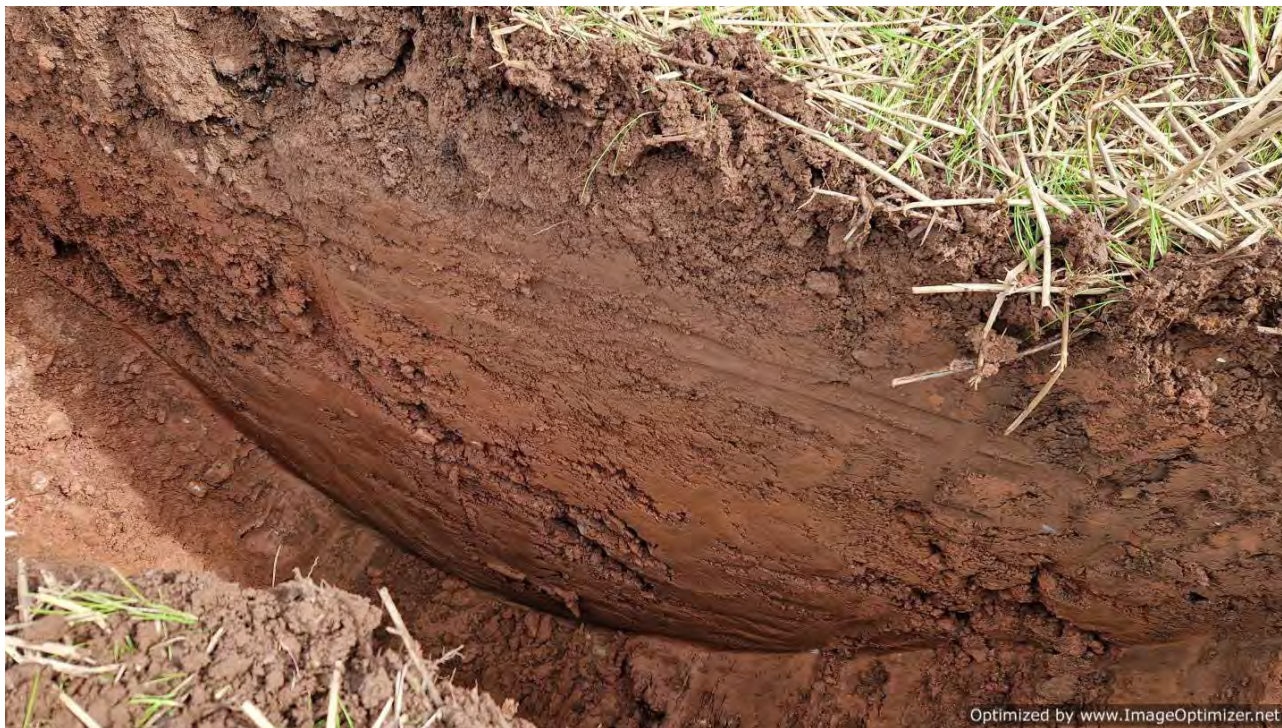
**GEO2022-5346: Uldale View, Egremont, Cumbria – TP27**

| Depth From (m) | Depth To (m) | Strata Description | Legend | Testing / Samples |
|---|---|---|---|---|
| | | End of trial pit at 2.00m.<br>Groundwater ingress (very fast) at 1.60m bgl. Running sand.<br>Poor stability in gravel layer.<br>Trial hole backfilled with arisings on completion. | | |

Based on the results of the ground investigation, localised perched groundwater ingress should be anticipated across the site. It is recommended that allowance be made for some groundwater control measures (i.e. pumping equipment) particularly during wetter periods of the year, as the materials encountered may deteriorate following exposure to surface water.
