## **PHASE 2: GROUND INVESTIGATION REPORT**

**PROPOSED RESIDENTIAL DEVELOPMENT OF**

**LAND OFF ULDALE VIEW, EGREMONT**

**Report Ref:** 2022-5346

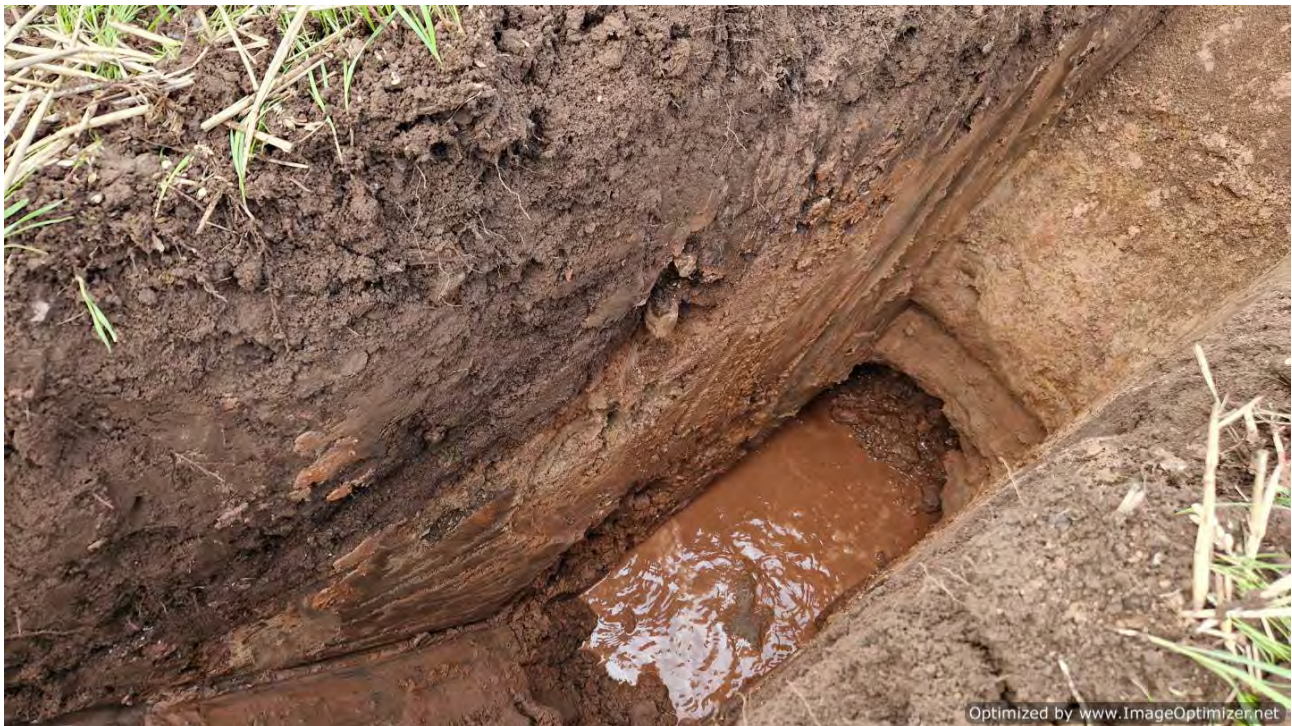
**GEO2022-5346: Uldale View, Egremont, Cumbria – TP28**

| Depth From (m) | Depth To (m) | Strata Description | Legend | Testing / Samples |
|---|---|---|---|---|
| | | End of trial pit at 2.20m.<br>Groundwater ingress at 0.60m (perched).<br>Trial pit remained stable.<br>Trial hole backfilled with arisings on completion. | | |

Based on the results of the ground investigation, localised perched groundwater ingress should be anticipated across the site. It is recommended that allowance be made for some groundwater control measures (i.e. pumping equipment) particularly during wetter periods of the year, as the materials encountered may deteriorate following exposure to surface water.
