Our Ref: 4046-G-L031 Rev A

Date: 30<sup>th</sup> May 2023

**Phase 3B Bolt-on Edgehill Park & Former Phosphate Storage Area – Verification of Delineation & Excavation of Slag/Concrete Sub-base & Metal Contaminated Granular Made Ground**

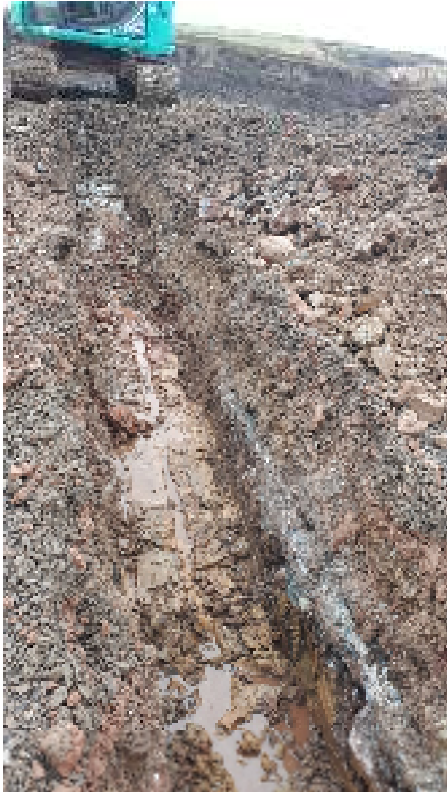
Slag and Concrete Sub-base was encountered in TP1111 & TP1111A beneath the rear garden and footprint of a proposed residential access at the rear of Plots 213-215 within Phase 3 of the development. Chemical analysis presented in correspondence reference 4046-G-L028 Rev C has not identified any contamination in the Slag & Concrete Sub-base Made Ground. However, the material was considered physically unsuitable to remain at shallow depth within rear gardens, although was considered suitable to be retained as sub-base beneath the shared residential access driveway.

| <b>Photograph 2:</b><br><br>Trial Pit TP1111A exposed extent of re-concretised Slag/concrete sub-base and underlying Glacial Till. | | | |

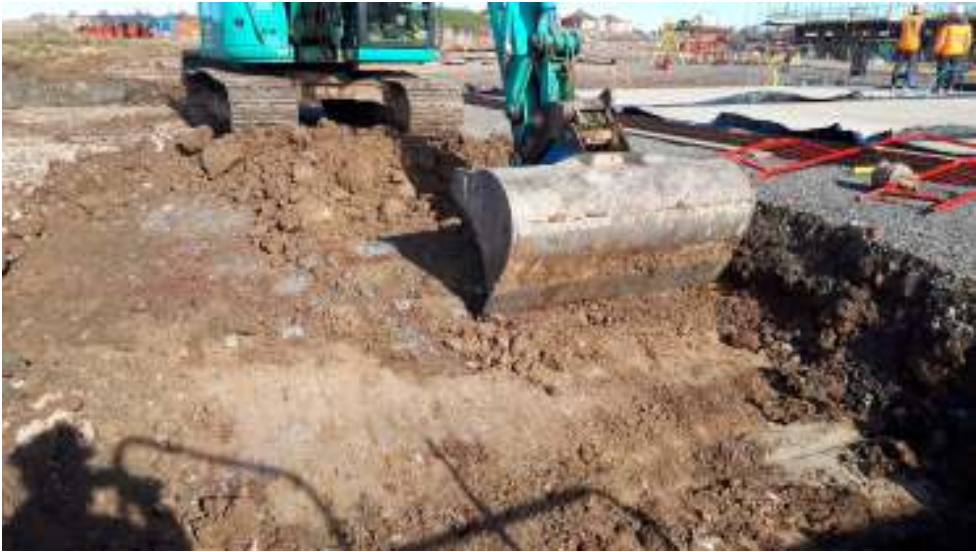
| <p><b>Photograph 3:</b></p> <p>Excavation of Slag/concrete sub-base.</p> | | | |

Delineation and excavation was undertaken by RHI Ltd on the 8<sup>th</sup> March 2023 supervised by IDG. The Sub-base was excavated from depths of between 0.15m and 0.75m from an area of approximately 47m<sup>2</sup> depicted on Drawing reference 4046-G-D065 Rev C in Appendix A. Approximately 20m<sup>3</sup> of Sub-base material was deposited directly into the excavation for the adjacent residential access drive. The extent and depth of the Sub-base excavation and the depth and extent of the access drive were surveyed by RHI Ltd. A copy of the survey is presented in Appendix A. A photographic record of the excavation and placement within the road cutting is provide in Appendix C.

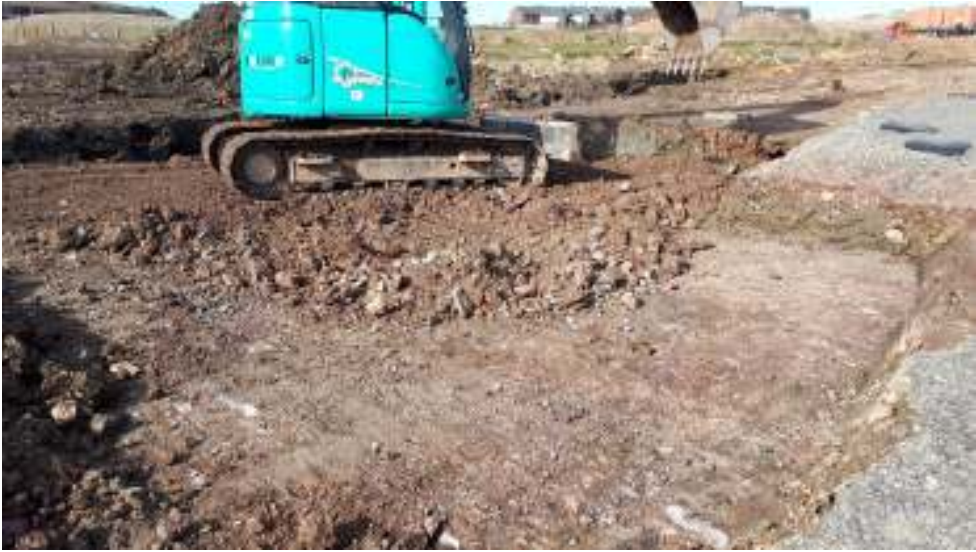
| <p><b>Photograph 4:</b></p> <p>Slag/concrete being tracked in to access drive, parking &amp; hardstanding footprint.</p> | | | |

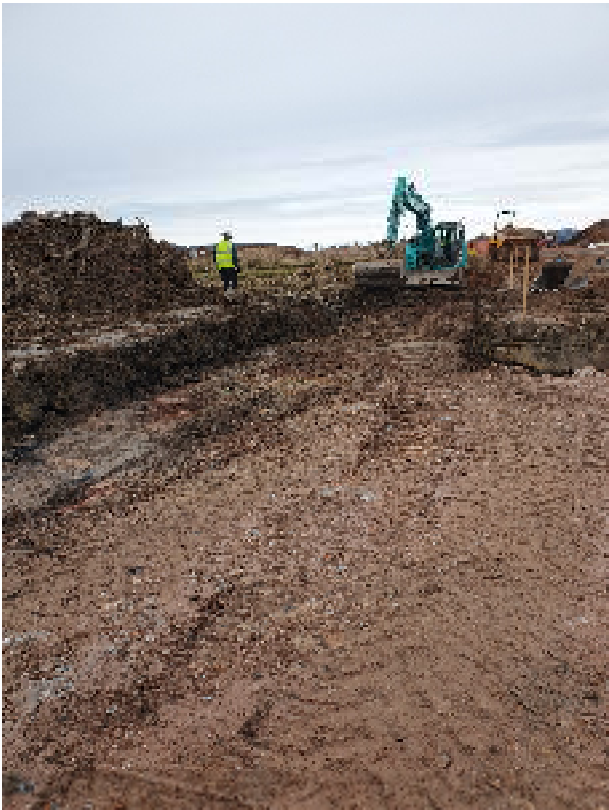
| <b>Photograph 5:</b><br><br>Continuation of access drive footprint excavation to accommodate Granular Made Ground | | | |

Delineation and excavation of the Granular Made Ground was undertaken by RHI Ltd on the 8<sup>th</sup> and 9<sup>th</sup> of March by RHI Ltd supervised by IDG. The Granular Made Ground was excavated from the site surface to depths of between 0.35m and 0.7m from an area of approximately 350m<sup>2</sup> depicted on Drawing reference 4046-G-D065 Rev C. Approximately 200m<sup>3</sup> of Granular Made Ground was placed upon visqueen at the location depicted on Drawing 4046-G-L065 Rev C, prior to placement in the adjacent residential access drive. The stockpiled material was placed into the access drive cutting on 9<sup>th</sup> and 10<sup>th</sup> March 2023 by RHI Ltd. The extent of the access road footprint was recorded by survey prior to and post placement.

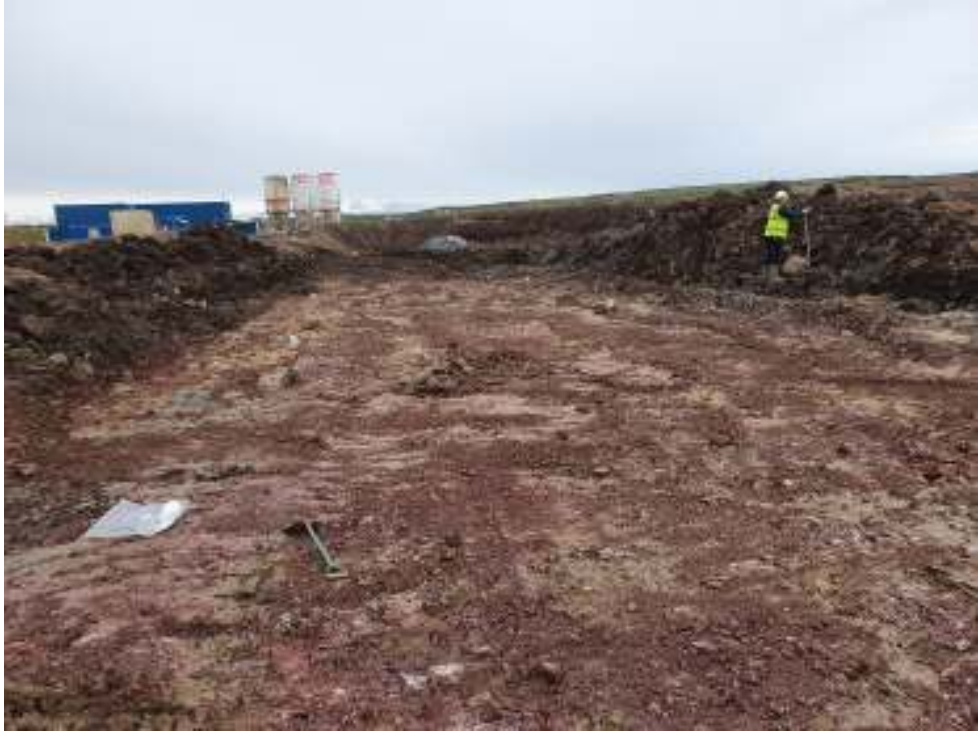
Granular Made Ground comprising red-brown and purple-brown coarse sandstone gravel and cobbles which contains elevated concentrations of arsenic and beryllium was encountered in TP1108.

| <b>Photograph 6:</b><br><br>Delineation & excavation of Granular Made Ground extended from TP1108. Note sample tubs at sampling locations. | | | |

Samples were obtained from the base of the excavation to demonstrate complete removal of the Granular Made Ground. Samples were dispatched to the chemical laboratory with a representative testing schedule including pH, arsenic & beryllium. The laboratory results have been compared with current S4UL and C4SL screening criteria for a residential with plant uptake screening criteria; The results are presented in Appendix B.

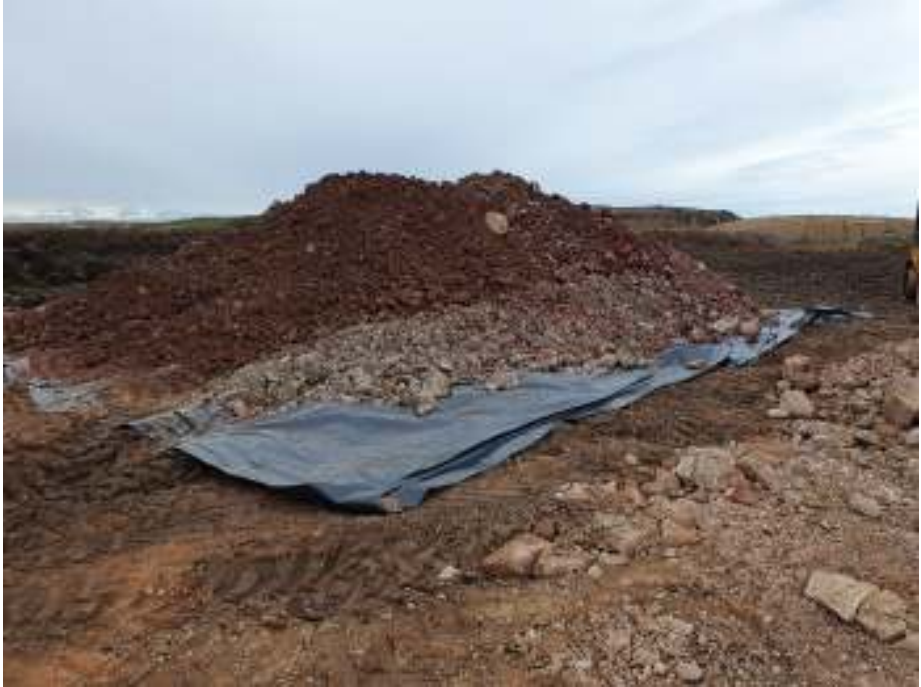
| <b>Photograph 7:</b><br><br>Stockpile of Granular Made Ground on visqueen. | | | |

A photographic record of the excavation, stockpiling and placement into the access drive is provided in Appendix C.

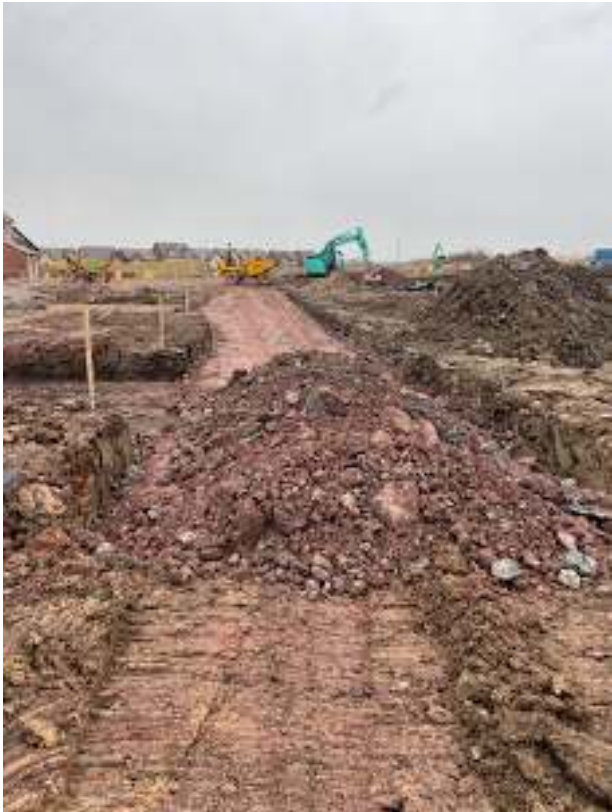
| <b>Photograph 8:</b><br><br>Granular Made Ground being placed into access drive cutting. | | | |

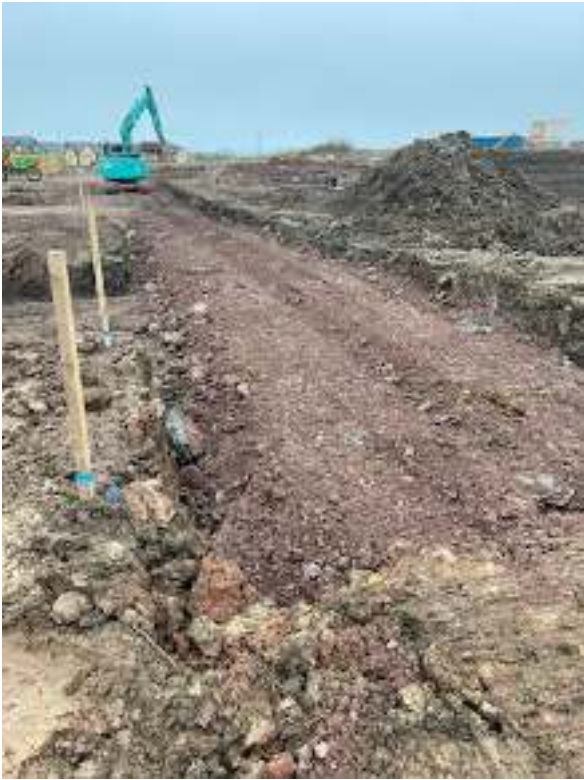
| <p><b>Photograph 9:</b></p> <p>Granular Made Ground removed from visqueen (right of excavator) and placed in access drive cutitng.</p> | | | |

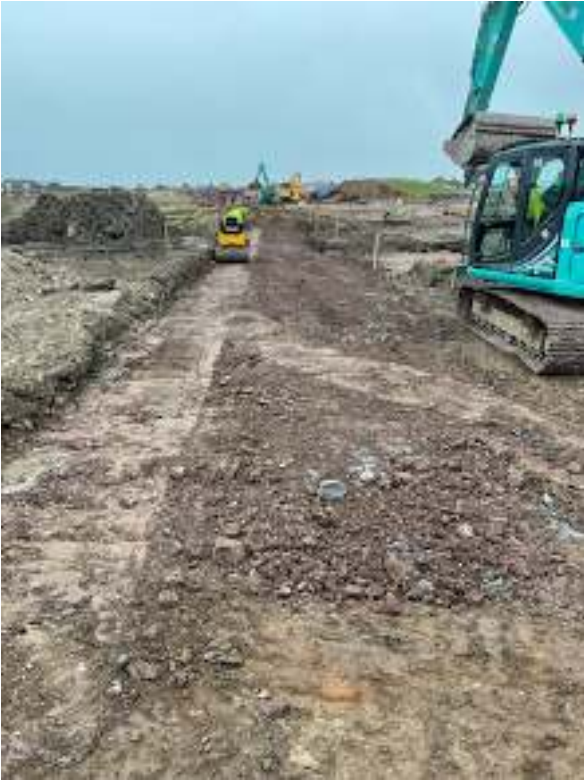
| <p><b>Photograph 10:</b></p> <p>Granular Made Ground being rolled into access drive footprint.</p> | | | |

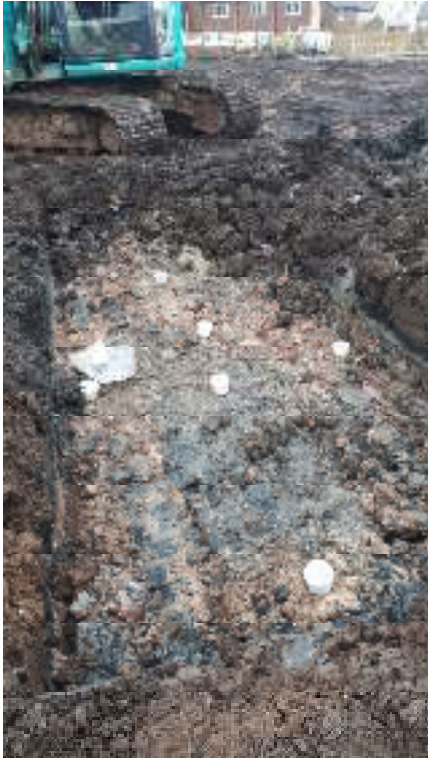
Samples TP1116-S1 – TP1116-S6 were obtained from the side walls and base of the Made Ground in the excavation. Laboratory screening did not detect any evidence of asbestos or asbestos fibres in any of the delineation samples.

| <b>Photograph 11:</b><br><br>Asbestos Delineation Pit excavated down 0.35m at position of TP1116 to expose underlying Glacial Till deposits. | | | |

Detailed discussion of the delineation & verification of the removal of asbestos fibre contaminated soil is presented in IDG correspondence 4046-G-D028 Rev C and is summarised here to confirm remediation of Phase 3B is complete and the site is considered to be suitable for residential redevelopment. As discussed in the correspondence, IDG attended site on 16<sup>th</sup> February 2023. Approximately 3m<sup>3</sup> of Made Ground was excavated and placed upon visqueen and covered with visqueen to prevent any mobilisation of dust.

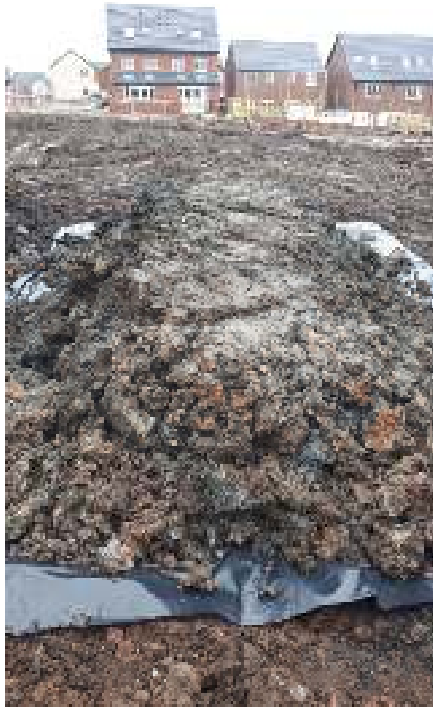
| <b>Photograph 12:</b><br><br>Excavated Asbestos fibre containing Made Ground placed upon visqueen and sealed with back of excavator bucket.. | | | |

Photographs of the delineation excavation and excavated soil stockpile are reproduced in Appendix C. The Waste Transfer Note presented in Appendix D confirms that the 8.6T stockpile was removed from site on 15<sup>th</sup> May 2023 by G & AM Lawson and disposed of to Port Clarence Landfill Site, off Huntsman Drive, Stockton on Tees TS12 1UE operated by Augean Limited.

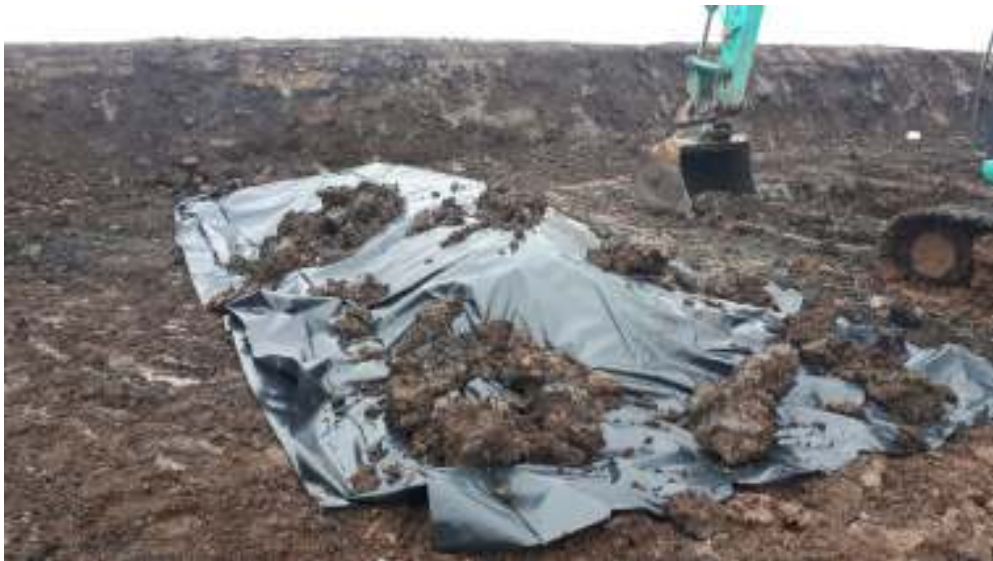
| Photograph 13:<br><br>Made Ground stockpile covered with visqueen, weighted with soil to resist predicted high winds. | | | |
