**Endoscopic Inspection of 'bricked up arch' - Distington Walled Garden,  
Distington, Workington, Cumbria, CA14 4QY**

**Our Ref. No.:** CC26BAT027  
**Date:** 14 October 2026  
**Your Ref. No.:** CU00066684

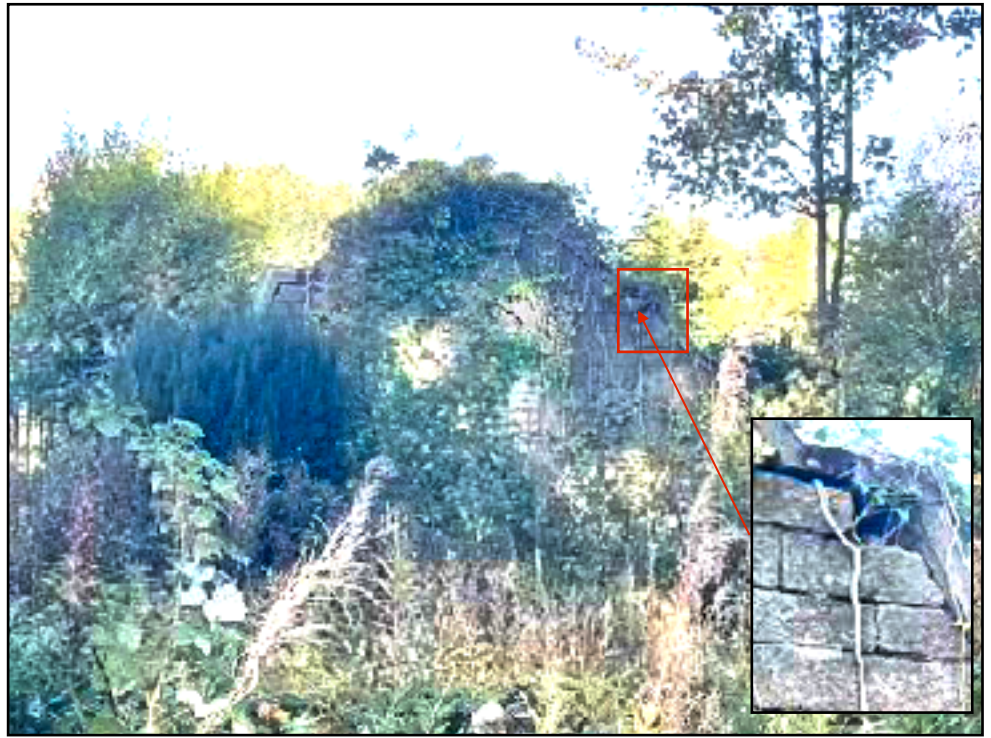
The identified gaps on the southern side - beneath wall top coping stones - were inspected in detail, with the entirety of the crevice which is of a size adequate to permit bat access being visible using an endoscope. These crevices were broadly very simple spaces, with friable mortar debris present and invertebrates were abundant. Garden snails (*Cornu aspersum*), common shiny woodlouse (*Oniscus asellus*) and common rough woodlouse (*Porcellio scaber*) were all found to be abundant as were slugs (species unknown). These species all favour damp and humid conditions. No evidence to suggest bats have been present within these

gaps was identified. No droppings, staining or disturbance of natural debris (loose mortar and frass) indicative of bat access was identified. Gaps beneath wall top coping stones on the southern side of the wall are deemed to offer no more than 'negligible' suitability roosting habitat for bats.

**Figure 3:** Showing the southern side of the 'Stone Walled Garden Entrance' with details of 'negligible' suitability potential roost features inset.

- The works should be conducted under a precautionary Ecological Watching Brief so as a re-checking inspection can be conducted and appropriate action taken should signs of bats be encountered.
- During the remediation of the existing stone arched garden entrance the coping stones will be lifted vertically, the crevice beneath inspected and cleaned out and then the stones re-sited on a bed of mortar - rather than just being re-pointed.
- Gaps within the intrados of the arched entrance should be retained / reinstated once the brick infill has been removed. Whilst no evidence of bats was identified, and the potential of this feature is currently considered to be 'negligible', the potential offered could be enhanced by creating a more enclosed and less exposed ingress / egress.
