# Heritage Impact Assessment

## *6 Duke Street Whitehaven*

Surface mounted LEVELS signage

CA28 7ER | 28 September 2026

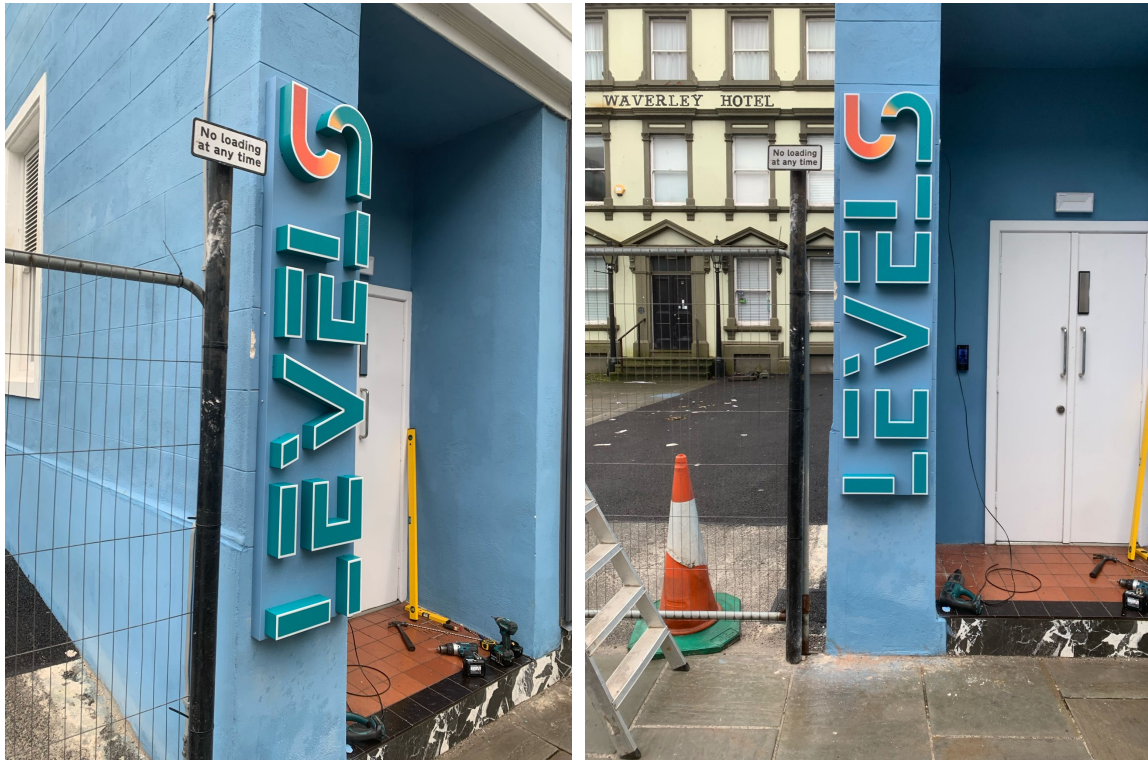
Photograph 1 at left shows the tray and lettering in oblique view. Photograph 2 at right shows the sign face and its relationship to the entrance pier and the Waverley Hotel beyond.

The blue tray reduces contrast with the surrounding surface, but occupies much of the pier width. The photographs do not establish the concealed fixing arrangement or whether the visible cable represents the completed installation.

The vertical sign occupies the narrow wall face beside the recessed entrance. Its blue backing reduces contrast with the painted surface. It does not appear to conceal the adjacent window opening or upper-storey decoration.

The sign occupies much of the available width and creates a conspicuous vertical element. The tray conceals part of the scored wall treatment, while raised lettering and the bright accent colour attract attention in close street views, including towards the Waverley Hotel. These effects are localised, but its relationship with the entrance pier warrants attention when confirming dimensions and projection.

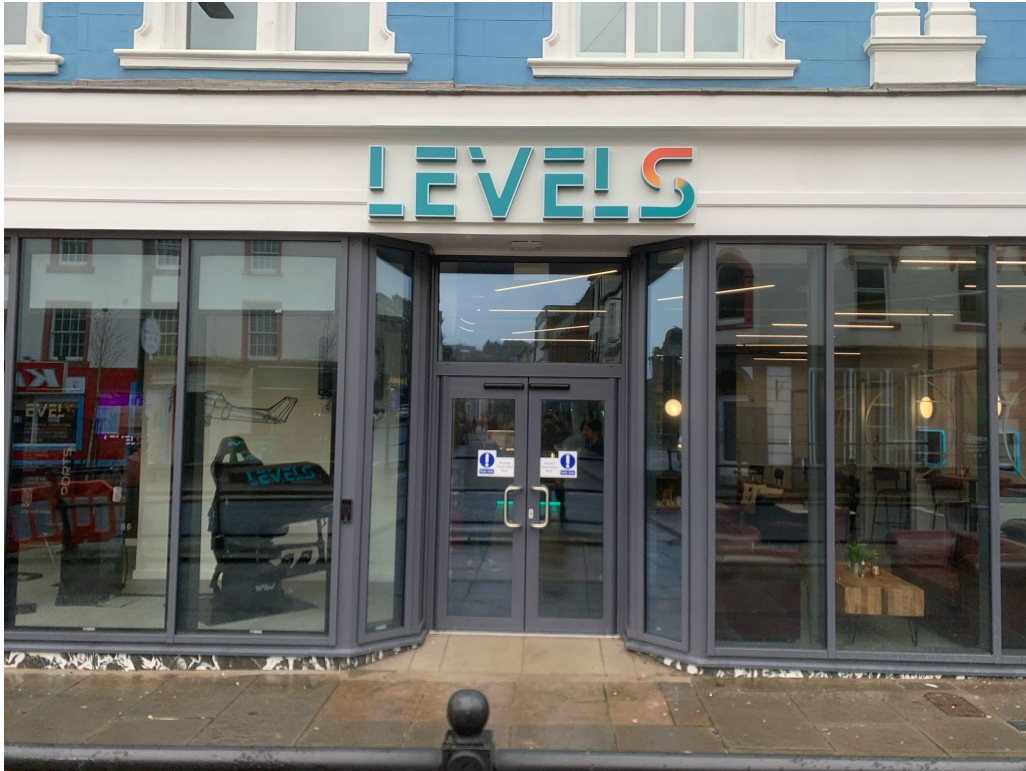
Photograph 3 Front view of the horizontal sign above the principal entrance.

The horizontal sign sits above the principal entrance within the ground-floor fascia. Its limited extent relative to the overall frontage allows the upper-storey windows, pilasters and decorative features to remain visually prominent. Its position relates logically to the commercial use and entrance.

The backing tray nevertheless introduces an additional rectangular surface and visible depth. Photographs 3 and 4 show it apparently covering a short section of horizontal fascia moulding and interrupting its continuity. Matching the surrounding colour reduces contrast but does not remove this effect. The age and significance of the affected fascia material require confirmation: covering modern replacement fabric and cutting or drilling historic mouldings have different implications.

- Confirm dimensions, materials, finishes and total projection in a coordinated drawing.
- Investigate whether the horizontal tray can avoid covering the fascia moulding.
- Record fixing locations, number, diameter, depth and receiving substrate; reuse suitable existing fixing positions where feasible and avoid decorative features.
- Conceal cabling along agreed routes that minimise intervention into historic fabric.
- Specify restrained, static illumination, with brightness and operating hours justified for this location.
- Record affected surfaces and provide compatible repair details for redundant holes or future removal.

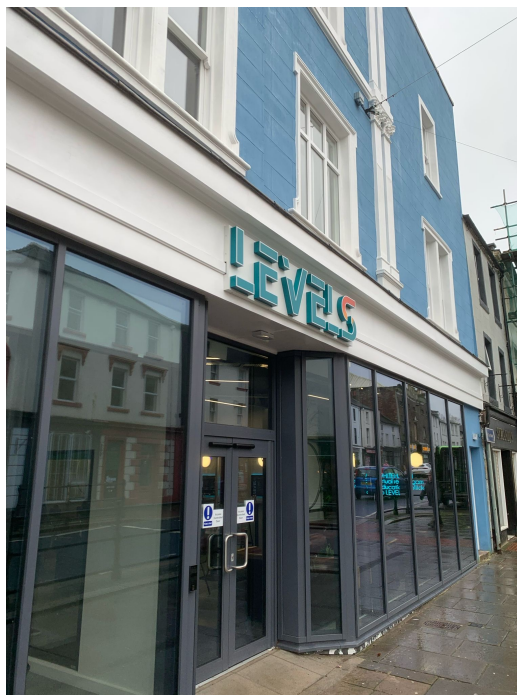
Photograph 4 Oblique view showing tray depth and the apparent interruption of the fascia moulding.
