**RE: MILLOM IRON LINE - MAINSGATE ROAD FOUL DRAINAGE LINK  
NATTERJACK TOAD PRECAUTIONARY METHOD STATEMENT AND ECOLOGICAL RISK  
ASSESSMENT**

# Natterjack Toad Precautionary Method Statement

Millom Iron Line - Mainsgate Road foul drainage link | Envirotech ref. 9977 | 2 September 2026

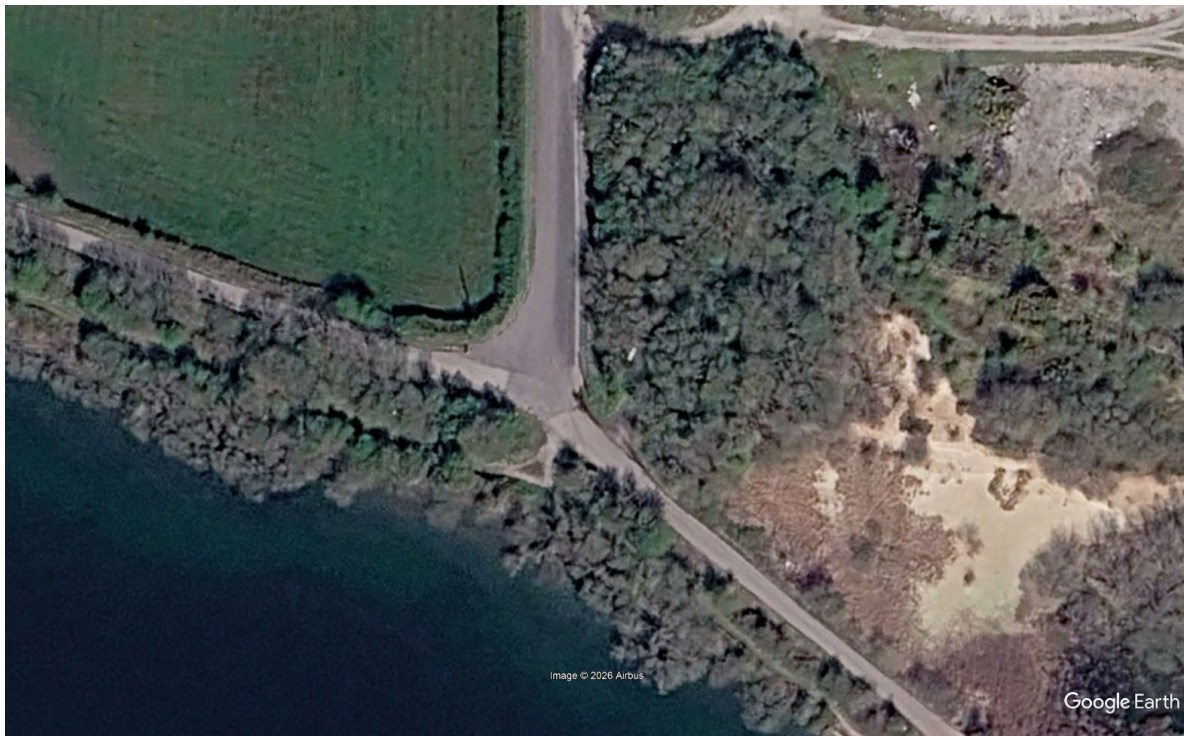
**Figure 1. Aerial view of the Mainsgate Road/access-road junction and wider setting. Source: Google Earth imagery supplied for the assessment.**

I have reviewed the supplied aerial image, site photograph and Curtins drawing MIL-CUR-RMG-00-DR-C-5241 P01. The proposal is to amend the alignment of the foul drainage link at Mainsgate Road. Approximately 4 m lies outside the route already consented under application 4/25/2198/0F1 and outside the highway authority's jurisdiction, requiring a separate planning application.

The application section is confined to existing tarmac road/hardstanding that is regularly crossed by vehicles. It contains no breeding, foraging, sheltering or hibernation habitat for natterjack toad. Although natterjack toads occur in very low numbers within the wider reserve, the chance of one entering this small work area is considered very low.

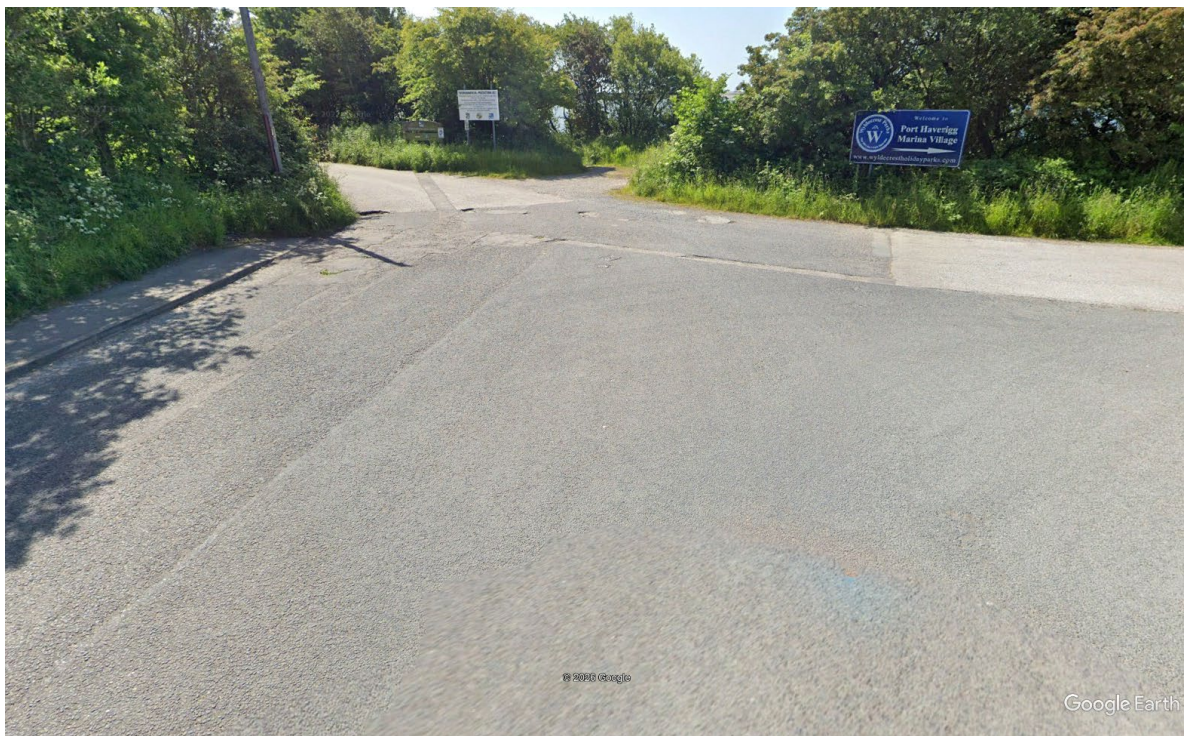
**Figure 2. View of the affected junction, showing the tarmac carriageway and hardstanding within the application section. Source: Google Earth image supplied for the assessment.**

Natterjack toad *Epidalea calamita* occurs in the wider reserve, but the local population is understood to be present only in very low numbers. The application footprint itself is tarmac road/hardstanding subject to regular vehicle movement. It contains no pond, bare sand, short open vegetation, burrowing substrate or ground-level refuges and is unsuitable as breeding or terrestrial habitat.
