**PHASE 2: GROUND INVESTIGATION REPORT &  
REMEDIATION STRATEGY**

**PROPOSED RESIDENTIAL DEVELOPMENT AT**

**FORMER BECKERMET SERVICE GARAGE**

**Report Ref:** 2026-7395

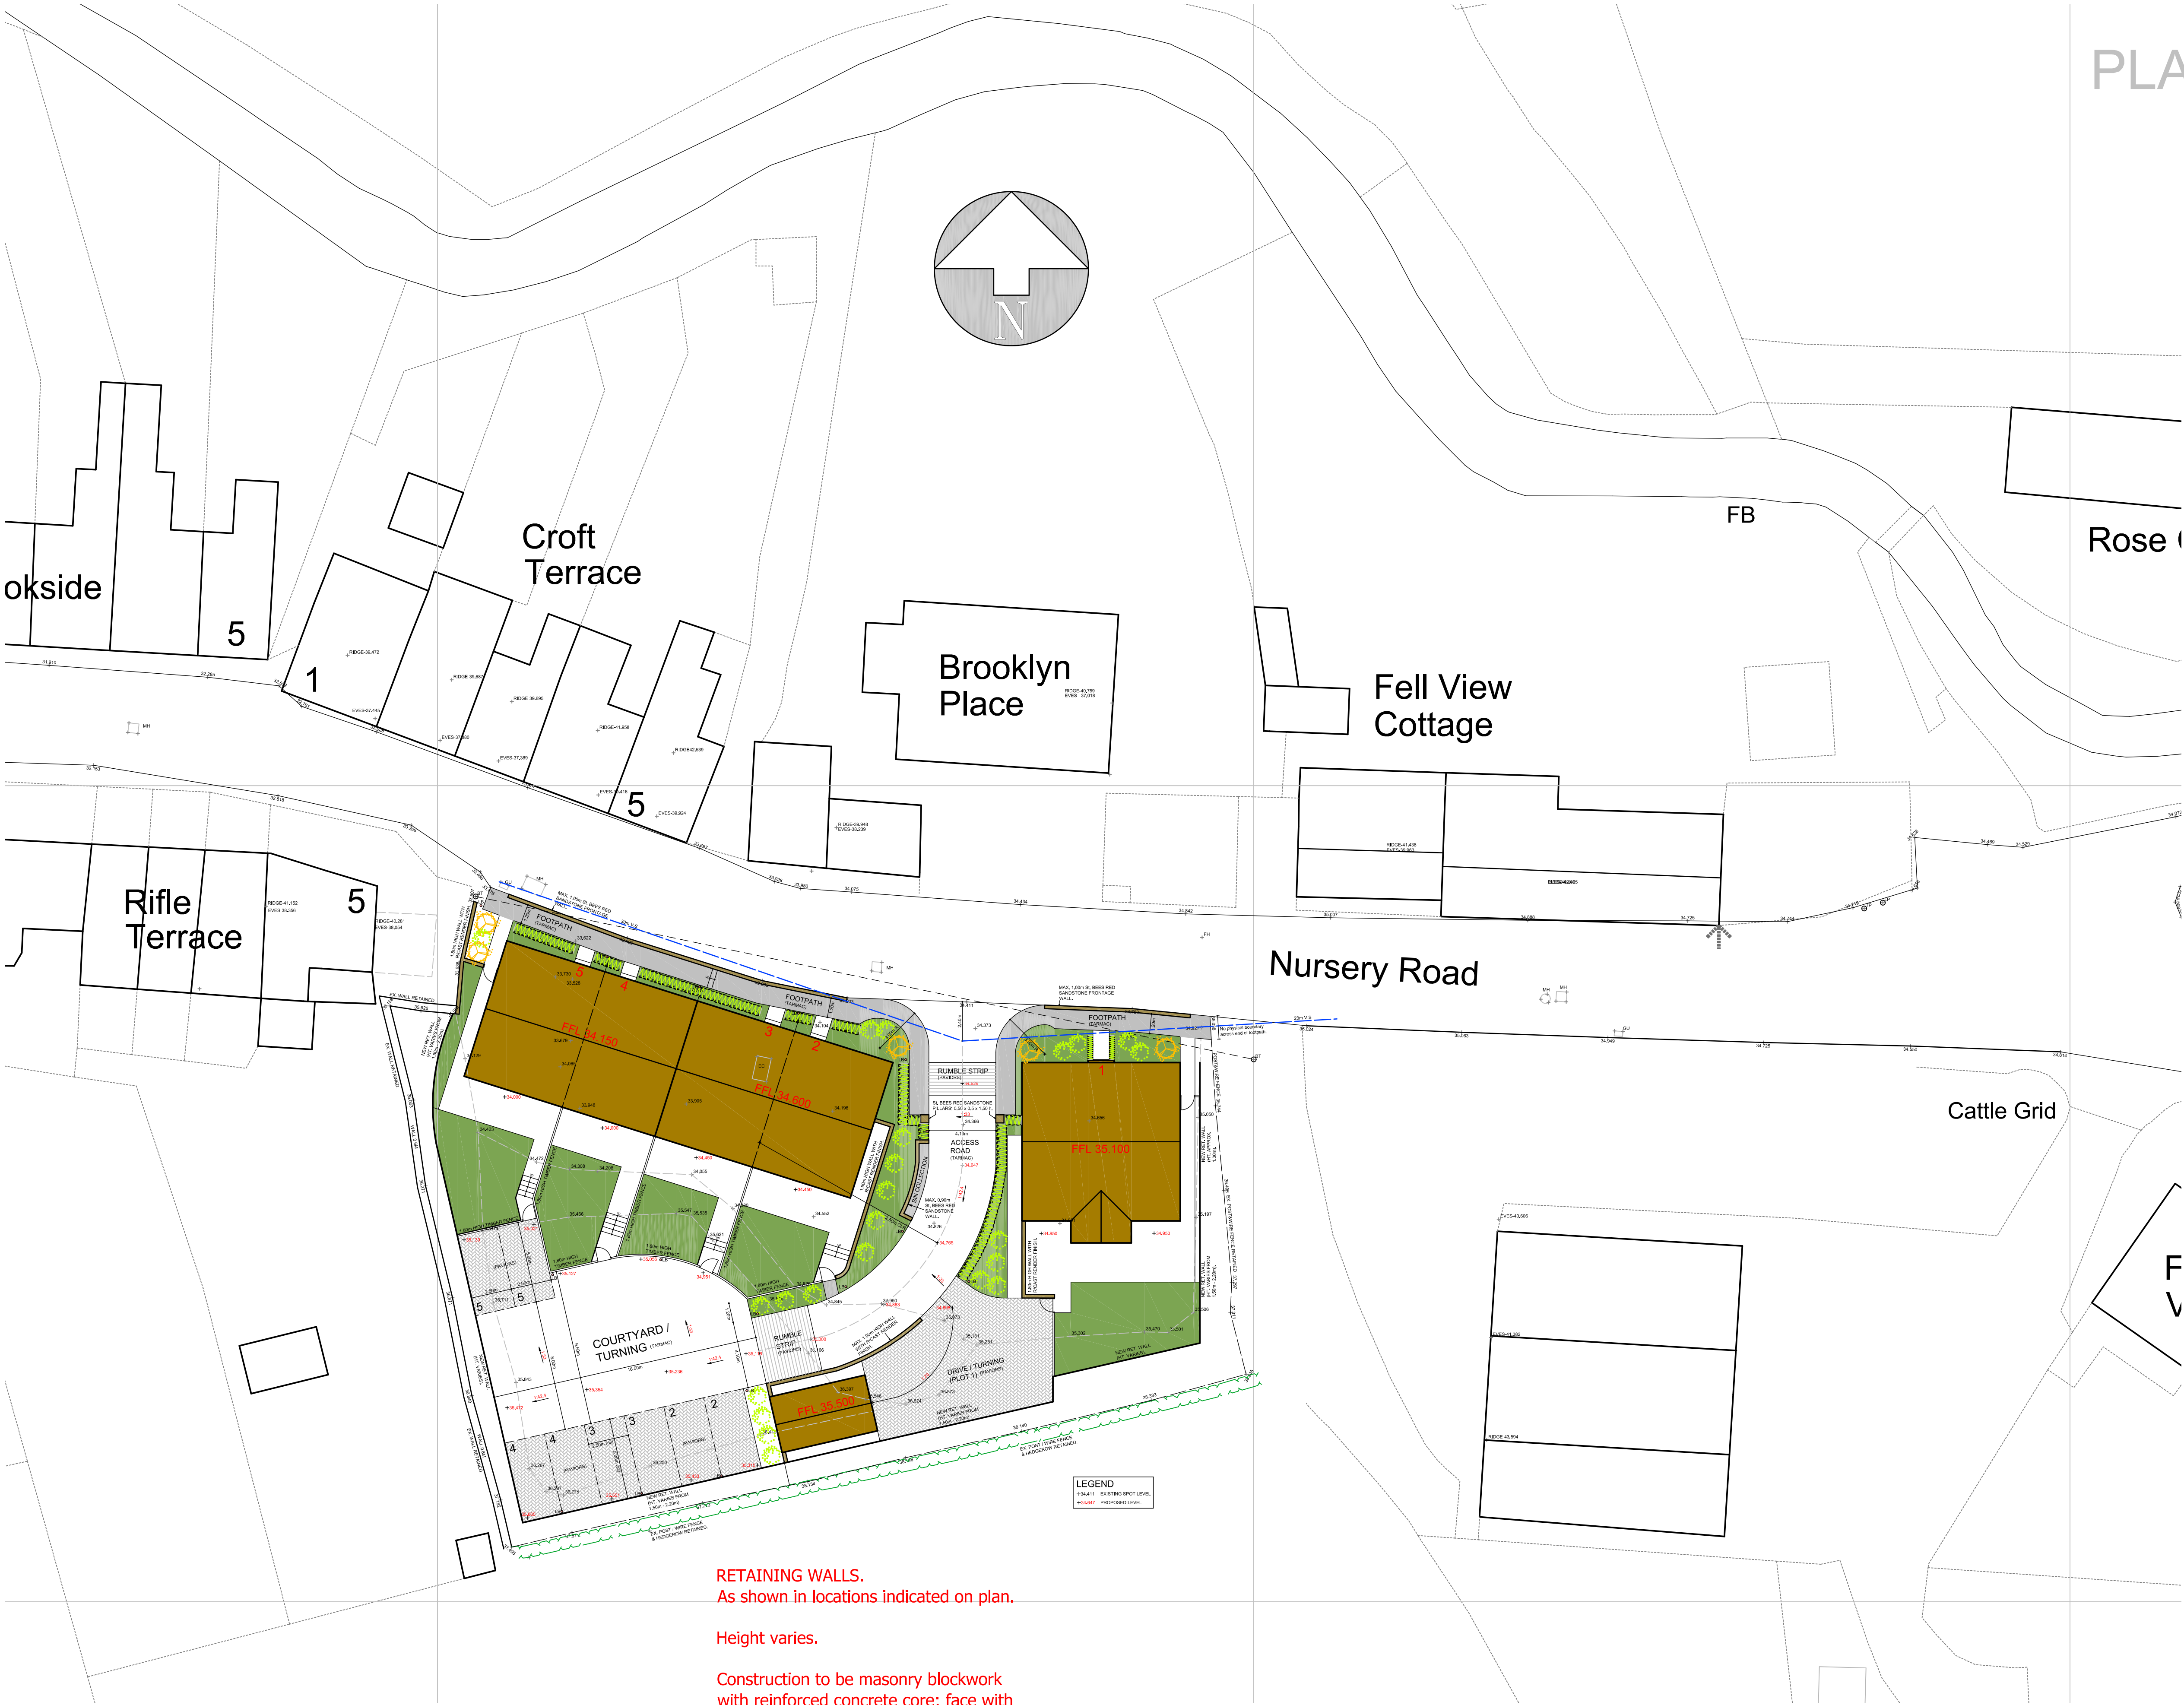
RETAINING WALLS.  
As shown in locations indicated on plan.

Height varies.

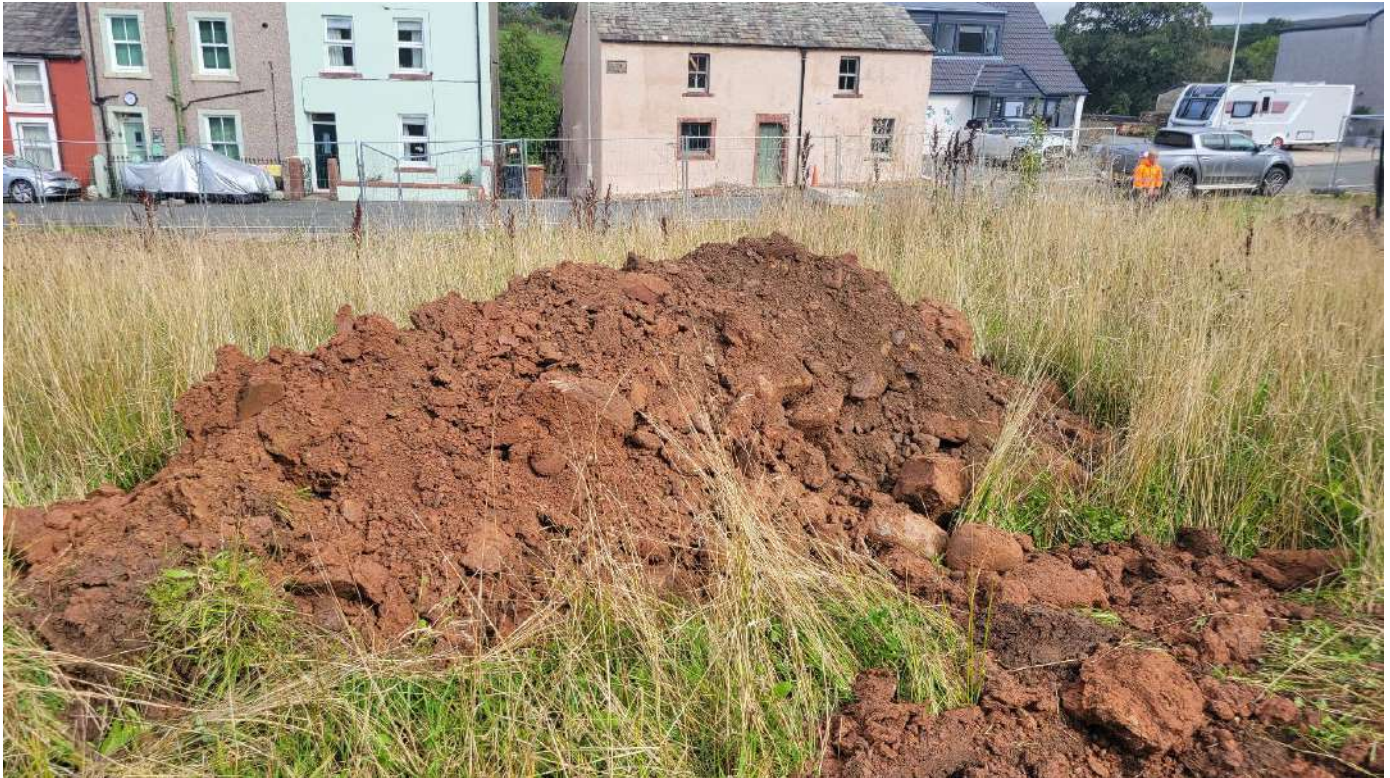
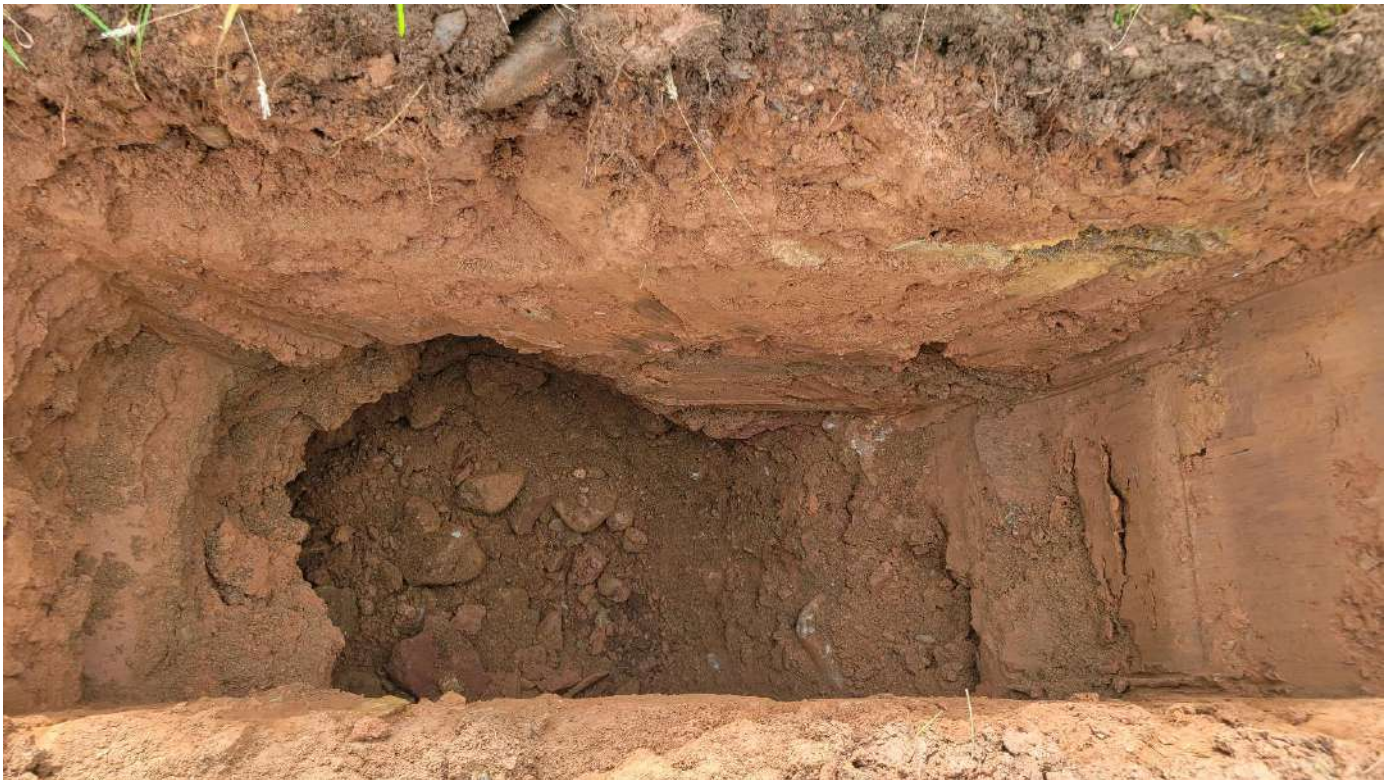
| Project Name<br>Land at Nursery Road, Beckermet | Project No.<br>GEO2026-7395 | | Start Date<br>2026-09-16 | End Date<br>2026-09-16 |

Visual and olfactory evidence of organic contamination was identified in TP06 between 0.50 and 0.80mbgl as black staining with an effervescent sheen present and a hydrocarbon odour. A hydrocarbon odour was also noted in TP01 from surface level to 0.40mbgl.

| Inst/<br>Backfill | Water<br>Levels | Samples and Tests | | | Level<br>(m) | Depth<br>(m) | Strata | | |
|---|---|---|---|---|---|---|---|---|---|
| | | 0.70 | ES 2 | | | (0.30) | | Soft dark grey slightly gravelly slightly sandy CLAY. Black staining and slight efferecent sheen present. Hydrocarbon odour present. | |
